Incident Summary #II-1512599-2023 (#32334) (FINAL)

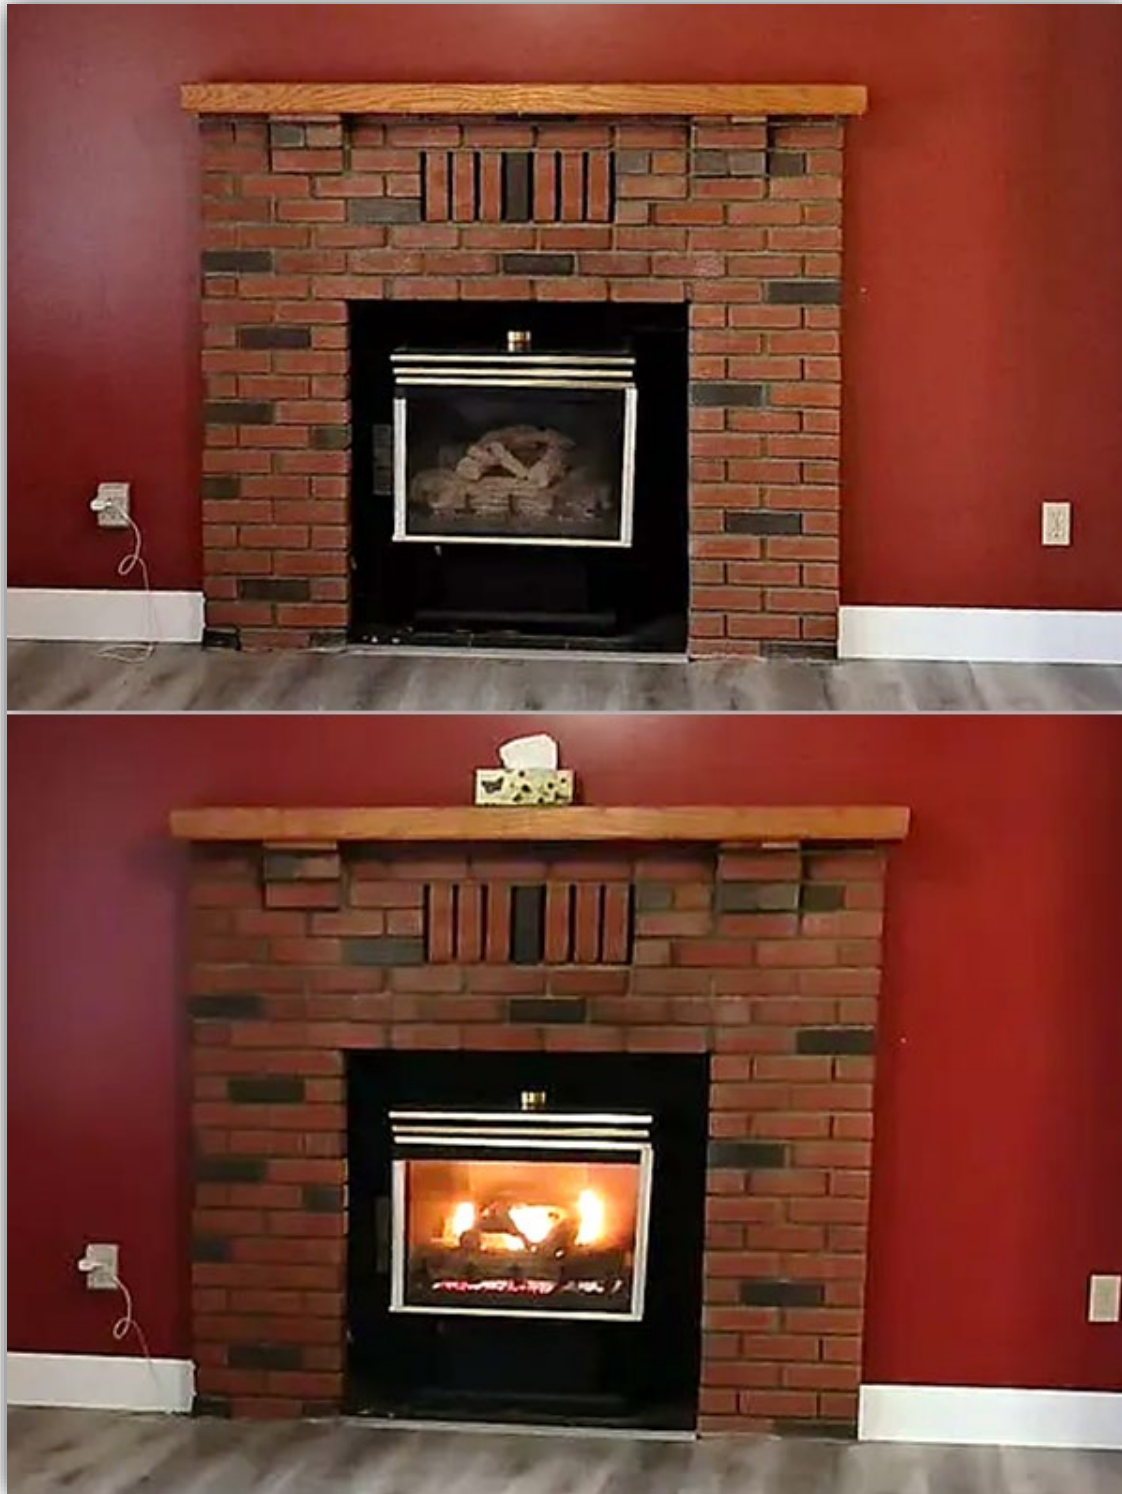
Photo 1 - The fireplace in operation in a realtor listing. The home was purchased approximately 1 month prior to the tenants moving in. This photo shows the aluminum trim pieces on the right side and the left side of the glass that were installed by previous owner to cover up the holes in the glass. (*Images taken from a public domain website*)

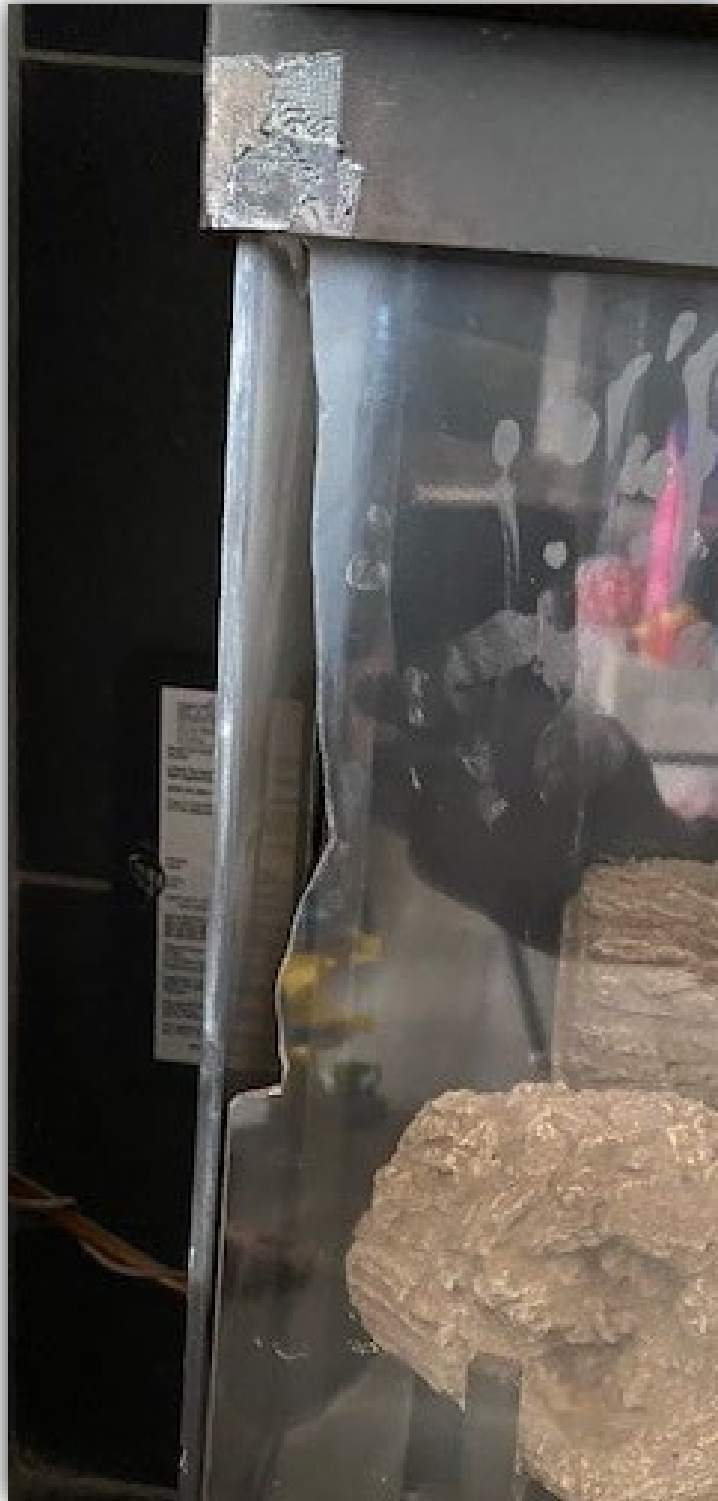
Photo 3 - Front glass panel with damage to glass on top left side.

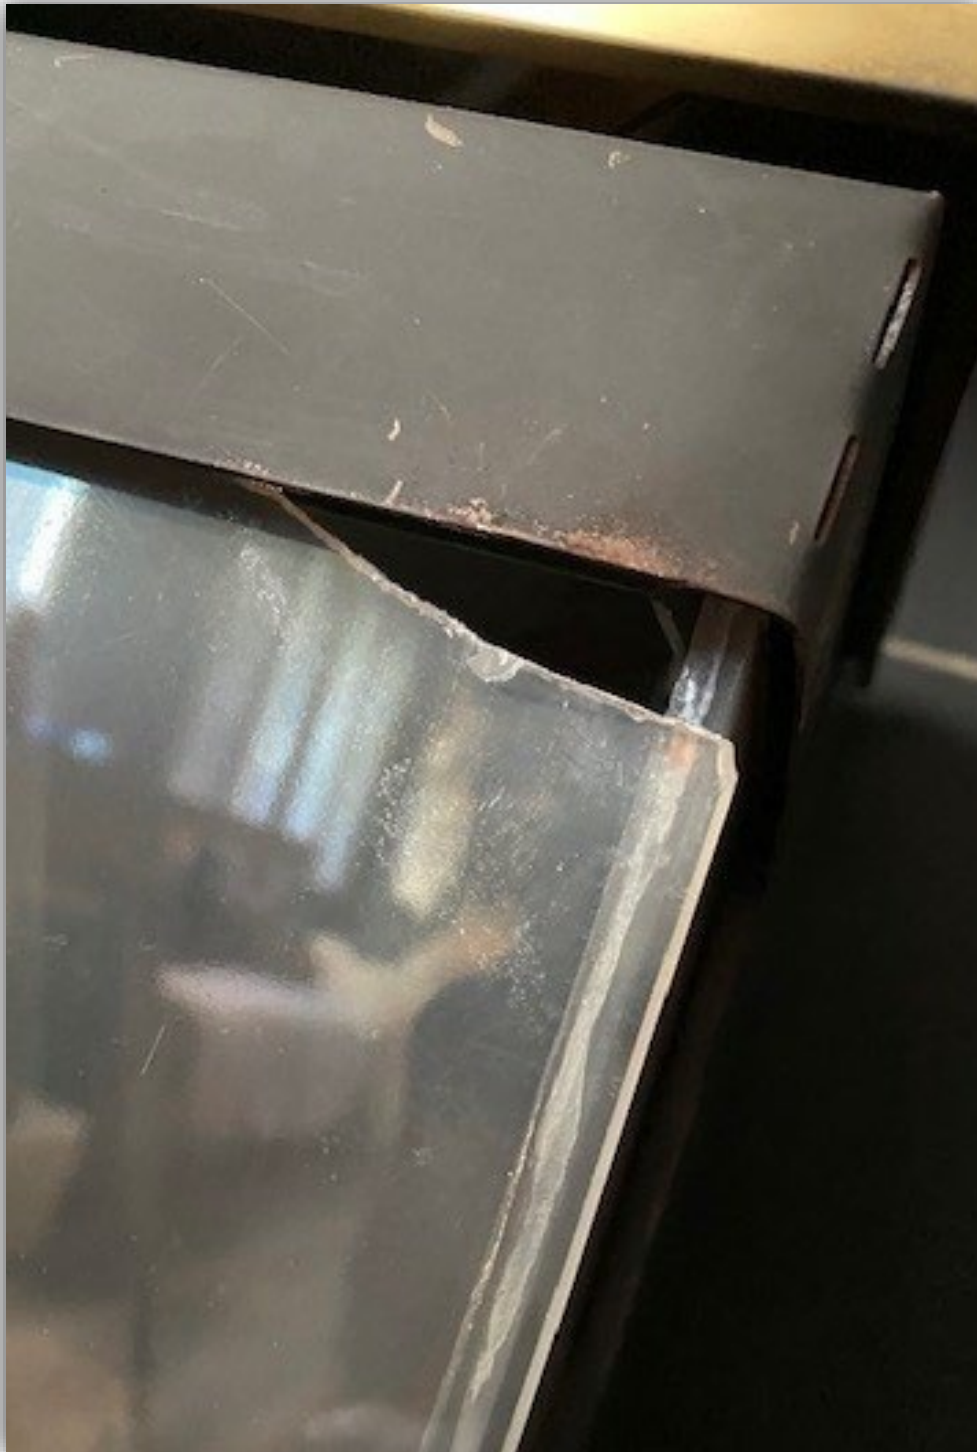
Photo 4 - Front glass panel with damage to glass on top right corner.

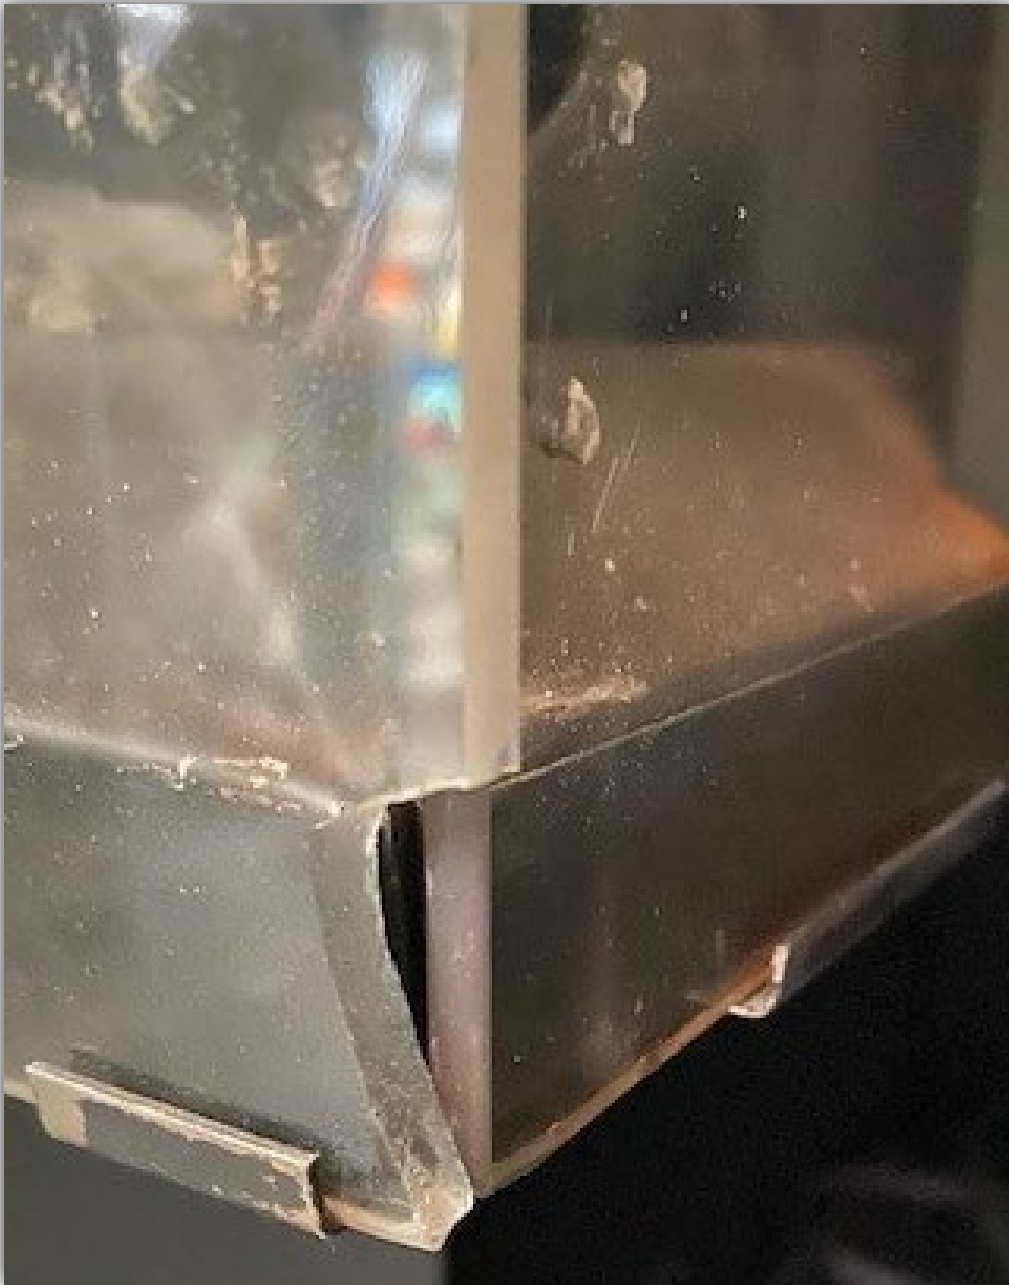
Photo 5 - Front glass panel with damage to glass at bottom right corner.

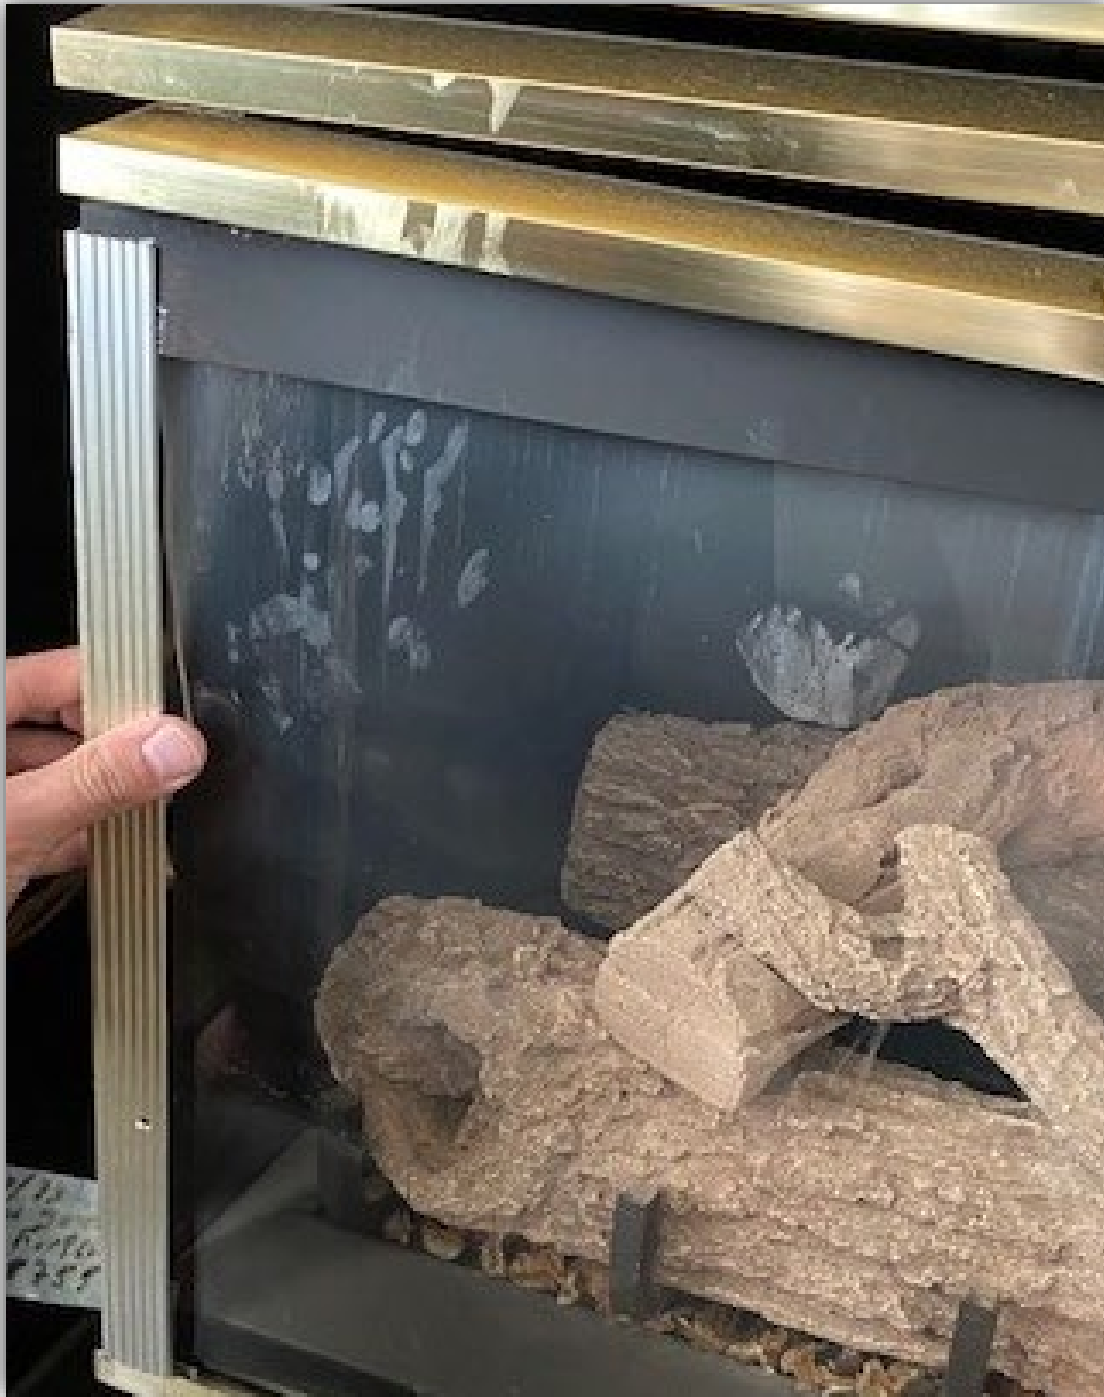
Photo 6 - Aluminum trim that was in place covering the damaged glass. This trim piece is not from the manufacturer.

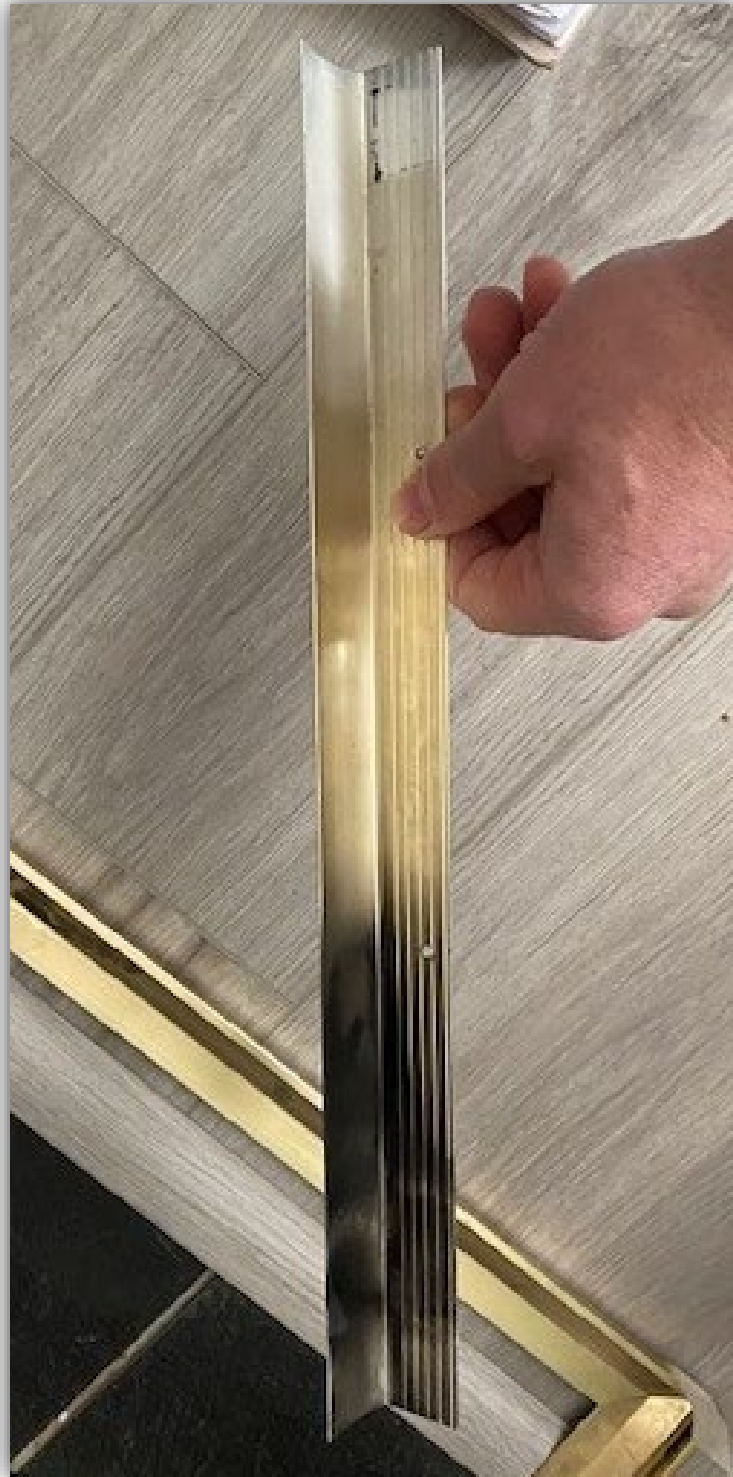
Photo 7 - The back of the left side aluminum trim piece showing discoloration from products of combustion from the damaged glass.

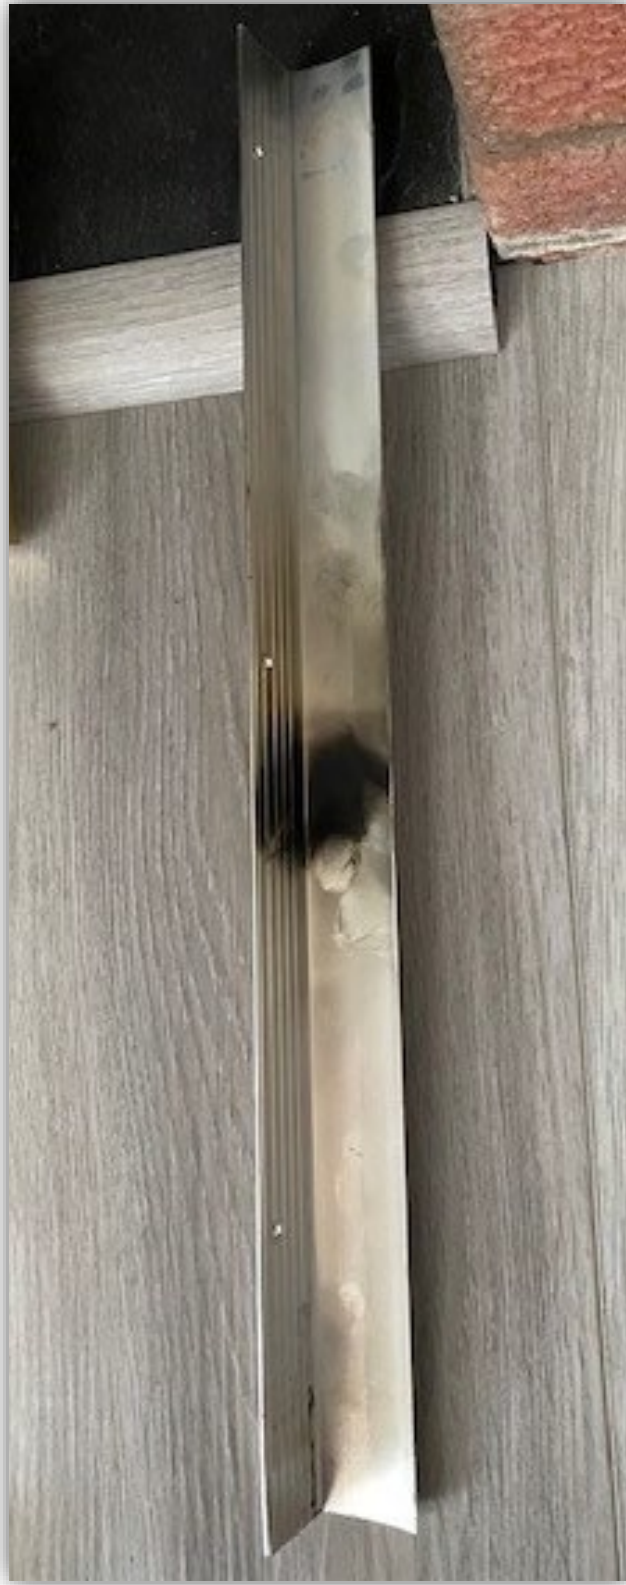
Photo 8 - The back of the right-side aluminum trim piece showing discoloration from products of combustion from the damaged glass.

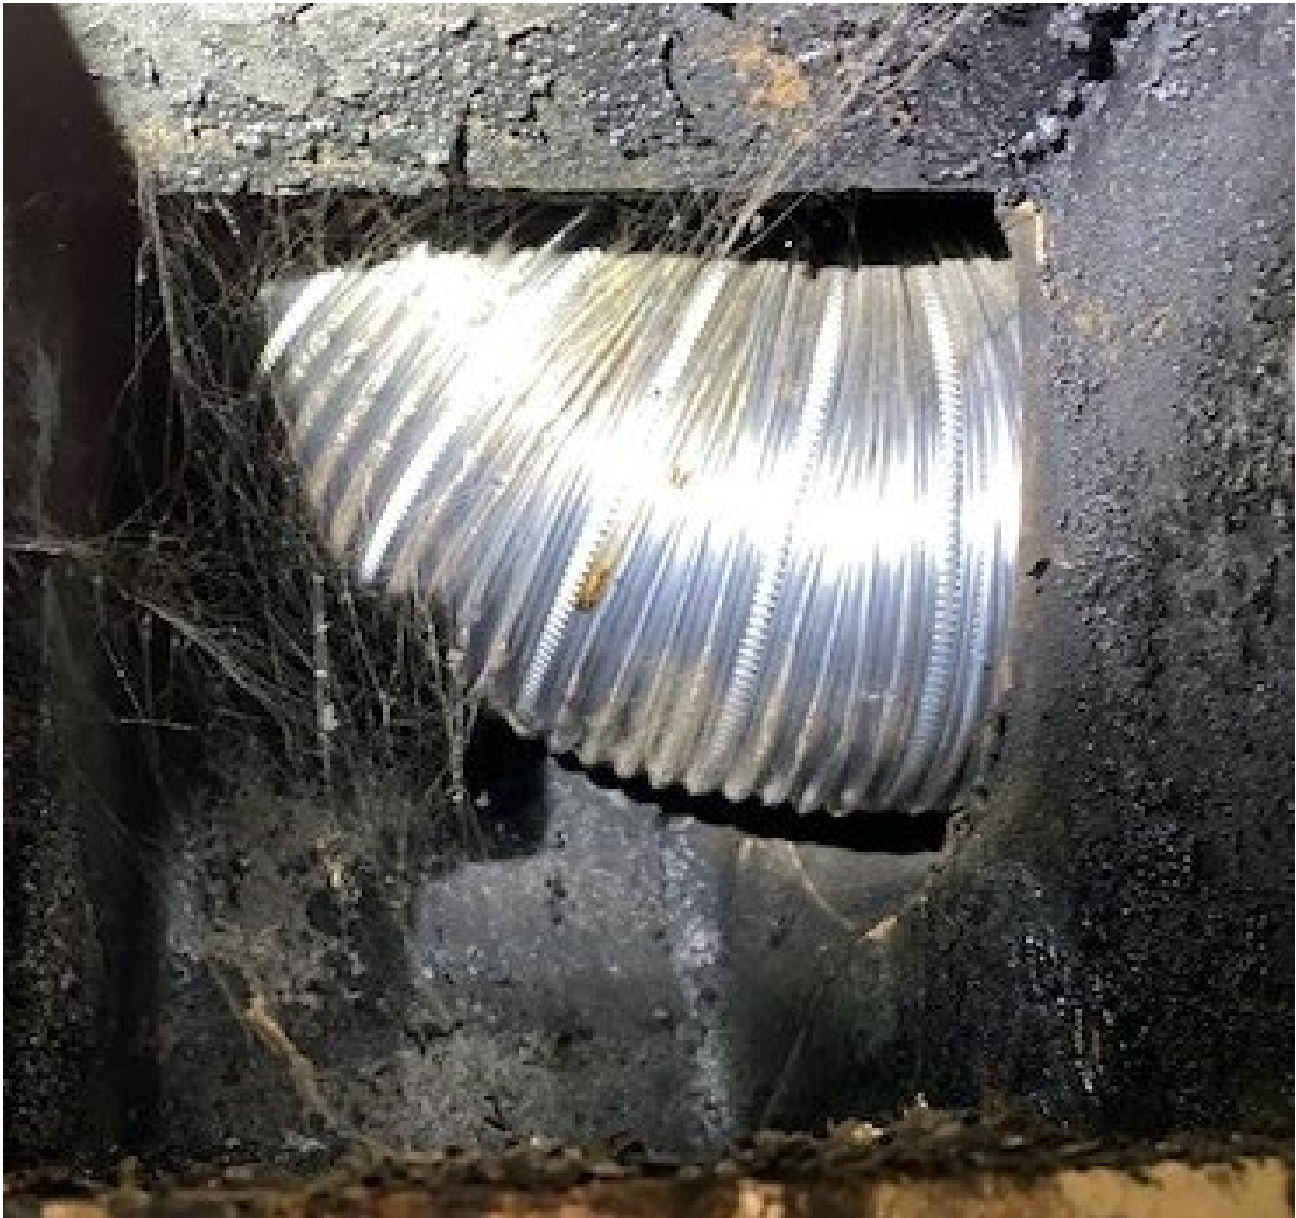
Photo 9 - Stainless steel chimney liner connected to the fireplace pulled through the existing masonry chimney. The installation manual does not describe using a chimney liner as part of the installation.

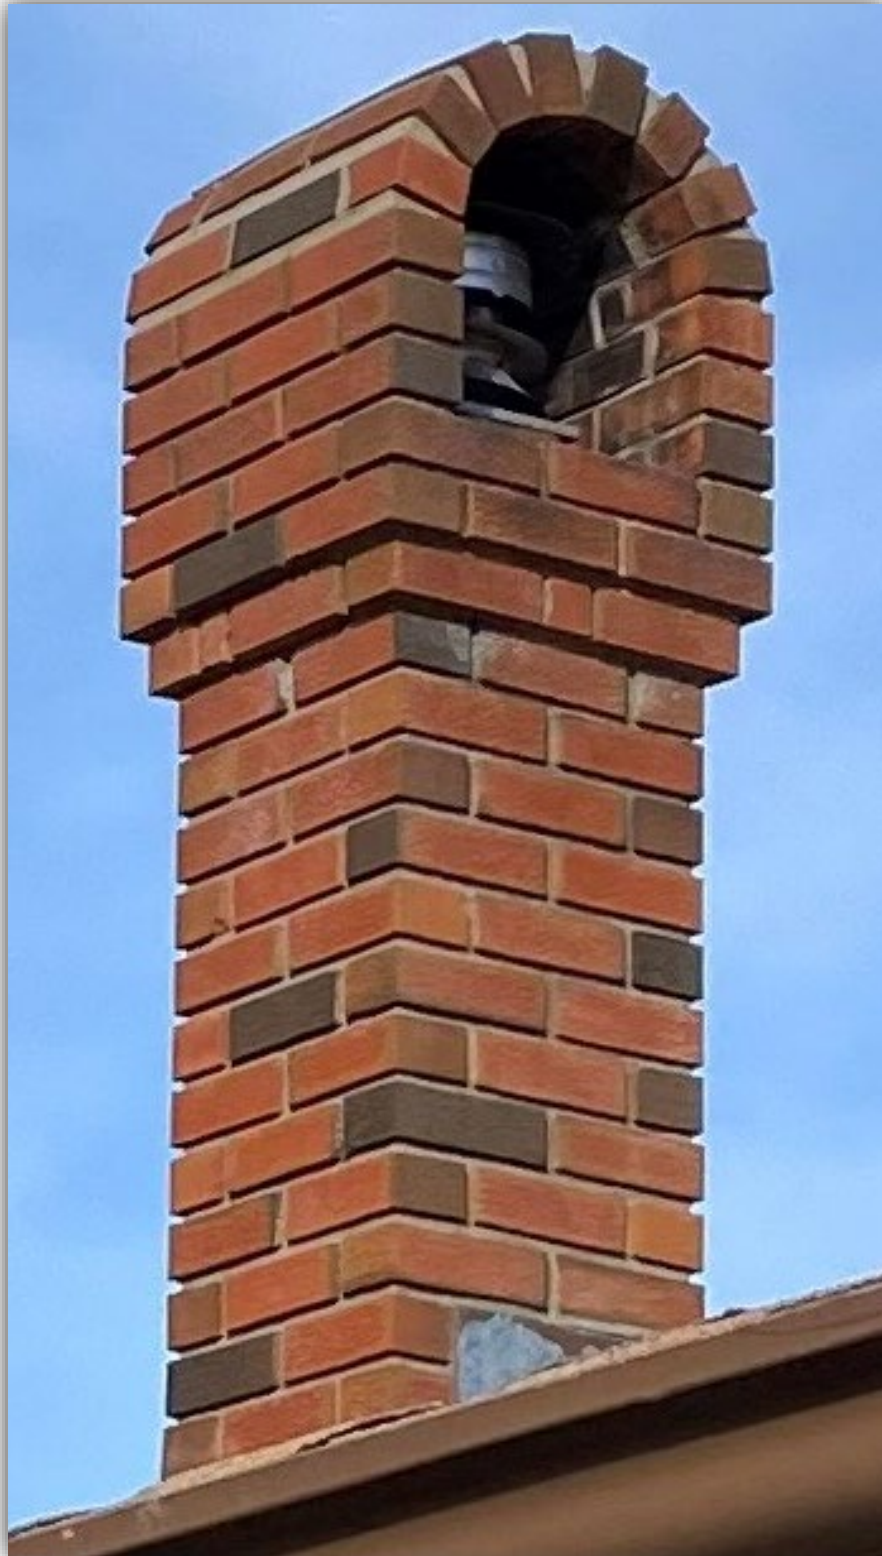
Photo 10 - The top arch of the existing masonry chimney is a restriction to the vent cap for the fireplace venting.
