Incident Summary #II-1157236-2021 (#21008) (FINAL)

SUPPORTING INFORMATION	Incident Date		March 6, 2021	
	Location		Cowichan Valley Regional District	
	Regulated industry sector		Gas - Propane system	
	Impact	Injury	Qty injuries	1
			Injury description	Burns to face, hands, ears, and legs.
			Injury rating	Major
	Damage	Damage	Damage description	Total loss of trailer and structures attached due to fire and explosion.
			Damage rating	Major
	Incident rating		Major	
Incident overview		A propane explosion and subsequent fire occurred in a recreational vehicle (RV) park on a 5 th wheel type trailer.		
INVESTIGATION CONCLUSIONS	Site, system and components		<p>A propane oven (make unknown) with four top burners and an oven has propane piping connected to an 80-gallon propane cylinder located outside the RV trailer (image 1). The stove and oven are controlled by five temperature controllers for each burner and one for the oven on the front side of the appliance (Image 3). When burner controllers are turned on, propane flows through the control valve to burner and is ignited by pilot burner.</p> <p>The stove does not have a pilot safety or thermocouple which, when pilot is lit, senses the

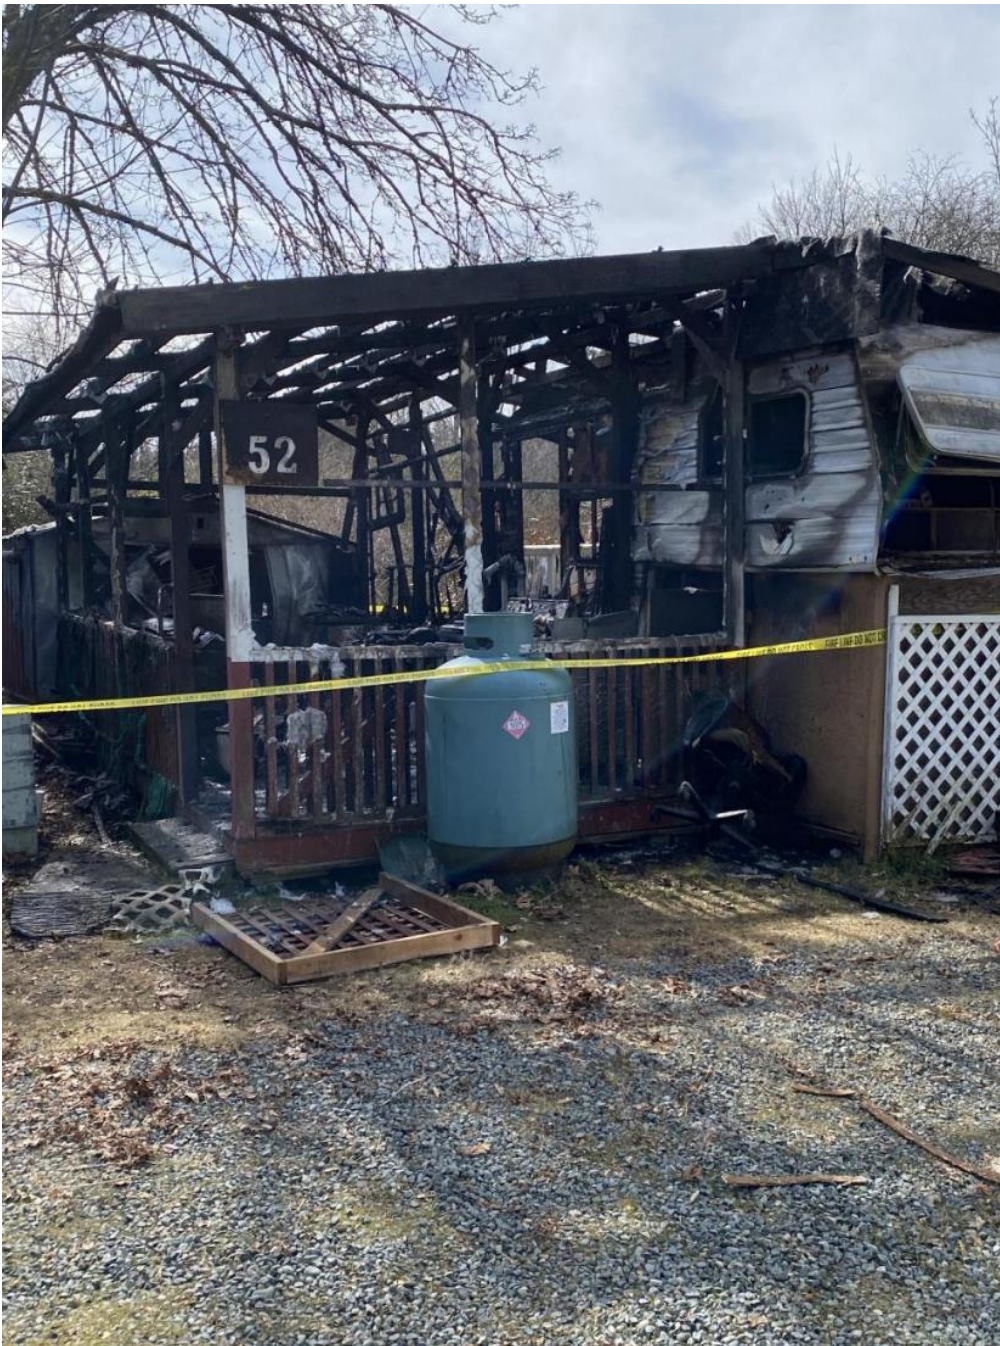
Image 1 - Structure fire Cowichan Valley 5th Wheel

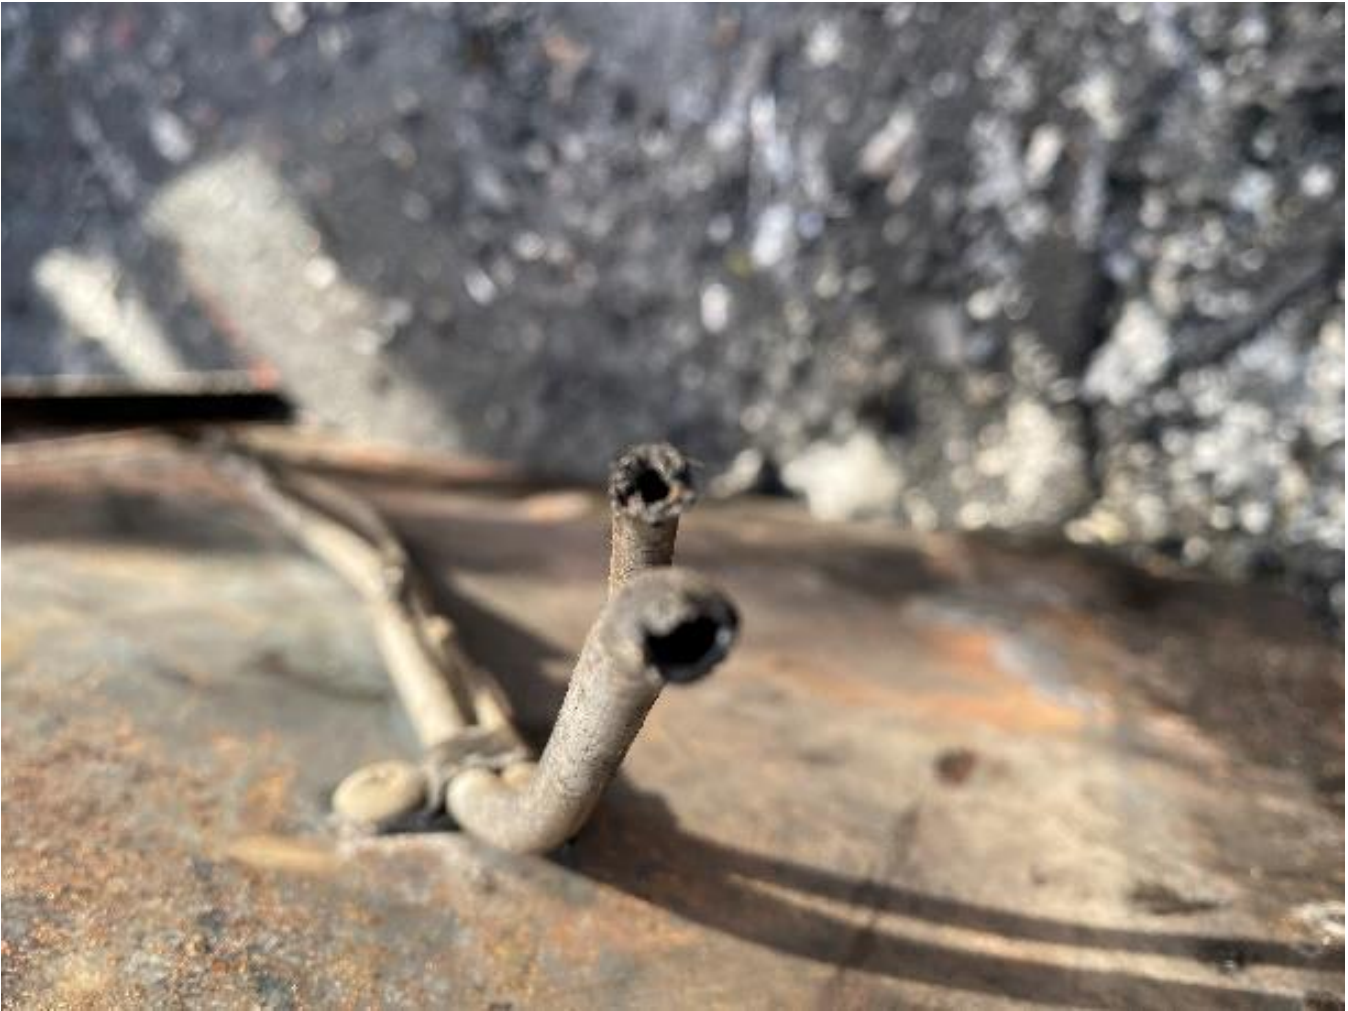
Failure scenario(s)		The pilot and main oven burner tubes at the back of stove had corroded allowing propane to leak into the back of the stove area. When the homeowner attempted light a stove top burner, propane which had pooled behind the stove ignited causing an explosion and fire.	
	Facts and evidence		<p>Witnesses stated the homeowner was lighting his stove top and in the process an explosion occurred causing severe injuries to himself and resulting in a fire that destroyed the 5th wheel trailer and surrounding structures.</p> <p>The propane stove is approx. 20 plus years old. The current owner has lived there 15 years and the trailer was not new when purchased.</p> <p>Site observations and photos show the gas tubing for the oven was severely corroded and separated at the back of the appliance (Image 2). Corrosion is believed to be caused by contact of two dissimilar metals, the aluminum piping, and the steel oven back.</p>

Image 2 - Corroded oven gas tubing behind stove

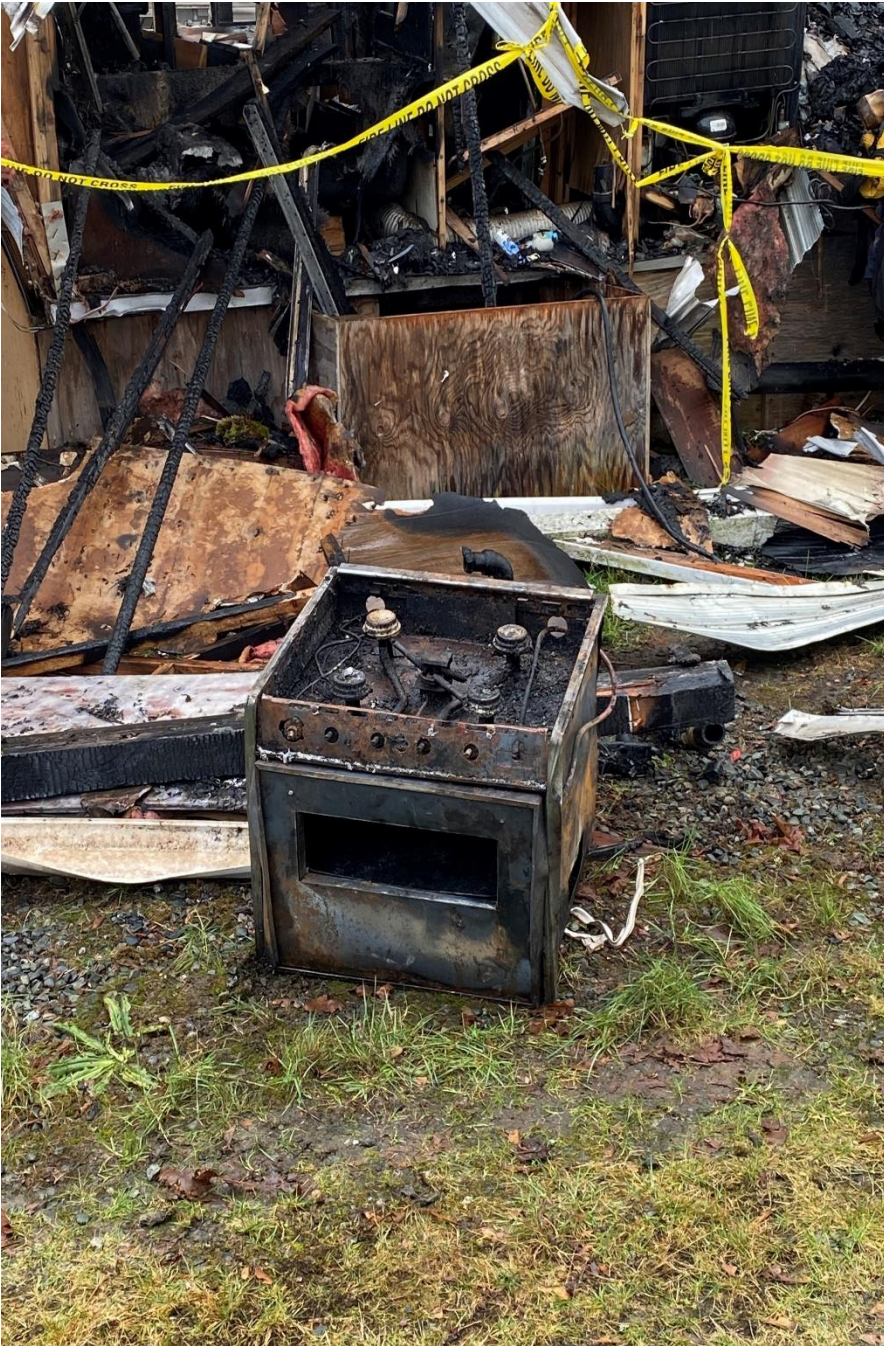
Image 3 – Gas stove after removal from trailer

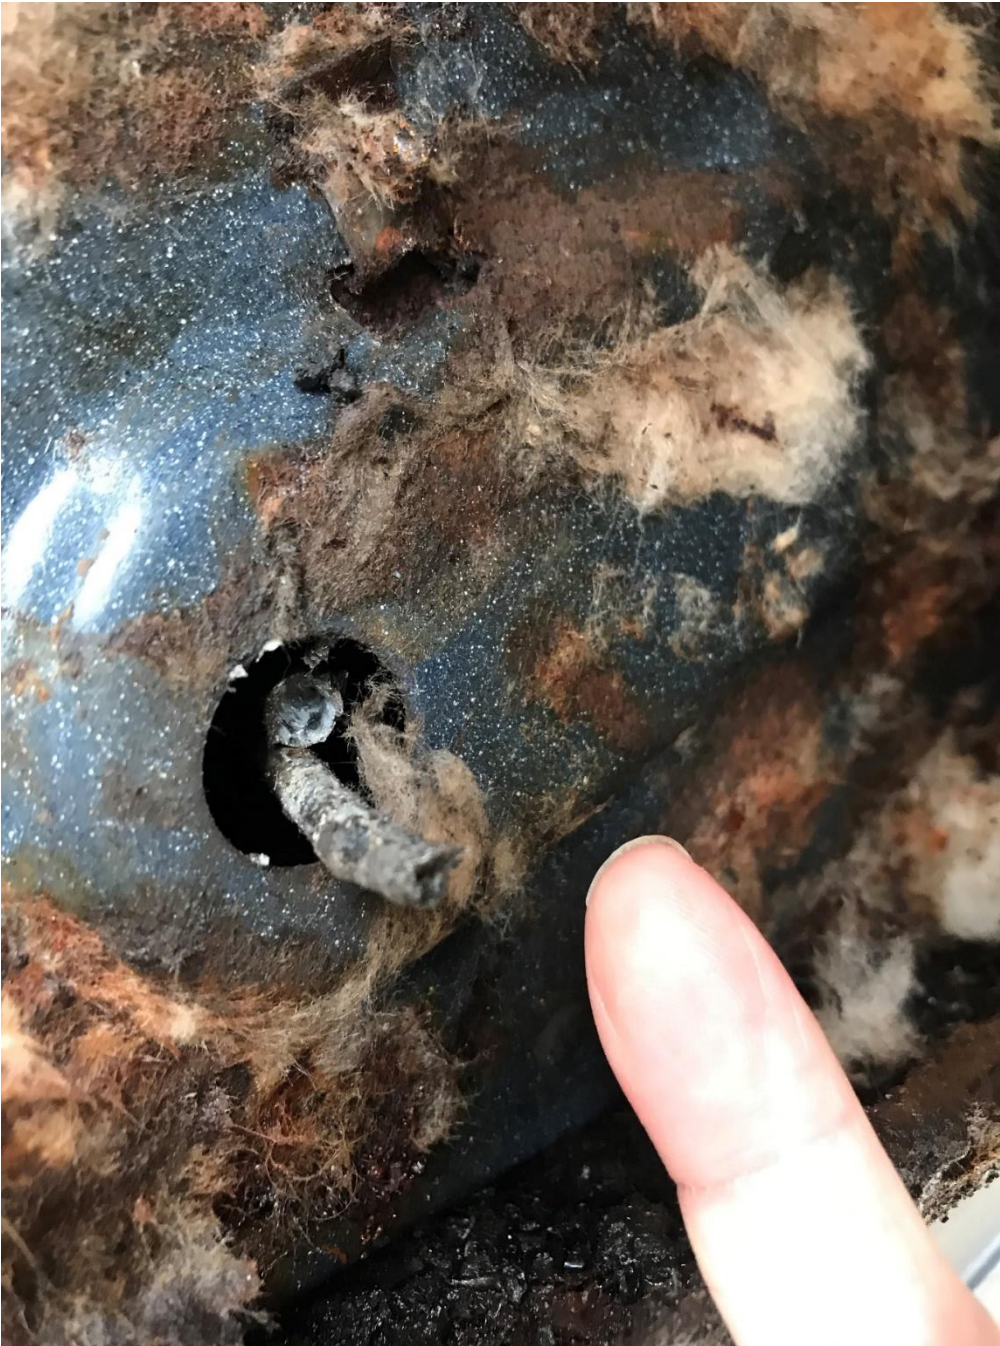
<p>No electrical connections were found in the area of the source of initial fire.</p> <p>During examination of the scene, the charring and burn patterns indicated that the fire originated behind the oven on left side of trailer. Examination of the stove after removal from the trailer showed signs of corrosion to the outer shell and rust holes on the inside and outside of the body. The gas tubing going to the oven burner was separated and corroded which would have allowed propane to leak into the surrounding insulation of the stove and pool into the void space behind the oven.</p> <p>There was no evidence of a propane leak detector or CO detector due to fire damage.</p>
Causes and contributing factors	<p>It is likely that the corrosion of the propane oven tubing, due to contact of dissimilar metals, caused the propane leak which was ignited when the owner attempted to light the top burners causing the explosion and fire.</p>

Image 4 - Corroded and plugged lines. Insulation removed for clarity

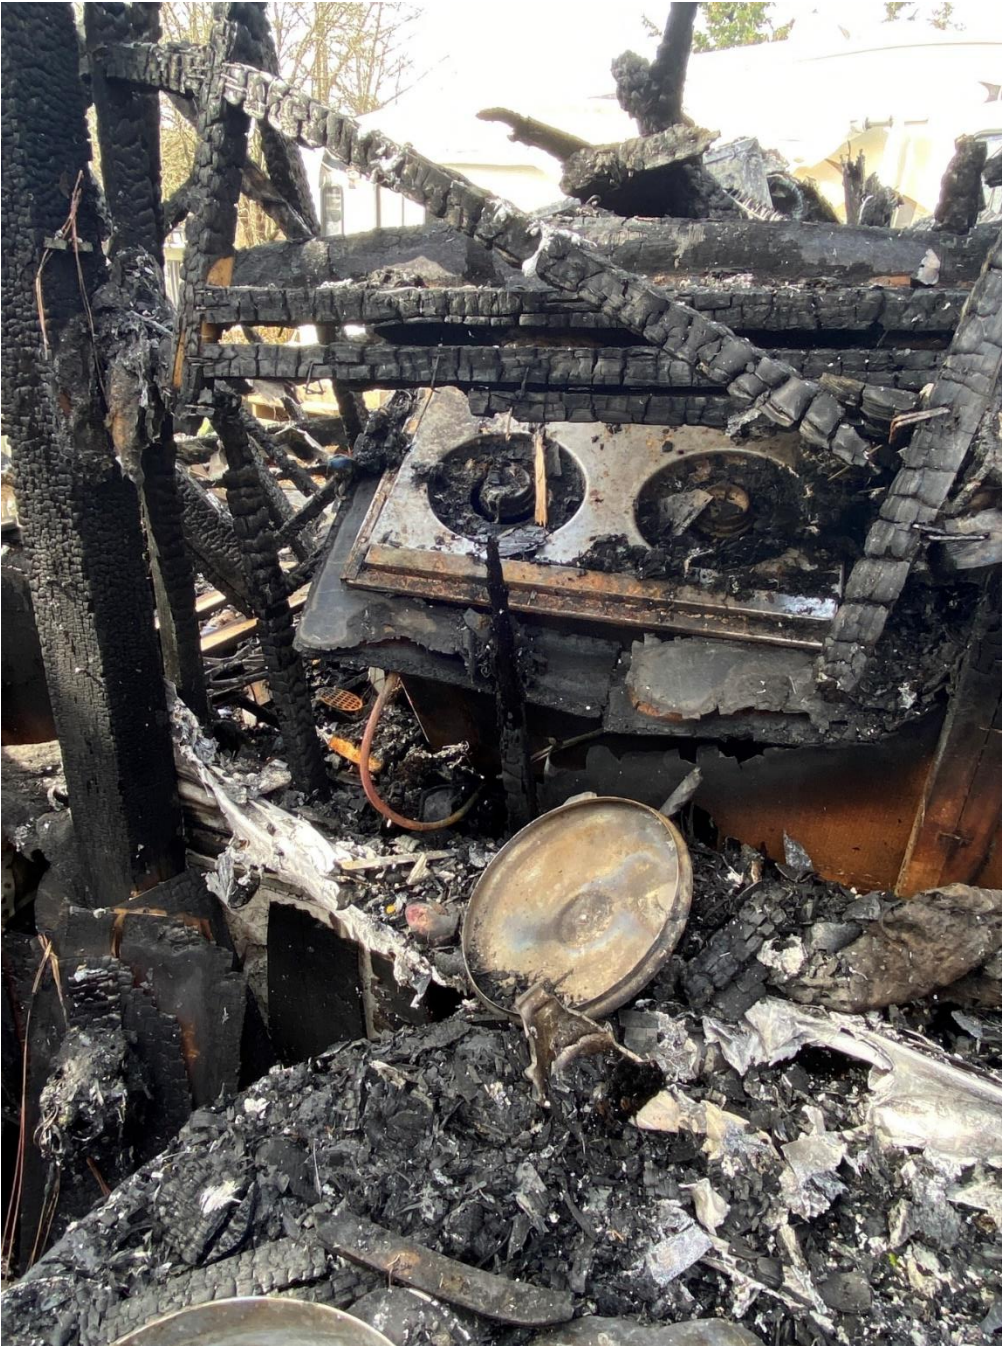
Image 5 – Gas stove prior to removal from trailer
