## Incident Summary #II-1327095-2022 (#26153) (FINAL)

| | Regulated industry sector | | Elevating devices - Elevator |
| Incident overview | | A failure of the variable frequency drive (VFD) unit caused the regenerative power to feedback to the regenerative resistor bank, which caused the resistors to become red hot and resulted in a fire. No one was using the elevator at the time of fire. | |

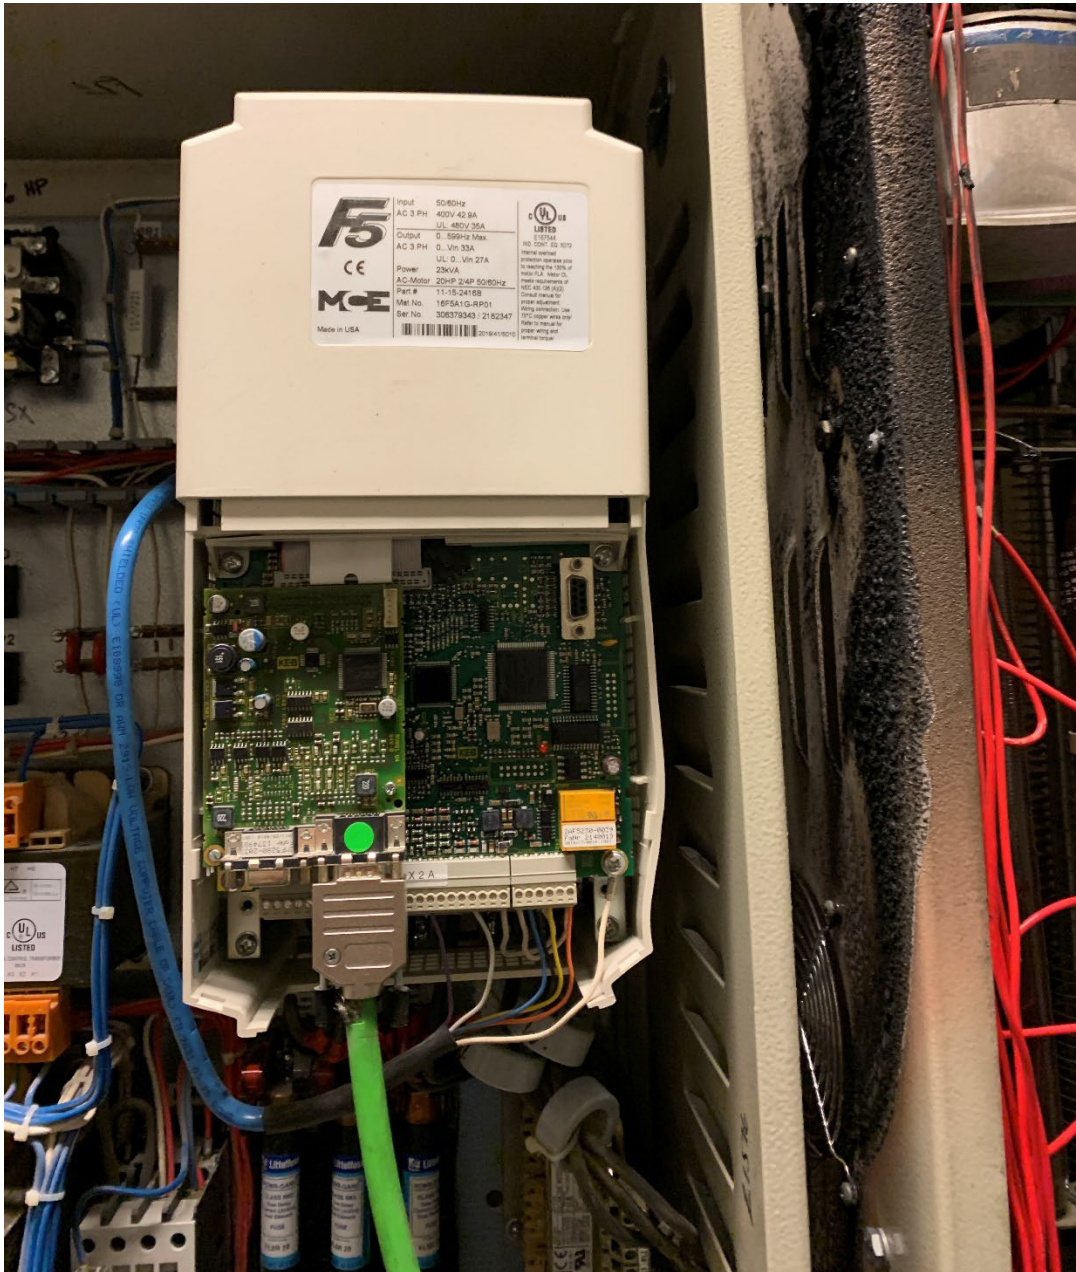
Image 1 - KEB F5 Drive

| Failure scenario(s) | A failure of the IGBT in the variable frequency drive (VFD) caused all the power to be shunted continuously on to the braking resistors which resulted in a fire in the braking resistors. |
| Facts and evidence | A technical bulletin was issued by the manufacturer confirming that drives may have potential issues with the IGBT power module that could result in premature failure of the drive. After discussing the situation with the notifier/mechanic, it was concluded that the failure was part of the technical bulletin from MCE. |

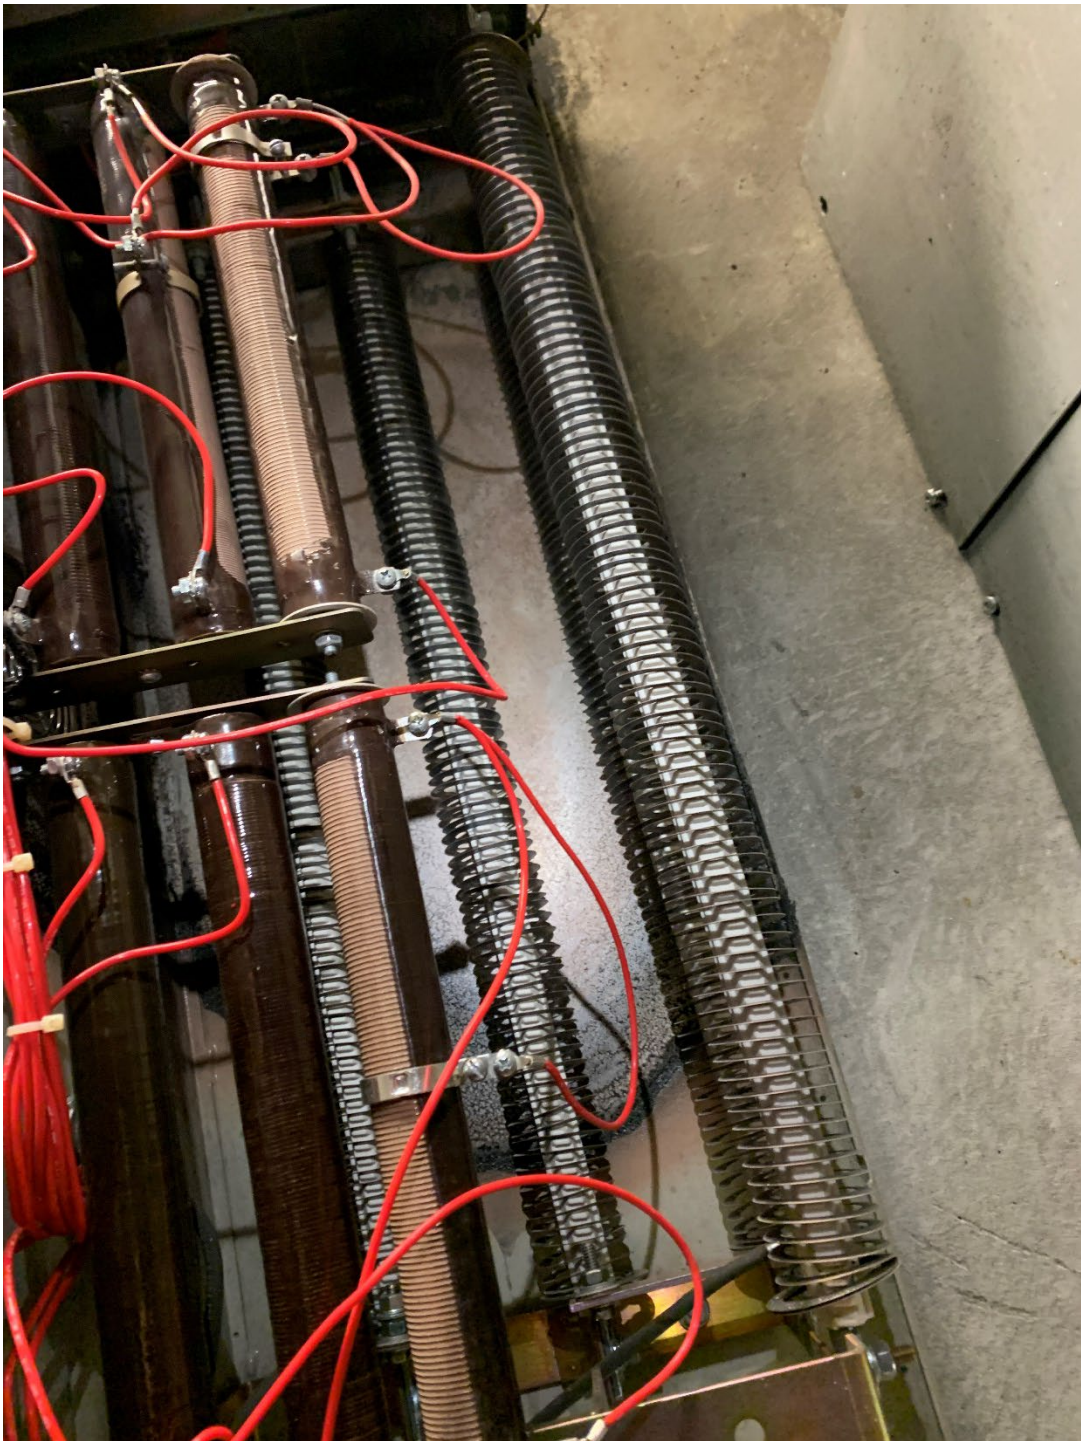
*Image 2 - Braking Resistors*

| Causes and contributing factors | It is very likely that a premature failure in the drive's power components resulted in an abnormal and continuous current flow to the braking resistors. The continuous current flow would have likely exceeded the resistors' power rating, to the point where the resistors ignited inside its compartment. It is very probable that any combustible material above or in proximity to the resistor's cabinet would have been affected by its radiant heat. |

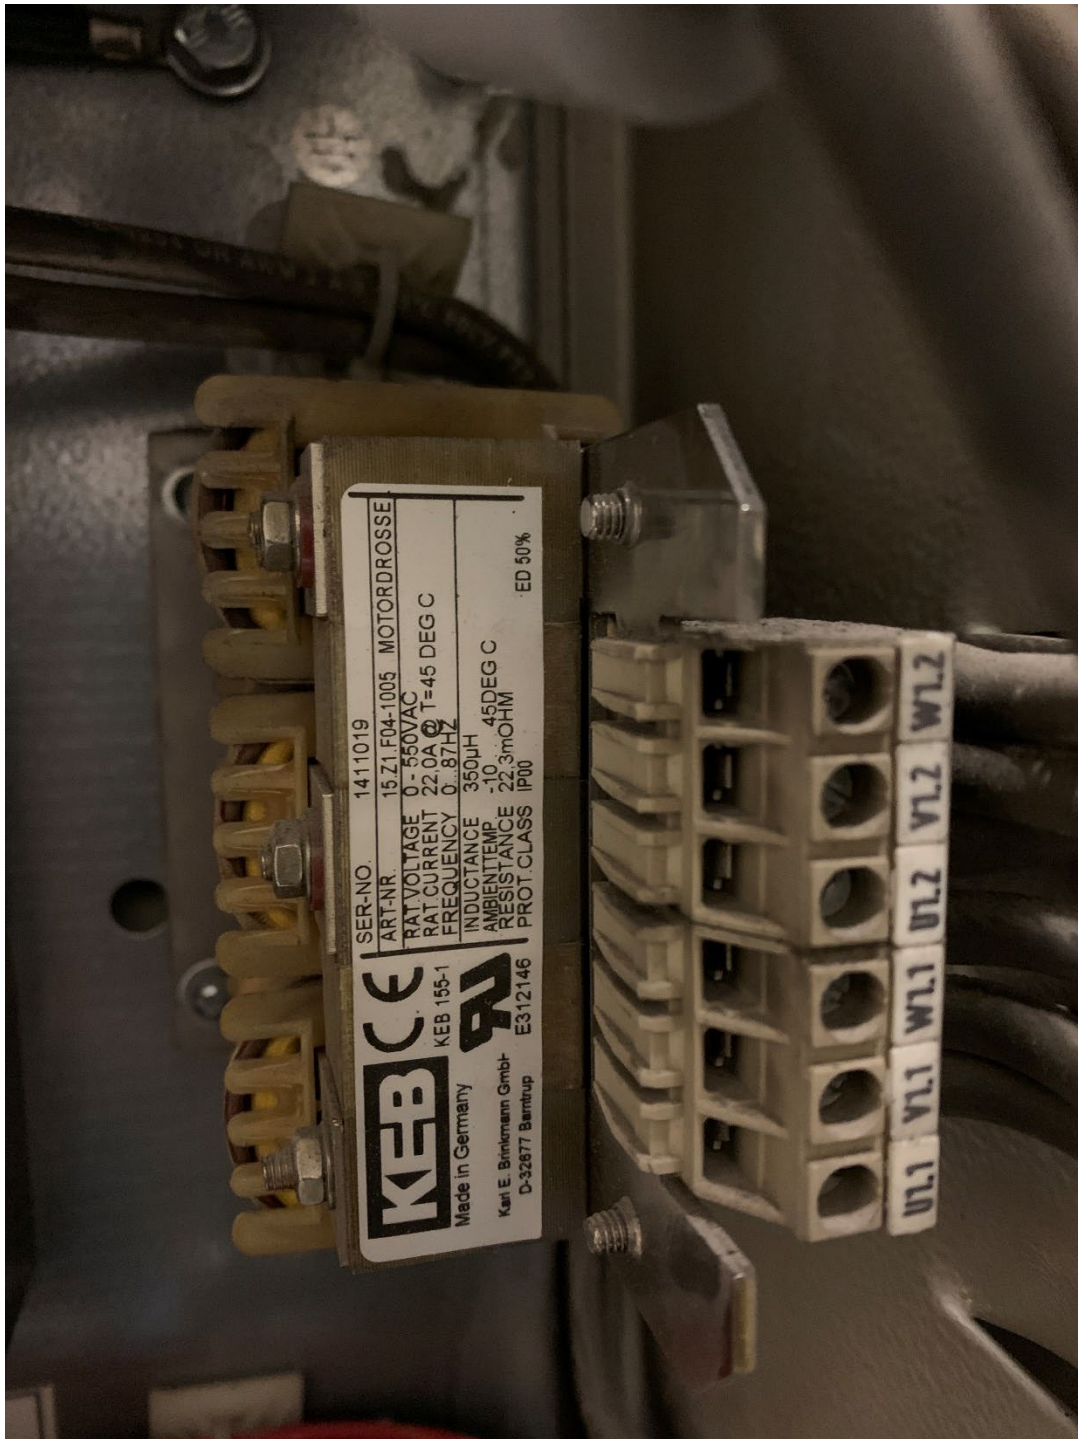
Image 3 - IGBT Power Module

**Description:** KEB recently informed MCE that the KEB 480V F5 size 16 and 17 G Housing Drives (16F5A1G-RPxx and 17F5A1G-RPxx) produced between the years of 2016 through 2019 have a potential issue with the Power Modules. This could result in a premature failure of the drive with a shorted transistor or "Error Over Current" (E. OC) fault. KEB will provide a warranty exchange of these drives if they fail with either:

1. Contact MCE and provide us with the job number and the failed drive serial number.
2. Decide whether to replace the failed drive with an identical one or upsize.
  - a. If identical replacement, we strongly recommend incorporating a Monitoring Circuit as an added protective measure to take the elevator out of service and disconnect power from the drive, in case of a fault. MCE will supply the Monitoring Circuit if requested by the contractor.
  - b. If upsizing to an H-Housing. It has the same height and depth as G-Housing, but it is 5" wider. Please note that some controller cabinet components may need to be relocated.
