Incident Summary #II-964492-2020 (#16301) (FINAL)

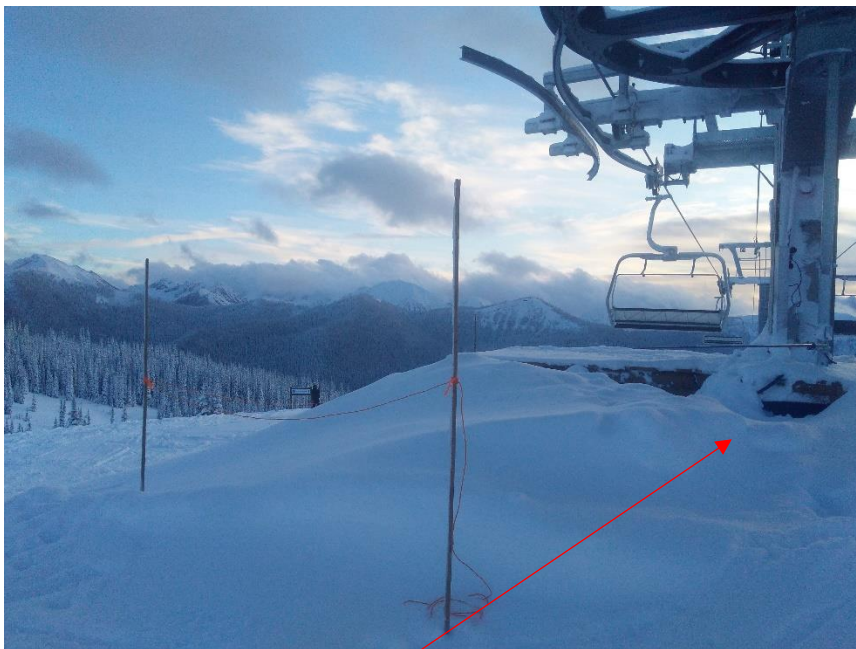
<p>passengers when they witnessed three foot passengers on the unload ramp. The unload terminal operator then initiated a normal stop from the lift hut, stopping the lift. The fourth foot passenger, having remained on the lift past the unload point, jumped from the carrier as the lift was coming to the initiated stop, sustaining their injury.</p>
<p>Facts and evidence</p>	<p>During the investigation interview with the top unload terminal operator, they verbally confirmed that although they had received adequate training, passed their lift operator examination, and been informed of the foot passengers from the load terminal operator, they lost focus and remained in the operator hut forgetting about the foot passengers inbound. The unload terminal operator confirmed they did not slow or stop the chair as required by the ski area policy and procedures.</p>
<p>Causes and contributing factors</p>	<p>It is likely that the operator remaining in the lift hut, losing focus, and failing to slow and then stop the passenger ropeway for foot passengers, was a contributing factor to this incident.</p>

Person fell at this location
