Incident Summary (Final # 5612654)

SUPPORTING INFORMATION	Incident Date		January 31,2017	
	Location		Vancouver	
	Regulated industry sector		Elevating	
	Impact	Injury	Qty injuries	none
			Injury description	none
			Injury rating	none
	Damage		Damage description	Driving machine brake arm broke
			Damage rating	major
Incident rating		major		
Incident overview		During operation the elevator car was at the top floor and suddenly moved in an uncontrolled manner and came to rest on the stops. Upon inspection, the brake arm had broken.		
INVESTIGATION CONCLUSIONS	Site, system and components		<i>The braking system consists of a brake drum that has two brake shoes on either side. The brake shoes clamp onto the drum to stop and hold the elevator. The brake shoes are connected by a spring and rod which require spring tension adjustments. See Figure 1. This elevator machine and brake design is approximately 80 years old, made of cast iron. It is a high usage elevator in an industrial setting.</i>

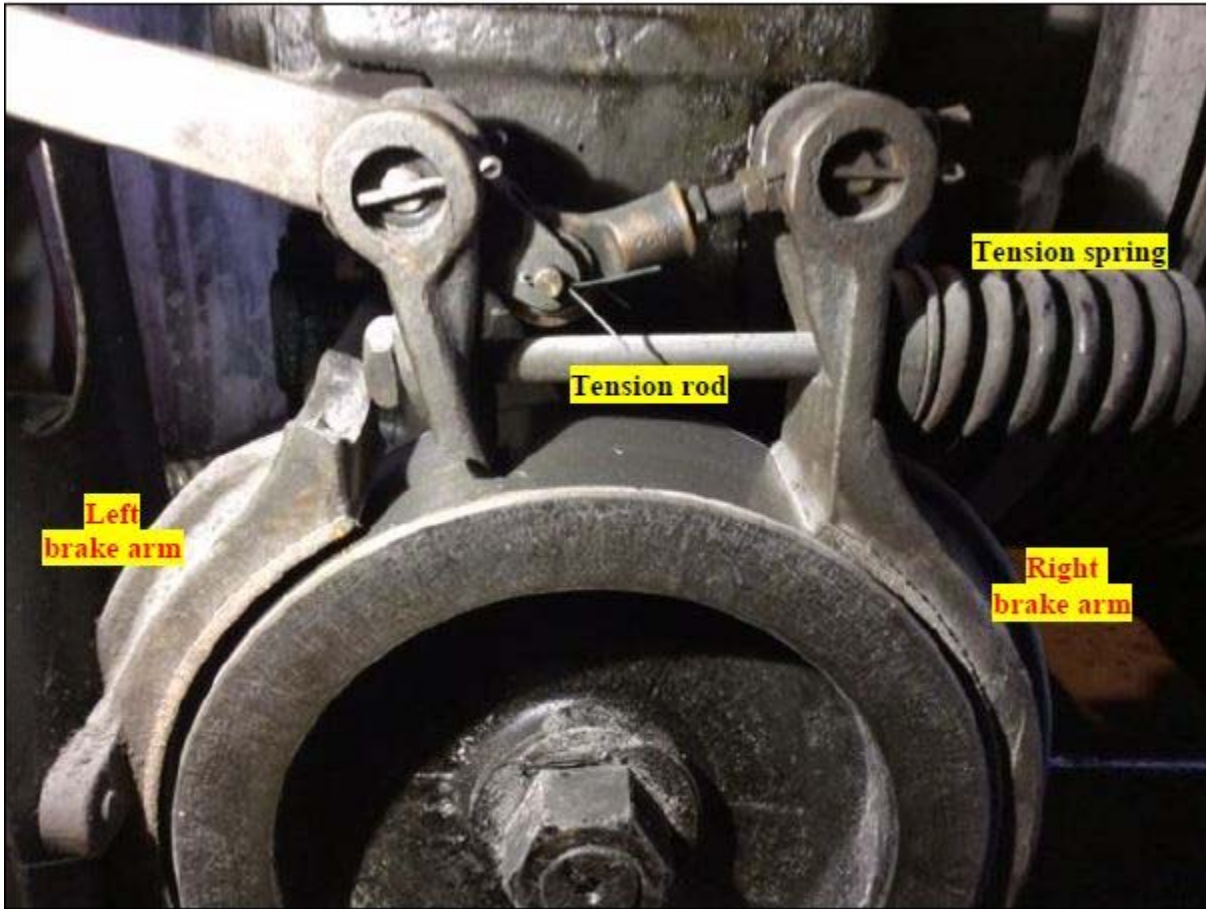
Figure 1 General design. Broken brake shoe, spring for tension adjustment. Photo edited by Acuren Group Inc.

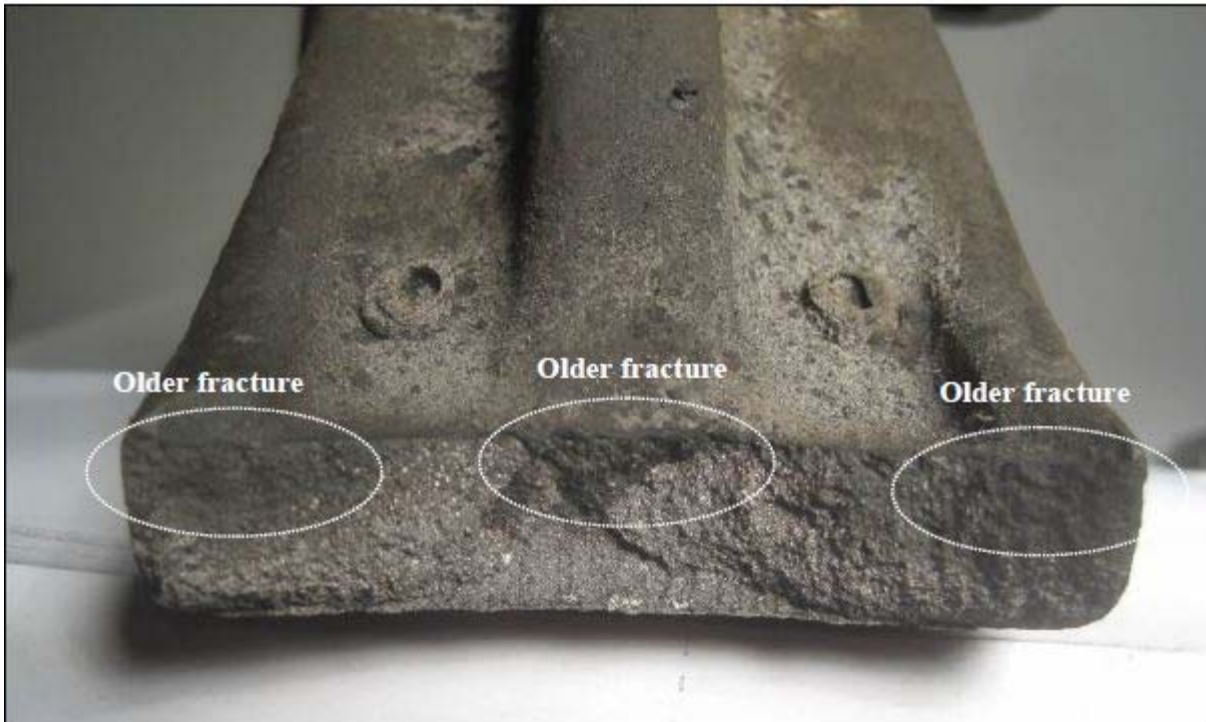
Failure scenario(s)		<i>The brake arms have a portion that were thin and under stress. The material used was cast iron and fails in a brittle manner. The cast iron began to crack and then fractured all the way through. See Figure 2. Acuren Group Inc. also found indications of cracking on the (right) or non-failed brake arm. See Figure 3. It is probable that the spring tension adjustment may have increased and applied added stresses to the brake arms. The addition of flat washers to assist with the spring tension adjustment are visible in Figure 4.</i>	
	Facts and evidence		<i>An examination of the brake arms conducted by Acuren Group Inc. and photographs taken of the components illustrate the failure. Figure 5 shows a pre-existing crack in the cast iron. The report also suggested that the failed brake arm “exhibited a brittle appearance which is as expected for a grey cast iron component failure.” See page 2 section 2.2 of Acuren Group report.</i>

Causes and contributing factors		<i>It is highly probable brake usage surpassed the brake components fatigue life. The tension on the thin and stressed section of the brake arm began to crack over the years and finally fractured all the way.</i>

Figure 2 Cross section- darker areas show previous cracking. Photo courtesy of Acuren Group Inc.

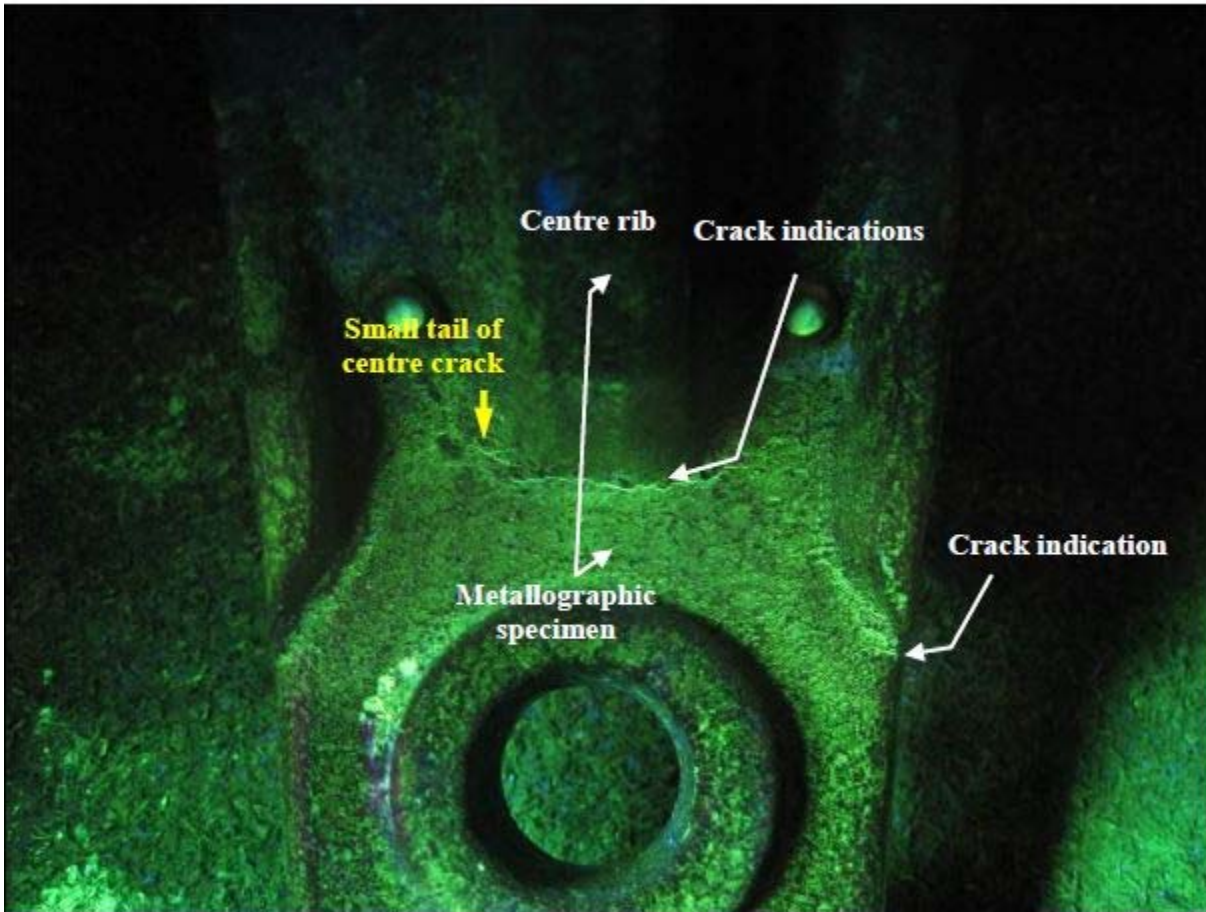
Figure 3 Shows the non-failed brake arm cracking, Photo courtesy of Acuren Group Inc.

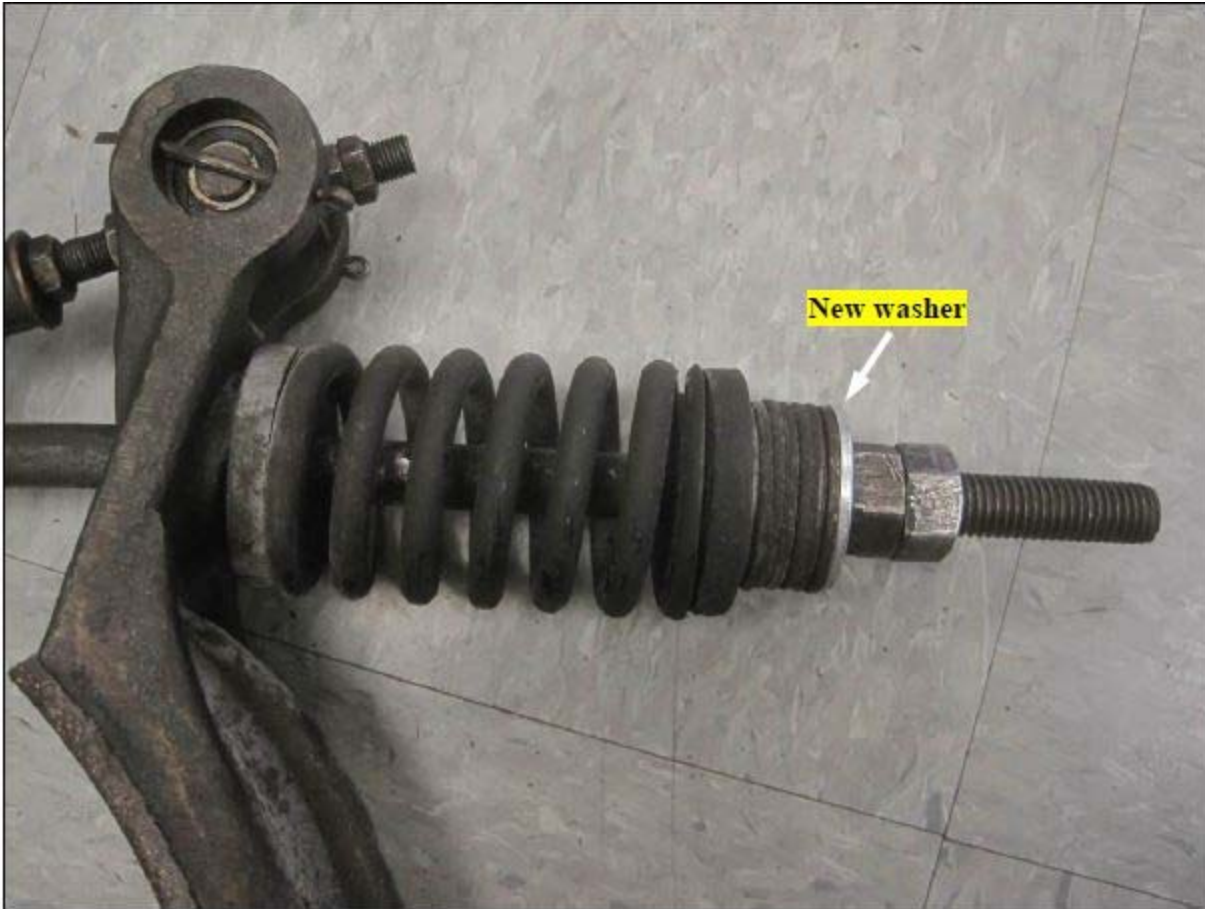
Figure 4 Shows the addition of Flat washers for tension adjustment. Photo courtesy of Acuren Group Inc.
