**SEA TO SKY GONDOLA
HAUL ROPE FAILURE**

DATE OF FAILURE: AUGUST 10, 2019

TECHNICAL SAFETY B.C.
SUITE 600 - 2889 EAST 12TH AVENUE
VANCOUVER, BC
V5M 4T5

File Number: 60515188 – Revision 1
Date: August 23, 2019

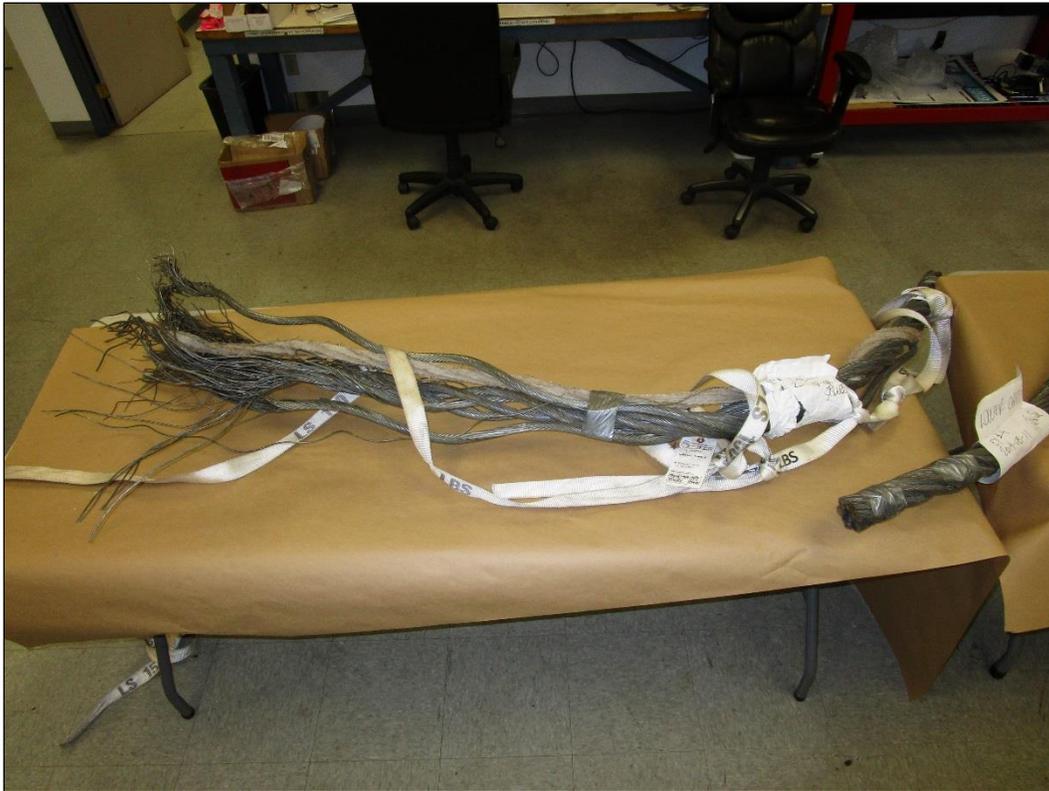
Figure 1 Uphill end of severed haul rope.

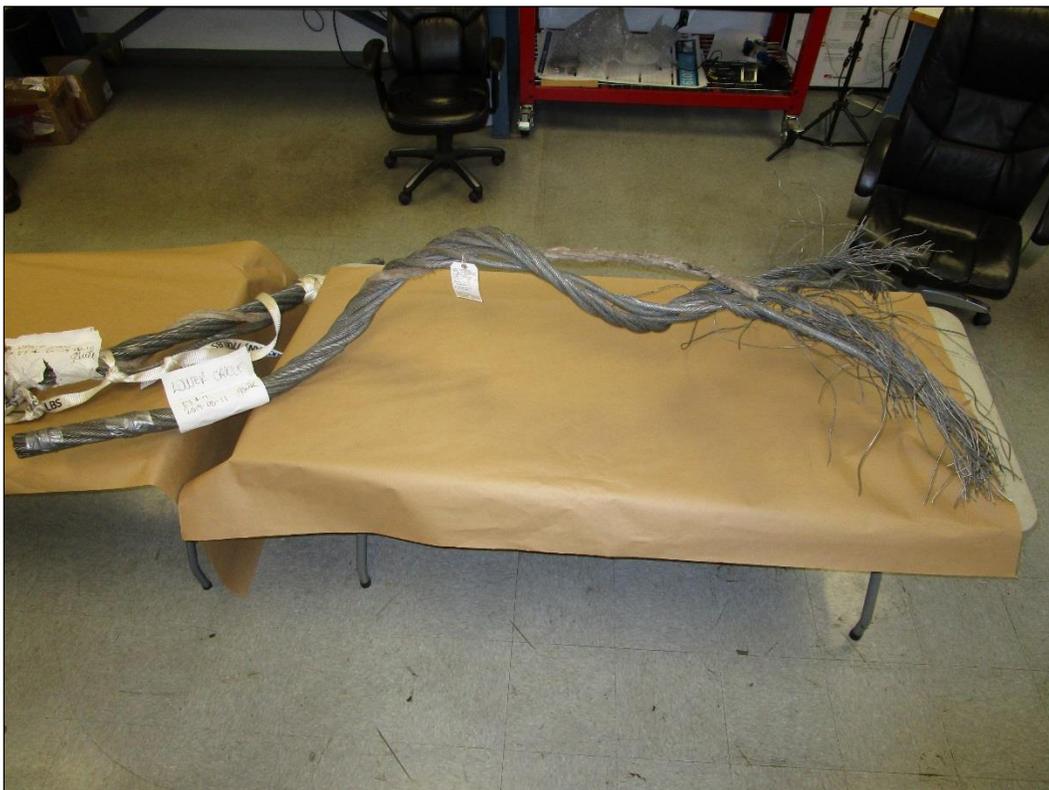
Figure 2 Downhill end of severed haul rope.

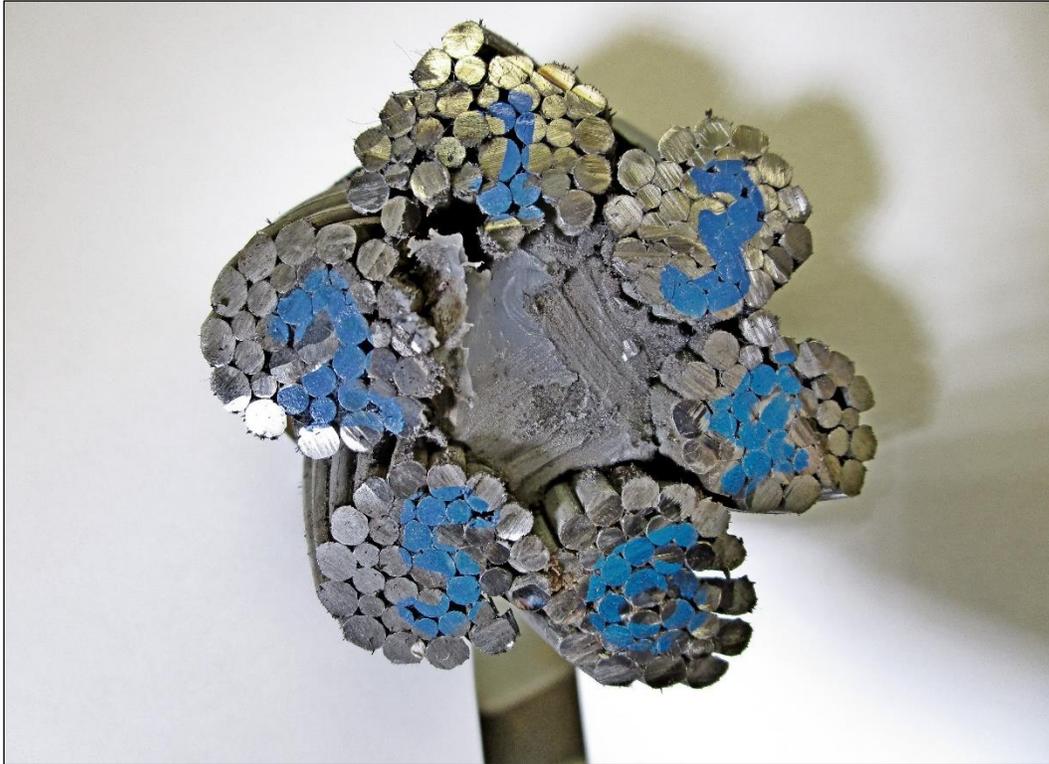
The clean-cut end of the haul rope (cut during sample removal) was initially numbered at Acuren as shown in Figure 5. The most through-cut wires were found with strands 3 and 4. This is the location where the cut was likely initiated. The position of [REDACTED] with respect to the initial cut is shown in Figure 22.

The evidence shows that the least number of through-cut wires was found with strand No. 5 (zero through-cut wires). This was therefore the final strand to fail. Strand No. 6 contained only one through-cut wire. It was therefore likely that strand No. 6 failed catastrophically at the same time as strand No. 5.

Figure 5 End of haul rope as cut at site. Strand are arbitrarily labelled 1 – 6.

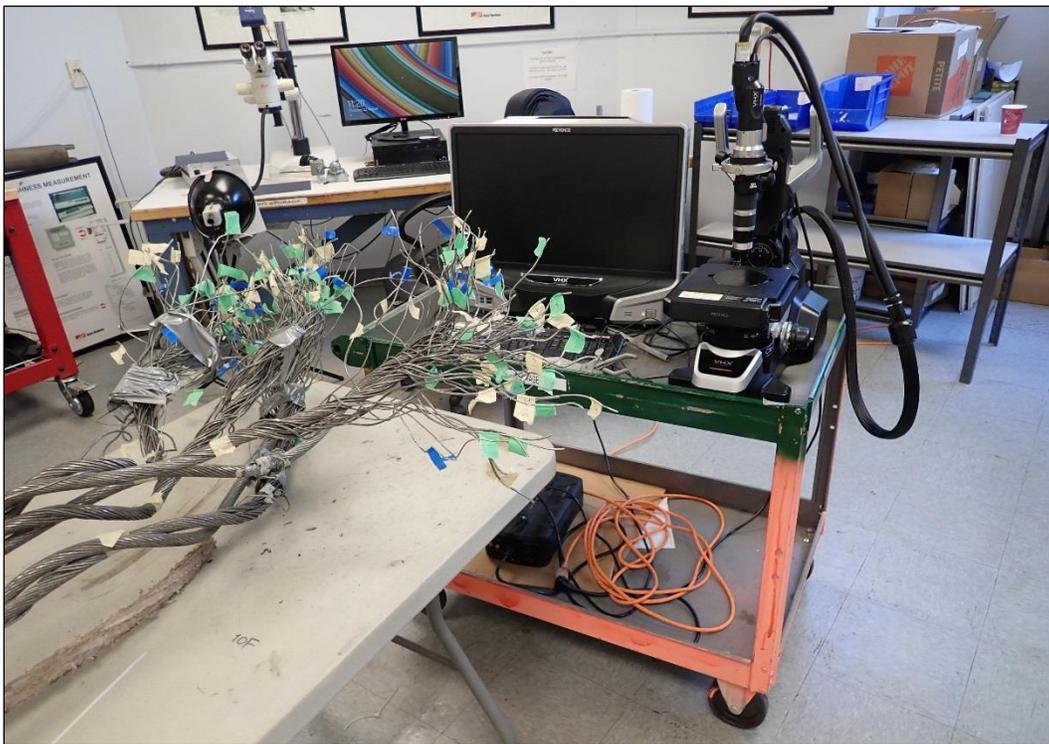
Figure 6 Fractured wire ends labelled with yellow, green and blue tape corresponding to labels used in Tables 1 – 6 (Appendix B) describing fractures. Keyence microscope used to magnify and document end features is shown in background.

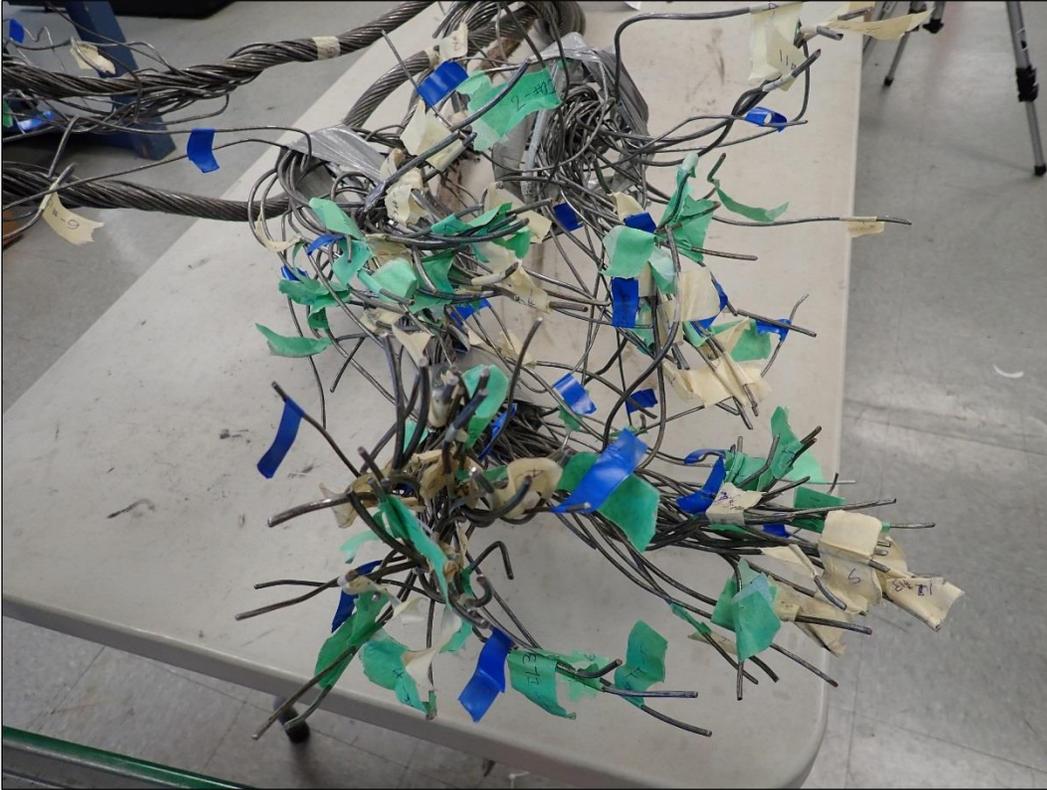
Figure 7 Closer view of wire ends on downhill side of severed haul rope.

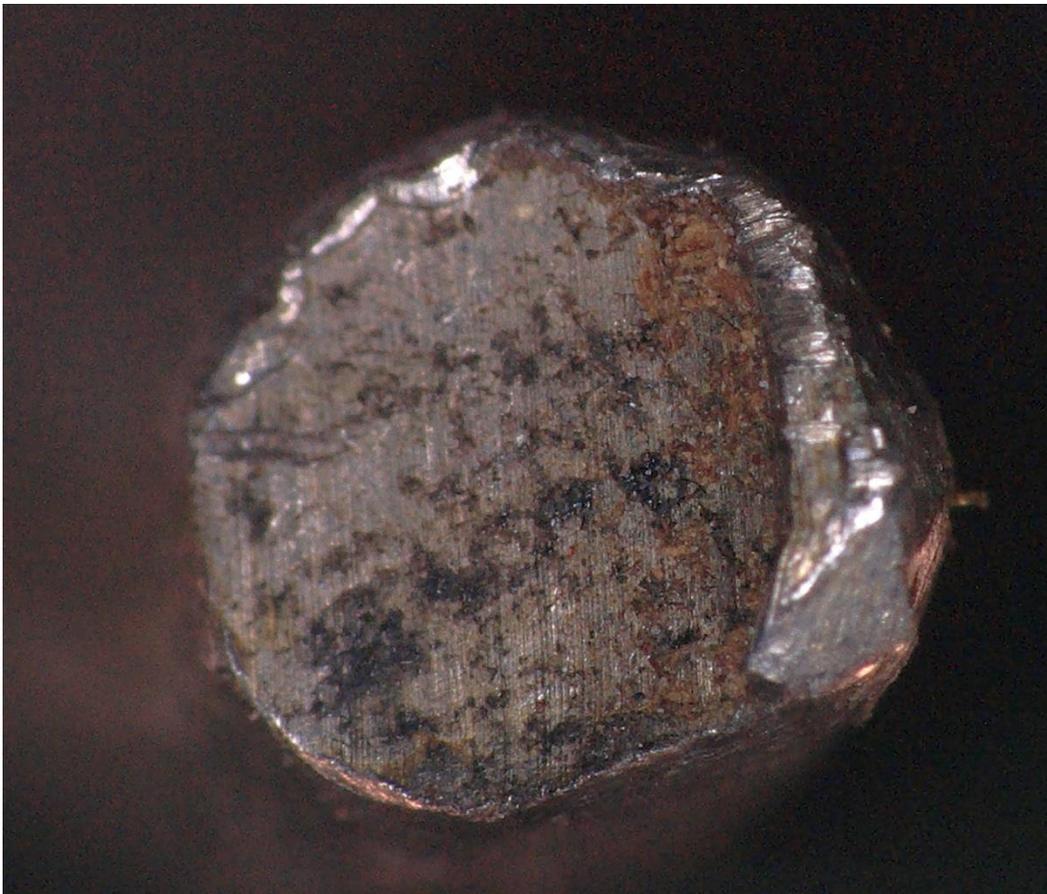
Figure 8 – Through-cut, Strand 4, outside wire 5

Figure 8 Typical through-cut wire on strand 4. Outside wire 5.

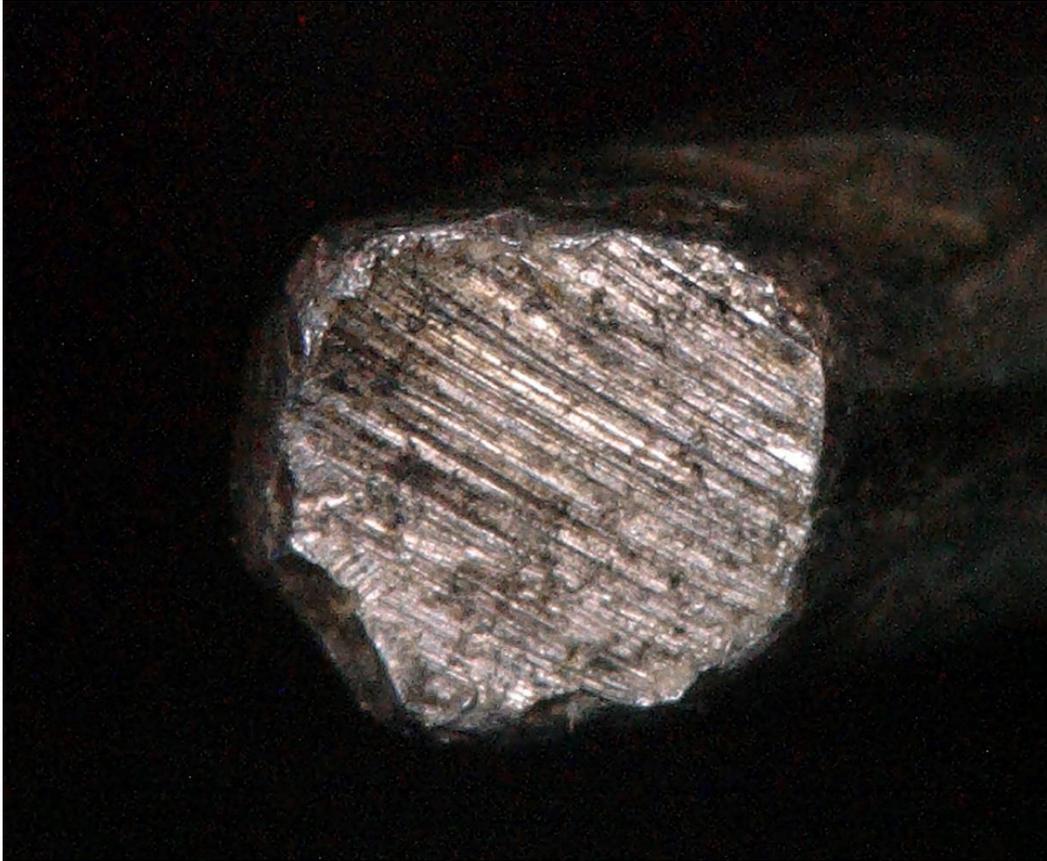
Figure 9 – Through-cut, Strand 3, outside wire 7

Figure 9 Typical through-cut wire on strand 3. Outside wire 7.

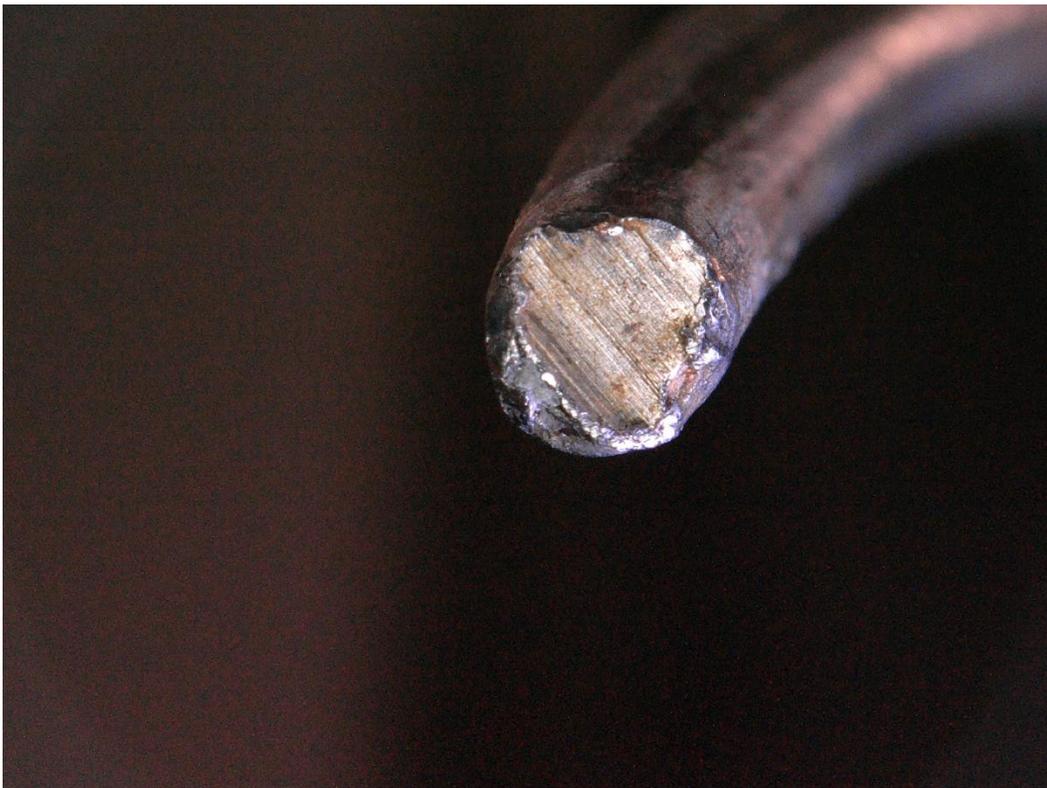
Figure 10 – Partial cut, overload, Strand 4, outside wire 6

Figure 10 Partially cut wire on strand 4. Outside wire 6.

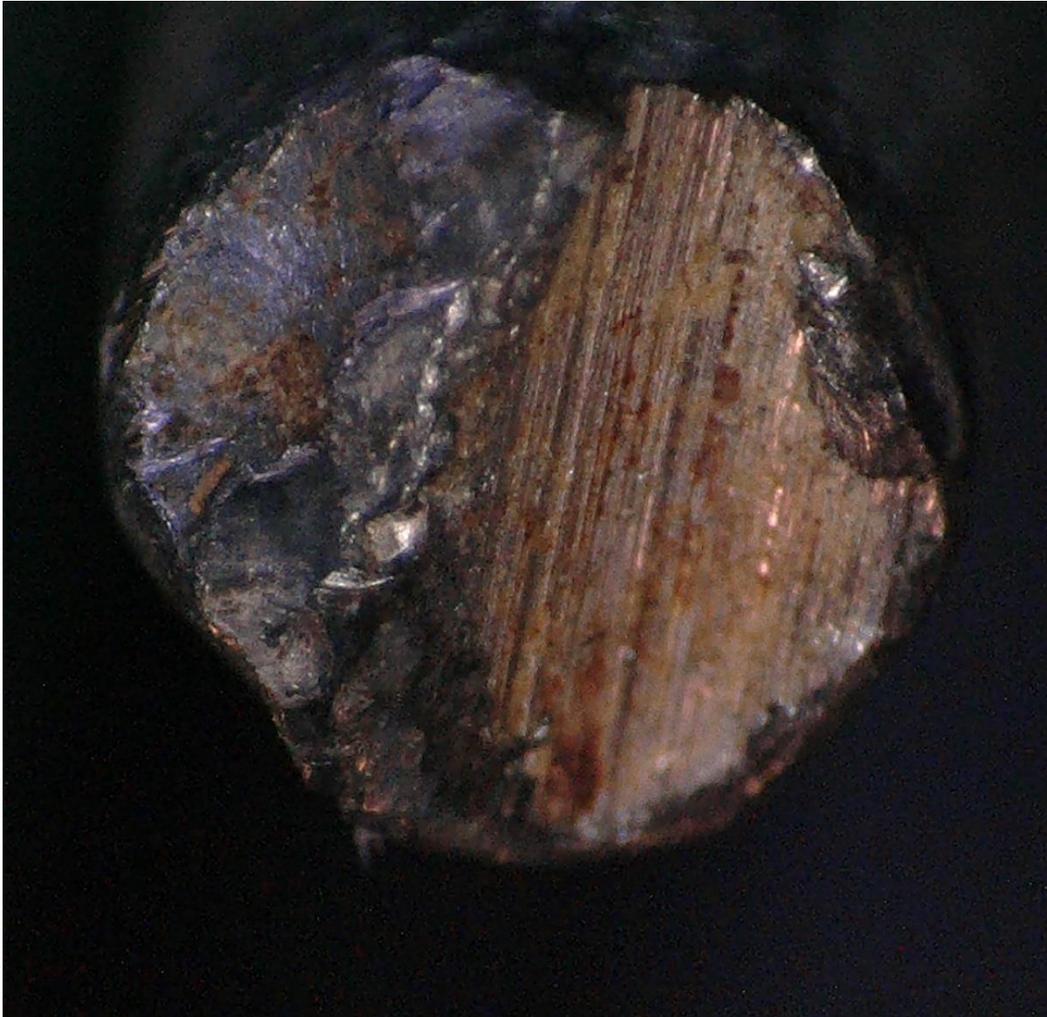
Figure 11 – Partial cut, overload, Strand 3, outside wire 2

Figure 11 Partially cut wire on strand 3. Outside wire 2.

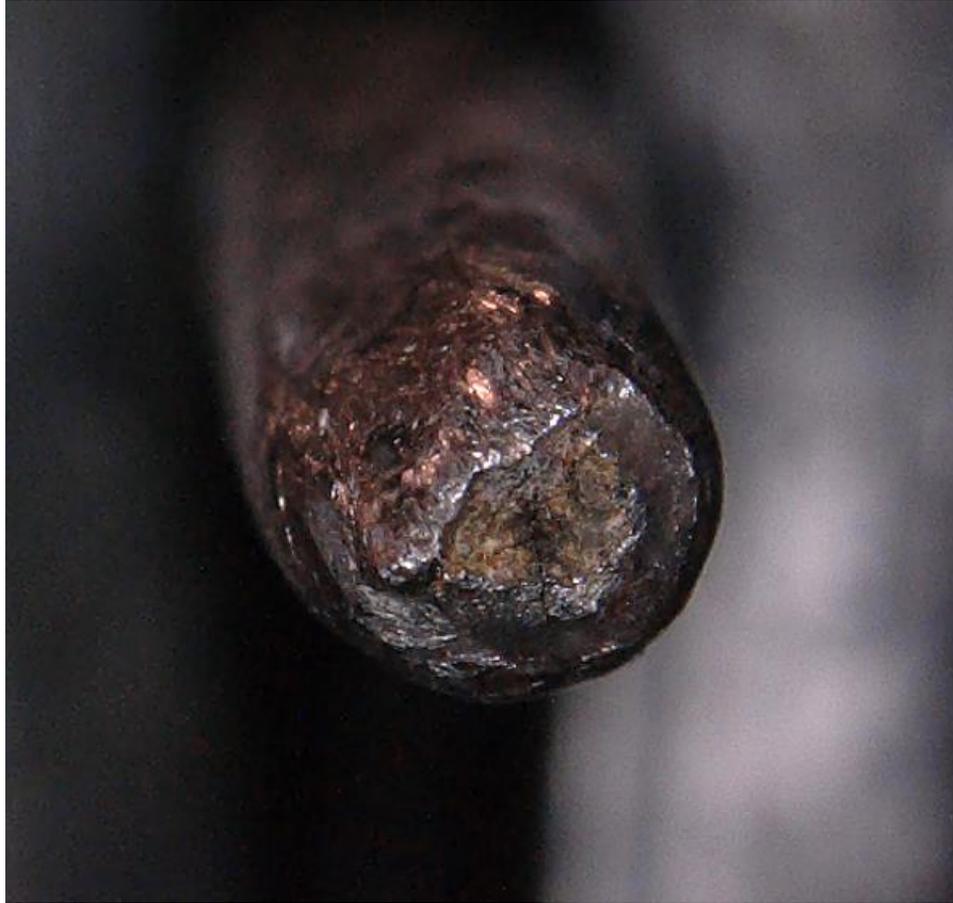
Figure 12 – Cup and cone tension overload, Strand 1, inside wire large diameter wire 13

Figure 12 Cup and cone tensile overload on strand 1. Outside wire 13.

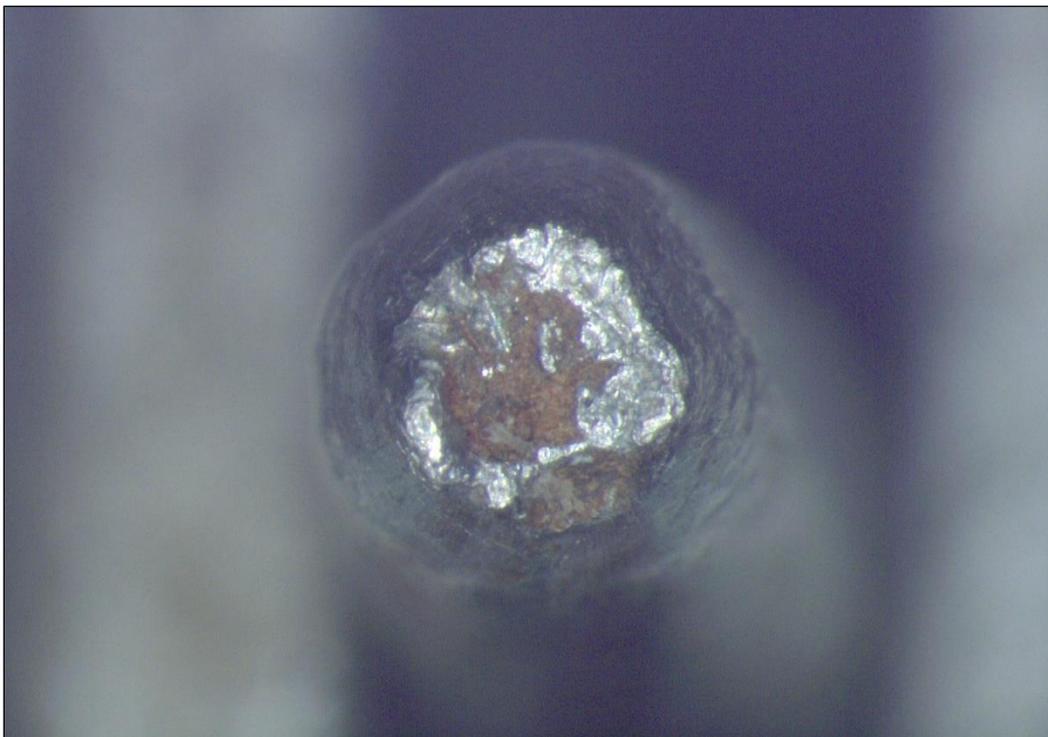
Figure 13 – Cup and cone tension overload – Strand 2, outside wire 10

Figure 13 Cup and cone tensile overload on strand 2. Outside wire 10.

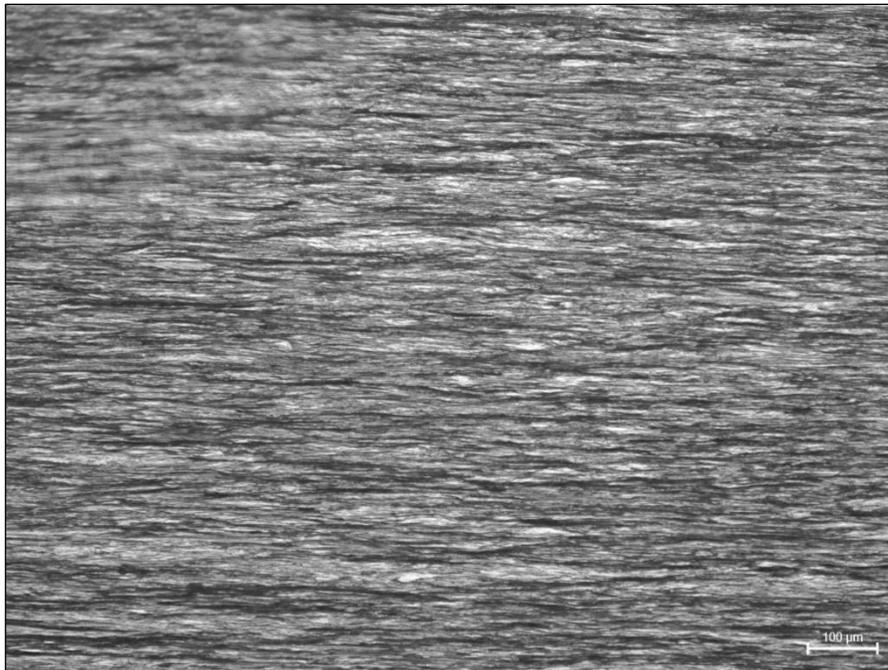
A typical outside wire microstructure is shown in Figure 14. The microstructure consists of severely cold worked ferrite and pearlite. The hardness in this area of the wire was VHN 262, which corresponds to an ultimate tensile strength of 280,000 psi (1930 MPa). This is typical for high strength steel wire that has been galvanized after drawing.

Figure 14 Typical wire microstructure. Microstructure is severely cold worked ferrite-pearlite. Sample has hardness of HVN 262 (etched 2% Nital; Mag. 200X).

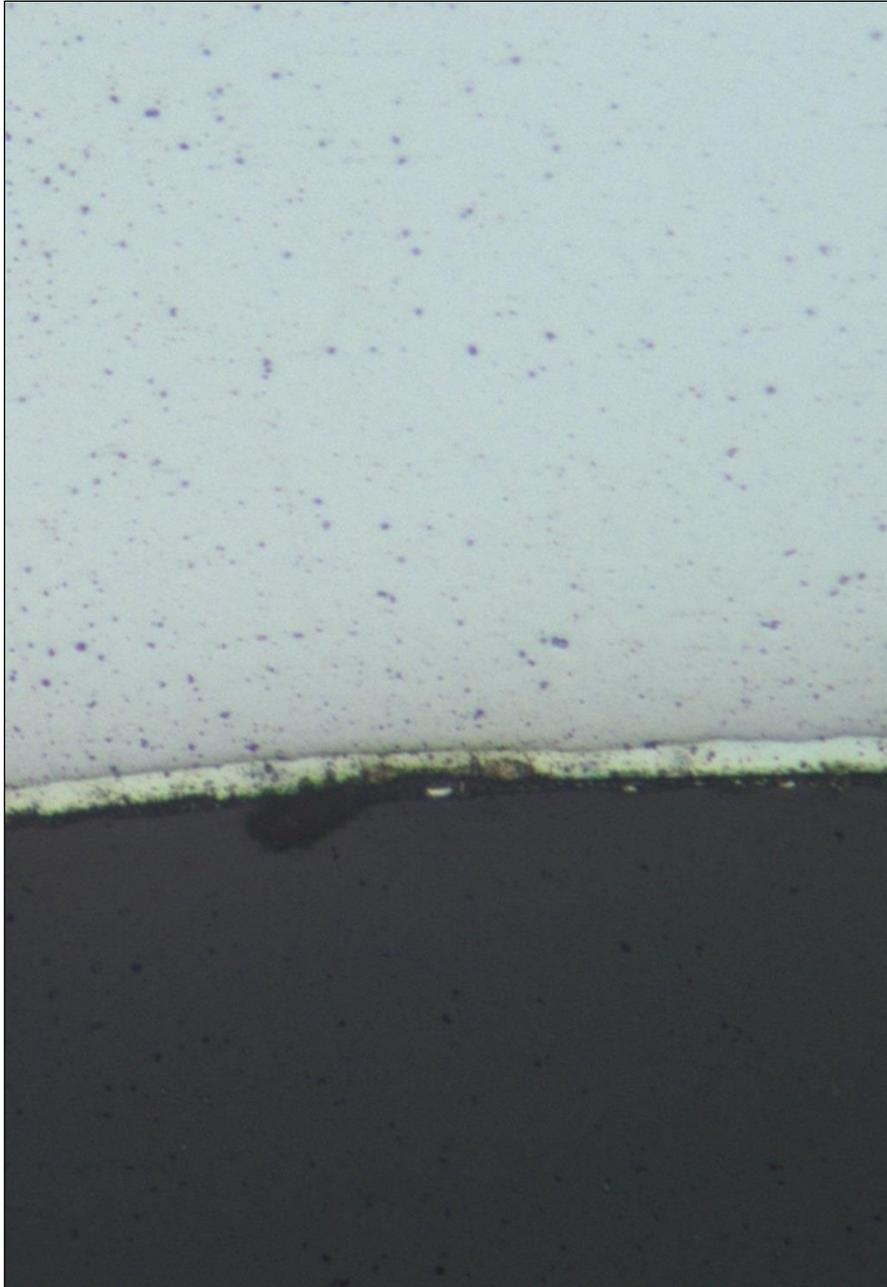
The galvanizing on the wire surface is shown at low magnification in Figure 15. The galvanizing is fully intact and has a thickness of approximately 10 microns.

Figure 15 Typical galvanizing layer on wire strand. Zinc layer is uniform and approximately 10 microns thick. (mag x 200; Unetched)

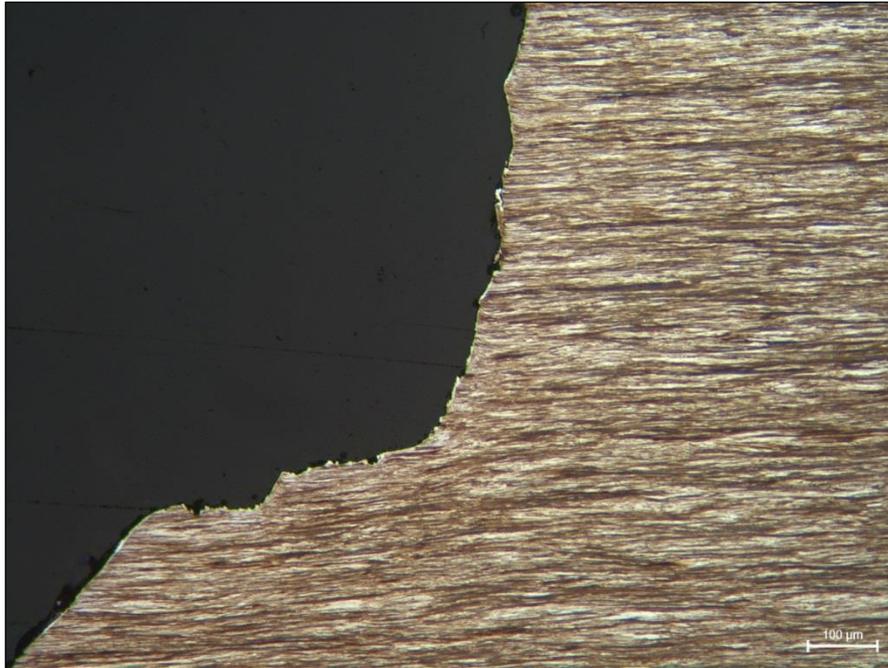
Figure 16 Cross section through typical [redacted] partial cut. [redacted] (etched 2% Nital; Mag x 200)

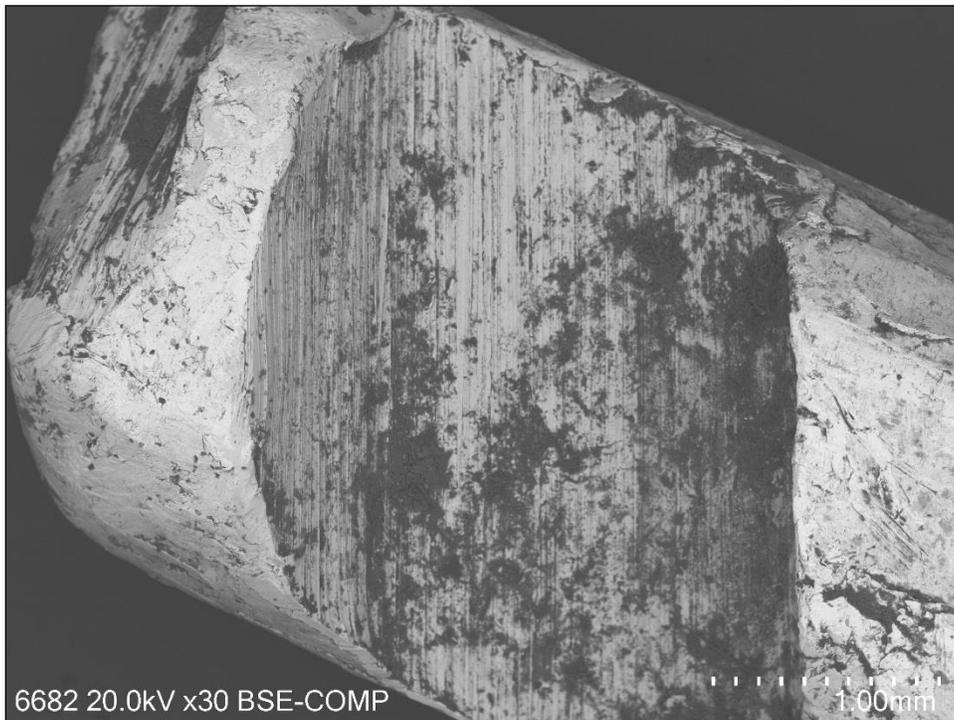
Figure 17 SEM view of typical wire partially cut with [redacted]. Edges are well defined.
