Incident Summary #II-1017254-2020 (#17872) (FINAL)

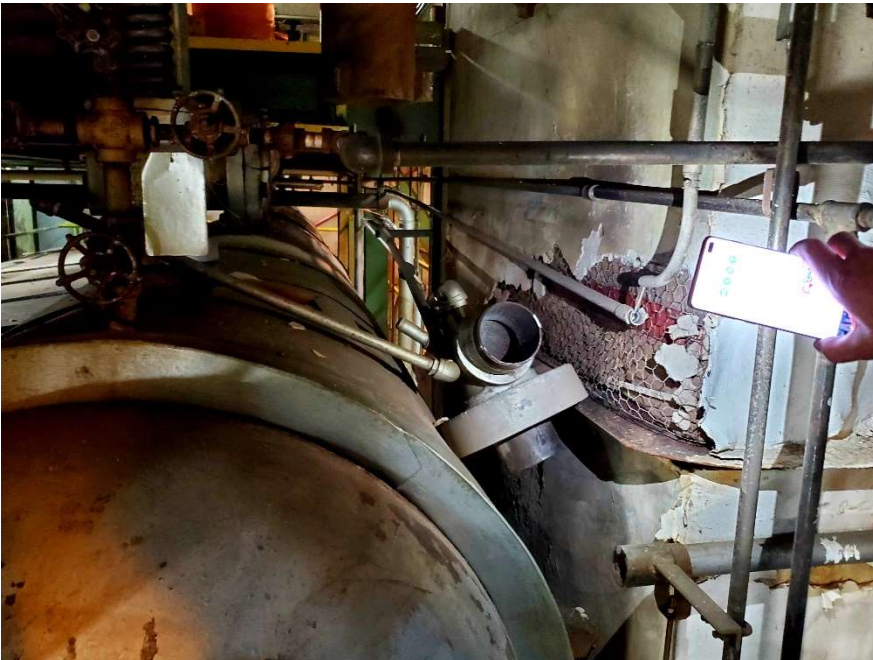
Facts and evidence	This was an in-service failure, discovered by the operating crew after testing of the safety valve was stopped. The drip pan was found to be no longer connected to the safety valve and was laying between the steam drum and the flue-gas uptake ducting. The safety valve flange showed significant damage (see photos). The drip pan arrangement no longer connected to this safety valve (see photos). The flange that connects the drip pan assembly to the safety valve was found to have multiple radial cracks that extended from the threads to the outer flange rim (see photos)

Drip Pan between steam drum and flue-gas uptake ducting

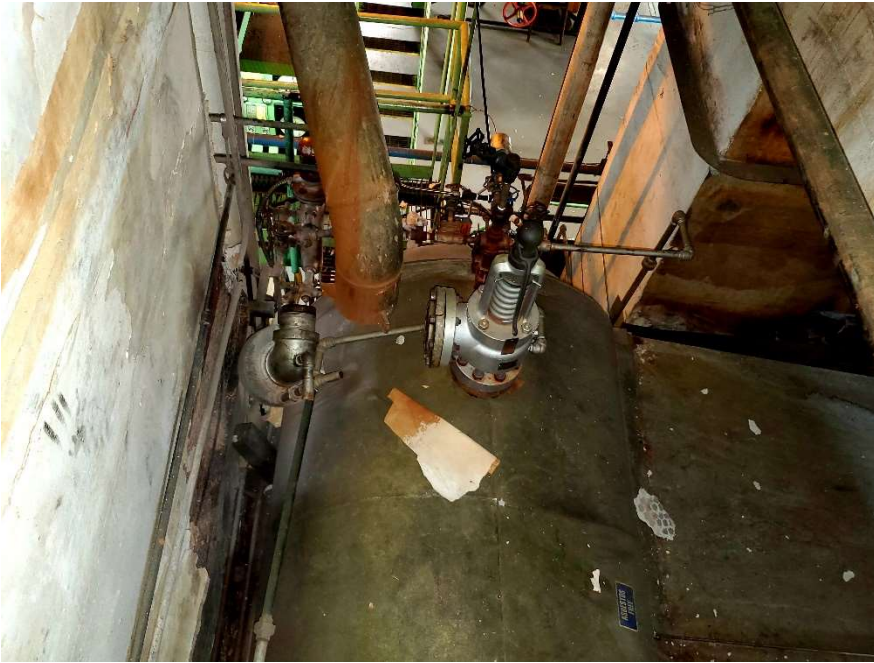
Safety Valve drip pan location from above.

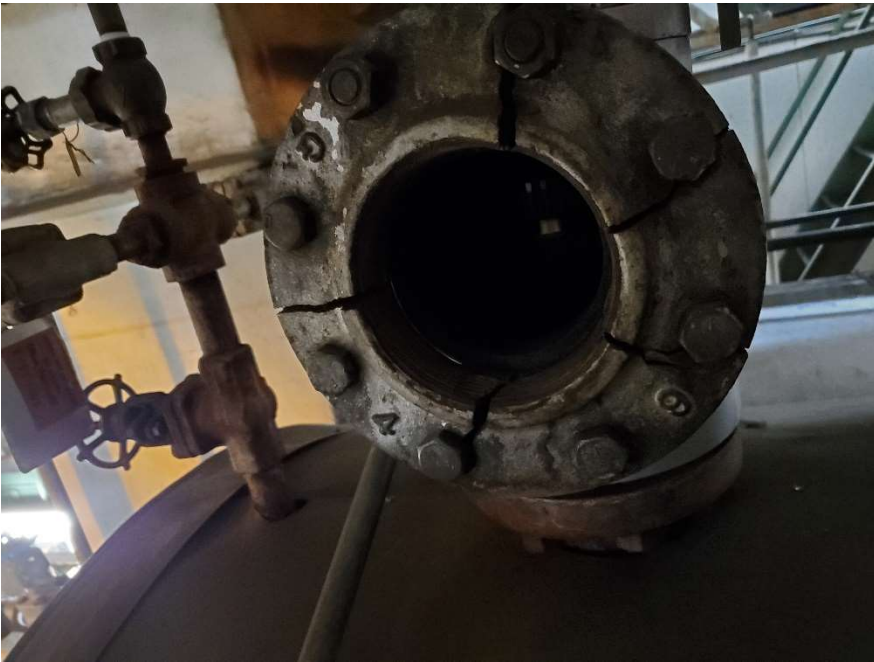
It is very likely, these flange cracks allowed the short pipe nipple to be forced out of the safety valve by the discharging steam forces.

The flange material was determined to be of cast iron material. Although acceptable for the pressure and temperature expected in the discharge piping, consideration for the cycling shock stresses generated may not have been considered at the time of installation.

Safety Valve outlet flange showing radial cracking

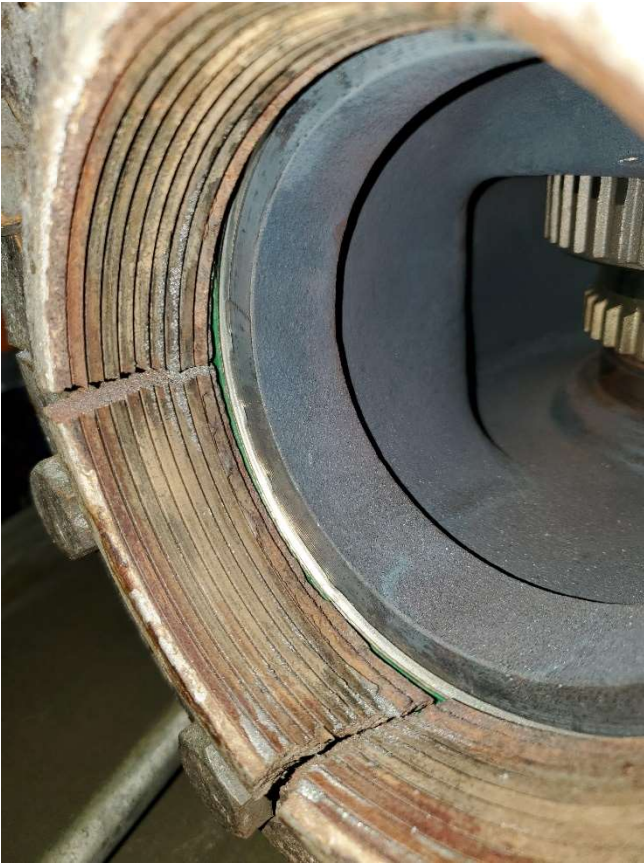
Safety Valve outlet flange showing internal through cracking

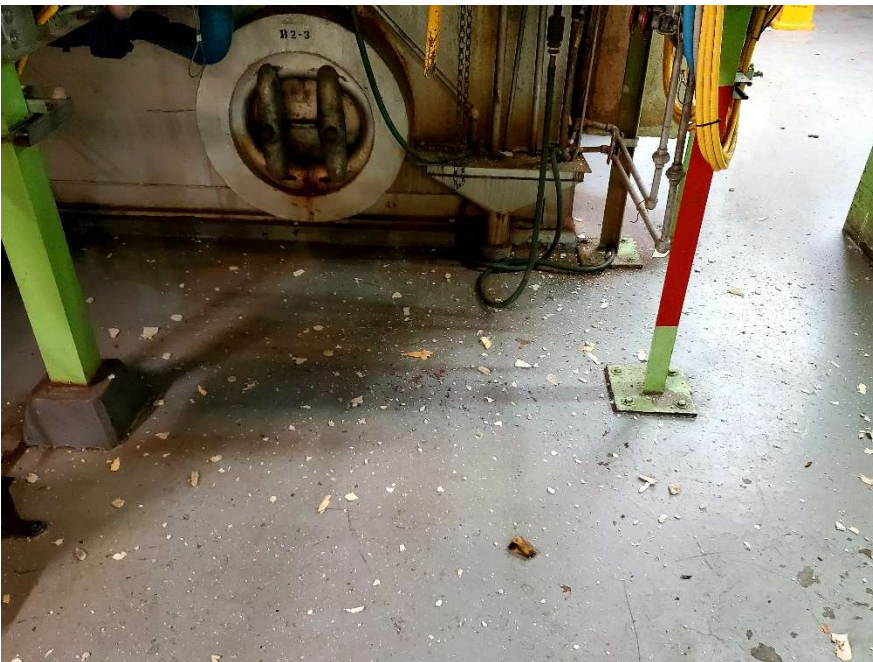
Disturbed asbestos from the steam hitting the ductwork insulation.

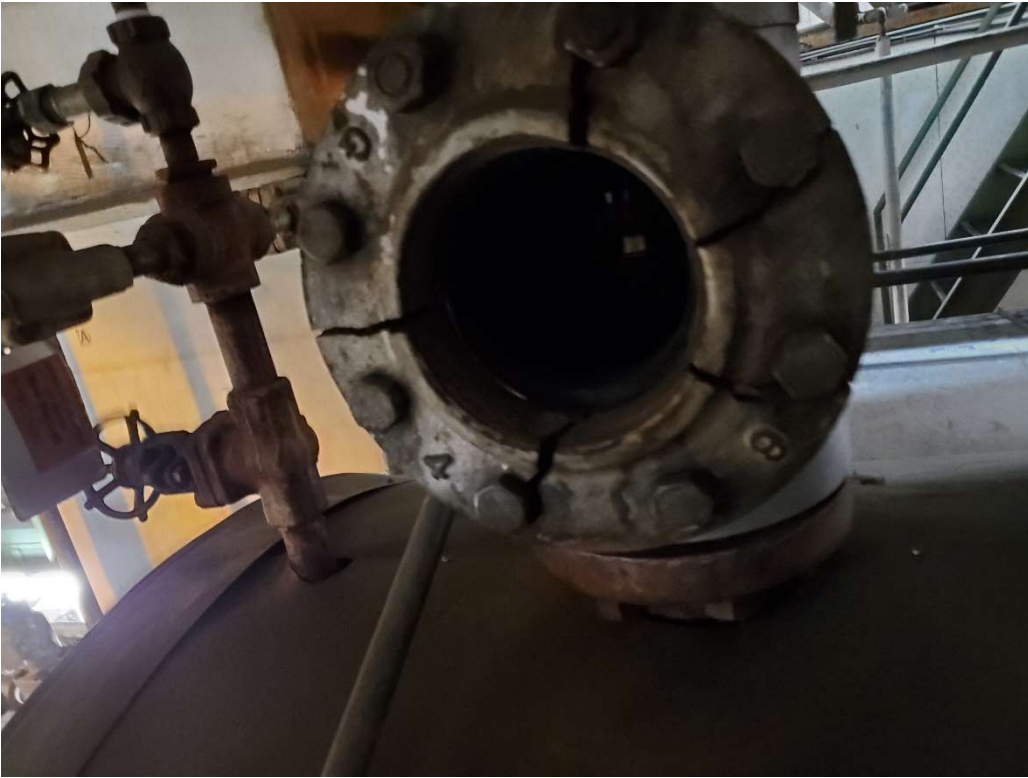
Outlet safety valve flange, still in place, note radial cracking.

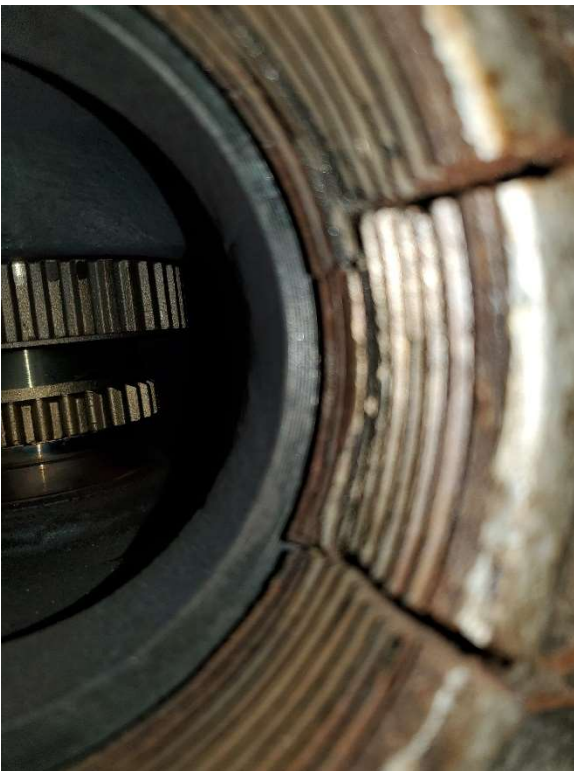
Safety Valve outlet internal cracks

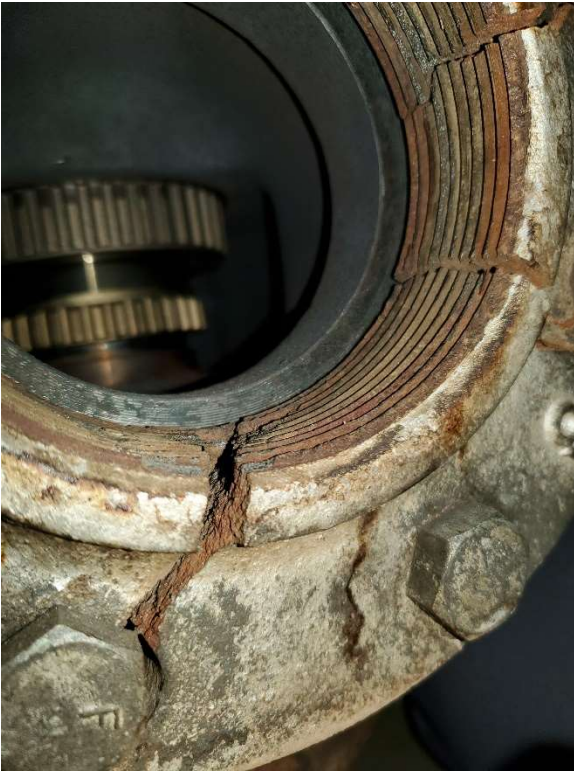
Safety Valve outlet flange cracking
