Incident Summary #II-1028261-2020 (#18434) (FINAL)

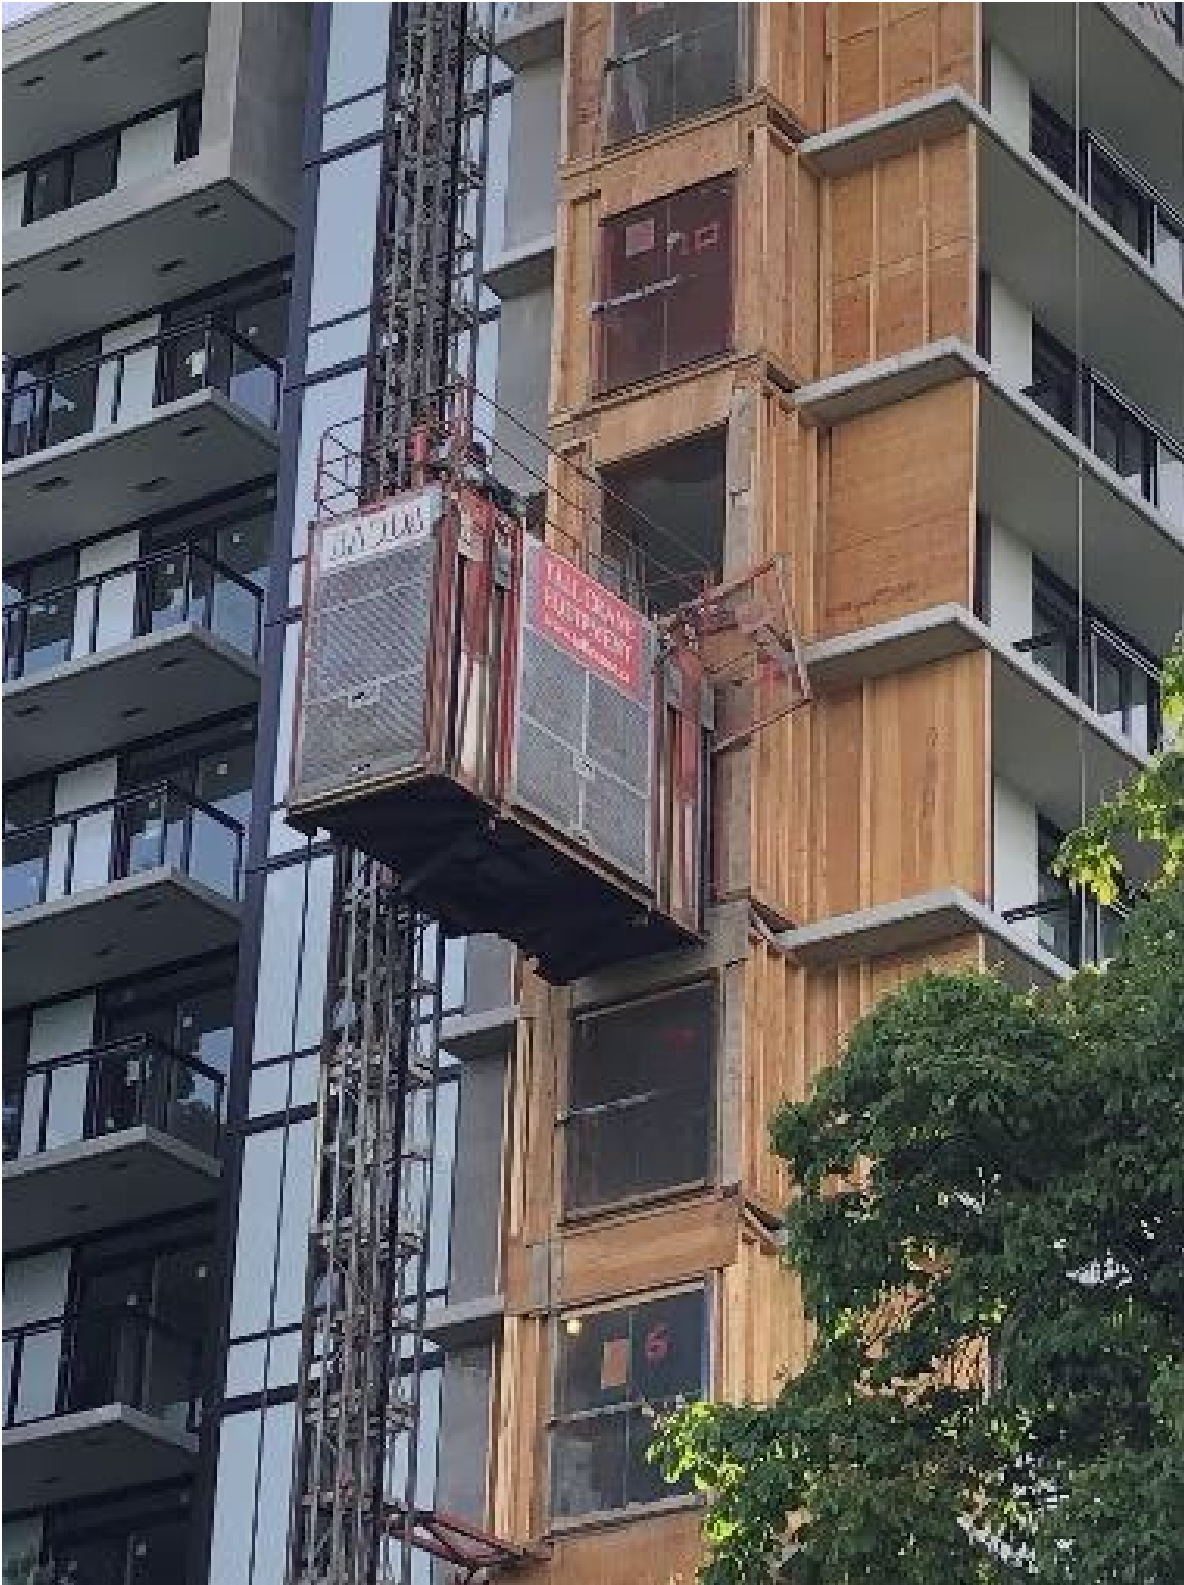
Failure scenario(s)	During the operation of the unit, the opening and closing of the gate caused the screws to loosen/move away from the hoarding structure which resulted in the gate to car clearance decreasing. Due to this decrease in clearance, as the car traveled in the up direction it struck the gate lock. The impact of the car and gate lock broke the gate fasteners and subsequently tore the gate from the hoarding.	
	Facts and evidence	<p>During an inspection in February 2020 it was noted that sill gaps were not within code requirement of 0.5" to 2". The gap was from 2.5" – 2.75" during the inspection. The contractor was informed that they needed to decrease this sill gap to within code requirements. The contractor subsequently installed shims to bring the sill gaps into compliance.</p> <p>Based on my conversation with the elevating devices contractor, they have stated that the screws used were the same screws that were originally installed on the gates which were 2.5" in length. Since the gates were shimmed out by as much as 1" this left only 1.5" of screw engagement. The manufacturer recommends at least 2" of engagement into the wood frame. Based on my conversation with the site, they stated that this information was not conveyed to them.</p>

Gate dislodged from hoarding

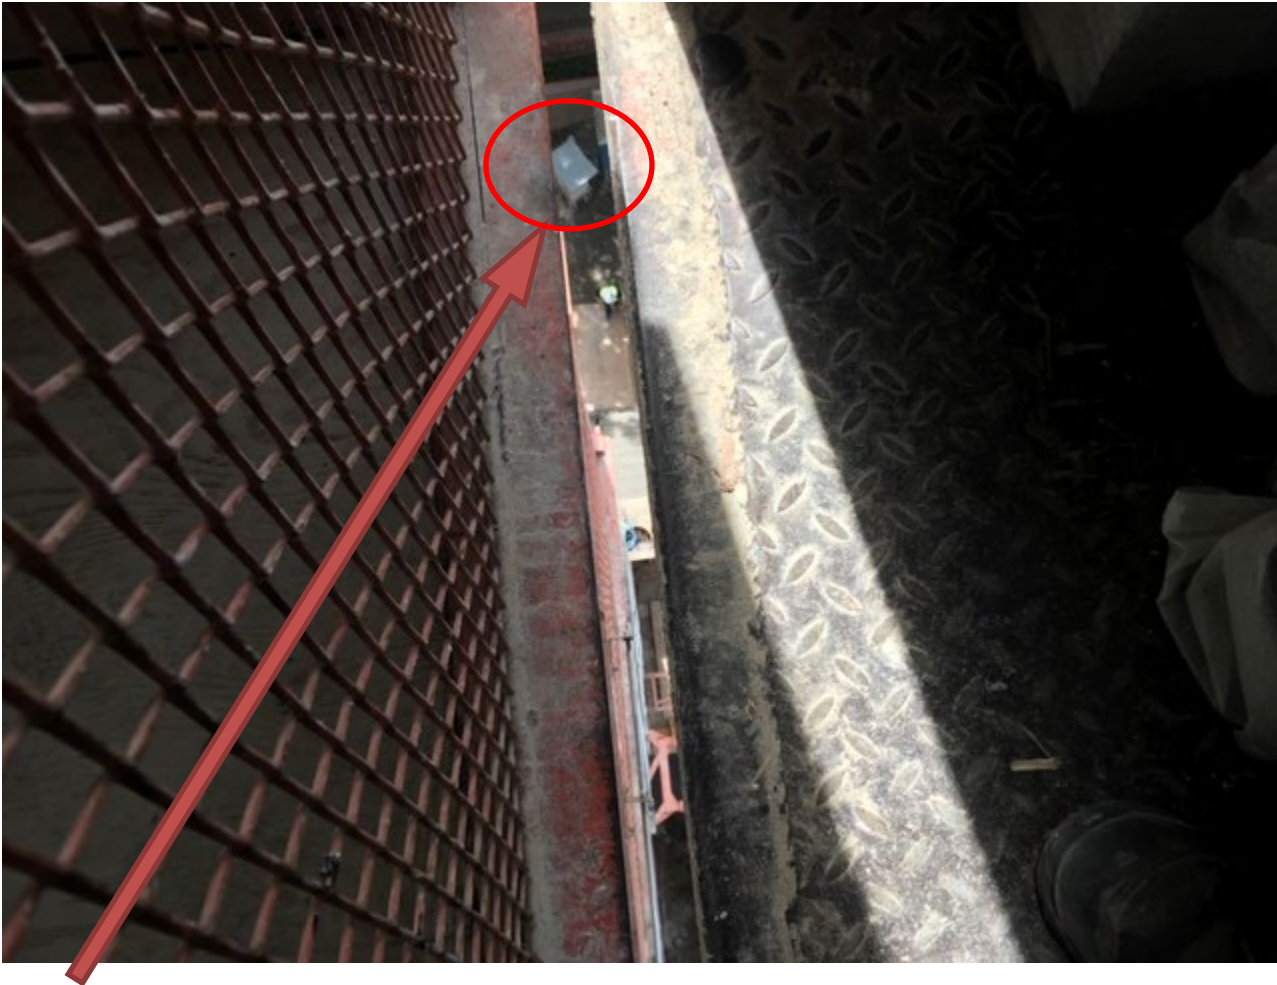
Gate Lock Contact Point – Gate Lock torn from the gate assembly

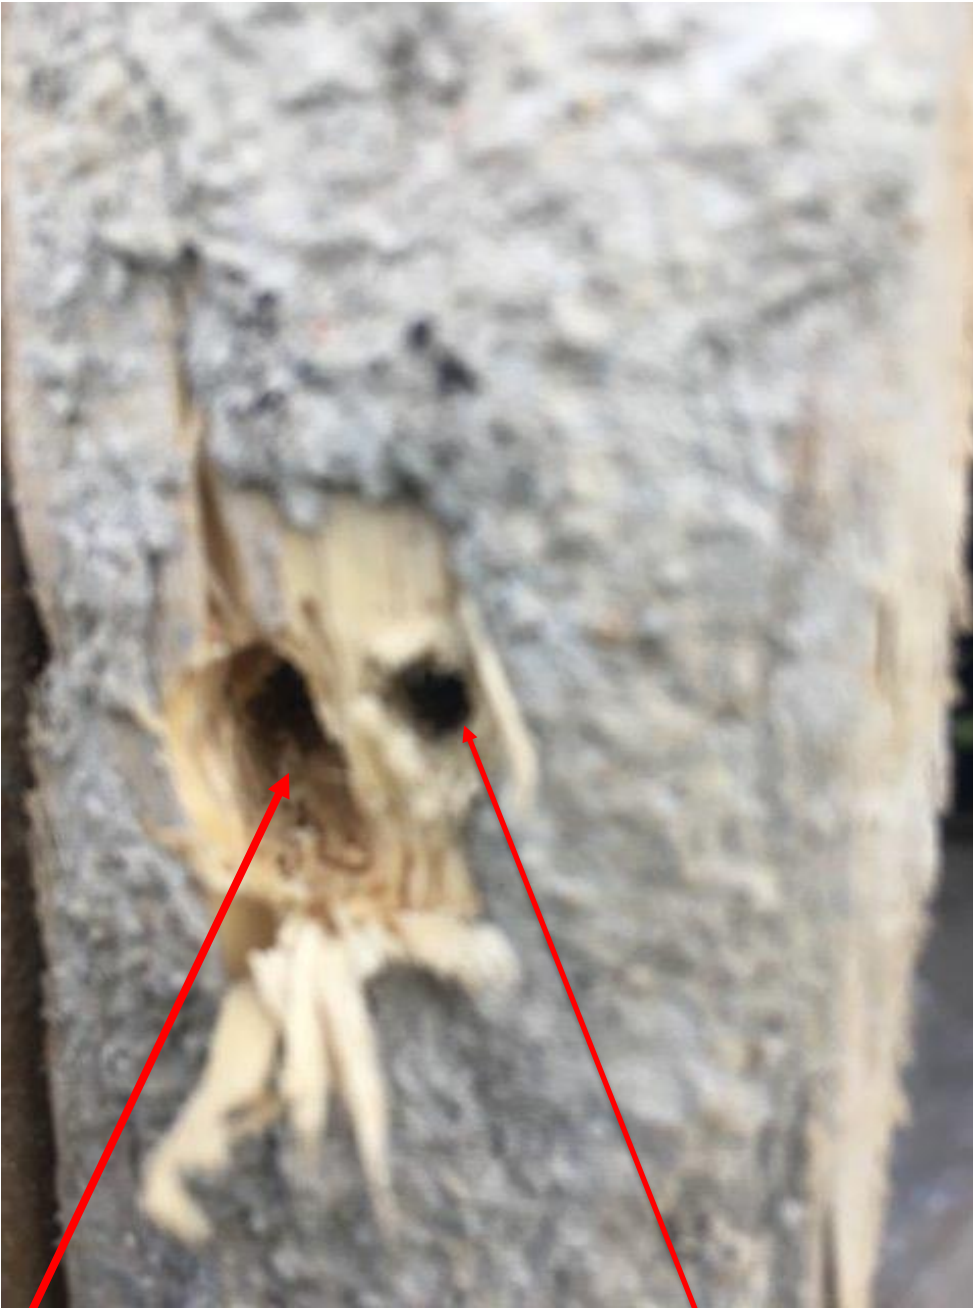
Anchoring point after first inspection to space the gate out to comply to sill to sill gap requirement

Anchoring point during first inspection

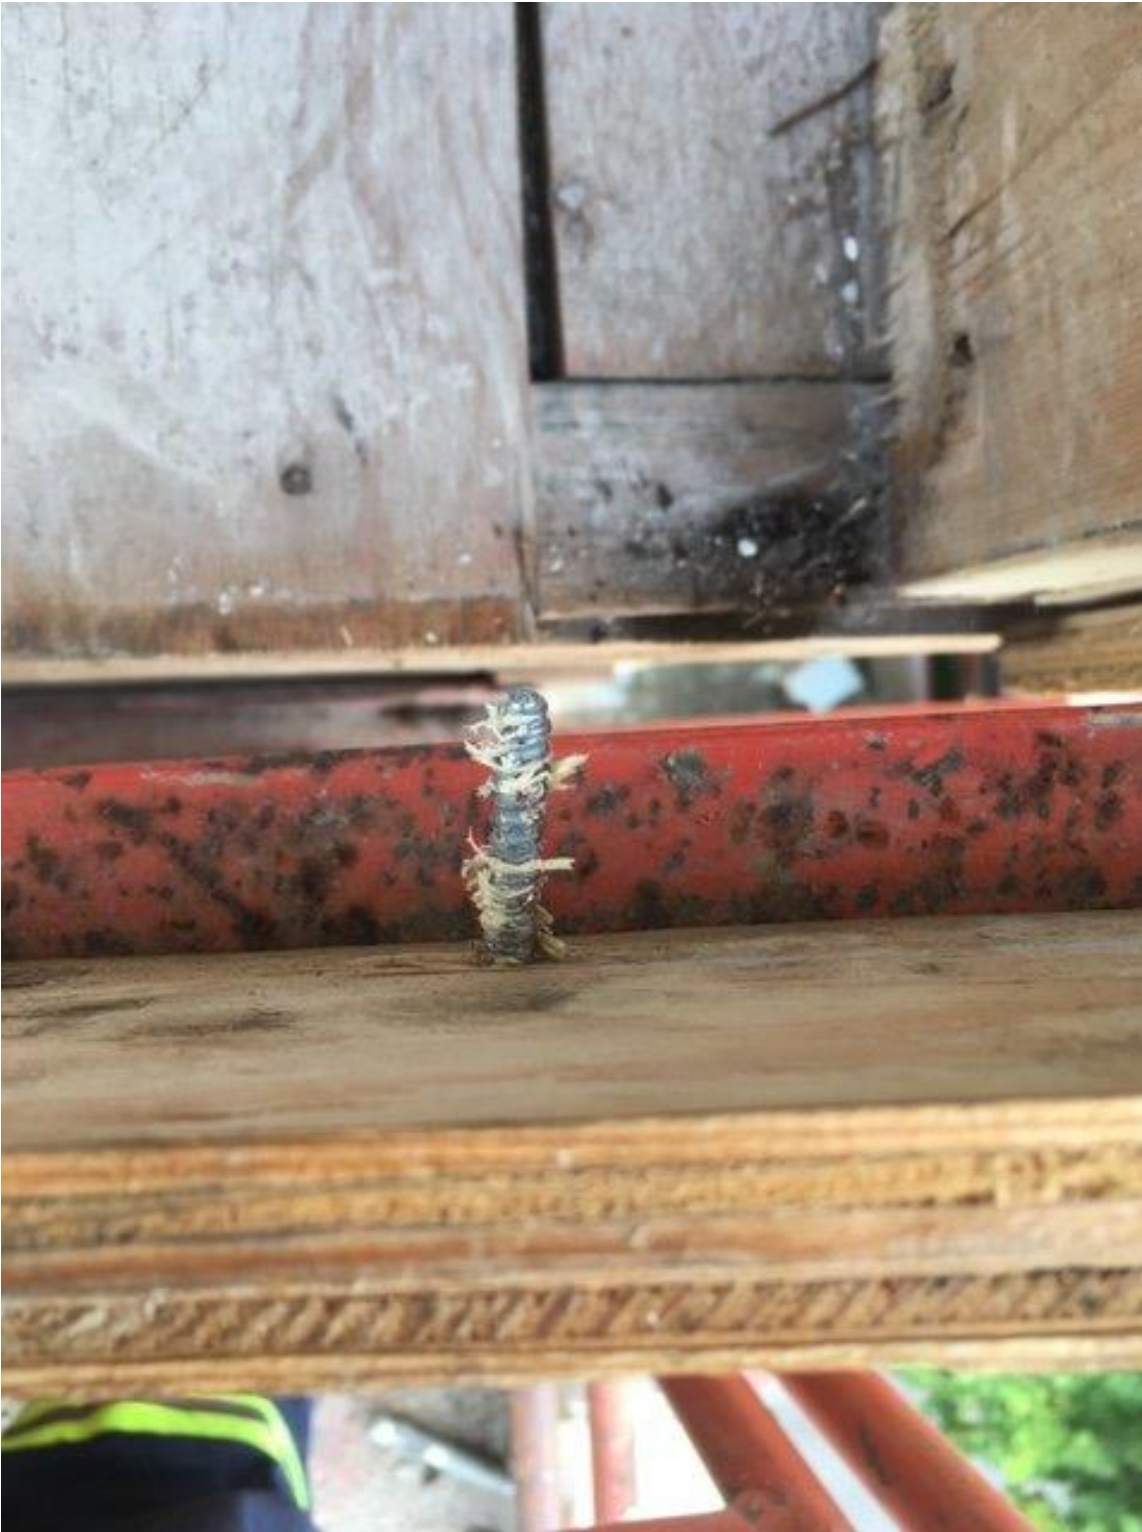
Causes and contributing factors	It is highly probable that landing gates being installed with undersized fasteners contributed to this incident. It is probable that the elevating devices contractor not communicating the minimum fastener length requirement to the general contractor contributed to this incident.

Lag screw used
