## Incident Report #II-935221-2019 (#15840) (FINAL)

Appendix B: Chiller Failure – Root Cause Analysis

**PORT ALBERNI SPORTSPLEX CHILLER  
FAILURE – ROOT CAUSE ANALYSIS**

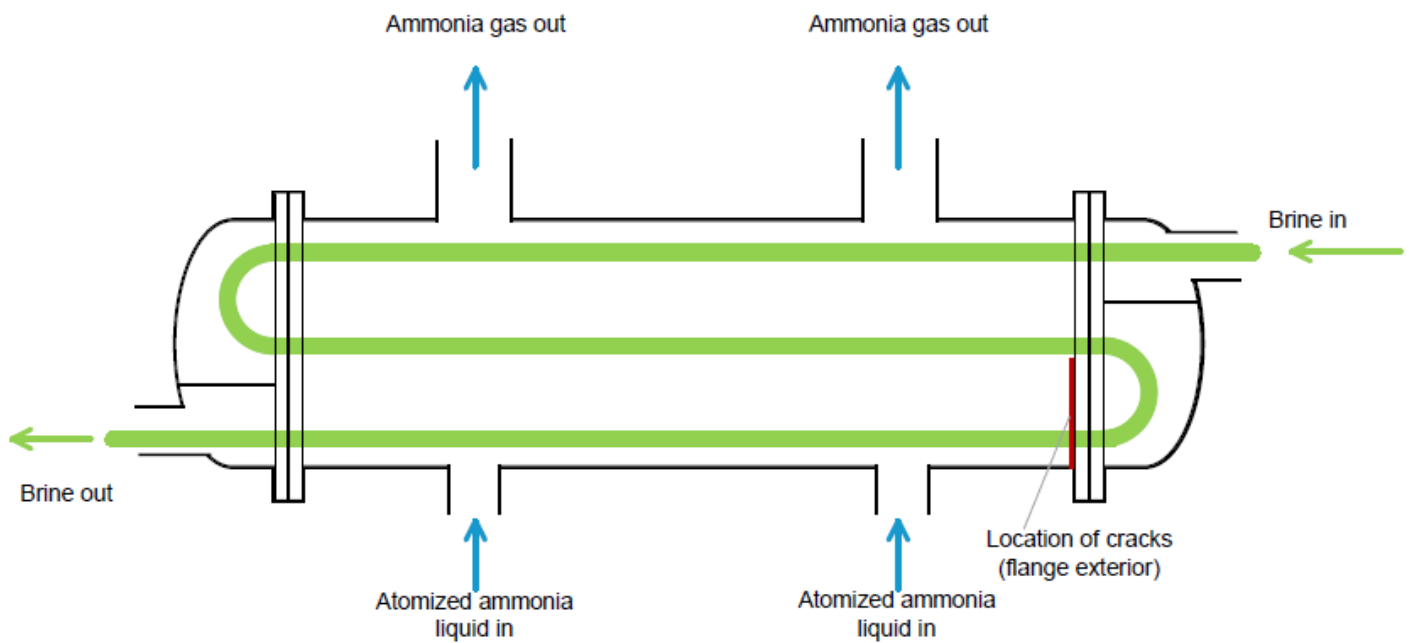
Figure 1: Schematic diagram of incident chiller showing the general flow direction of brine and ammonia.

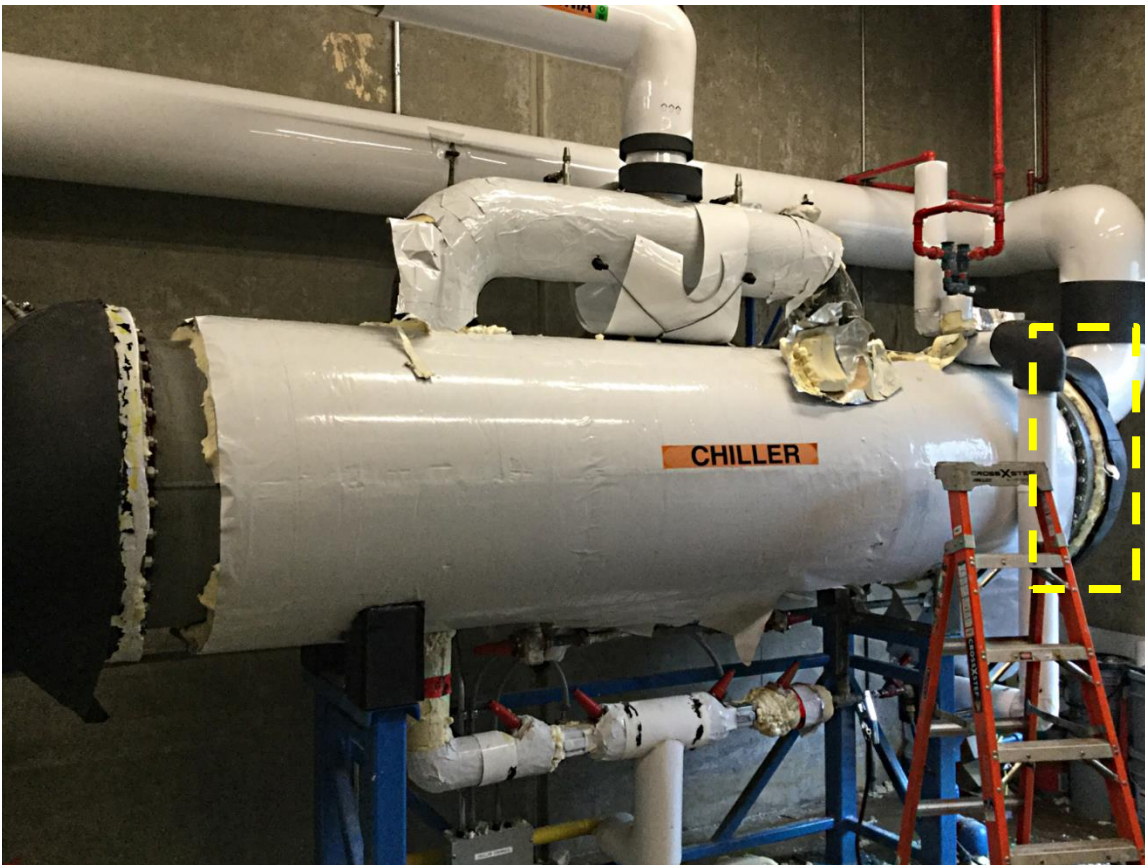
Figure 2: Location of weld failures along 180° of the circumferential shell to head flange weld.

UT evaluation of the shell seam and the shell to flange welds detected cracks at the locations shown in Appendix B. All of the cracks are on the bottom 180 ° of the shell and relatively uniformly spaced around the shell circumference. No cracks were found at any other location.

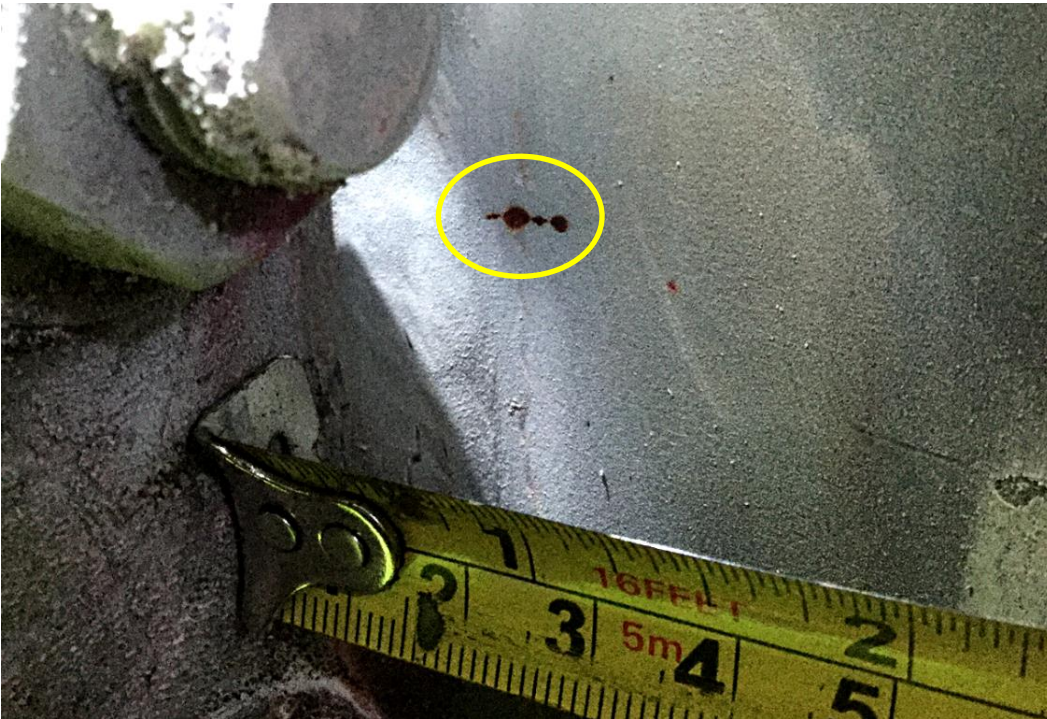
A company was retained by the refrigeration contractor to conduct non-destructive testing to locate the source of the ammonia leak. Visible liquid penetrant inspection (LPI) conducted on the shell-to-inlet flange circumferential weld identified a 0.250-inch-long crack originating from the weld and extending into the base metal of the chiller shell (Figure 3). The crack was located at the 9 o'clock position (viewed from south end of vessel) and was perpendicular to the weld, as shown in Figure 3.

Figure 3: First crack found in the weld, revealed using liquid dye penetrant inspection. The crack was 0.250-inches-long and extended from the weld into the parent material.

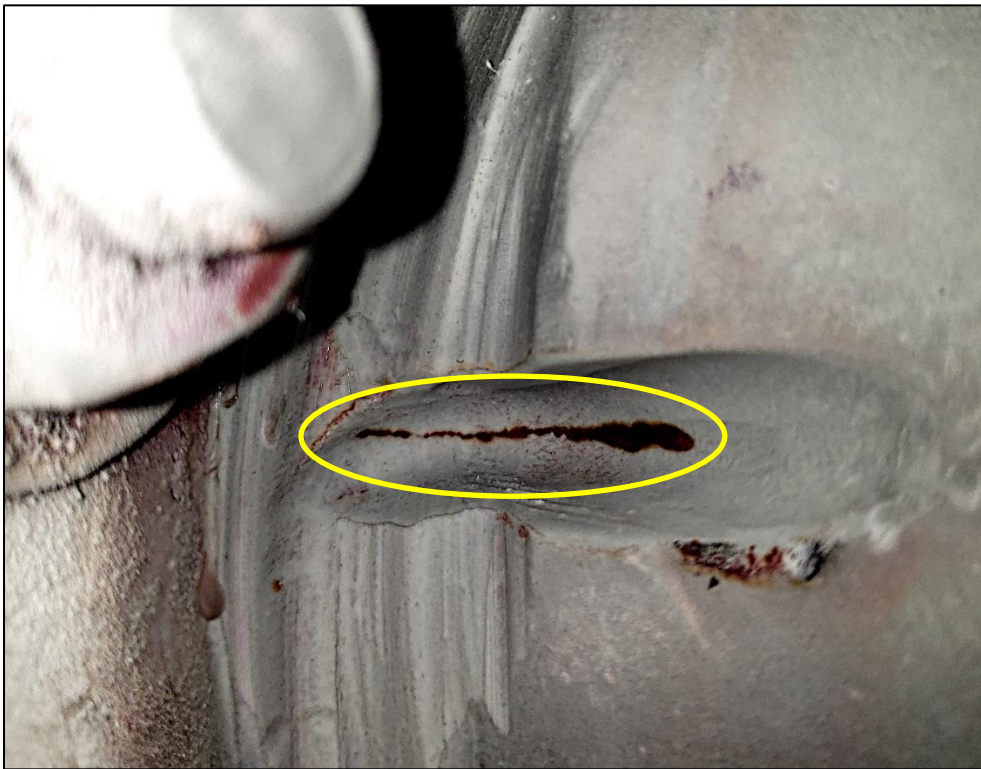
The full size of the crack through the weld and shell was determined by sequential grinding and LPI at 1/16-inch-deep to 1/8-inch-deep intervals. This revealed the crack to be subsurface to the weld extending from the flange into the shell of the chiller as shown in Figure 4. The final crack length was measured to be ¾-inch long and extended fully through the wall of the shell. It was evident from these inspection results that the crack started inside the weld and propagated to the surface over time. This raised suspicions that other internal cracks could be present. Ultrasonic testing is commonly used to detect the presence of internal cracks in these cases. The refrigeration contractor hired a welding contractor to repair the weld crack but did not conduct ultrasonic testing to determine if any more cracks were present.

- a. Ammoniacal SCC follows sustained static stress in mild steel, such as stress present in the heat-affected zone of welds with high residual stresses. Such cracks due to SCC are often oriented parallel to the weld bead. The weld cracks found in the chiller shell were oriented perpendicular to the heat-affected zone and propagated in a straight line with no visible branching (Figure 4).

Figure 4: Larger internal crack (from Figure 3) visible after surface grinding. The crack was approximately 0.750-inches-long and extended up to the flange.

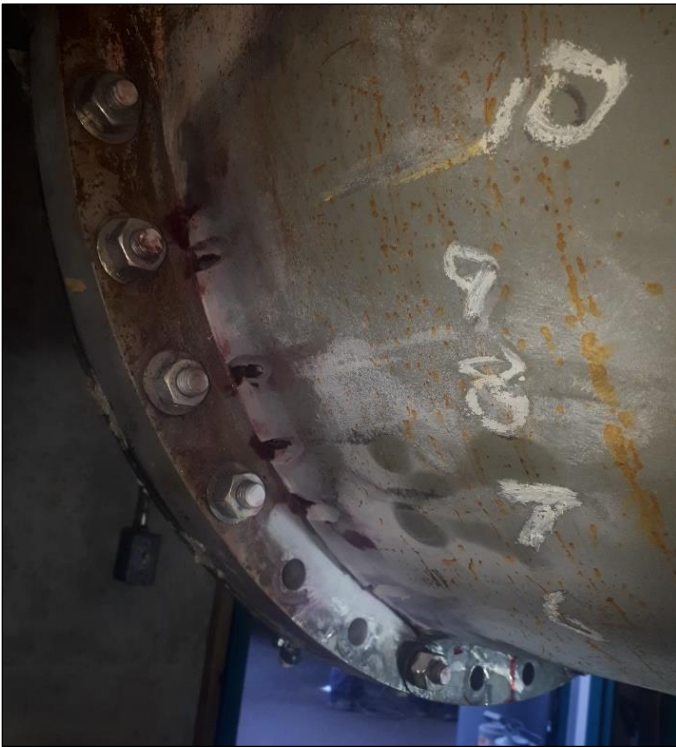
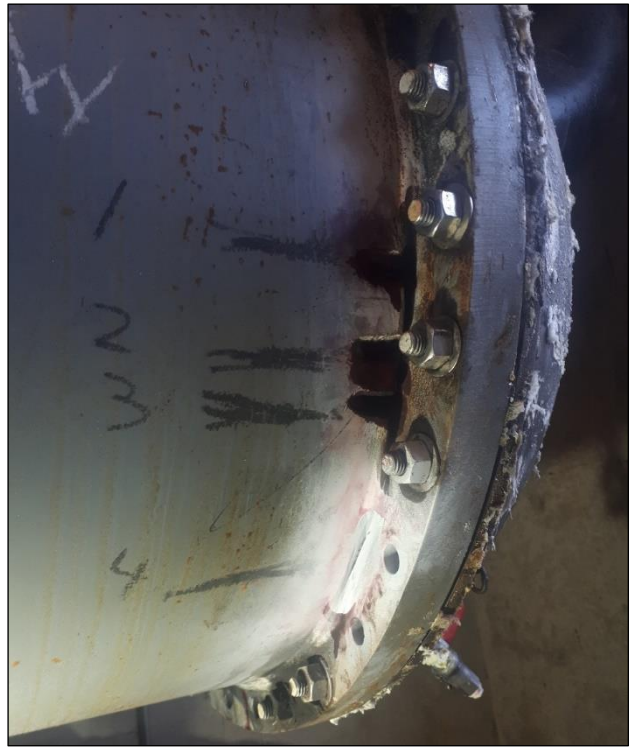
A total of 11 weld cracks were found in the same weld (Figures 5 & 9). No deficiencies were noted during examination of the other welds in the vessel. Progressive grinding of the weld in the ten new locations found large internal cracks of a similar nature to the original weld failures, being longitudinal into the chiller shell (Figures 6 & 7).

Figure 5: Location of 10 weld cracks found by ultrasonic testing. (Source: Acuren report)

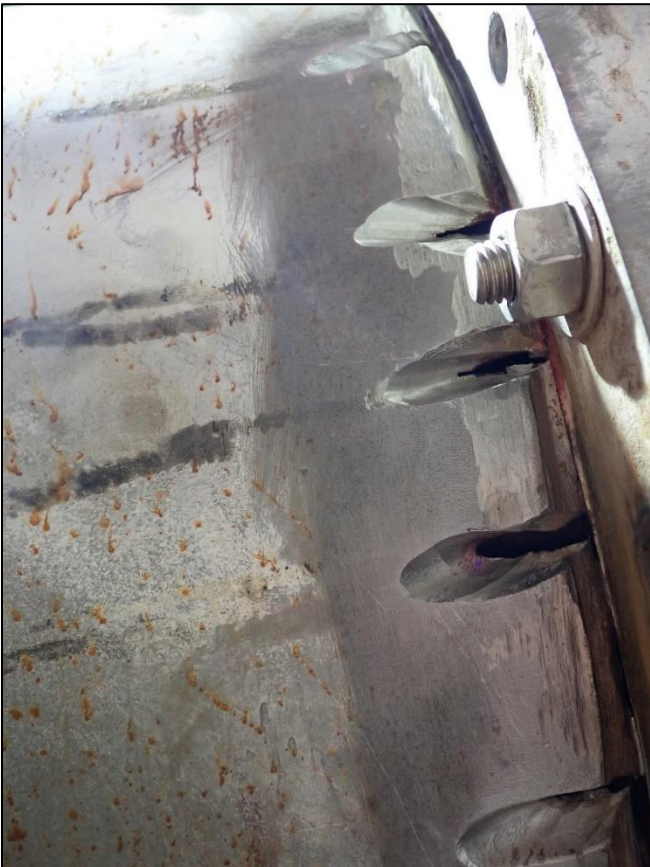
Figure 6: Large internal cracks found when welds ground to reveal inner shell surface. (Source: Acuren report)

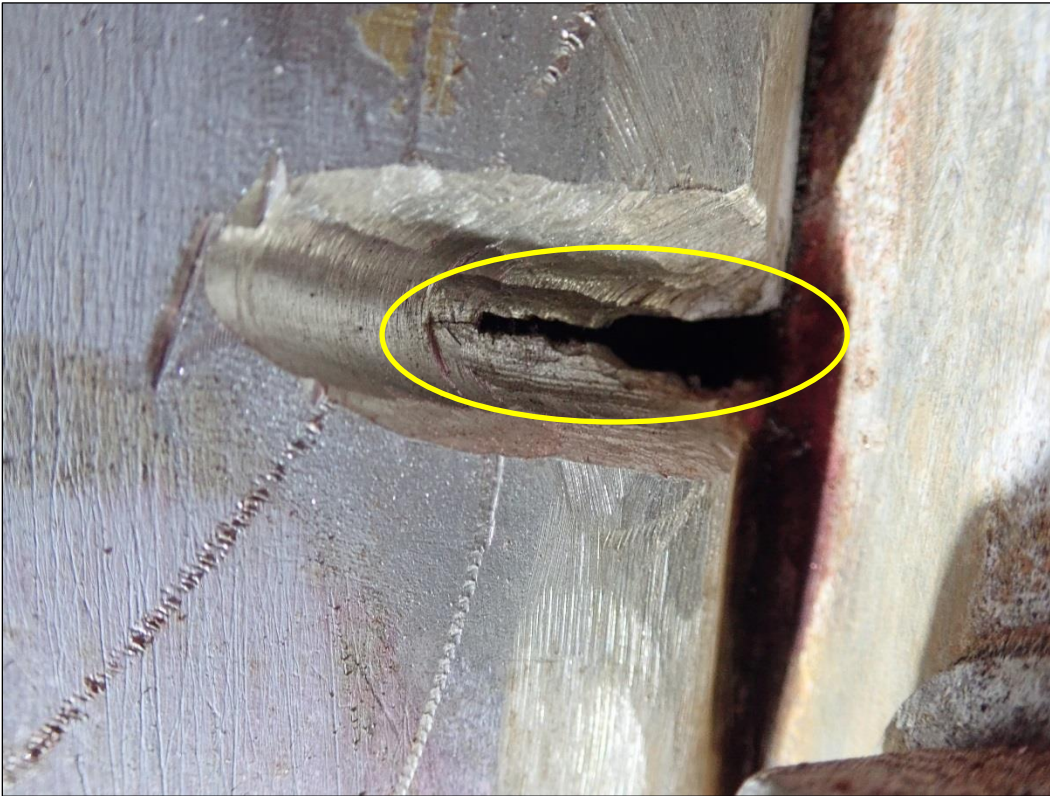
Figure 7: Close up view of typical weld crack size at the inner shell surface. (Source: Acuren report).

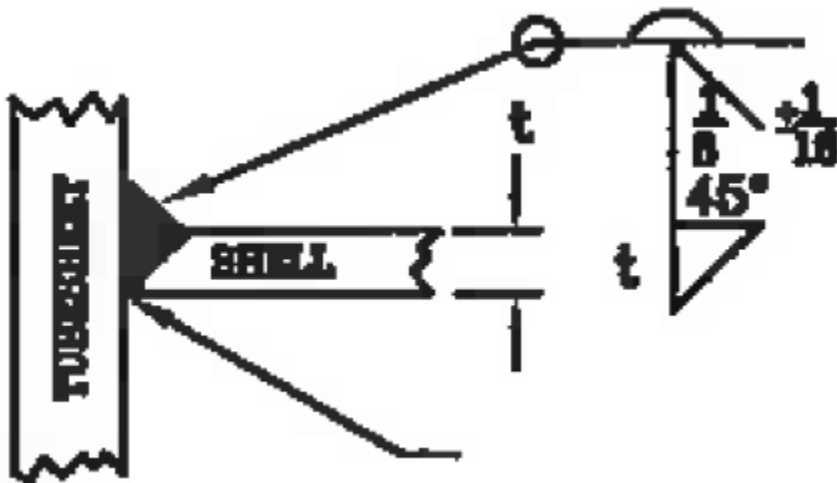
Figure 8: Weld joint detail between the shell and tubesheet [head flange]. Source: manufacturer's assembly drawing.

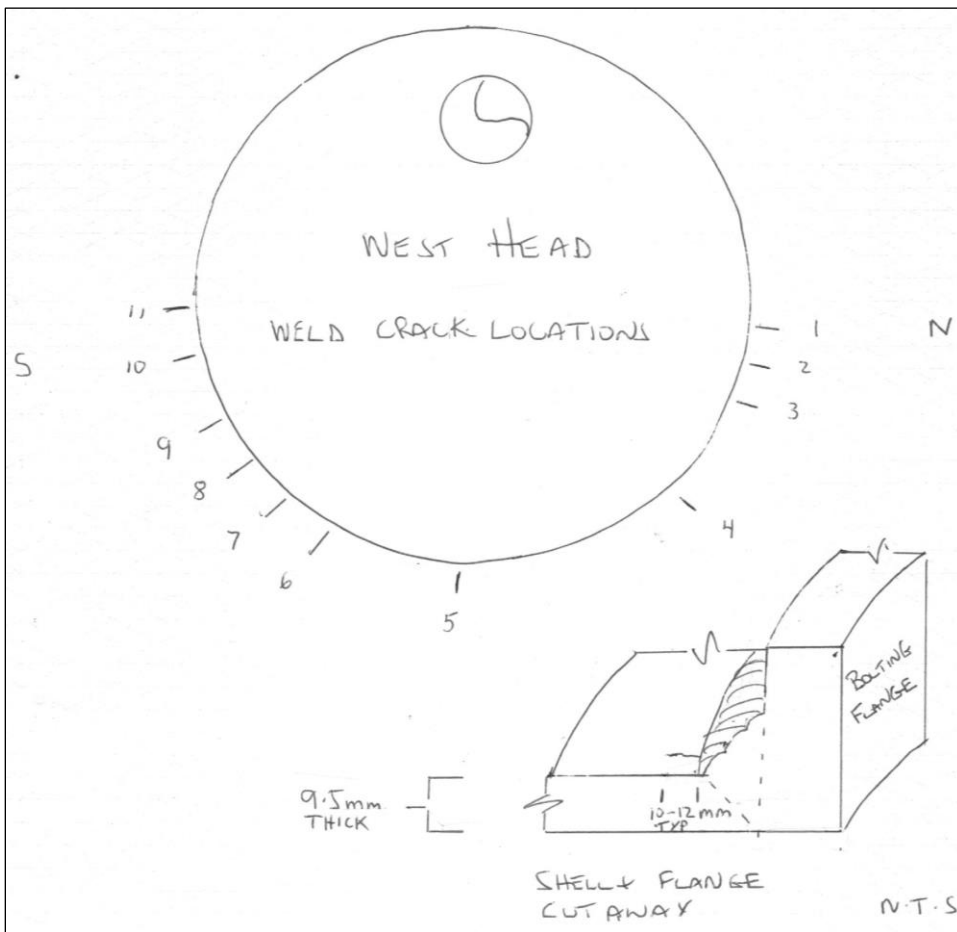
Figure 9: Location of 11 weld cracks found and weld joint detail between the shell and flange. (Source: Acuren report)

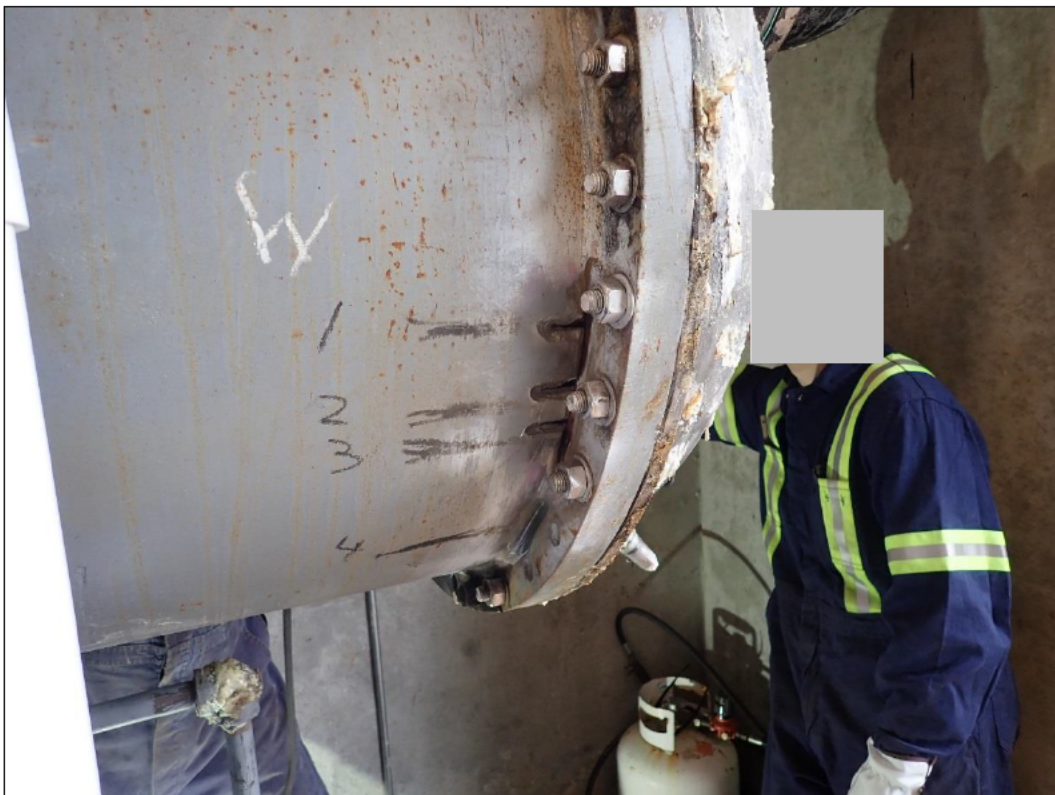
**Figure A-2** Opposite side of chiller flange showing location of cracks labelled 1, 2, 3, and 4.

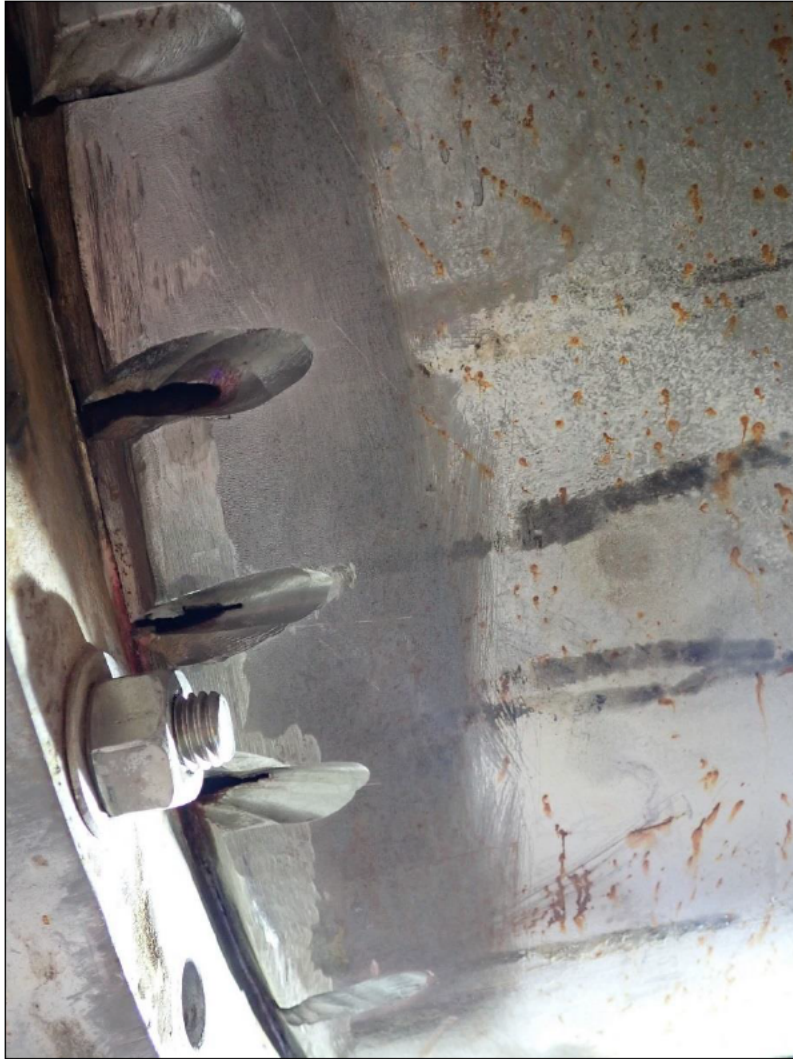
cracks were similar in shape and were transverse to the flange weld. Grinding revealed a short axial crack extension into the parent shell material in every case (Figure 3).

**Figure A-3** Short axial crack entering the shell of the vessel.

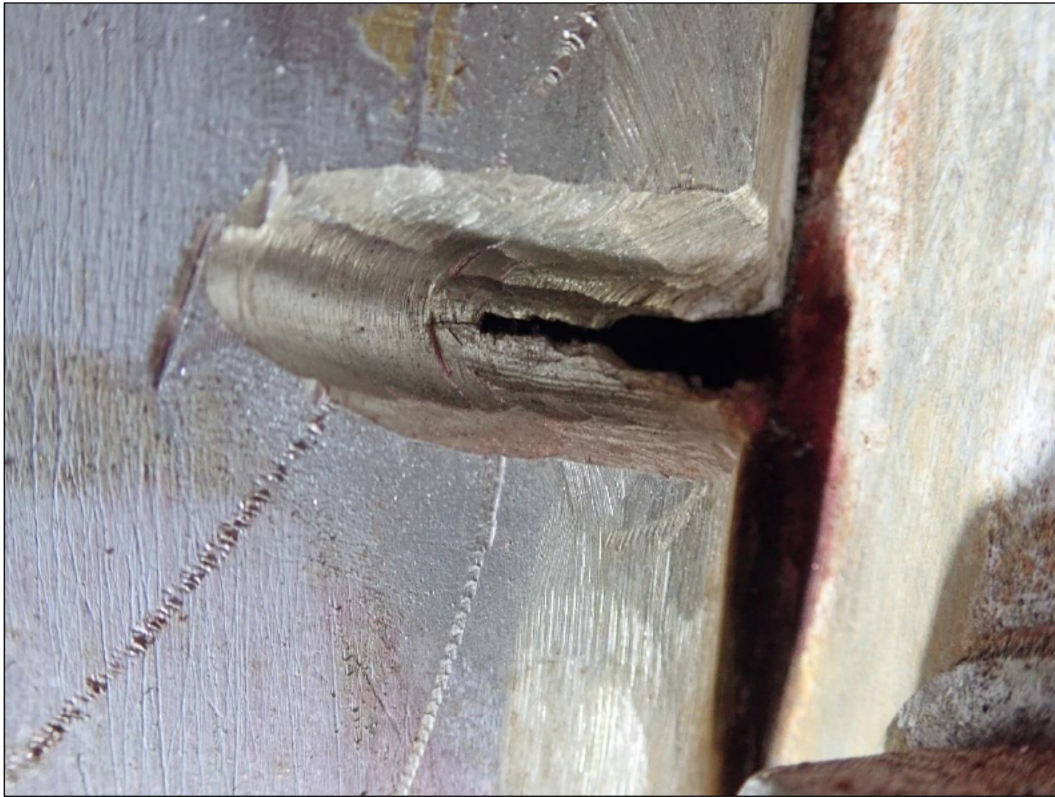
The gap opening between the two sides of the cracks ranged between 1 and 2 mm (Figures 4 and 5). Residual compressor oil was visible draining from the cracks around the bottom of the vessel. The bulk of this oil was removed, but the interior surface was coated with a thin film of oil and presented a source of hydrogen for welding.

**Figure A-4** Ground out crack showing opening of 1 -2 mm and depth of 3/8”.

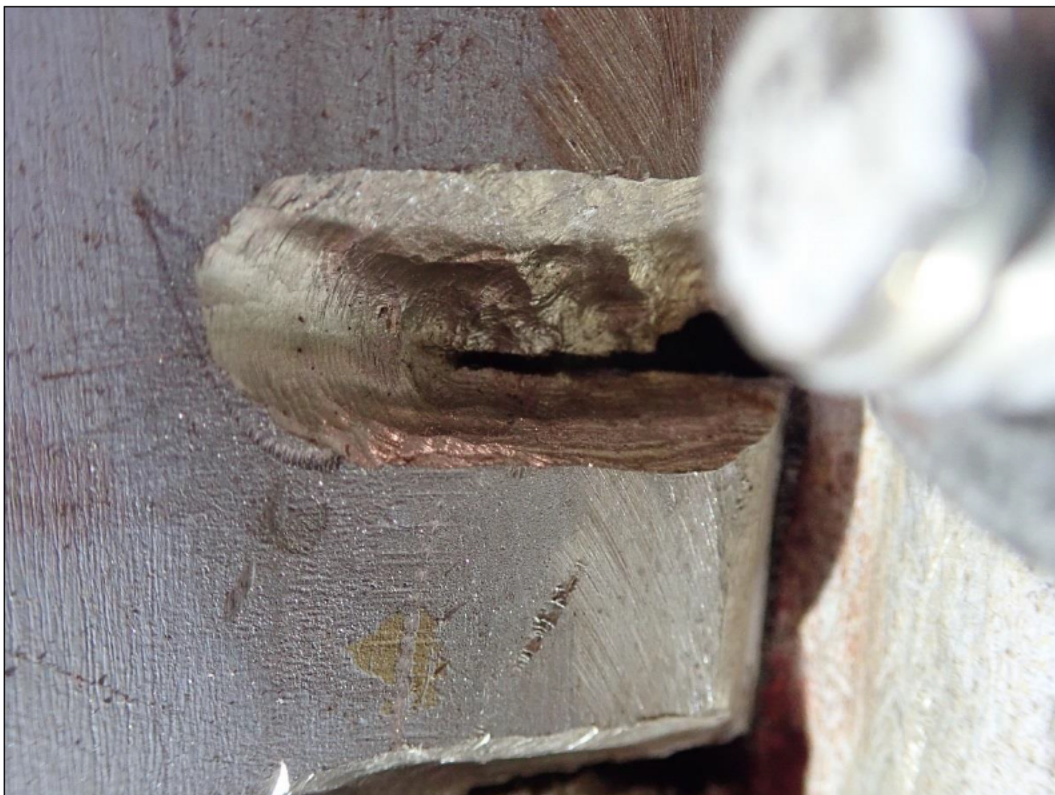
**Figure A-5** Second ground out crack showing opening of 1 -2 mm and depth of 3/8”

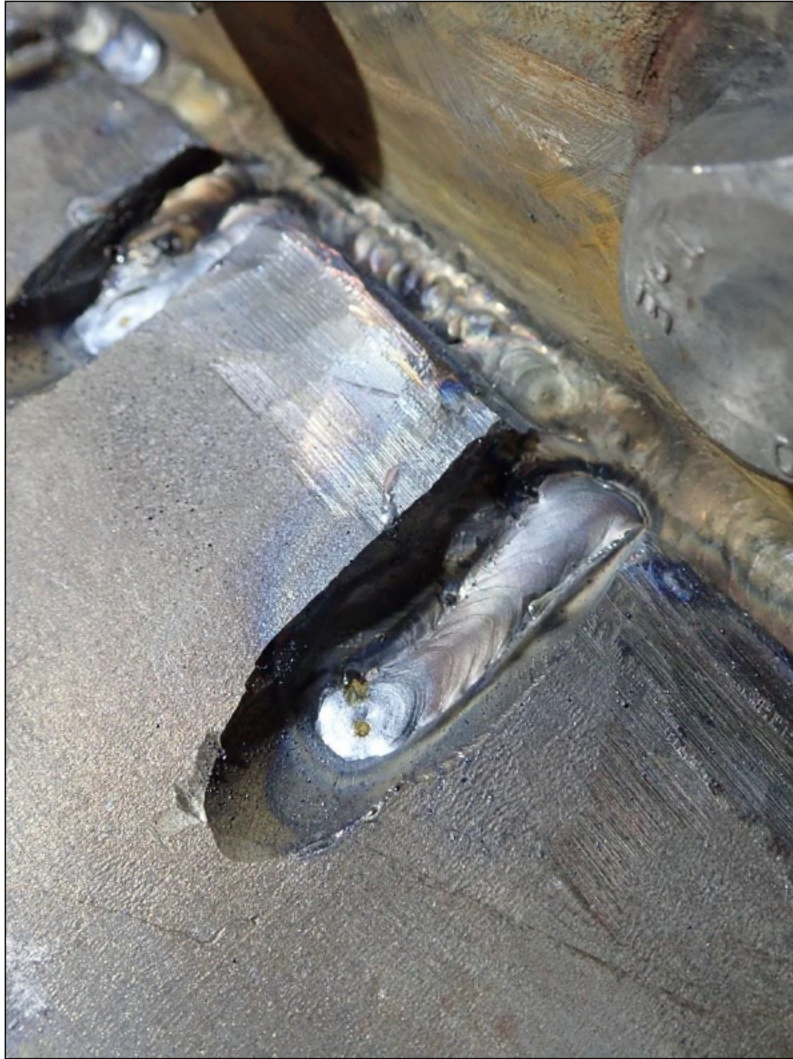
**Figure A-6** Typical crack after hot pass is placed.

Repair welding was performed using Geo – Tech welding procedures GTI-CS7 and GTI-CS9 (Appendix D). The root and hot passes were performed using the GTAW process and ER70 S3 filler metal (Figure 6). The fill and capping passes were performed using the SMAW process and E7018 welding rods.

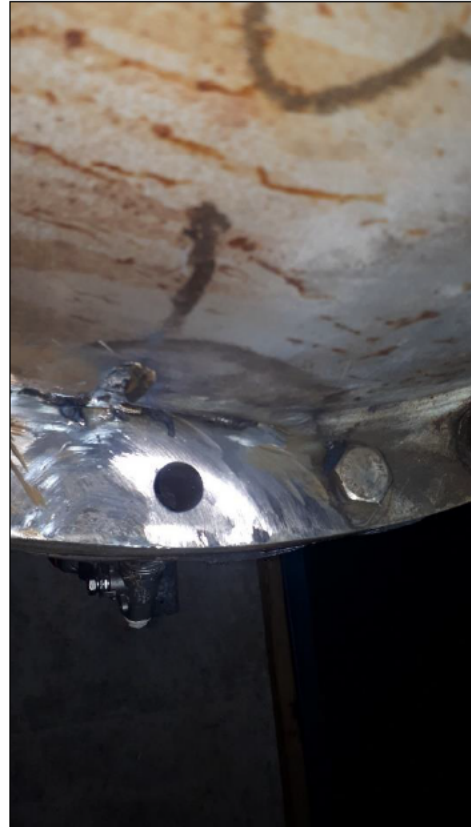
*Photo B-2:*  
Location #5 excavation site.

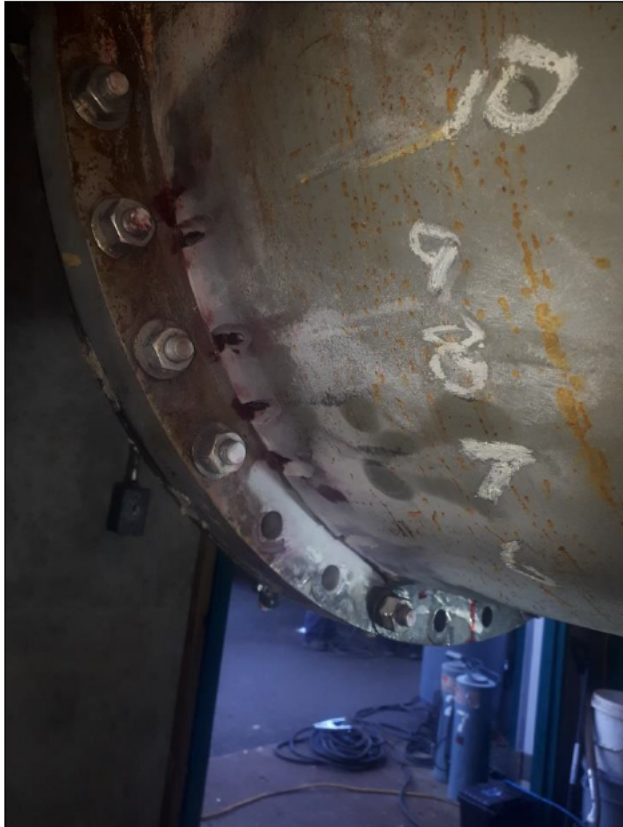
*Photo B-3:*

Locations 6-10 excavation sites.

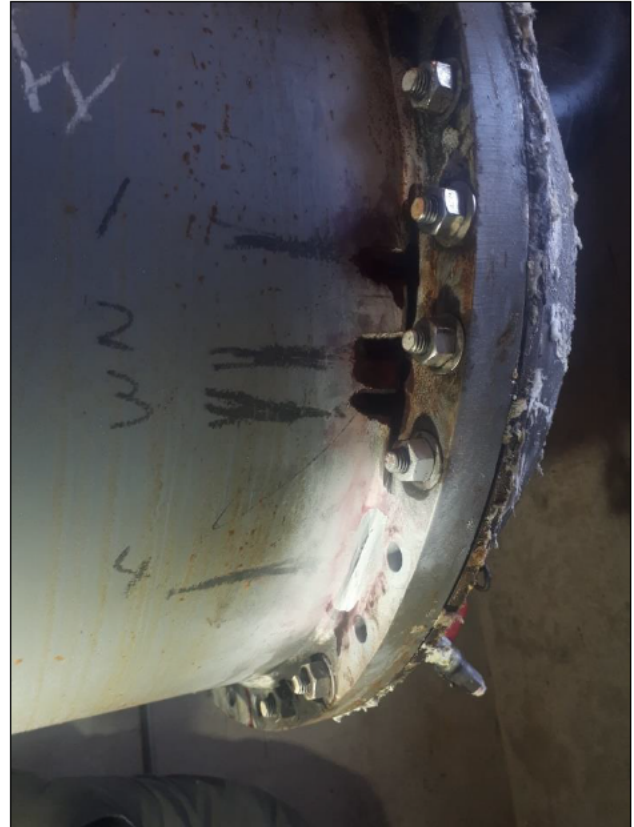
*Photo B-4:*

Locations 1-4 excavation inspection prior to rewelding.

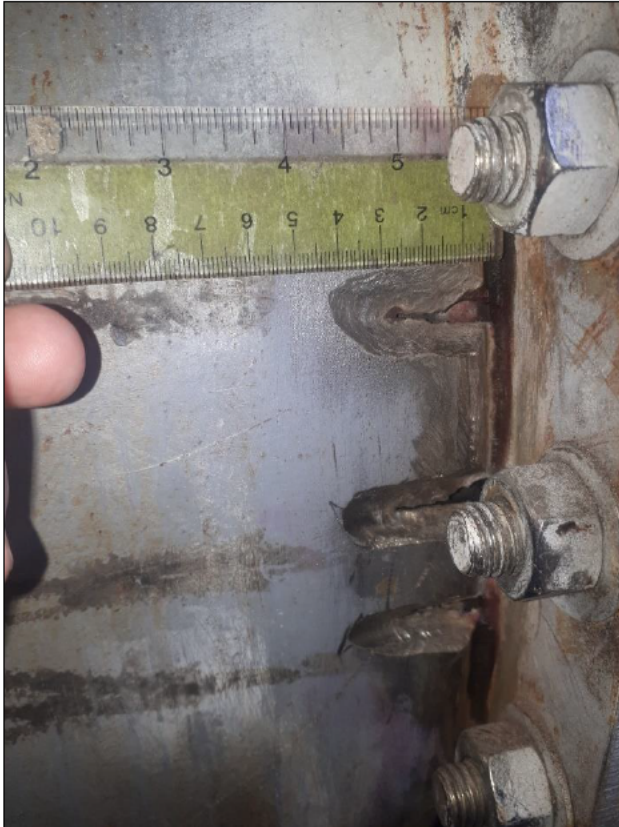
*Photo B-5:*  
Close-up of typical excavation site with fillet removed.

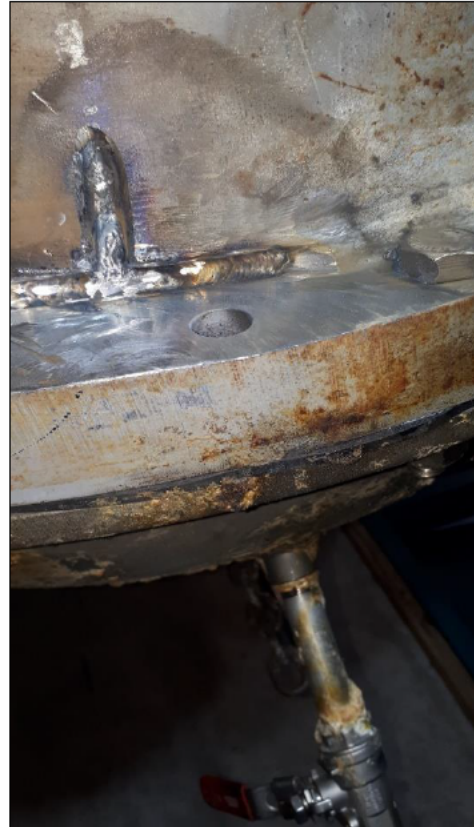
*Photo B-6:*  
Location #5 final root pass inspection.

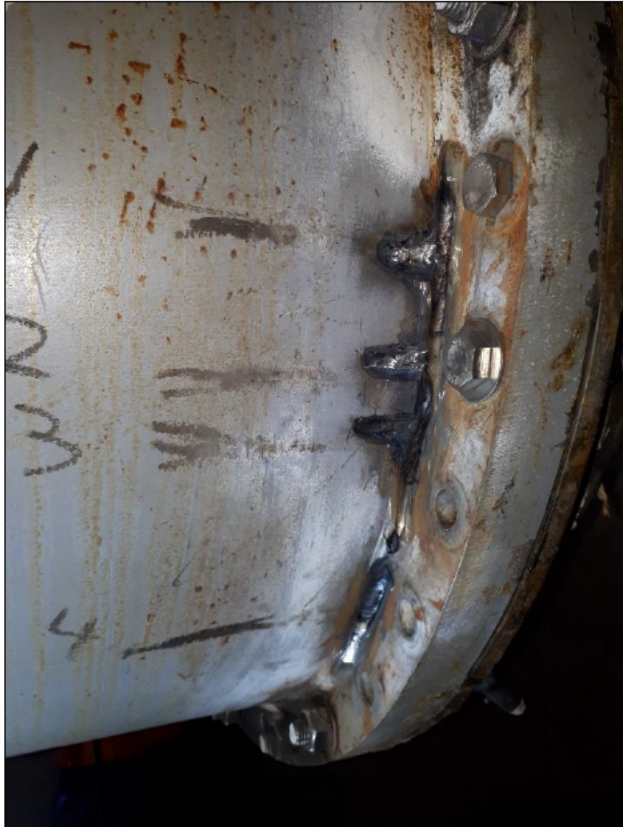
*Photo B-7:*

Location 1-4 root pass.

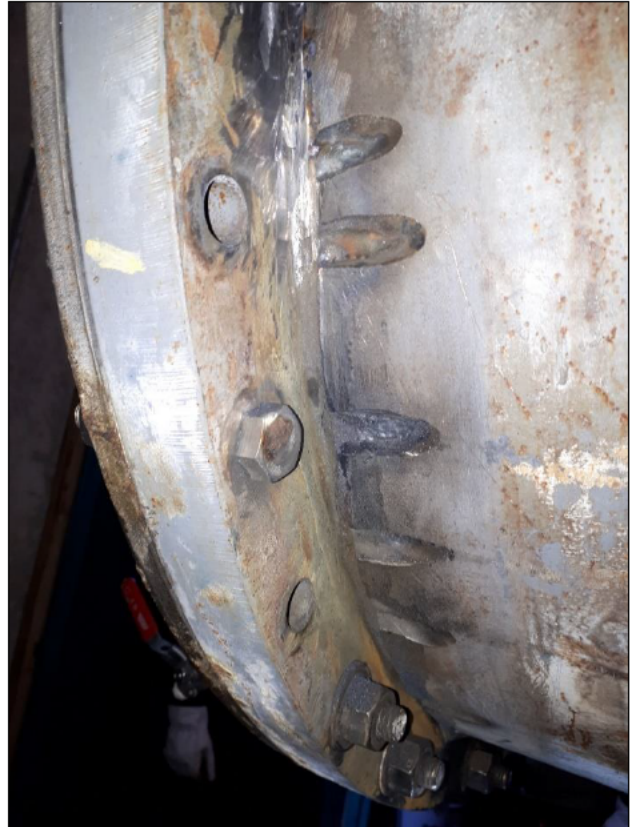
*Photo B-8:*

Locations 6-10 root pass.

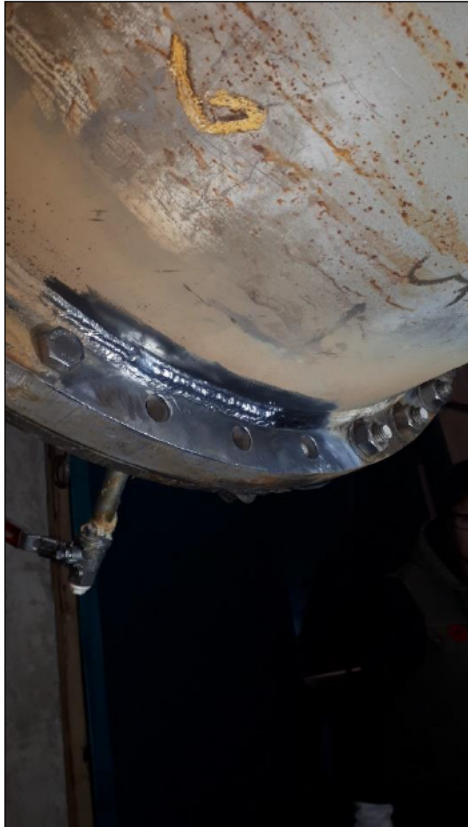
*Photo B-9:*

Final fillet weld inspection.

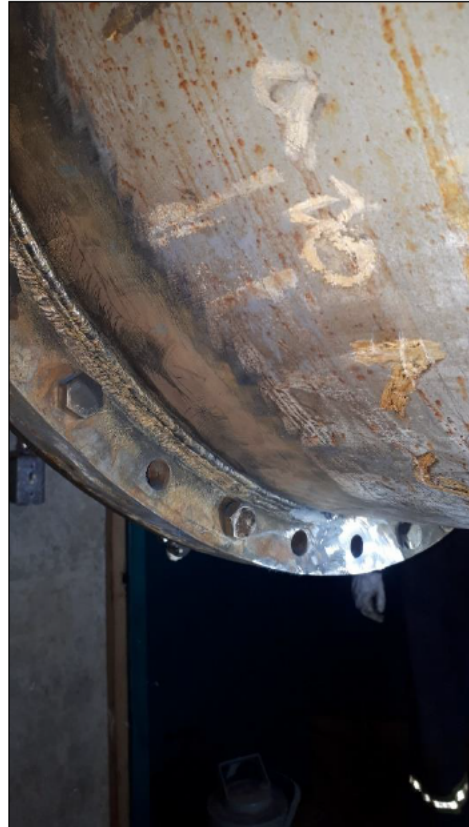
*Photo B-10:*

Final fillet weld inspection.

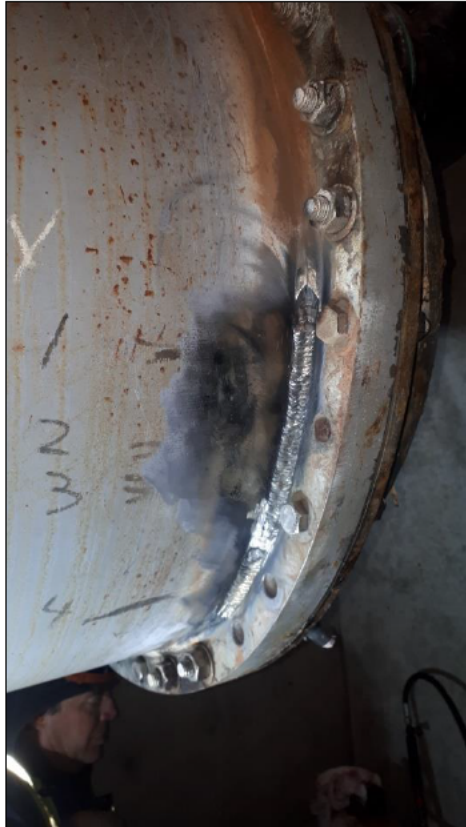
*Photo B-11:*

Final fillet weld inspection.

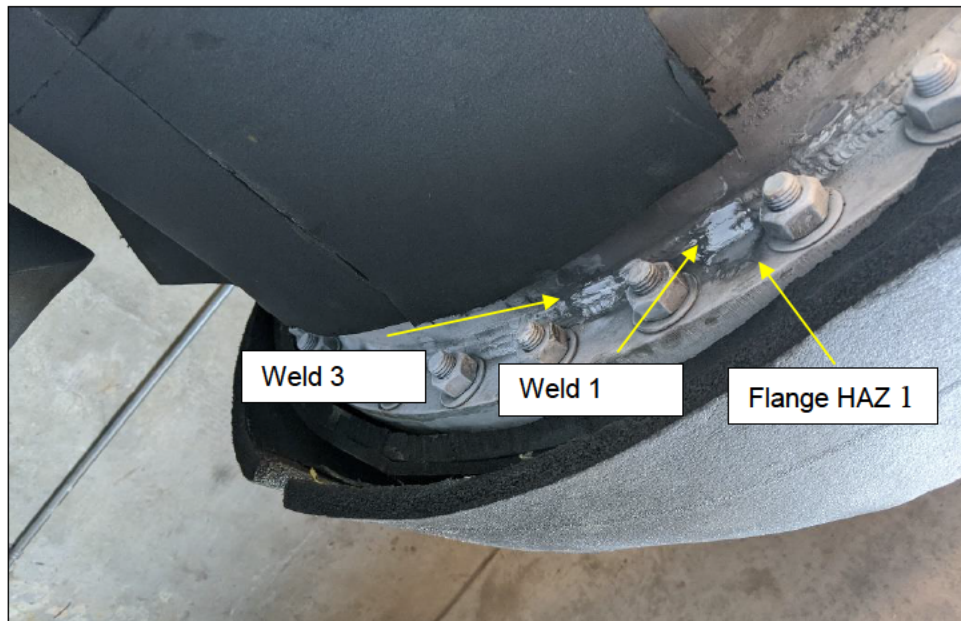
**Figure 2** Repair Weld Hardness Locations

Hardness testing was performed on the weld metal and heat affected zone of typical repair welds. The hardness test report is shown in Appendix E. The original weld metal and the repair weld metal is slightly harder than the parent SA516 grade 70 material (HB 195). No excessive hardness was detected in the HAZ or weld metal of the repair welds.
