Incident Summary #II-1672016-2024 (#44218) (FINAL)

SUPPORTING INFORMATION	Incident Date	February 9, 2024	
	Location	Interior	
	Regulated industry sector	Passenger ropeways - Above surface ropeway	
	Impact	Qty injuries	1
		Injury description	Concussion, multiple broken bones, internal injuries that required long term hospitalization.
		Injury rating	Major
	Damage	Damage description	N/A
		Damage rating	None
	Incident rating	Major	
Incident overview	A social media video was viewed by an adolescent male, in which a passenger jumped from a ropeway and rode away on their snowboard. The young man was riding the same chairlift uphill with their friend. Over half-way up the ropeway, the adolescent male passenger jumped from the carrier, in an attempt to replicate the actions of the individual in the social media video.		
INVESTIGATION CONCLUSIONS	Site, system and components	<p>The passenger ropeway involved was a fixed-grip double chair lift. Passengers load chairlift by maneuvering to a designated loading point. An operator is positioned at this specific location, to aid passengers and operate ropeway controls. Snowboard passengers are instructed/required to detach their back foot to allo

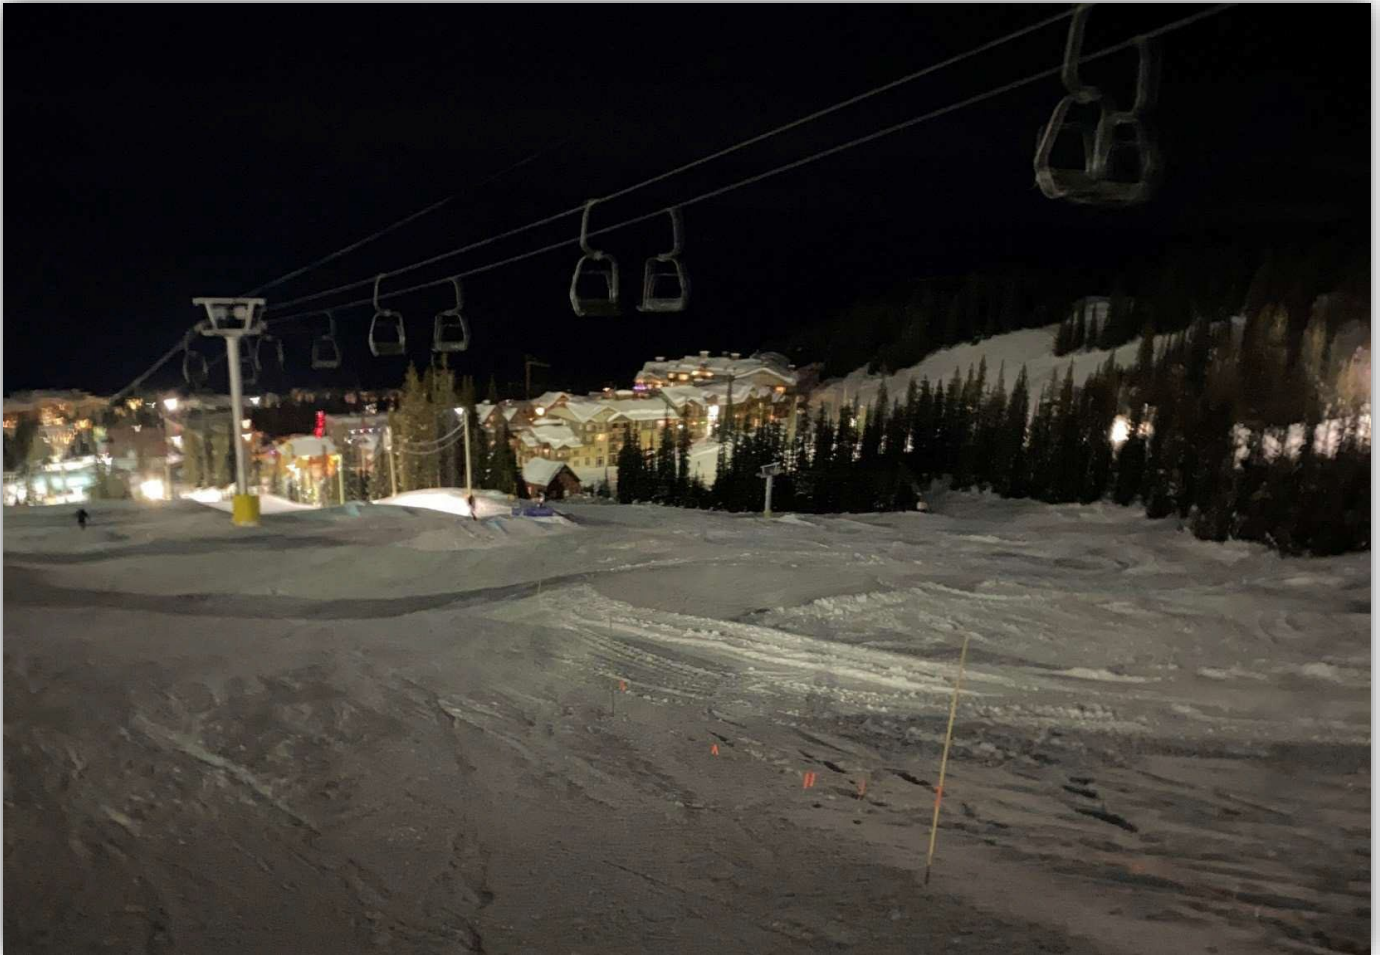
<p>Safety Officer observations:</p> <ul style="list-style-type: none"> • All required ropeway signage was in place. <ul style="list-style-type: none"> ○ Restraining Device instructional signage was located on Tower 2. • The incident location was the same lift and location as the one that was highlighted in the social media video. • The Boarder/Skier-Cross course was still in development with minimal snow, and the area closed off. • The measured distance between the bottom of carrier and the incident landing location was 8.5 meters (28 feet). <p>Chairlift:</p> <ul style="list-style-type: none"> • Fixed-grip double chair. • Maximum ropeway speed 2.0 m/s. • Operating ropeway speed 1.7 m/s. • Upper half of ropeway lift line is above a Boarder/Skier-Cross course. <p>CSA Z98-14:</p> <ul style="list-style-type: none"> • Ropeway location and alignment; Site Selection clause 4.3.1: <ul style="list-style-type: none"> ○ When selecting the location and alignment of an installation, consideration shall be given to factors that are known to affect the operational requirements of the installation. The following shall be considered when necessary: <ol style="list-style-type: none"> I. Ski slopes and trails. II. Control of air space below, above and adjacent to the installation. III. Carrier height above the ground or other surface. • Vertical Clearances clause 6.3.1: <ul style="list-style-type: none"> ○ Where persons are permitted under a ropeway, a minimum clearance of 4 m shall be provided between the underside of a carrier and the snow profile, ground, and any obstruction.

Image 1 - Incident Location.

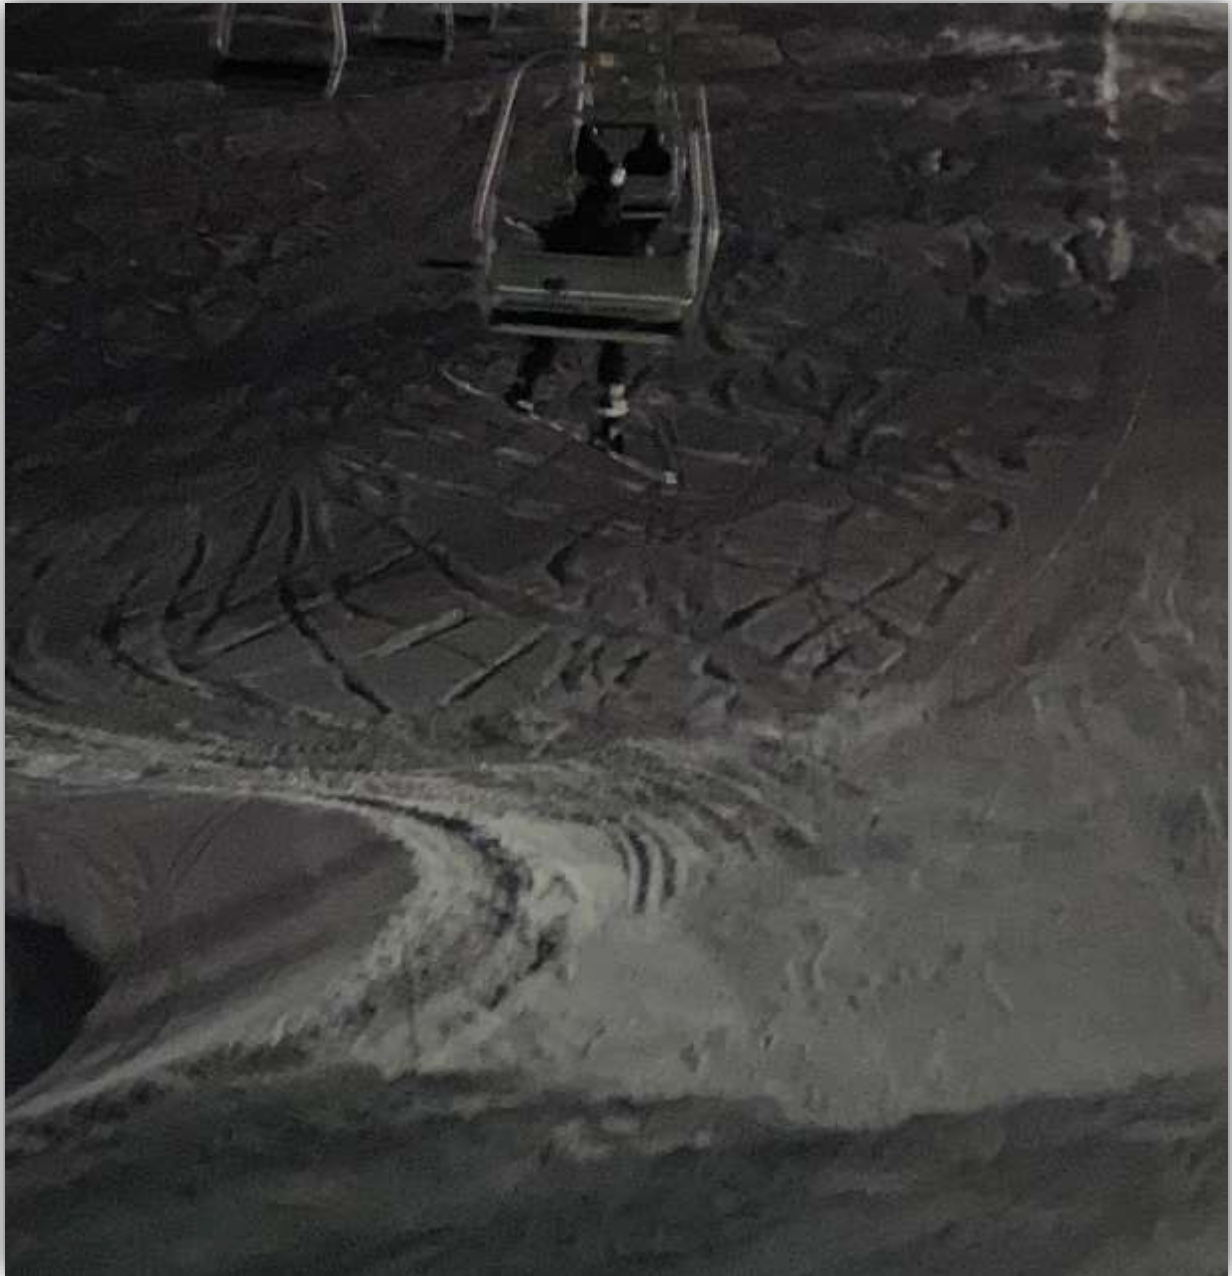
Image 2 - View from carrier.
