## Incident Summary #II-1249160-2021 (#23870) (FINAL)

| | Location | Courtenay, British Columbia | |
| | Regulated industry sector | Electrical | |

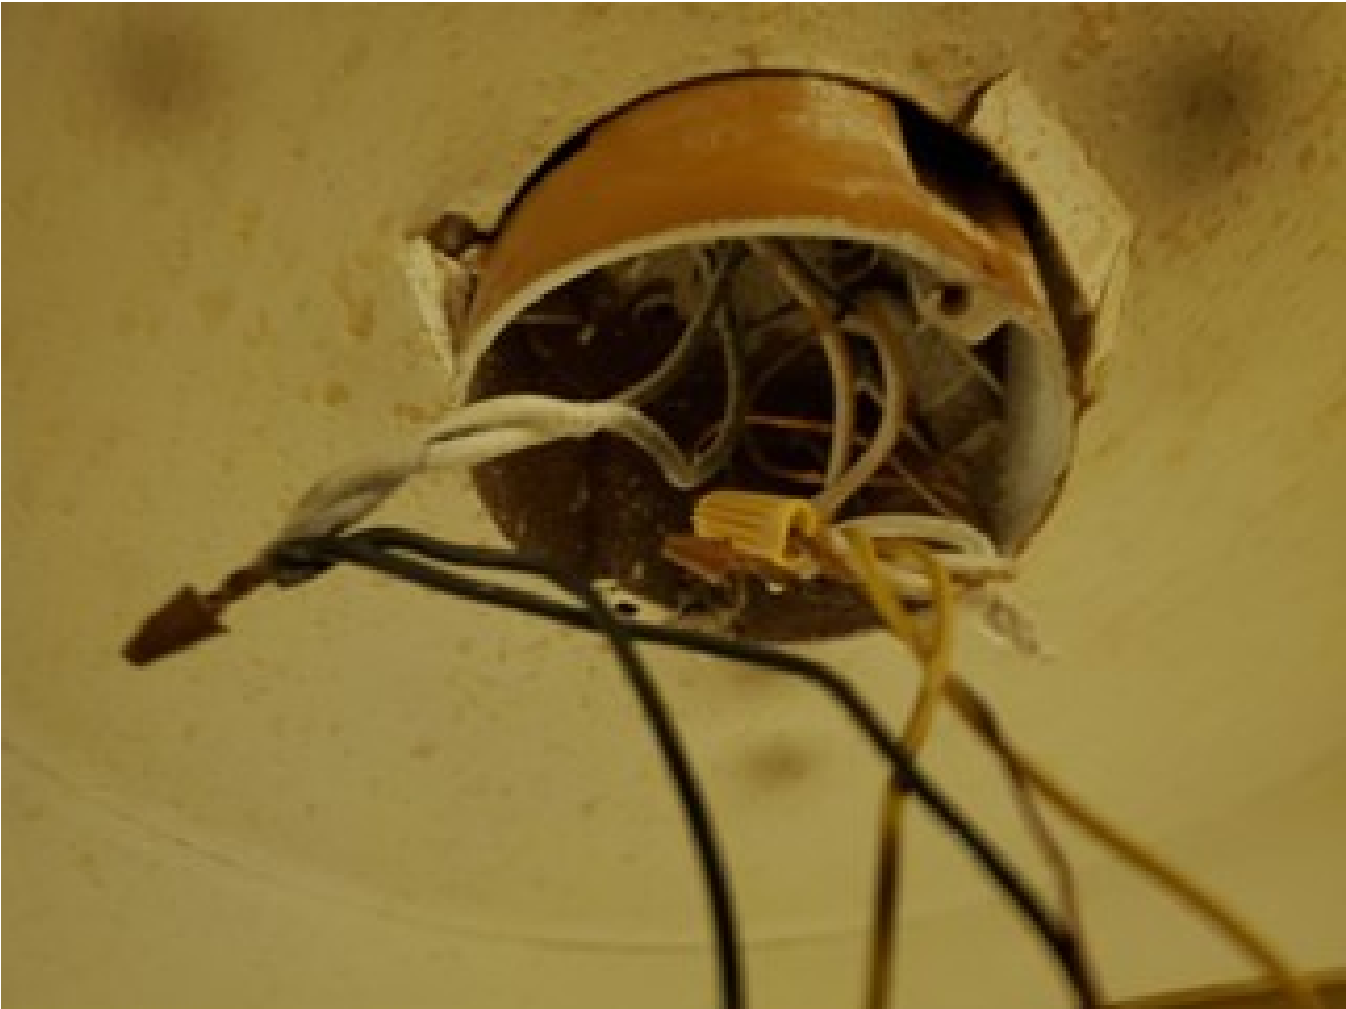
| Causes and contributing factors | <p>The cause of this incident was likely due to the fixtures normal heat production radiating unrestricted to the ceiling above. During the field installation it is probable that the approved fixture was altered by removing the factory installed insulation to expediate installation.</p> <p>It is likely that only 4<sup>th</sup> floor fixture boxes were affected because they backed onto the higher temperature attic. Over time the heat deteriorated the junction box until it could no longer support the fixture.</p> |

Image #1– Ceiling junction box that supported the light fixture. Shows wire nut melted off, distorted screw hole top left and darkened ceiling.

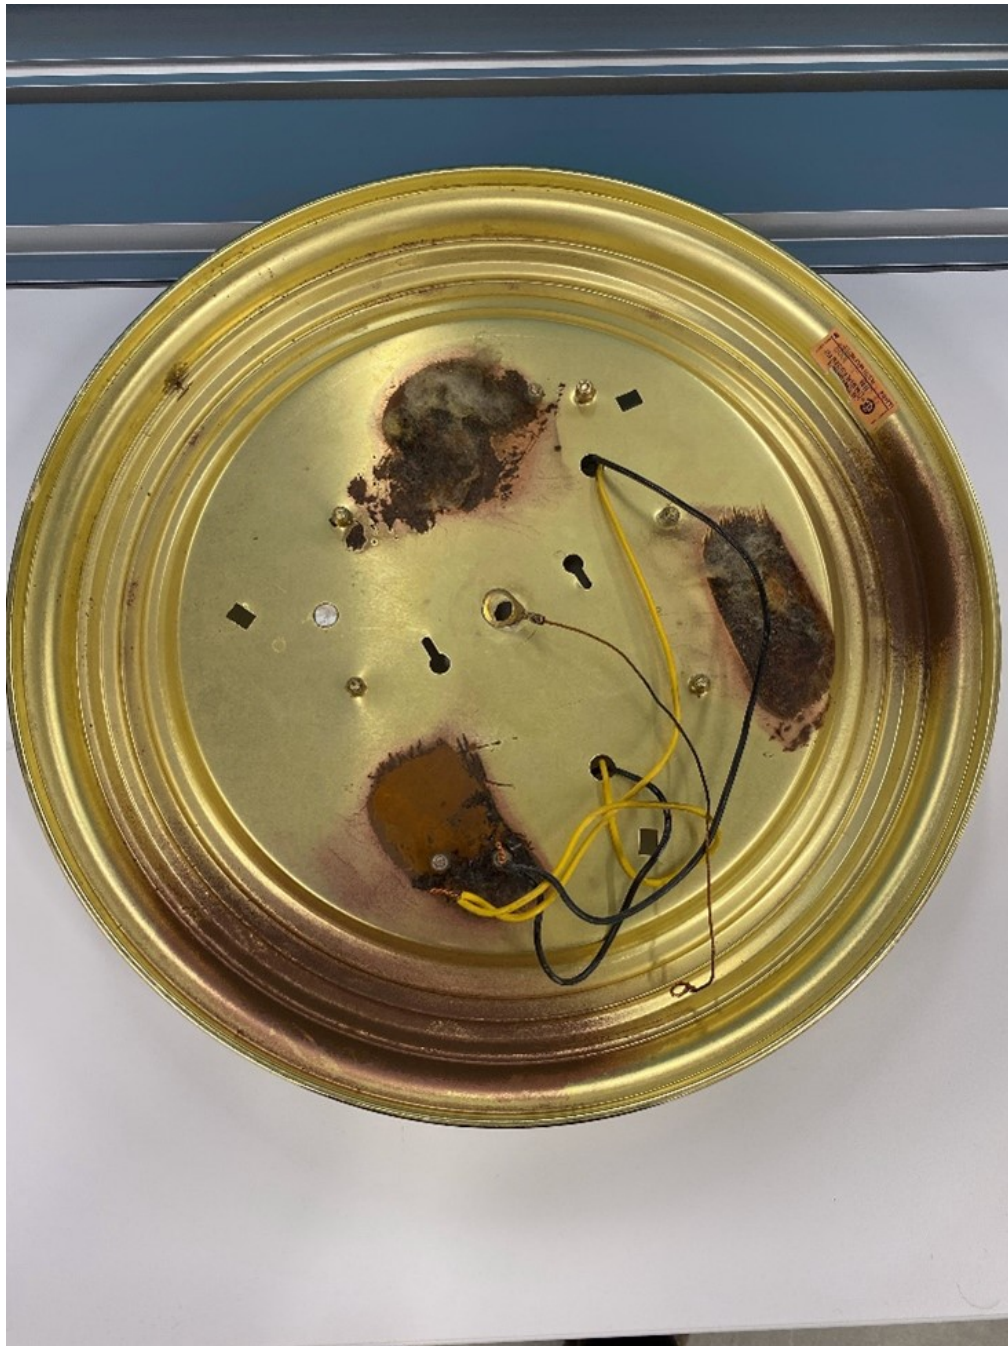
Image 2– Back side of fixture showing discolouration and remnants of insulation barrier that was once in place.

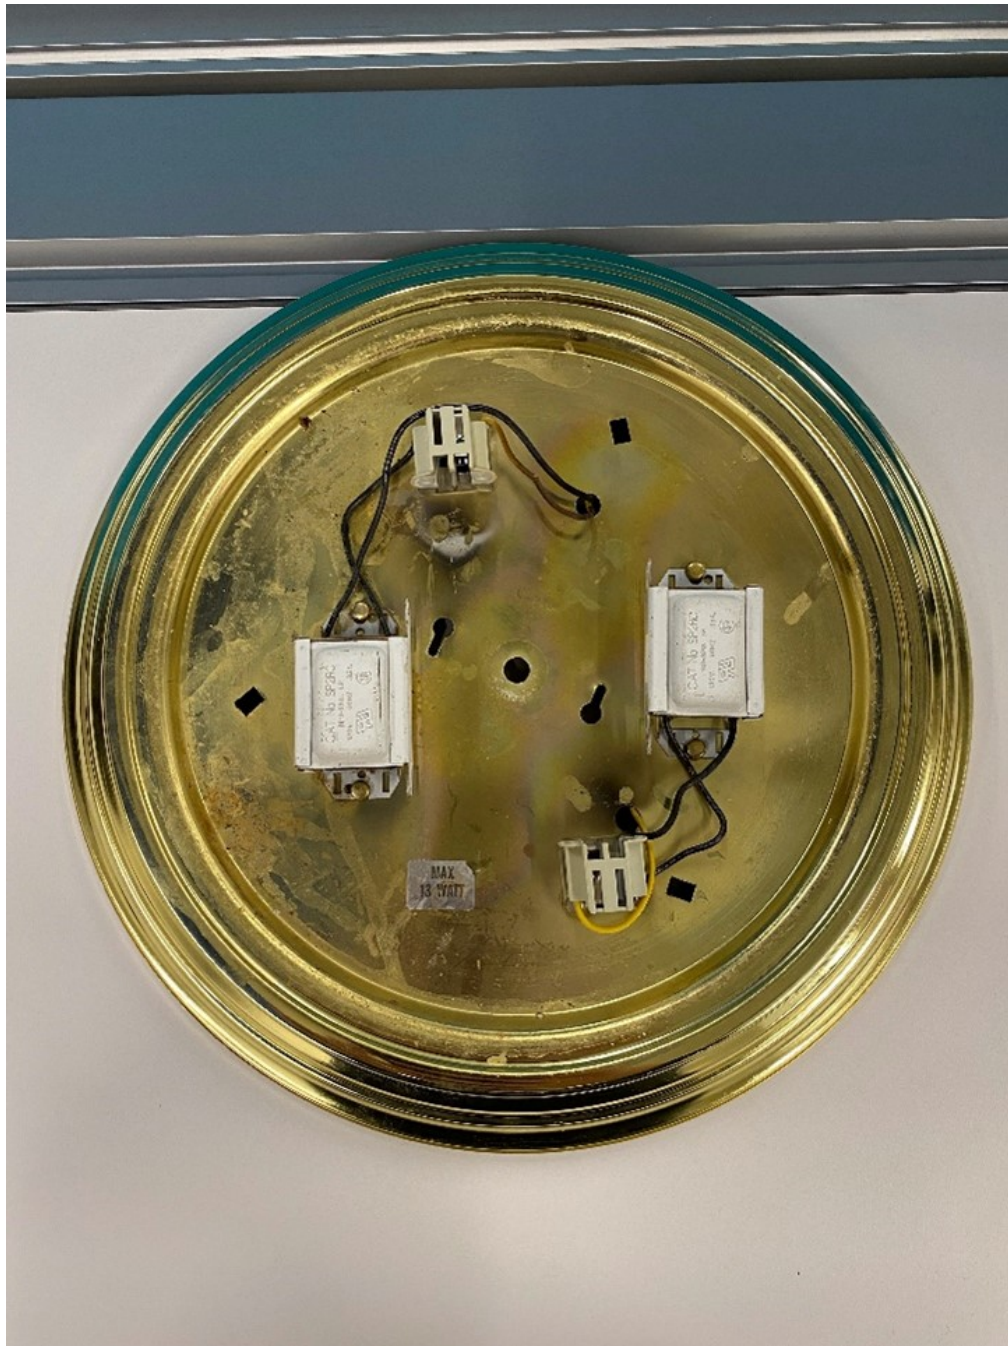
Image 3 – shows dual fluorescent lamp holders and ballasts.

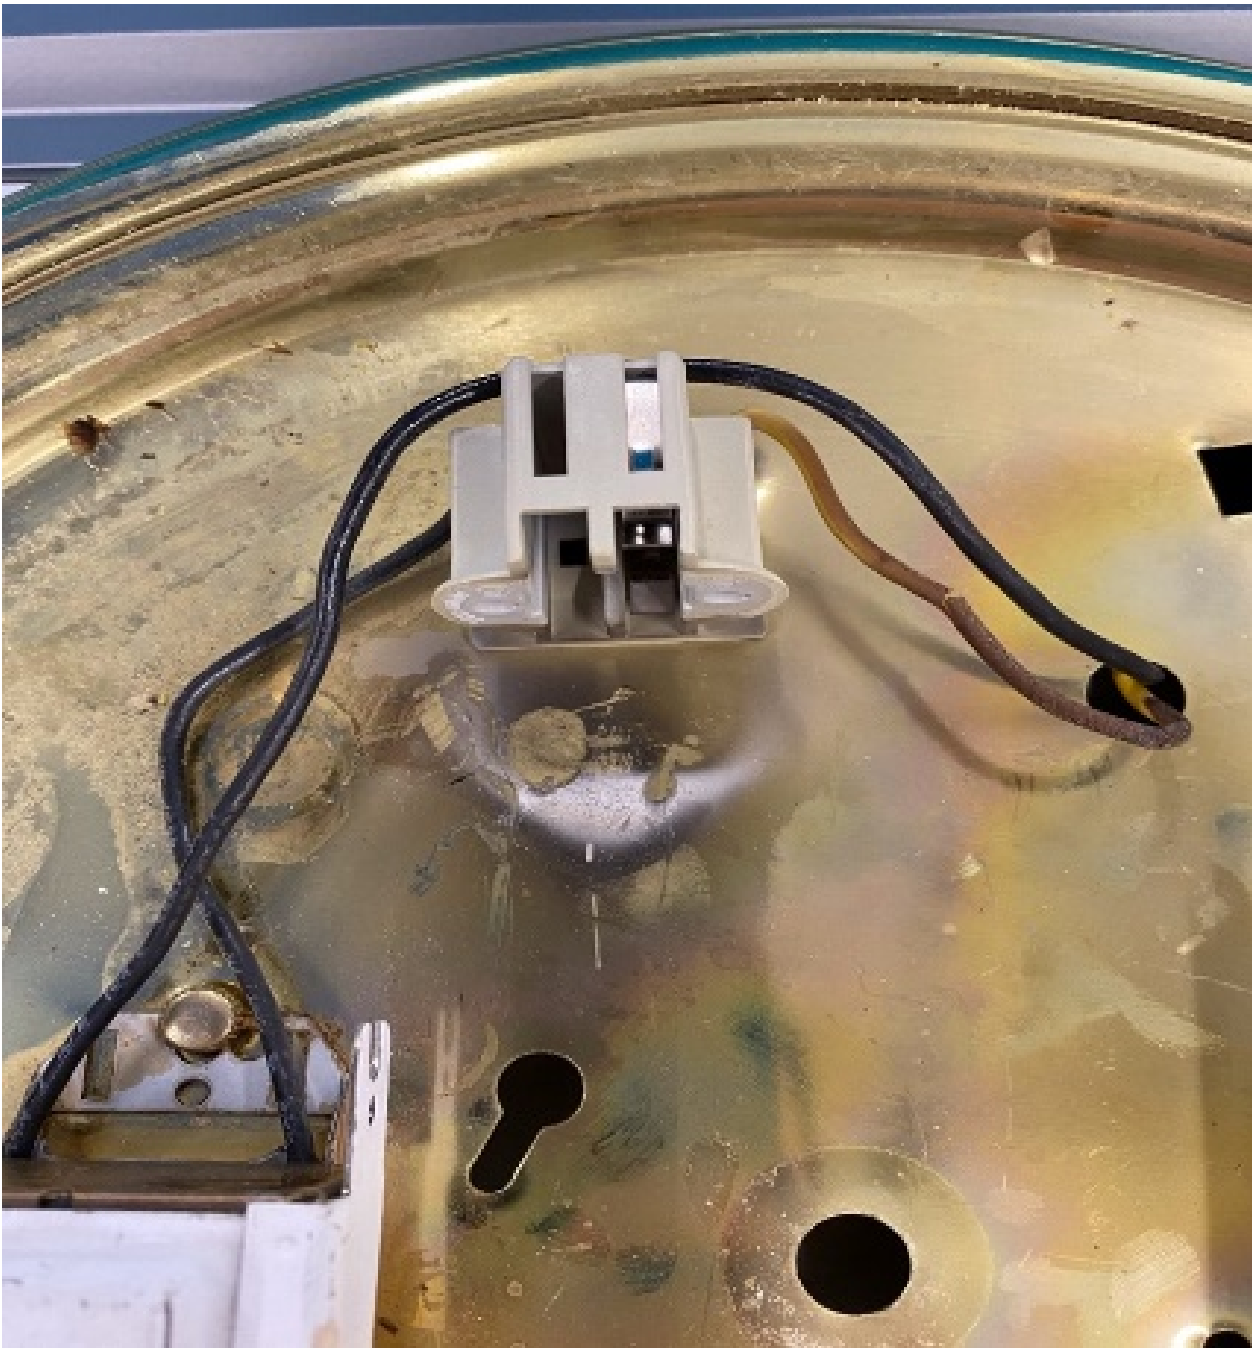
Image 4 – fixture shows discoloration from lamp heat and cracking on white conductor's insulation.

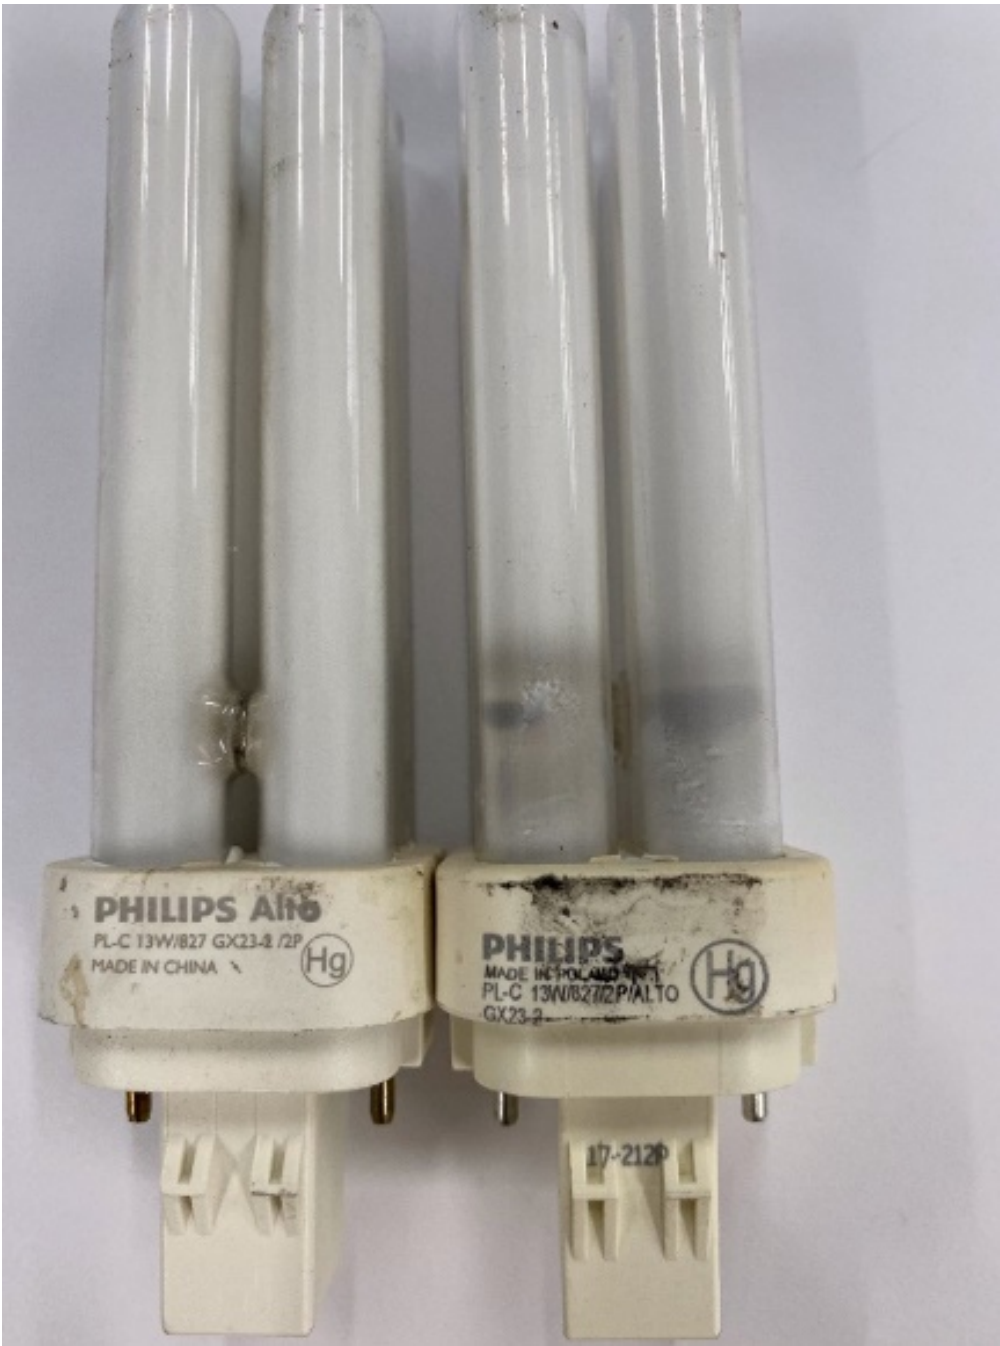
Image 5 – 13W fluorescent lamps as approved for the fixture.

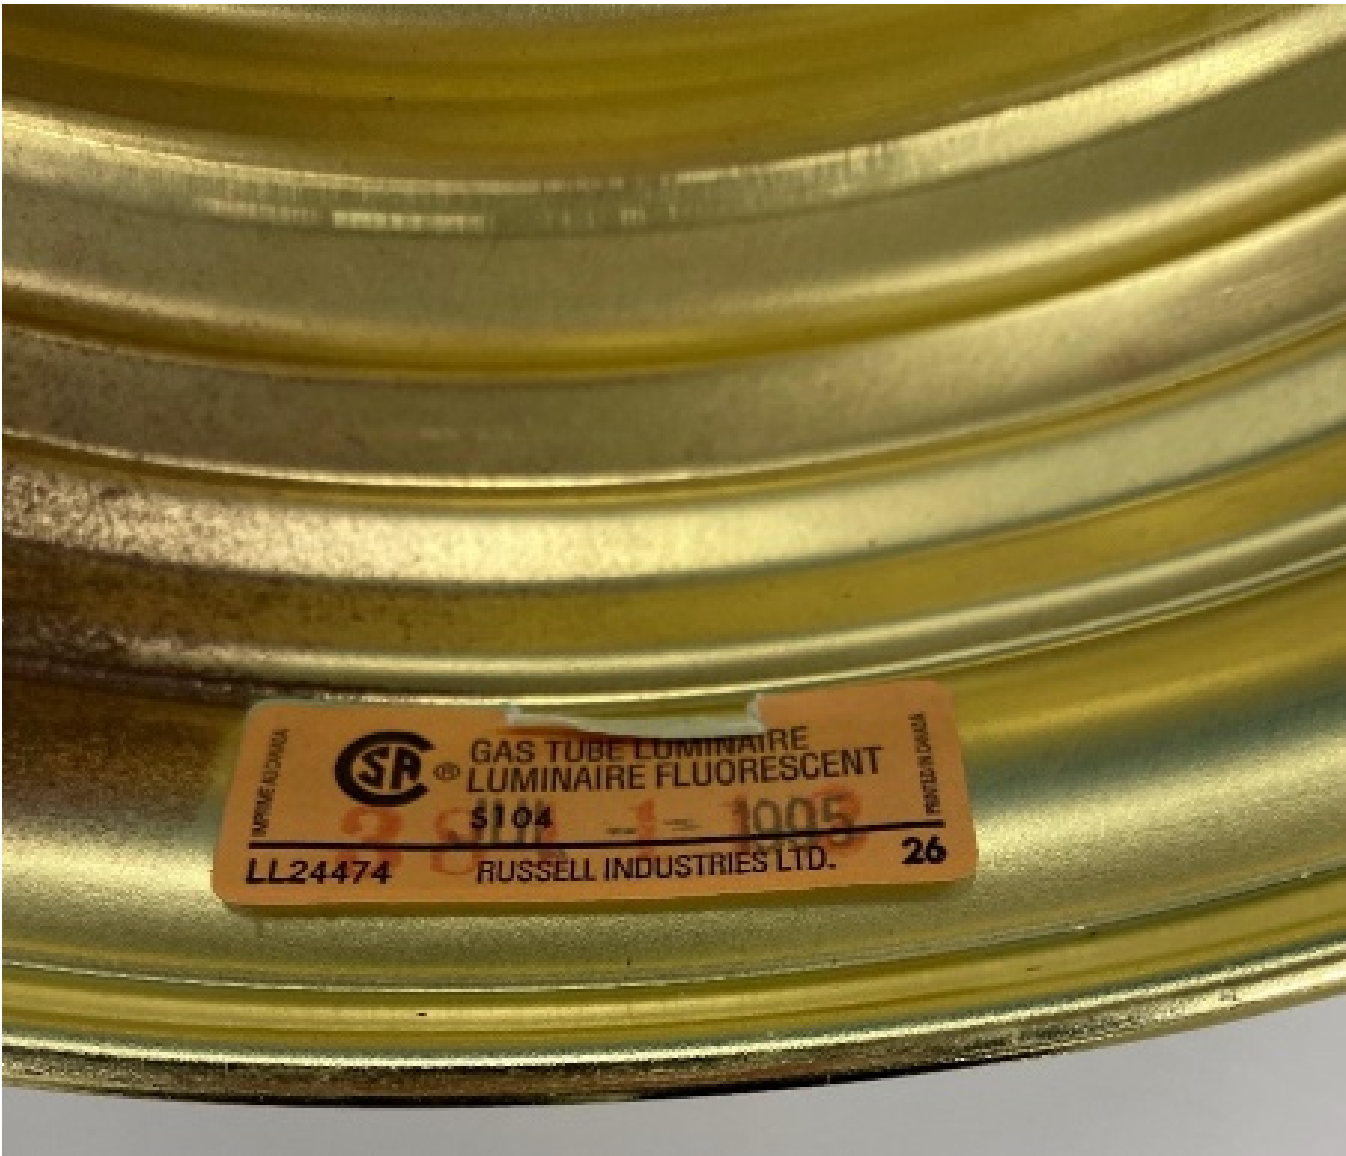
Image 6 - shows fixtures approval label.
