## Incident Summary #II-1695882-2024 (#45521) (FINAL)

SUPPORTING INFORMATION	Incident Date	April 9, 2024		
	Location	North Vancouver		
	Regulated industry sector	Boilers, PV & refrigeration - Refrigeration system		
	Impact	Qty injuries	0	
		Injury	Injury description	N/A
			Injury rating	None
	Damage	Damage description	A small amount of ammonia was released through an open pipe.	
		Damage rating	Minor	
	Incident rating	Minor		
Incident overview	An ammonia leak occurred inside the machinery room of a public athletic club with indoor ice facilities. The leak happened during decommissioning work of an ammonia refrigeration condenser by a refrigeration contractor and resulted in the facility enacting their Ammonia Release Emergency Protocol.			
INVESTIGATION CONCLUSIONS	Site, system and components	<p>Ammonia is a clear colourless gas with a strong pungent suffocating odour and is used as a refrigerant in some large refrigeration systems. Exposure to ammonia can irritate and burn the skin, mouth, throat, lungs, and eyes. Exposure to high levels of ammonia can be fatal.</p> <p>The refrigeration system at the facility includes ammonia condensers and connected ammonia piping. Their functio

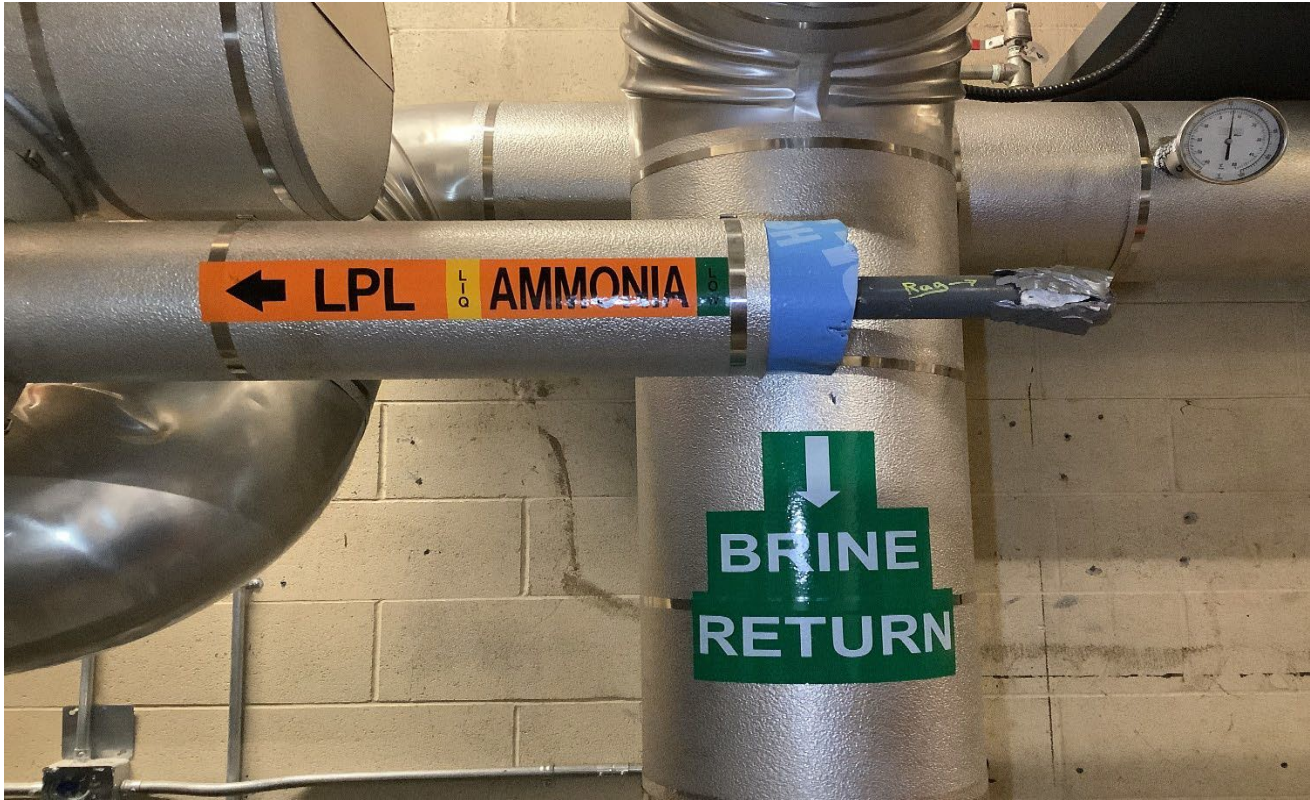
<p>Causes and contributing factors</p>	<p>It is highly likely that failure to nitrogen purge and vacuum the oil pot and drop leg did not remove all the ammonia from the refrigeration system prior to the cutting of the pipe, was the primary cause of the incident.</p> <p>Contributing factors to the incident include:</p> <ul style="list-style-type: none"> <li>• Failure to recognise that the bottom of the chiller, oil pot and drop leg will have enough ammonia diffused into the oil.</li> <li>• The temperature increased, ammonia diffused out of the oil and created enough pressure to push the duct tape out.</li> </ul>

Image 1 - The pipe that was cut.

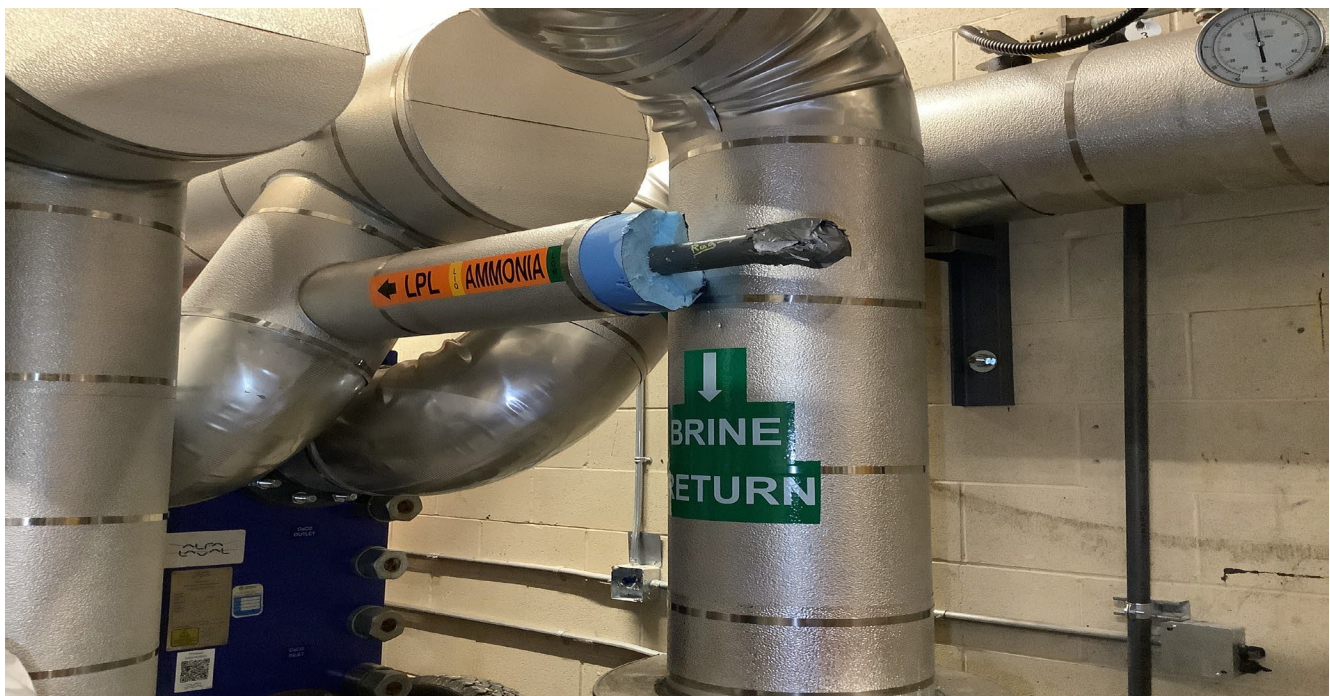
Image 2 - Ammonia pipe.
