**Incident Summary #II-1714299-2024 (#46717) (FINAL) - Revised on January 23, 2025**

| | Regulated industry sector | Electrical - High voltage electrical system (greater than 1000V) | |
| Incident overview | Two (2) people gained unauthorized access to components inside a high-voltage energized electrical substation resulting in major injuries. | | |

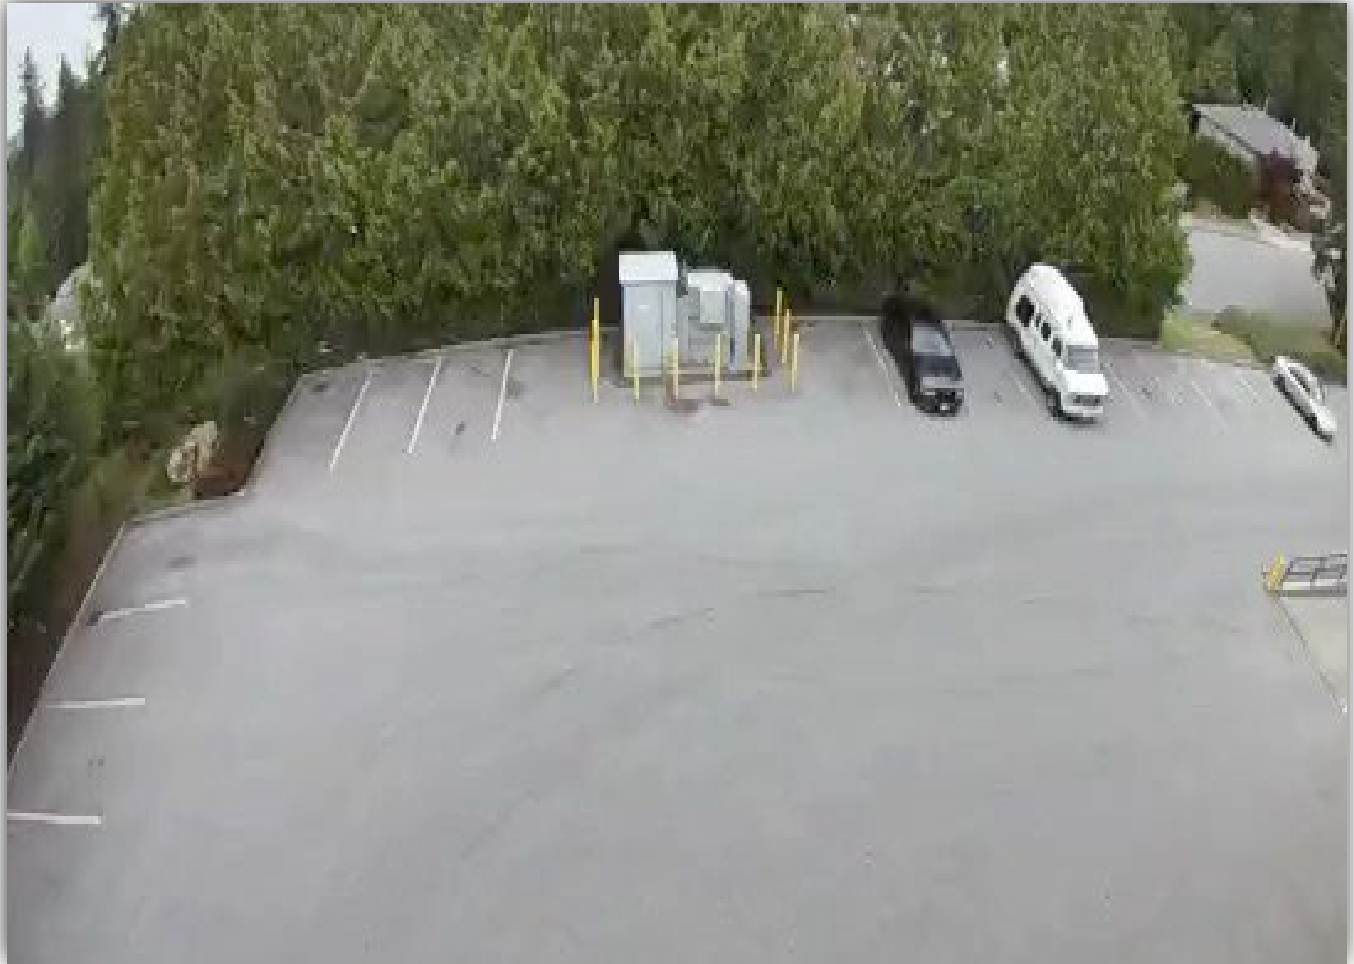
| <p>Facts and evidence</p> | <p><b>Fieldwork observations</b></p> <ul style="list-style-type: none"> <li>• The substation is not clearly marked as to what it is or contains from the front 3 side (<a href="#">Image 1</a>).</li> <li>• Signage on the front does not make it clear what type of equipment was within the enclosure (<a href="#">Image 3</a>). Signage on the utility portion (located at the back) was much clearer that the enclosure contained dangerous electrical equipment (<a href="#">Image 4</a>) compared to the consumer access door.</li> <li>• Sticker type warning labels on the consumer side access doors were observed as minimal, black and white on public facing sides, with some red on the same type of label placed on the rear facing (accessed side). Approximately 6x3 inches and faded in some areas (<a href="#">Image 3</a>). Graffiti and writing on doors creates a distraction visually for the impact of the warning labels that are there (<a href="#">Image 3</a> and <a href="#">Image 4</a>).</li> <li>• The rear side and access point for the incident was facing a line of trees which were trimmed previously due to loitering and drug use which was identified by managers at the mall as a hazard, but the trees were not fully removed due to concern by neighbouring residents on the other side concerned of unsightly views to parking lot (<a href="#">Image 2</a>).</li> <li>• Both access doors had been vandalized and tampered with. There were tool marks behind the padlocks and the lock for the utility side was bent (<a href="#">Image 7</a>).</li> <li>• The door, which was accessed, was covered in multicolor graffiti distracting from the small warnings labels (<a href="#">Image 6</a>).</li> <li>• there are pad locks on all outward facing doors which do not have specific regulation standards or tampering requirements but were observed to be typical consumer padlocks for securement and not marked with commercial use or special features.</li> <li>• The inside of the transformer had evidence of two contact or “scorch” marks from the electrical arcing (<a href="#">Image 6</a>).</li> </ul> <p><b>WITNESS STATEMENTS AND INFORMATION</b></p> <p>Utility Representative</p> <ul style="list-style-type: none"> <li>• When attending the incident to de energize the site, utility representatives noted the patient was no longer on site. They noted their lock on incoming access door was tampered with, scrape marks and graffiti were on the doors and outer walls of substation and their lock was present but bent. They replaced that lock on their higher-voltage side immediately.</li> <li>• Tampering and grinder marks were observed on several access doors on the treed side of the substation which is obscured from public view (<a href="#">Image 1</a> and <a href="#">Image 6</a>).</li> </ul> <p>Fire Department Statements</p> <ul style="list-style-type: none"> <li>• Substation was not declared de-energized by utility after electrocution, judged safe by first on scene/witnesses when attending and when injured was moved further from entryway nothing happened so fire members felt it was safe.</li> </ul> <p>Police Statements</p> <ul style="list-style-type: none"> <li>• The lock in which the incident occurred was declared by several witnesses to have been missing for weeks or months prior. No was lock found on the scene.</li> </ul> |

1. Existing warning labels on all parking lot did not effectively inform individuals of the severity of danger within the substation.
2. The proximity of trees on the side of the enclosure that was accessed made it less likely that the warning labels would be seen.

Image 1 – Substation within the parking lot. Tree area behind.

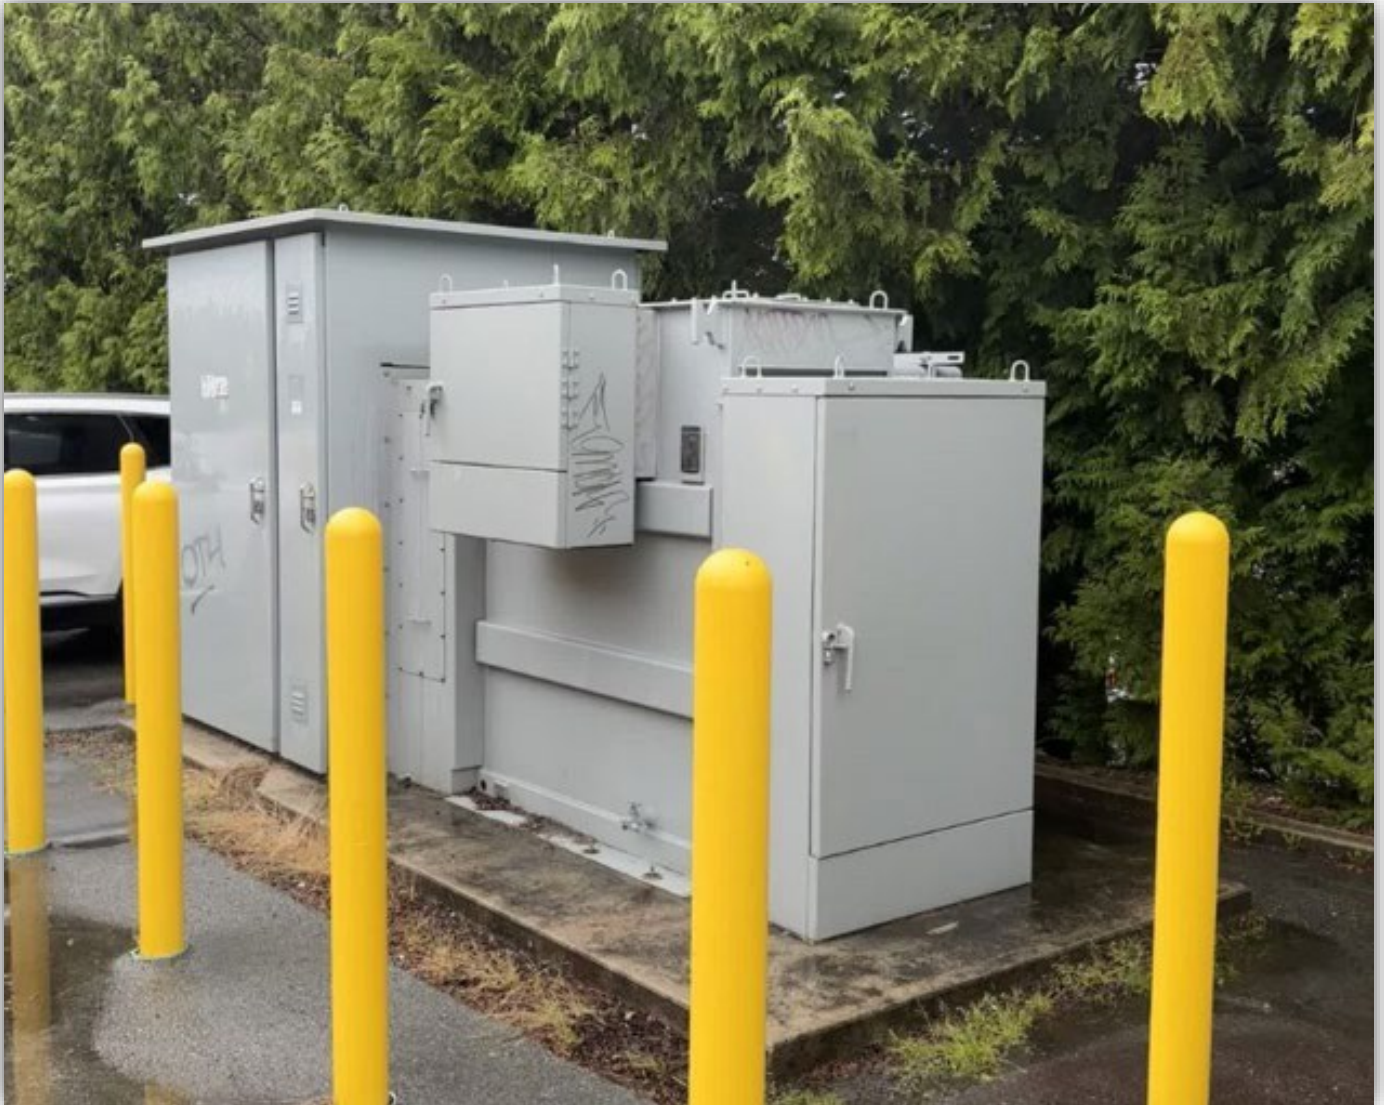
Image 2 – Public facing sides.

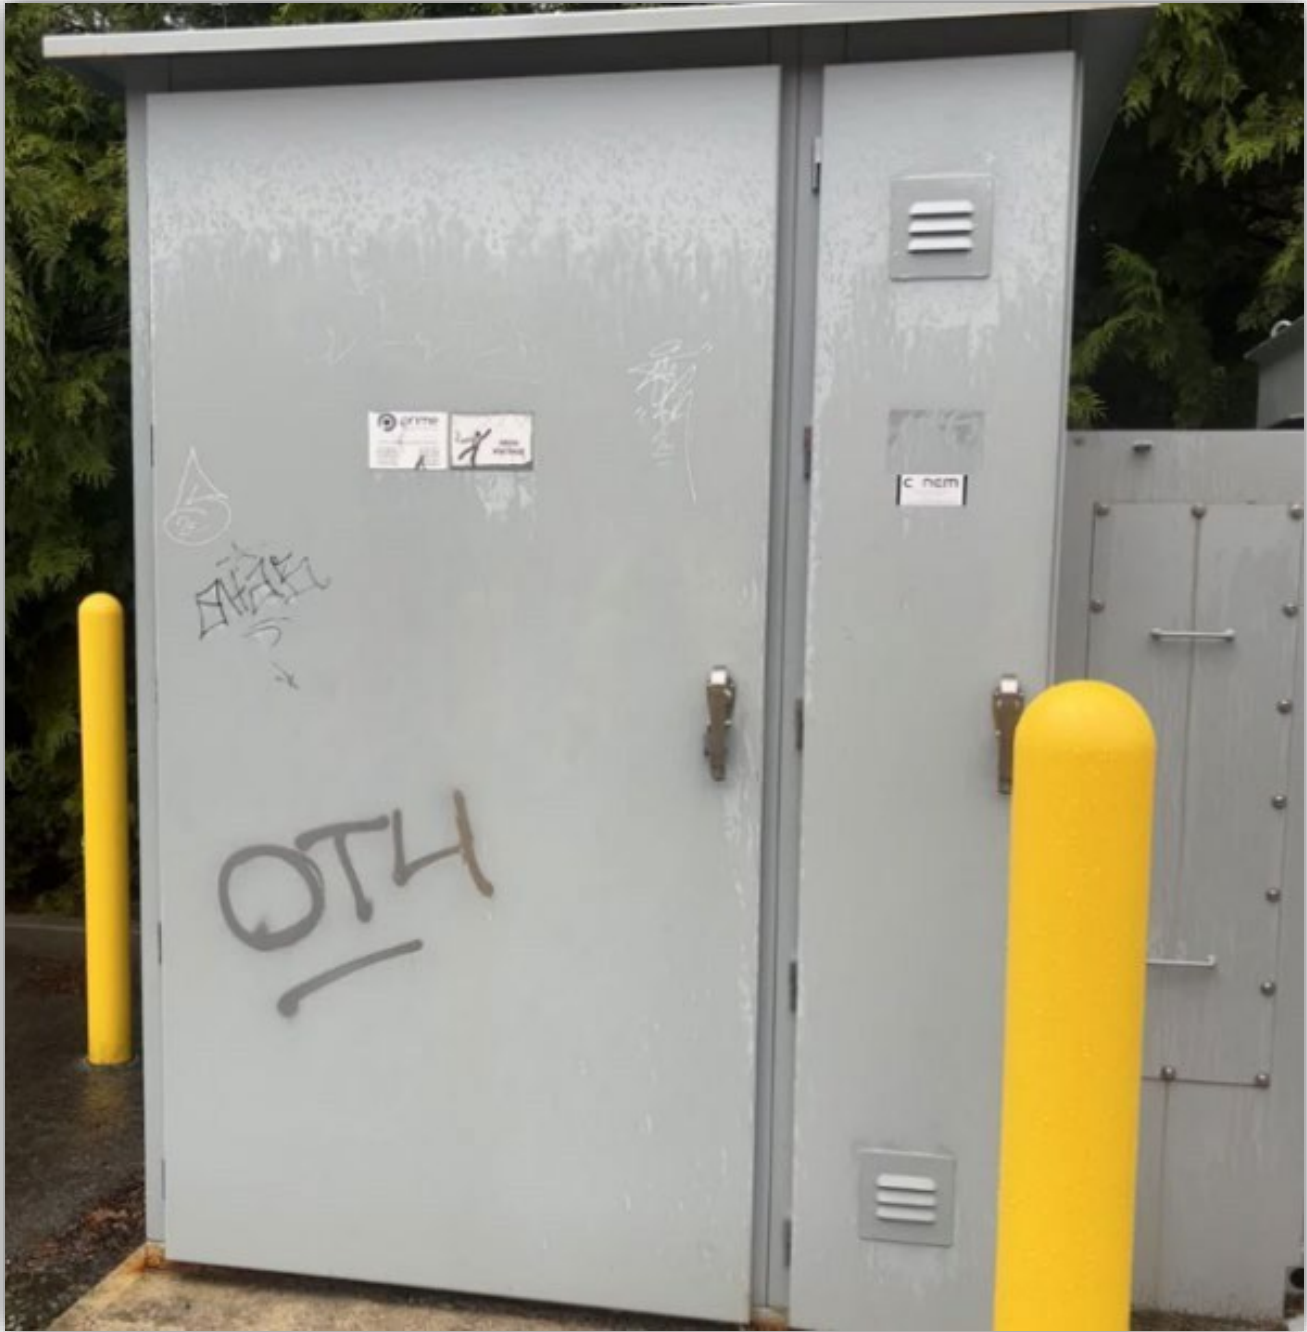
Image 3 – Faded public facing warnings.

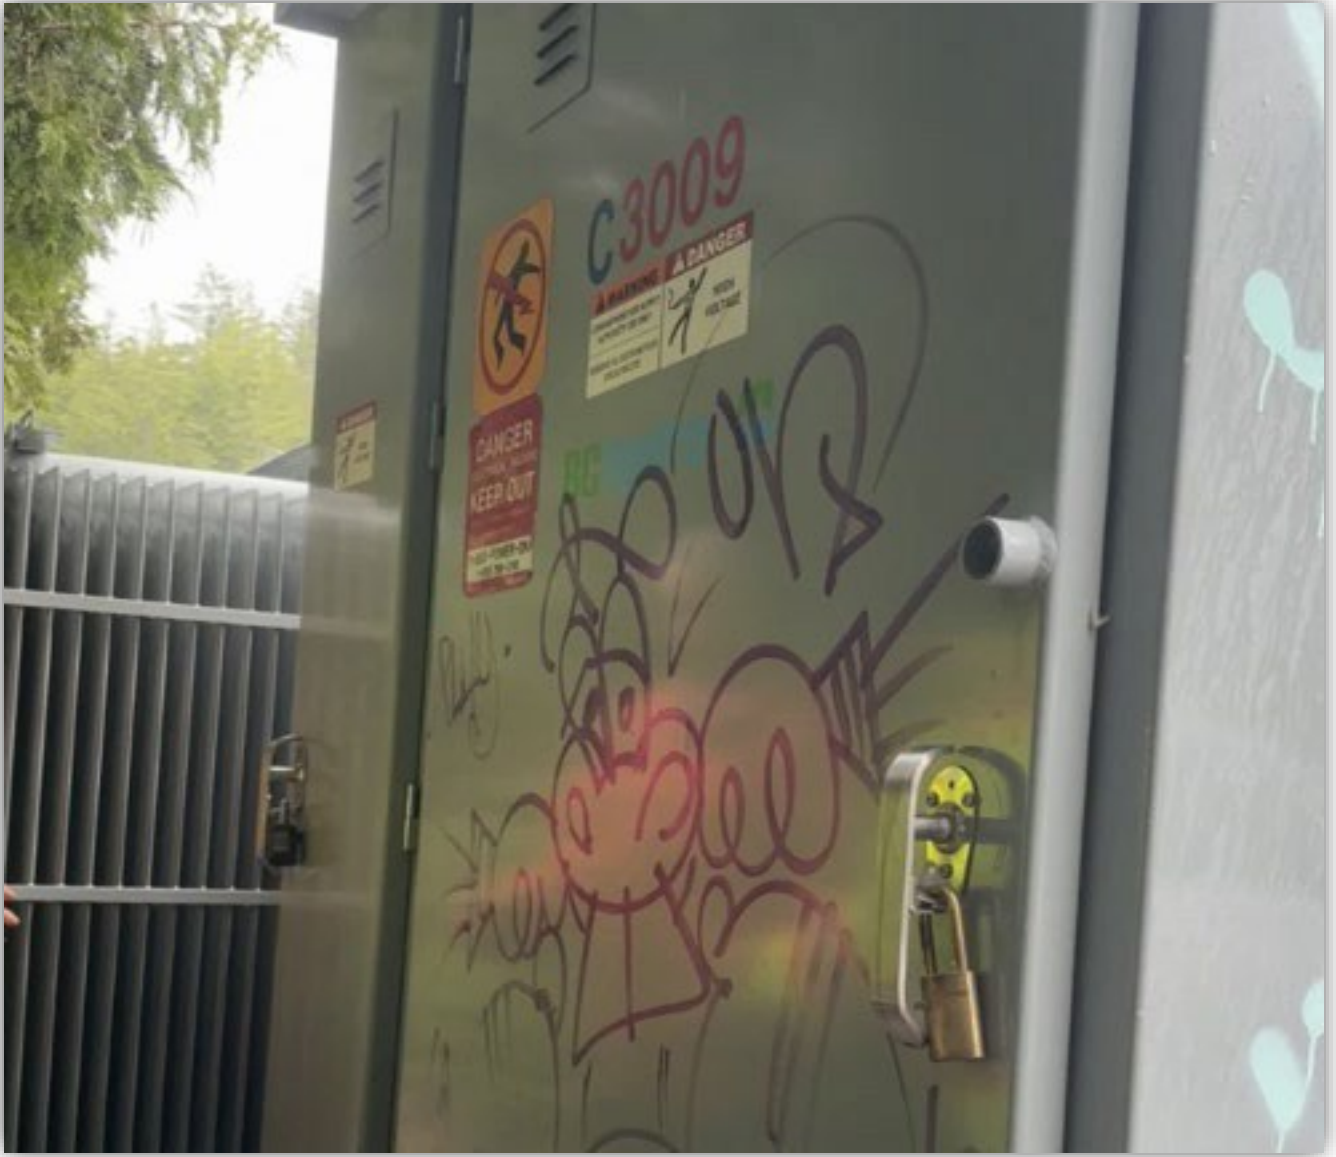
- Provided report showing required maintenance was performed in the required time.
- Stated the other lock on the incoming voltage side was missing when he arrived and damaged to the inside component indicating an entry and exit point where the incident took place. The second door was also marked likely by tools during the tampering.

Image 4 – Substation - Rear doors facing into trees and shows vandalism. Also shows private and public locks that were replaced after incident where previous locks were removed and damaged.

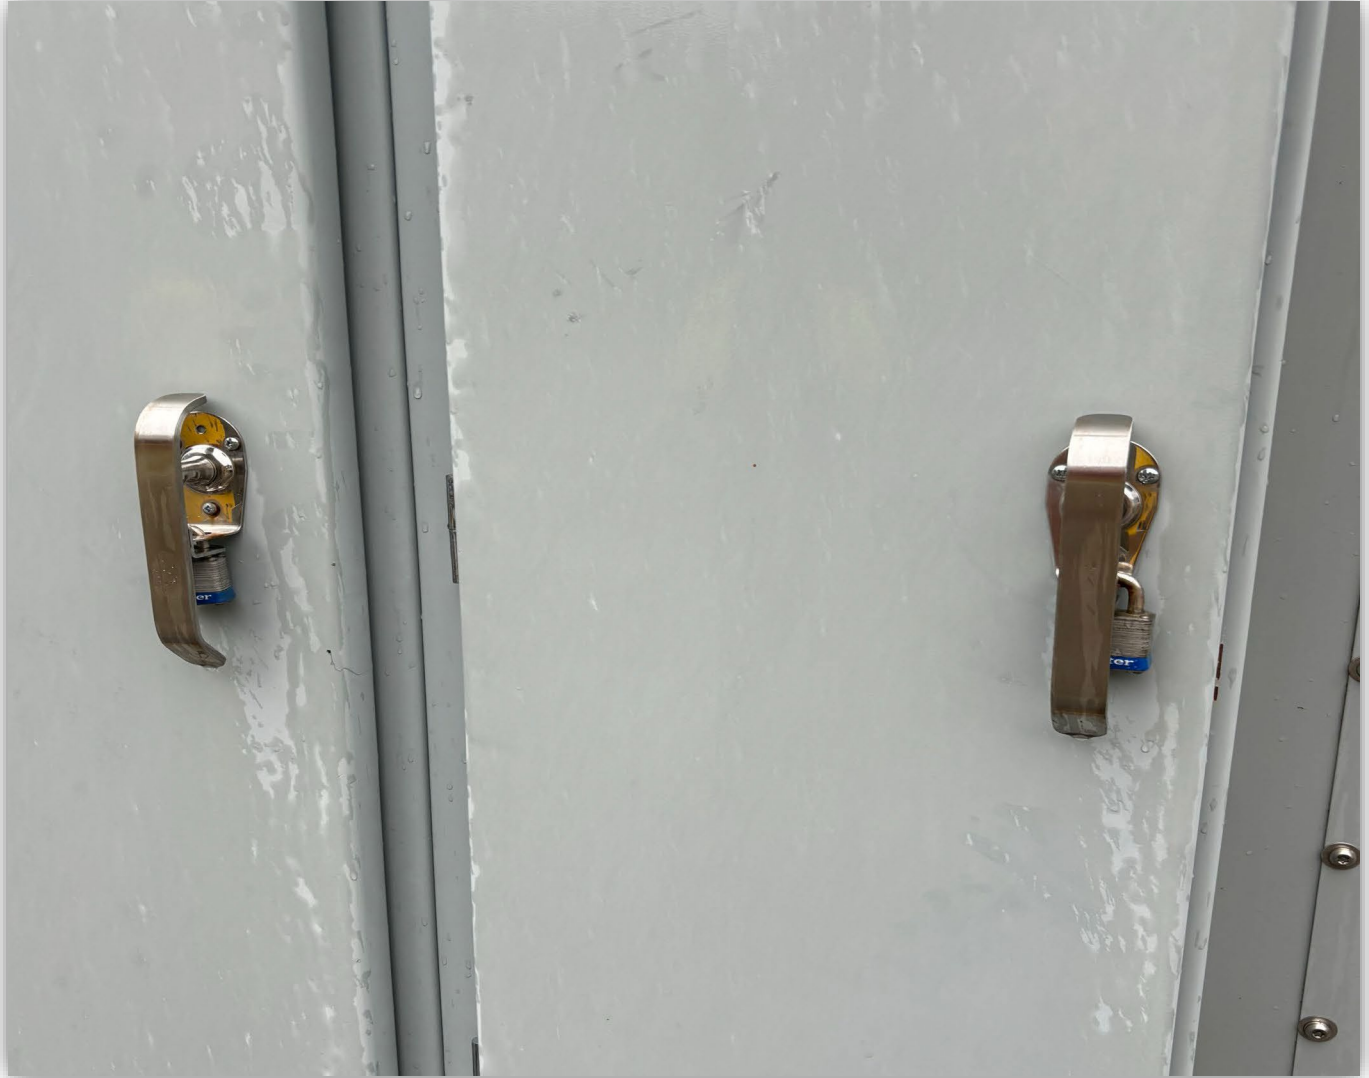
- Lock Manufacturer - Commercial Laminated Locks.
- Brand manufacturer confirmed type of lock used was for indoor or low exposure. If exposure to the elements is a consideration, a professional padlock may be a better option as per customer service.

1. The access panel was likely unsecured for an extended period of time prior to the incident providing free access to energized, high voltage components.
2. Locks used to secure the panel against unauthorized access were consumer grade and provided minimal resistance to tampering.
3. There was no requirement for regular visual inspection of the of the condition of the locks that secured the unit against unauthorized access.

Image 5 – Substation – Public facing padlocks.

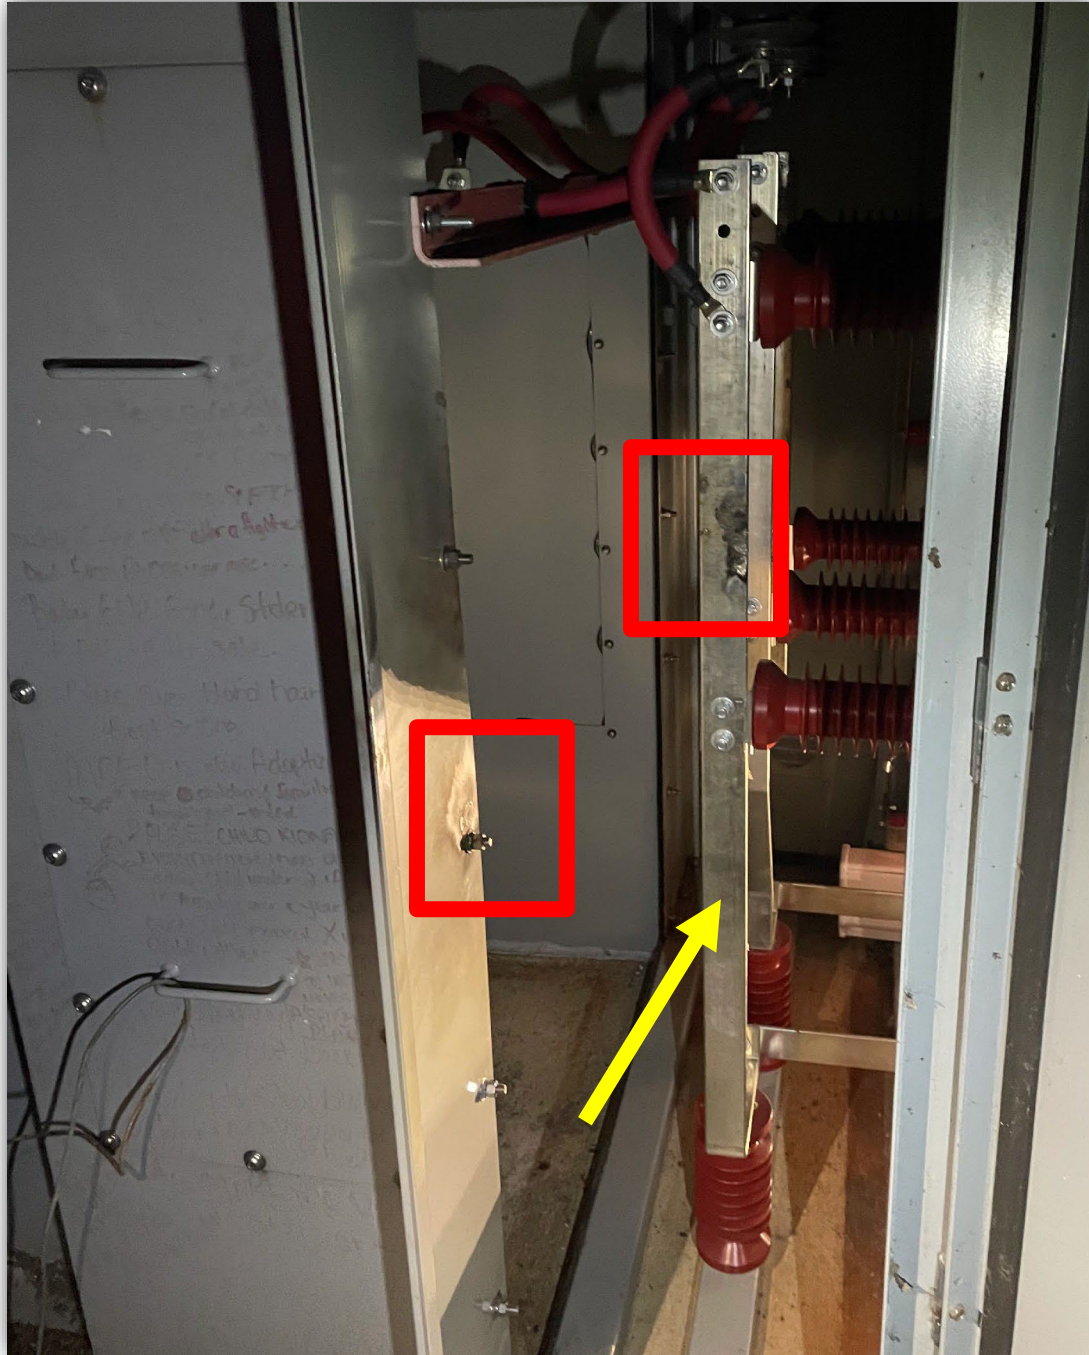
Image 6 – Red boxes show two (2) interior substation scorched contact points. This is where person one (1) of two (2) injured persons made contact inside doorway and created an entry and exit pathway for electric shock. Yellow arrow shows buss bar which is energized when the station is in operation.

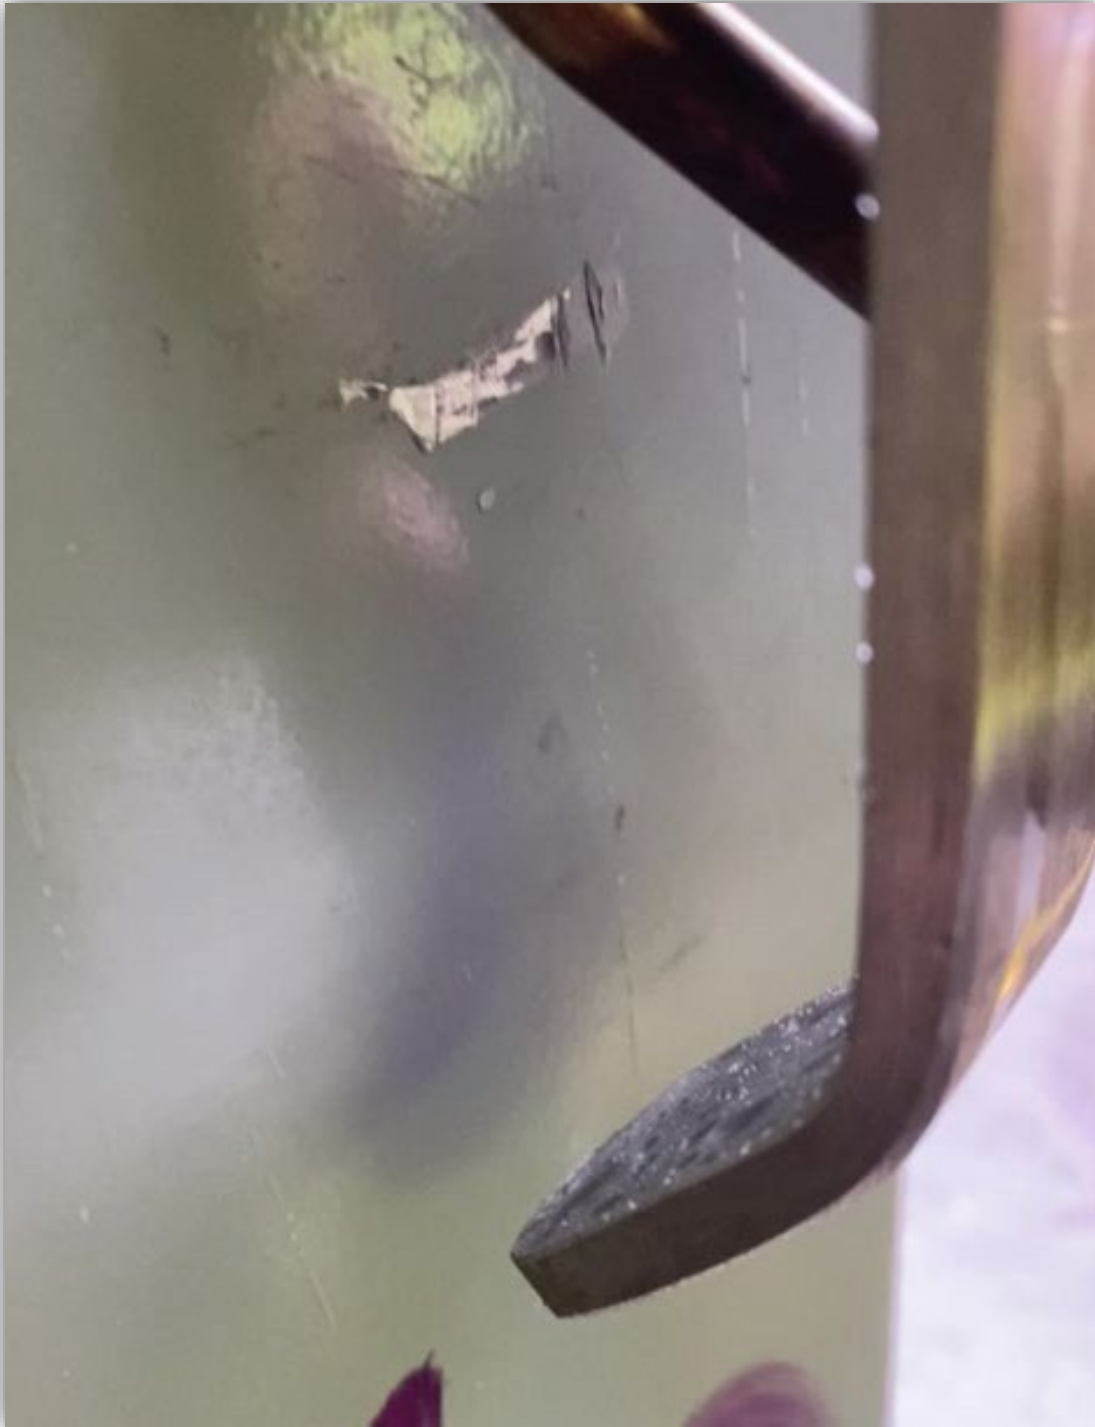
Image 7 – Scrape marks caused by tools during tampering and padlock removal by unknown persons prior to incident.
