Incident Summary #II-1722974-2024 (#47637) (FINAL)

SUPPORTING INFORMATION	Incident Date	June 14, 2024	
	Location	Summerland	
	Regulated industry sector	Gas - Natural gas system	
	Injury	Qty injuries	2
		Injury description	One individual received singed hair on their face and arms and a second individual experienced pain in their ears from the explosion concussion.
		Injury rating	Minor
	Damage	Damage description	The explosion caused the metal panels on the dryer to bend, deform and the top to blow off and collapse back into the machine. The drywall on the ceiling above the machine was damaged with cracks and puncture holes from the flying debris from items placed on the top of the machine. Flexible tubing for the exhaust hood fans started on fire and burnt leaving only the spiral wire left. A door frame on the building was pushed out.
		Damage rating	Moderate
Incident rating	Moderate		
Incident overview	An explosion occurred inside a gas fired textile dryer while in use at a commercial print shop. The explosion damaged the appliance and surrounding area inside the building.

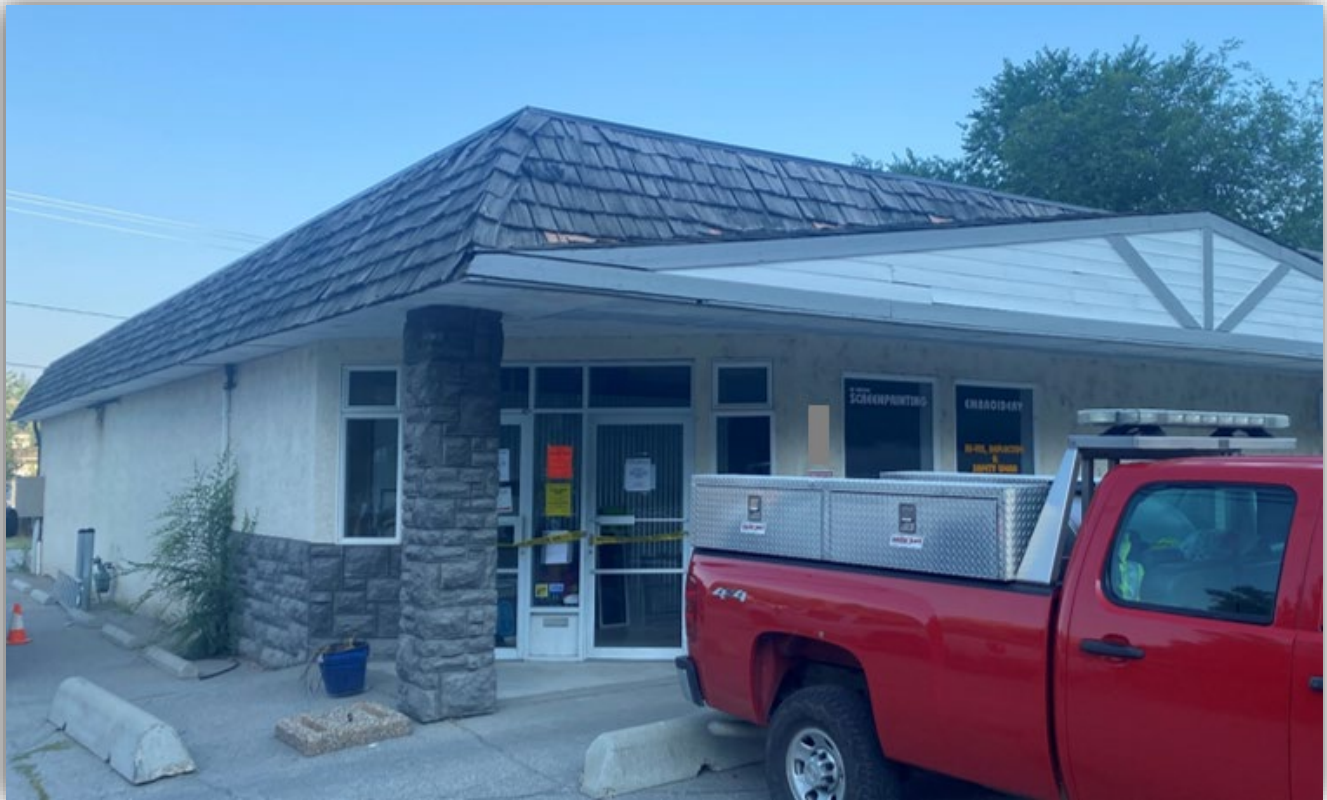
Image 1 – Front of the building housing the textile dryer that exploded.

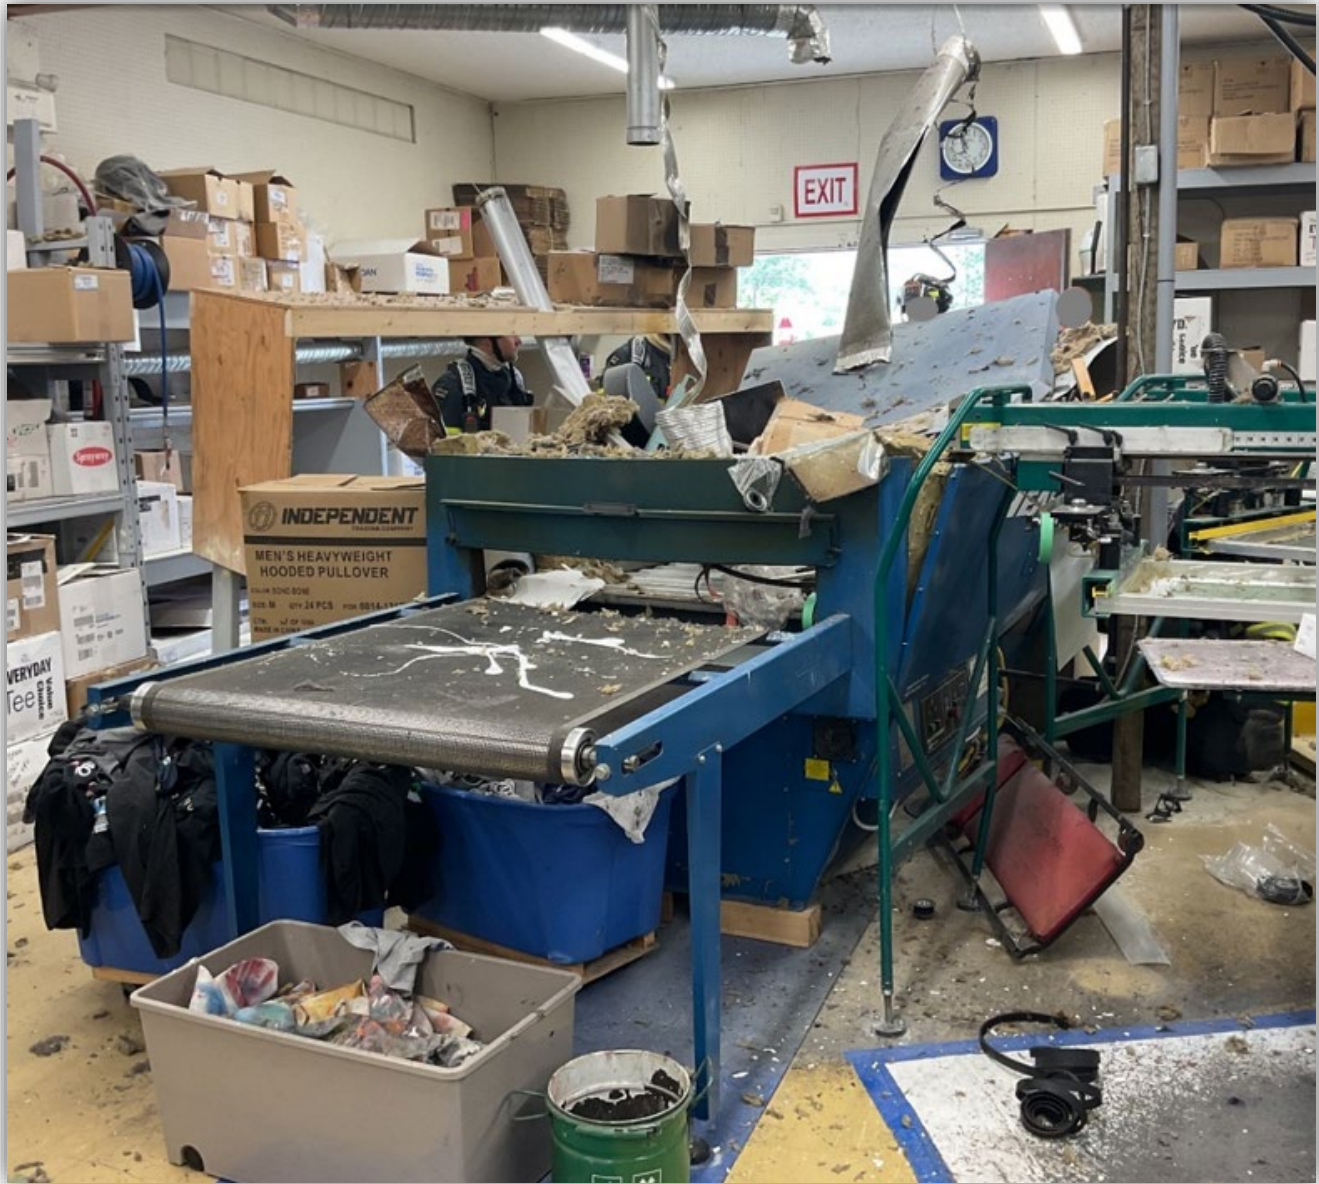
Image 2 – The textile dryer after the explosion showing the pushed-out dryer panels and explosion debris.

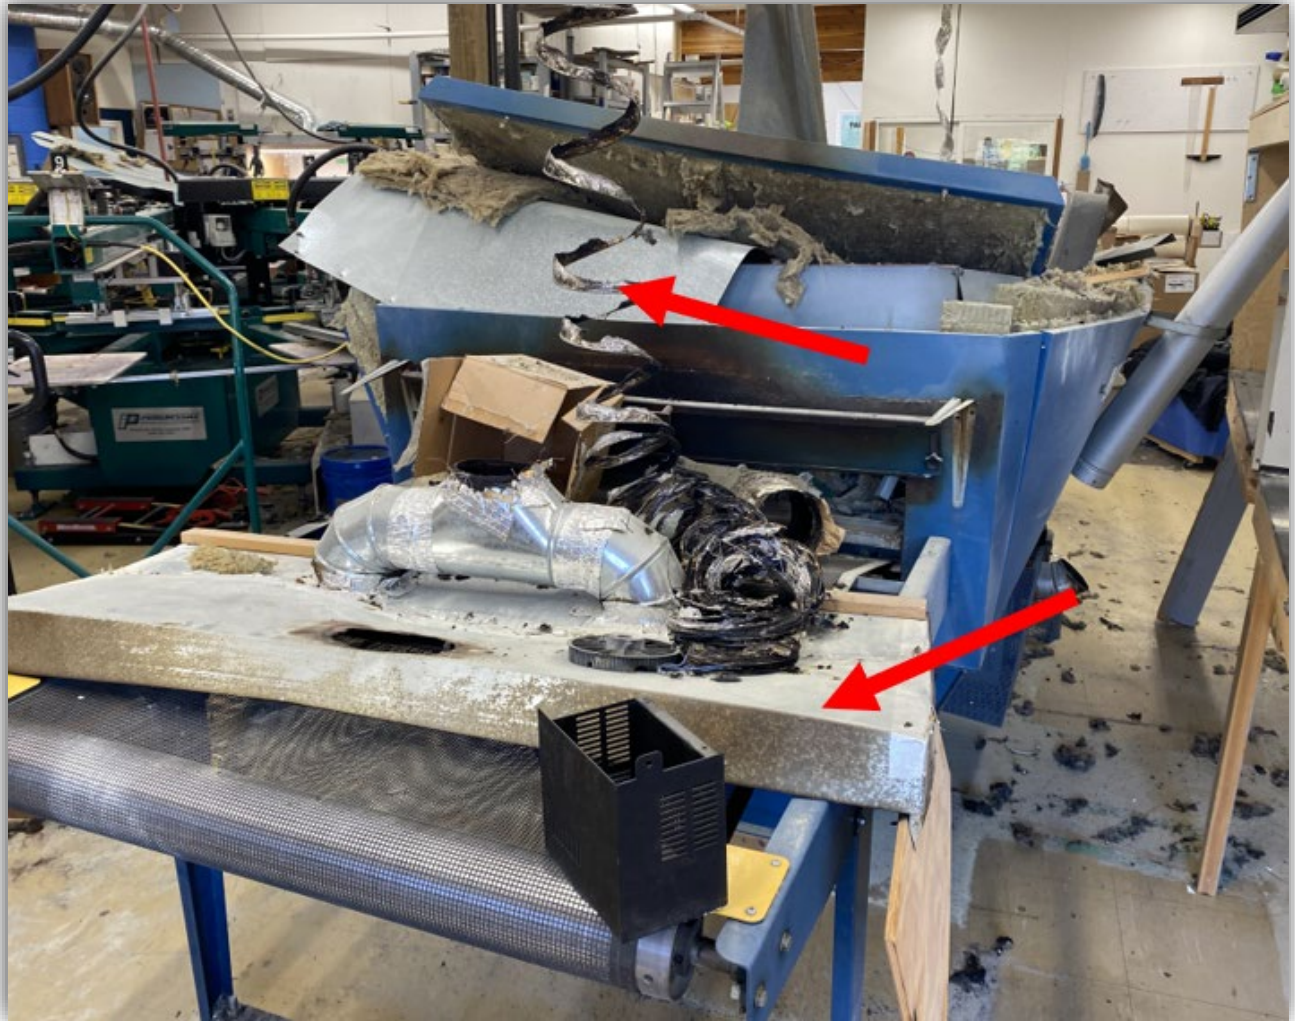
Image 3 –The arrows showing sheet metal hood and burnt flexible ducting for the custom exhaust ventilation system that was installed above the dryer inlet and outlet feeds for fume extraction.

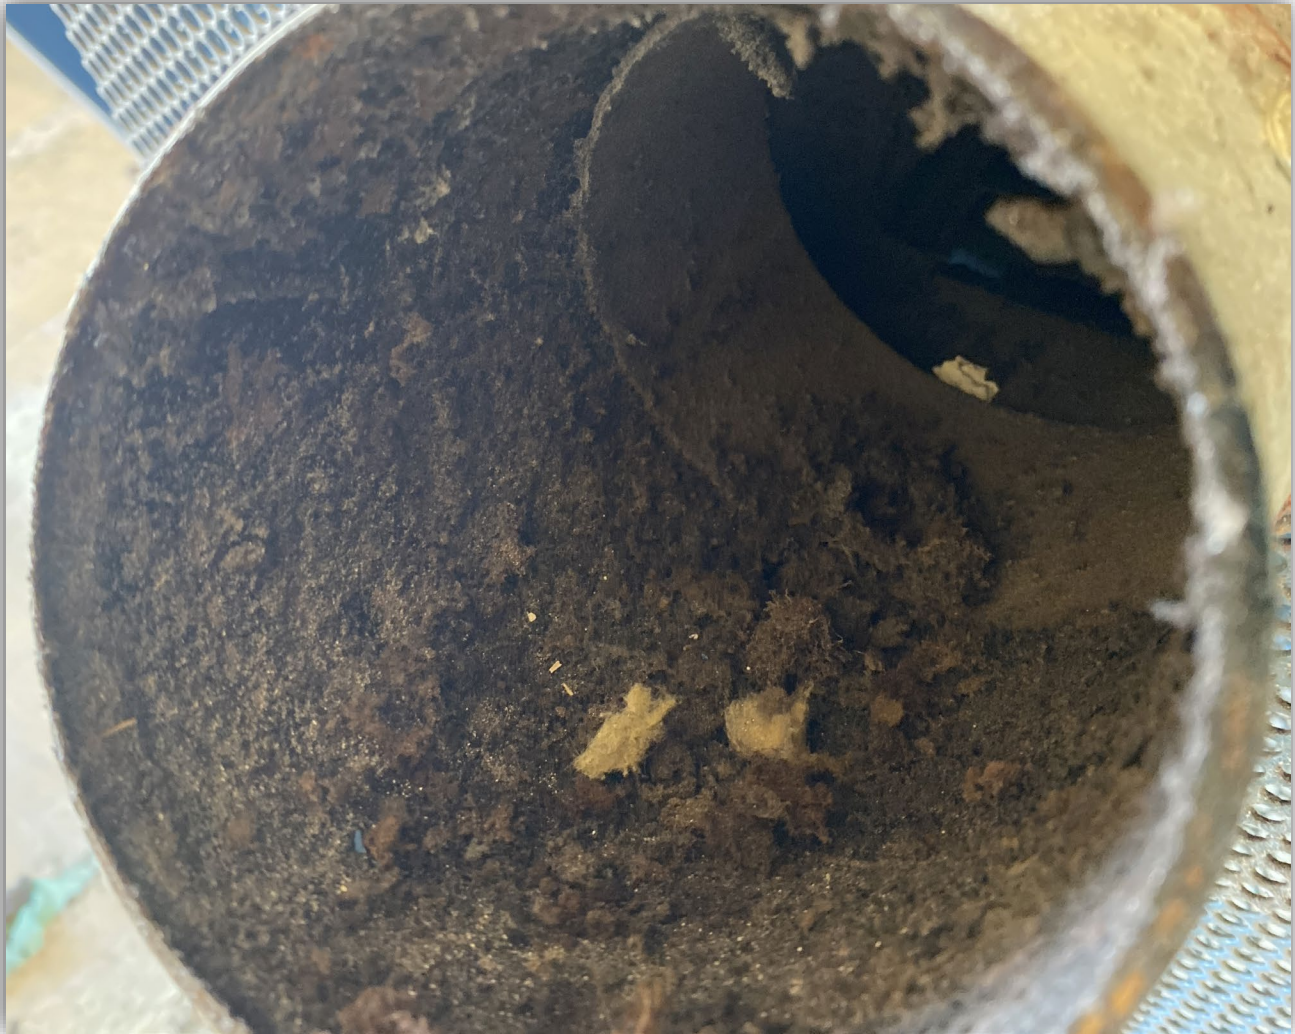
- The factory B-vent for the dryer was observed to have a dirty sticky coating and lint on the inside indicating it had not been checked or cleaned regularly as outlined by the manufacturer ([Image 4](#) and [image 5](#)).
- The force of the explosion appeared to originate from the upper conveyer area of the dryer and not the lower combustion chamber area.
- The majority of the damage was located at the top of the lid of the dryer.
- The unsecured rain cap on the dryer vent outlet had not been dislodged from the explosion ([Image 7](#)).

Image 4 – Inside of dryer exhaust vent showing dust, lint and debris from the operations process.

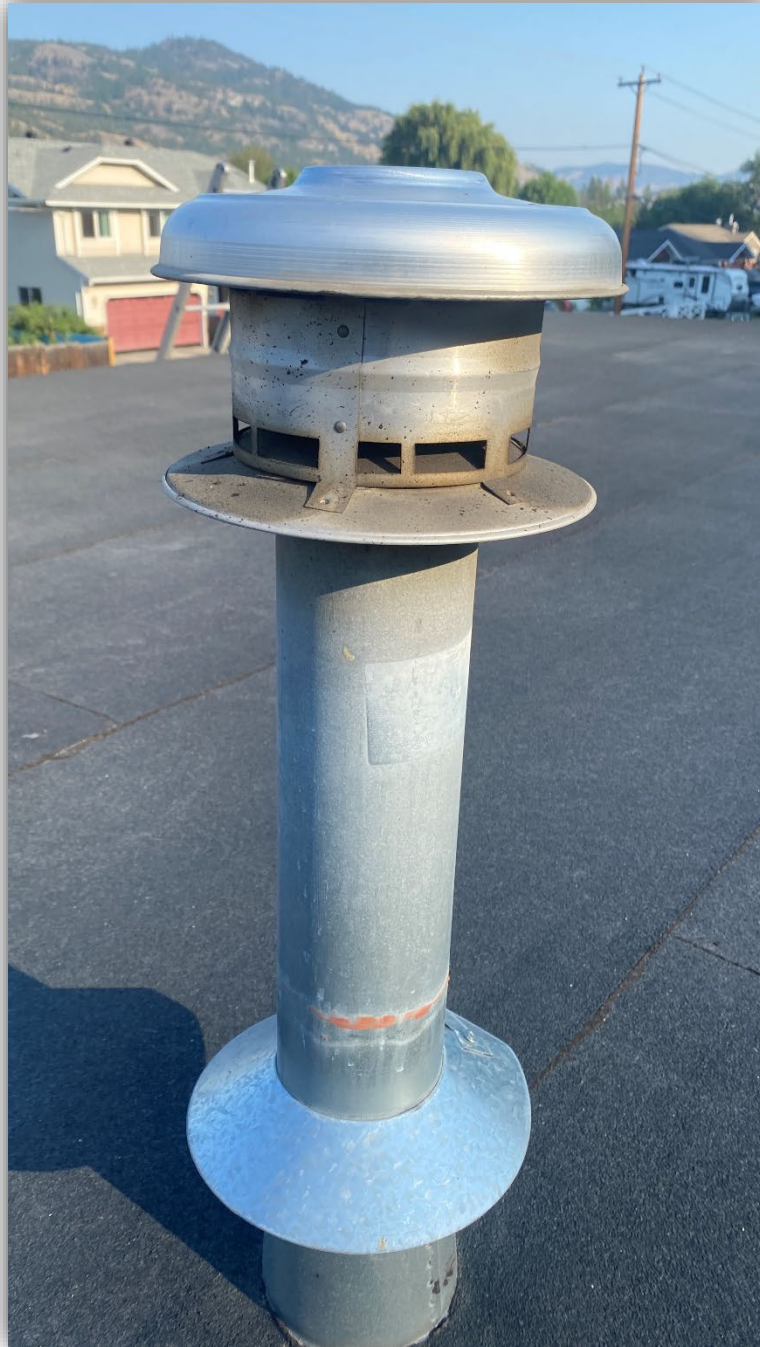
Image 7 – The b-vent termination for the dryer with the unsecured rain cap still attached after the explosion.

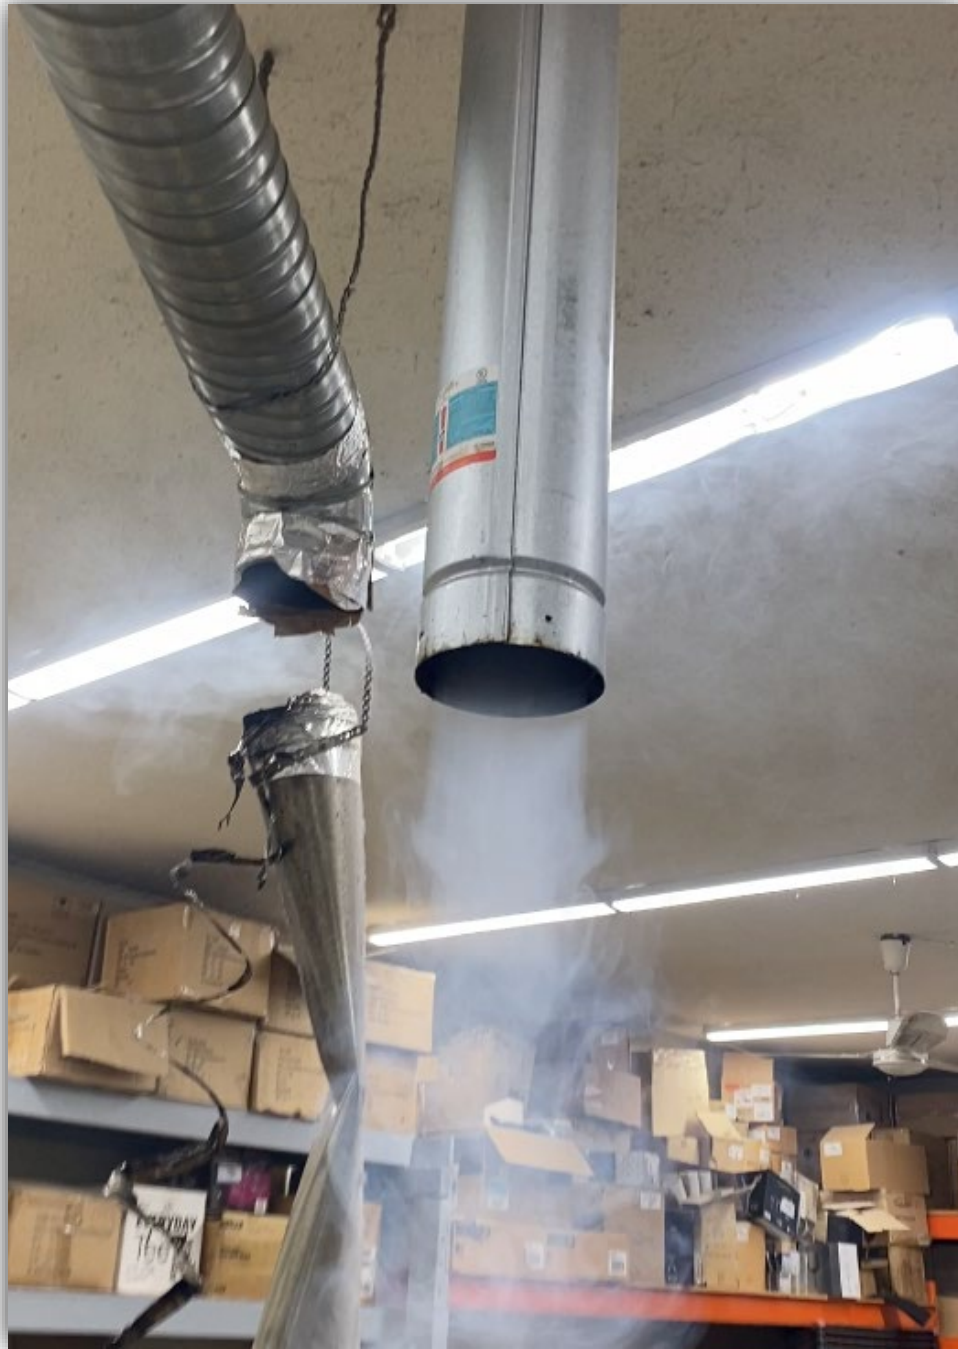
fans operating, smoke was drawn into the building through the disconnected vent identifying a negative pressure environment in the space (Image 8).
Causes and contributing factors	<p>It is likely that the conditions created by building pressure and lack of required combustion led to an accumulation of unburnt natural gas inside the appliance that ignited causing an explosion.</p> <p>Contributing factors to the incident include:</p> <ul style="list-style-type: none"> • The absence of the manufactures certified installation and operating manual that could have informed the owner of the air-supply and maintenance requirements. • The absence of routine maintenance for the gas systems by a certified technician allowed the dryer to operated under upset conditions for a prolonged period of time. • The modification of the dryer by the addition of the custom auxiliary fume extraction system may have contributed to upset operating conditions of the gas burner system. • The multiple exhaust systems in the building without appropriate make-up-air provisions created negative pressure conditions inside the building that may have contributed to upset operating conditions of the gas burner system.

Image 8 – Smoke from a smoke stick test being drawn into the building from the roof through the disconnected dryer vent due to a negative pressure condition in the building created by one exhaust fan operating.

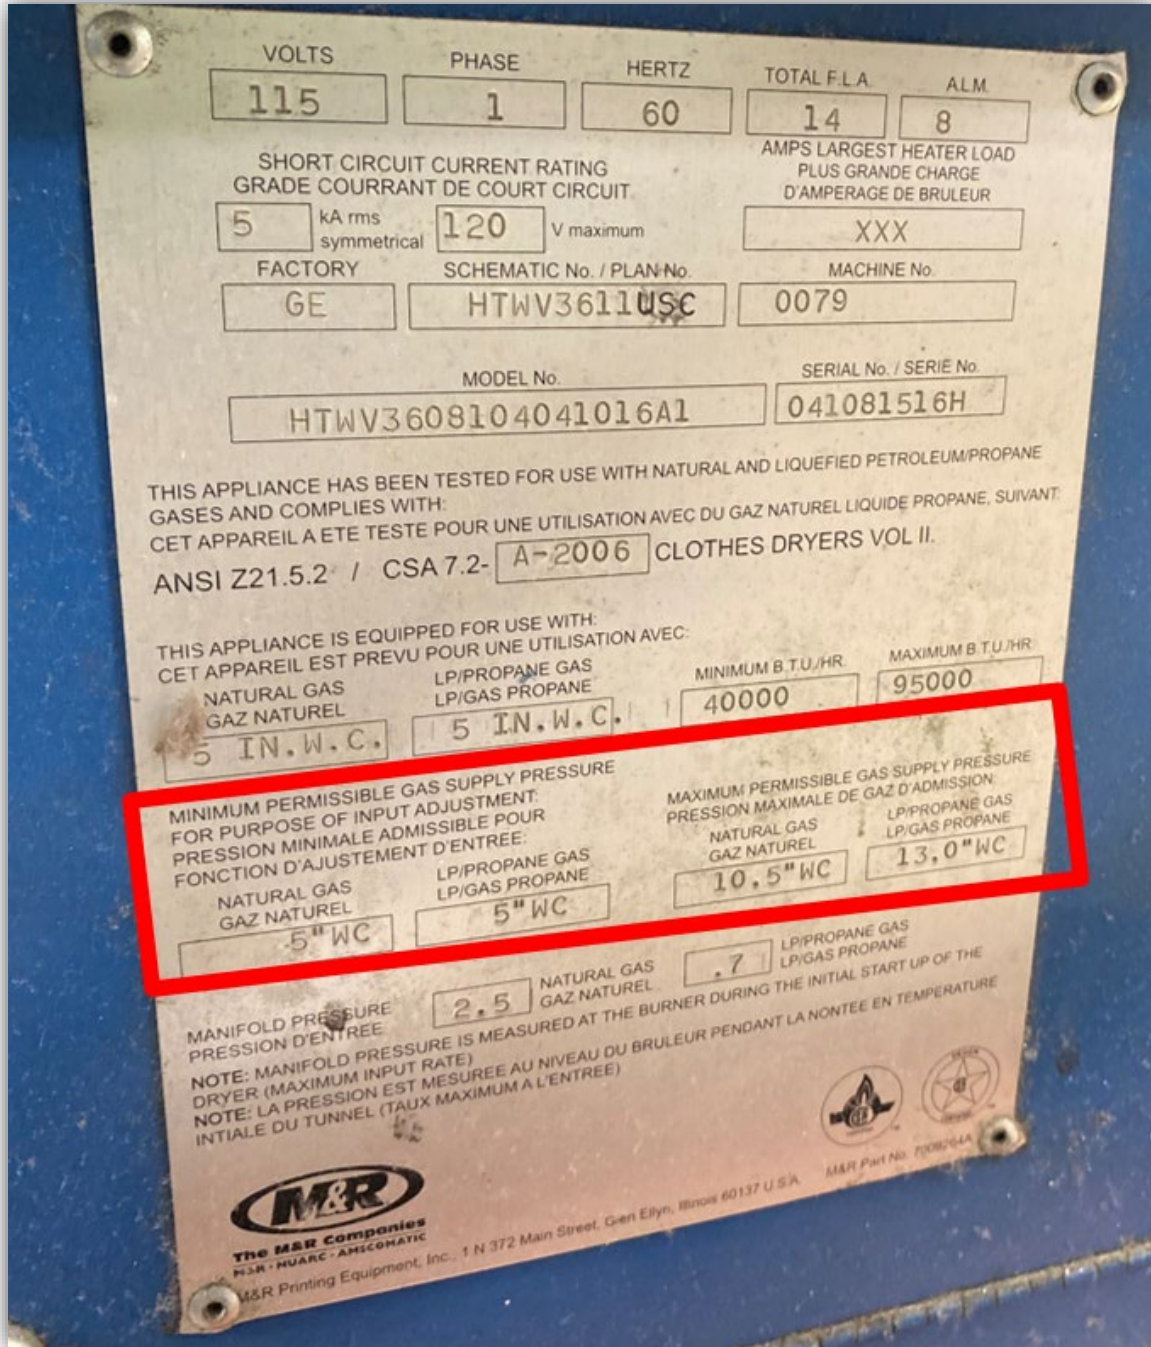
Image 9 – Data tag for the textile dryer showing the acceptable minimum and maximum gas supply pressures.
