## Incident Summary #II-800508-2019 (#10589) (FINAL)

SUPPORTING INFORMATION	Incident Date	August 20, 2018	
	Location	Whistler	
	Regulated industry sector	Passenger ropeways - Above surface ropeway	
	Impact	Qty injuries	0
		Injury description	NA
		Injury rating	None
	Damage	Damage description	Impact damage to the front forks of a mountain bike. (photo 5)
		Damage rating	Moderate
	Incident rating	Moderate	
	Incident overview	A mountain bike being transport up the ropeway lift line by a special purpose bicycle only carrier became dislodged from its rack and fell approximately 35' to the ground	
INVESTIGATION CONCLUSIONS	Site, system and components	<ul style="list-style-type: none"> <li>The detachable gondola ropeway is utilized in a downhill mountain bike operation.</li> <li>Passengers and their mountain bikes are transported by the ropeway.</li> <li>20 special purpose bike carriers spaced about every 4<sup>th</sup> or 5<sup>th</sup> carrier. Each carrier can hold up to 4 bikes loaded beside each other. The bikes are loaded onto the carrier perpendicular to line of travel. (see photo 1)</li> <li>The special purpose carrier (bike carrier) allows the passenger to roll their bike onto a

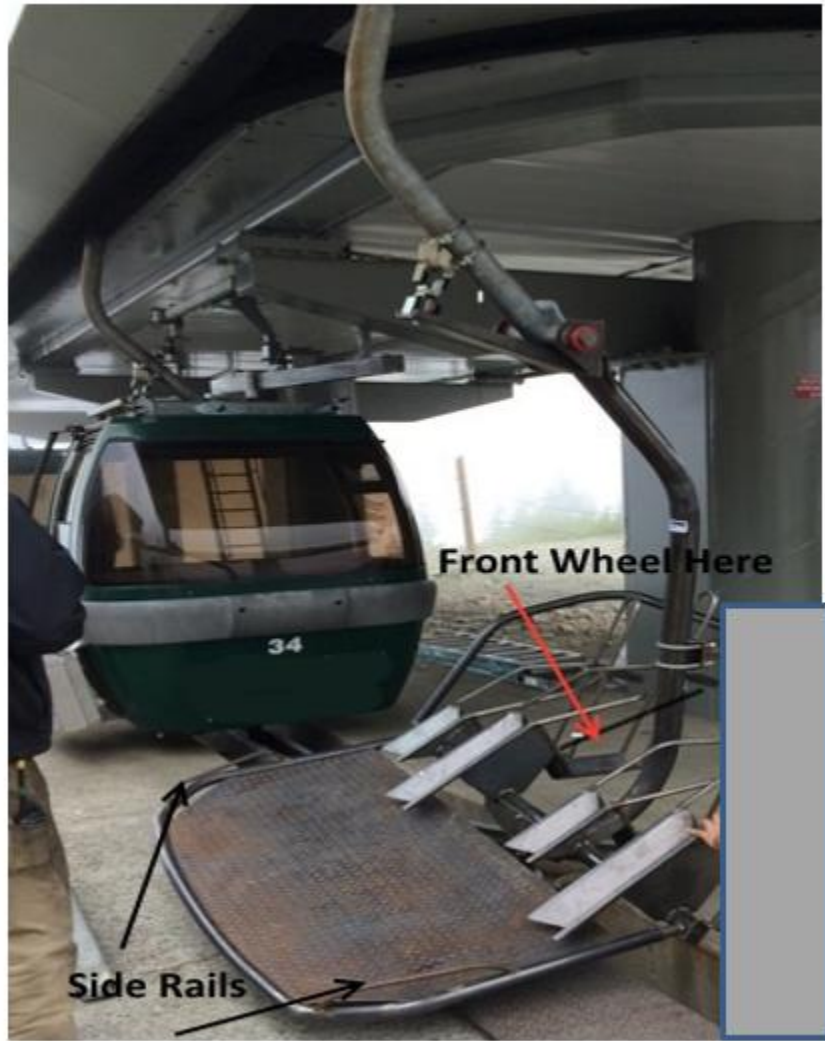
Photo 1- displaying the rails an where Wheel goes

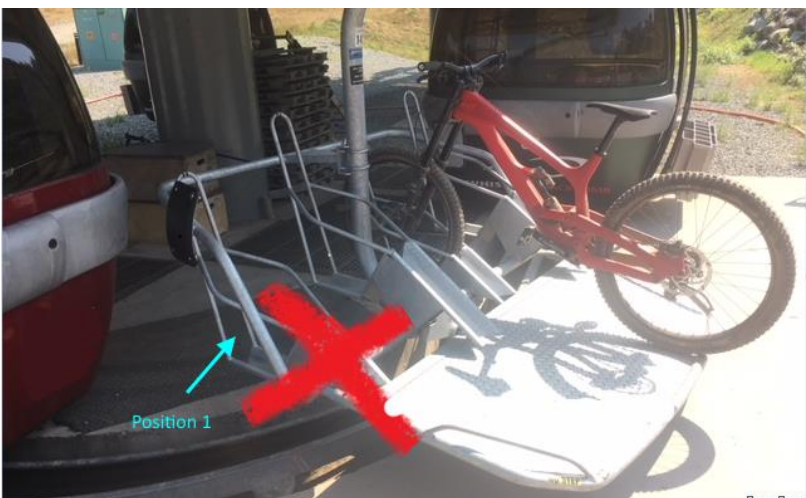
Photo 2 – Position 1 on rack of the special purpose carrier

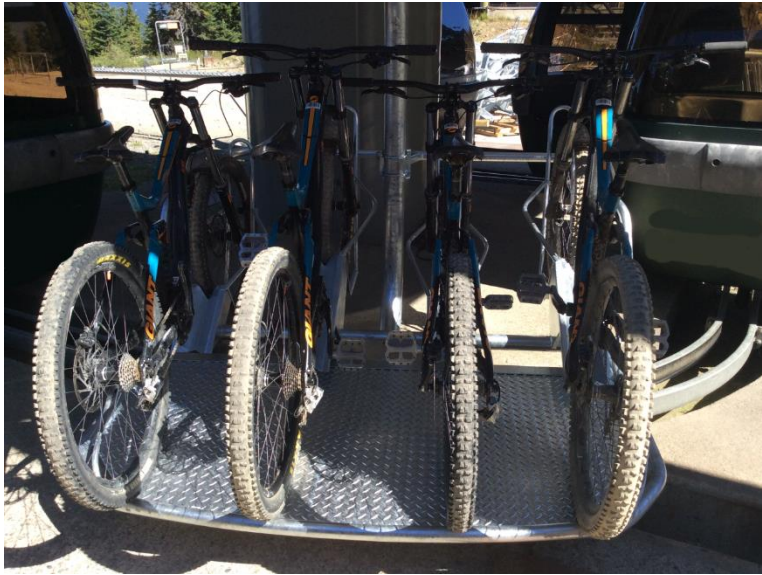
Photo 3 – Bikes in Racks

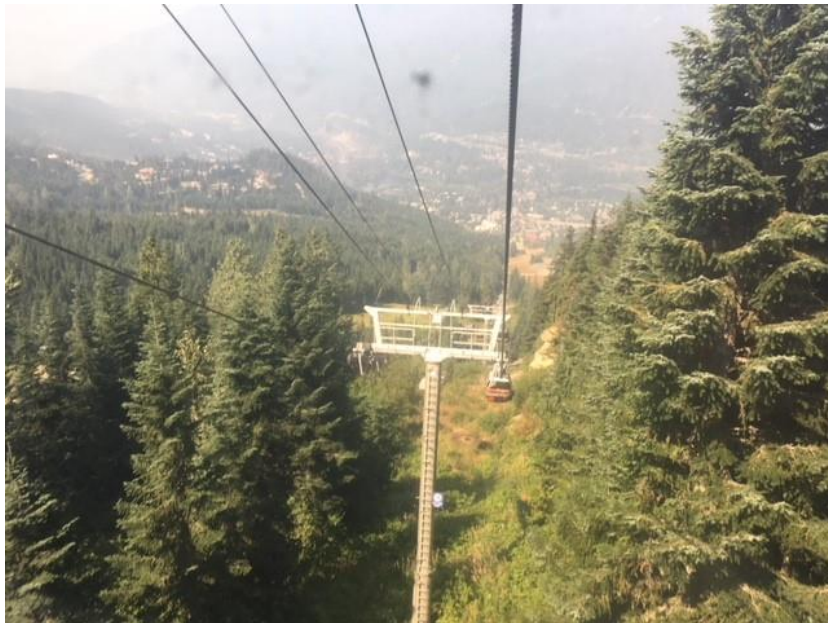
Failure scenario(s)	A mountain bike failed to remain on the carrier for the entire transportation cycle.	
	Facts and evidence	<p>Incident report submitted by operating contractor indicates:</p> <ul style="list-style-type: none"> <li>The bike had been loaded by the passenger into position 1 onto the rack of the special purpose carrier. (see photo 1,2 &amp;3 )</li> <li>The passenger reported that the gondola had stopped just before tower 17 (stop due to door fault).</li> <li>As the lift restarted they saw the bike shift in the rack and then jostle out of the rack as the carrier moved under tower 17 (photo 4).</li> </ul>

<p>Tower 17 is a hold down tower (rope is under the sheave wheels) and, as would be typical, will cause a bounce to the carriers (more than a support tower which has the rope above the sheave wheels) as they pass under the sheave wheels.</p> <p>Special bike carriers were installed in 2015, Installation/alteration work was conducted under an alteration permit issued by Technical Safety BC and included design review conducted by professional engineer licensed in BC.</p> <p>In communication with representative of the engineering consultant that conducted the design review, the belief is that no motion of the carrier could cause the rear wheel of the bike to bounce 2" over the side rail. The only way a bike could have gotten by the side rails is if it were an unusually long bike in which the rear wheel could slide around the side rail (the bike that was damaged was described as a medium sized trail bike).</p> <p>(Extra-long downhill bike were tested at the time of the acceptance test and it was determined that, in that case, the rear wheels were contained by the side rail.)</p> <p>Maintenance staff member indicated that they deemed there was a high likelihood that the rear wheel of the bike had been placed on top of the side rail. The front wheel of the bike is held within a steep sided rack in which the bike is removed by pulling it back, over and out of the pocket which contains it. The only likely way for the bike to become extracted from the front wheel rack (without a person pulling the bike back) is if it the rear wheel were to be left unsupported by the carrier deck.</p>

Photo 4, Tower 17- location of incident with bike

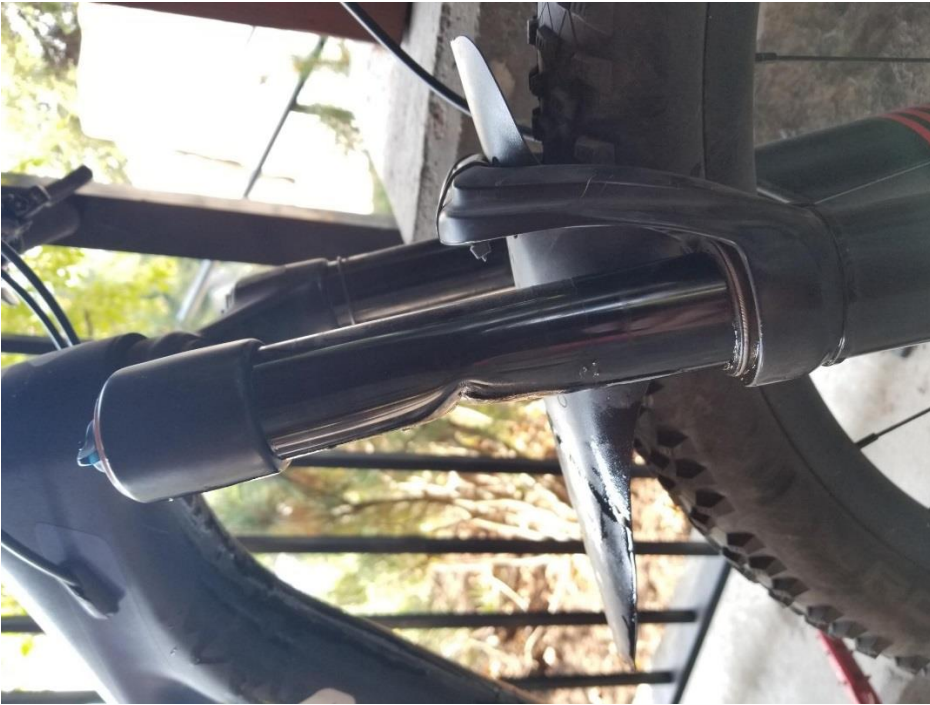
Photo 5, Damage to Bike
