Incident Summary #II-705299-2018 (#7610) (FINAL)

SUPPORTING INFORMATION	Incident Date	June 14, 2018	
	Location	North Vancouver	
	Regulated industry sector	Amusement Devices - Zip line	
	Impact	Qty injuries	2
		Injury description	Neck strain (headache, stiff neck) to 2 of riders
		Injury rating	Minor
	Damage	Damage description	NA
		Damage rating	None
	Incident rating	Minor	
Incident overview	2 riders sustained a neck strain type injury when the trollies they were riding engaged the braking system.		
INVESTIGATION CONCLUSIONS	Site, system and components	<ul style="list-style-type: none"> Groups of riders progress through a series of multiple zipline units. Guides lead and provide instruction to the groups of riders. Incident occurred on a unit with 2 parallel zipline ropes approximately 180 m long. Previous inspection records indicate an average rider speed of 10.9 m/s. Brakes at the landing station consist of a system in which the trolley is decelerated by engaging and compressing a set of helical springs. A configuration utilizing ropes, rope clutches, pulleys and a trolley capturing mechanism provides control of the rebound after the trolley engages the springs. The riders are in

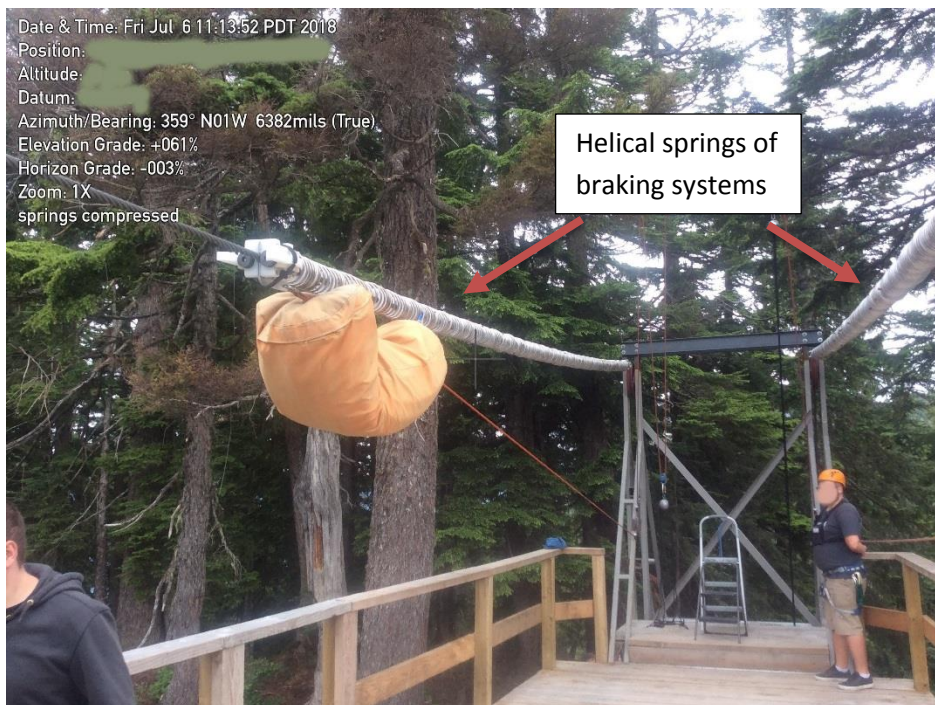
Braking System

Failure scenario(s)	The deceleration rate was of a magnitude that it caused injury to riders.	
	Facts and evidence	<p>A rider that had participated in the zipline tour, reported to Technical Safety BC that when they and their spouse (both riding the ziplines) came into the landing station and hit the braking system that:</p> <ul style="list-style-type: none"> The deceleration was described as “the shock was extremely abrupt”. The rider indicated that they were in the correct “Braking Position” when they approached the landing. Both riders sustained neck stain type injuries (neck pain, headache).
