Incident Summary #II-1019057-2020 (#17992) (FINAL)

SUPPORTING INFORMATION	Incident Date	May 30, 2020
	Location	Prince George
	Regulated industry sector	Boilers, PV & refrigeration - Boiler and pressure vessel system
	Impact	Qty injuries
		0
		Injury description
	Damage	NA
		Injury rating
		None
INVESTIGATION CONCLUSIONS	Site, system and components	Damage description
		High solids black liquor piping elbow ruptured and sprayed black liquor onto buildings and equipment.
		Damage rating
	Incident overview	Moderate
		At 12:30 am on May 30 th , 2020, failure of a 6" pressure piping elbow located on top of a storage tank resulted in black liquor being sprayed onto adjacent buildings, equipment and ground within an approximately 50m area. The line from the liquor transfer pump into the top of the tank failed and 74% black liquor solids were released for approximately 20 minutes. A similar failure had occurred on Feb 8, 2020.
		The organic matter in black liquor is made up of water/alkali soluble degradation components from wood. Black liquor is corrosive. High solids black liquor at a temperature of approximately 140°C is transferred from a concentrator vessel to a storage tank via stain

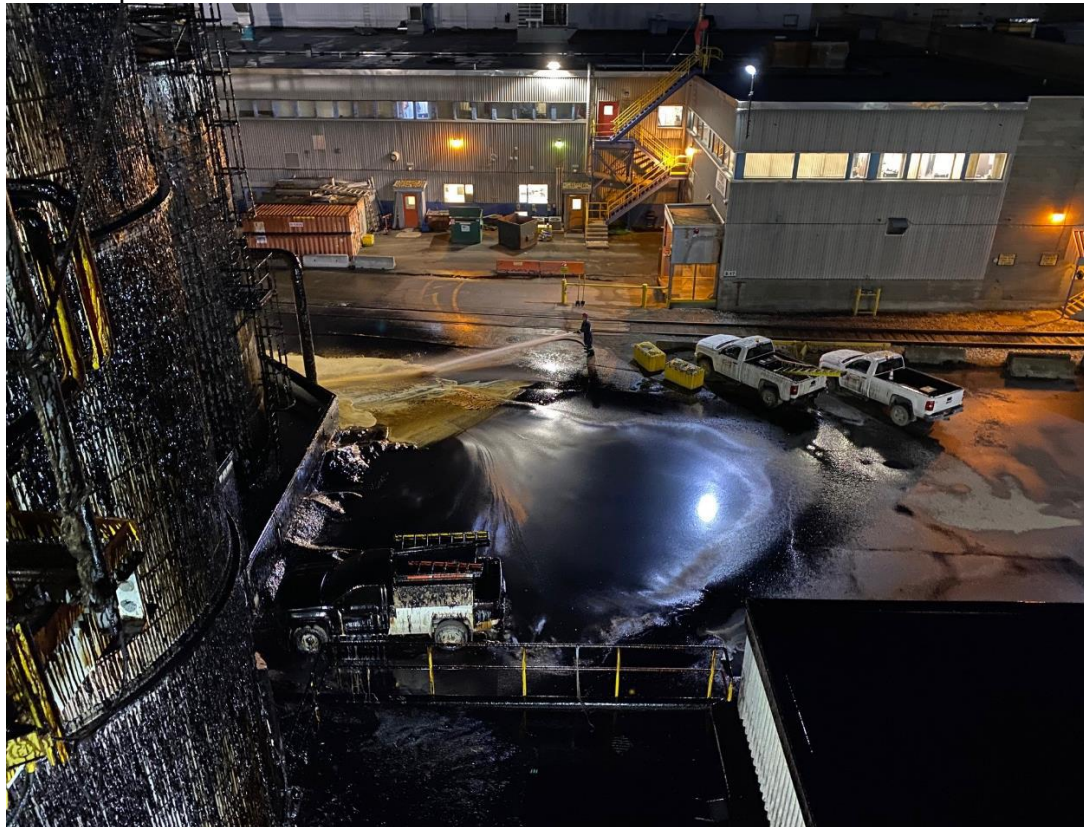
Black Liquor release

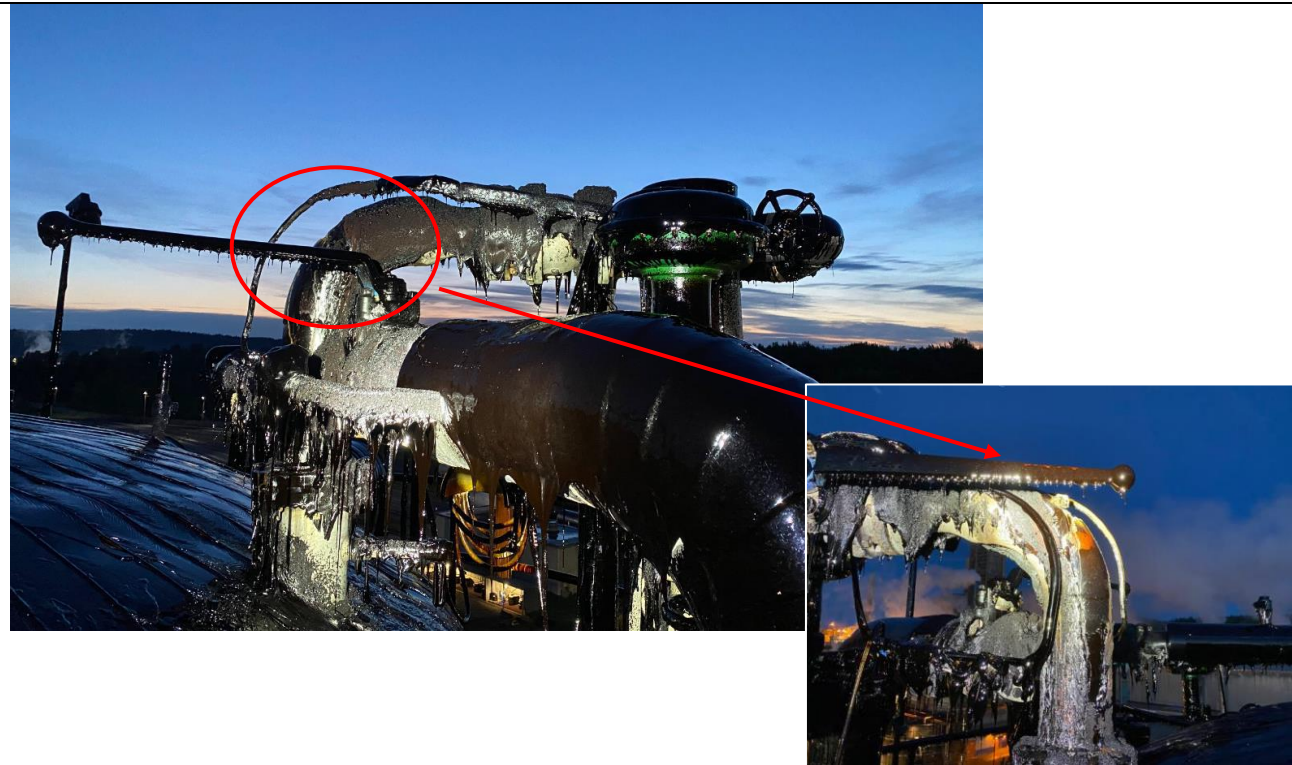
Heavy Black Liquor line piping on top of Black liquor storage tank

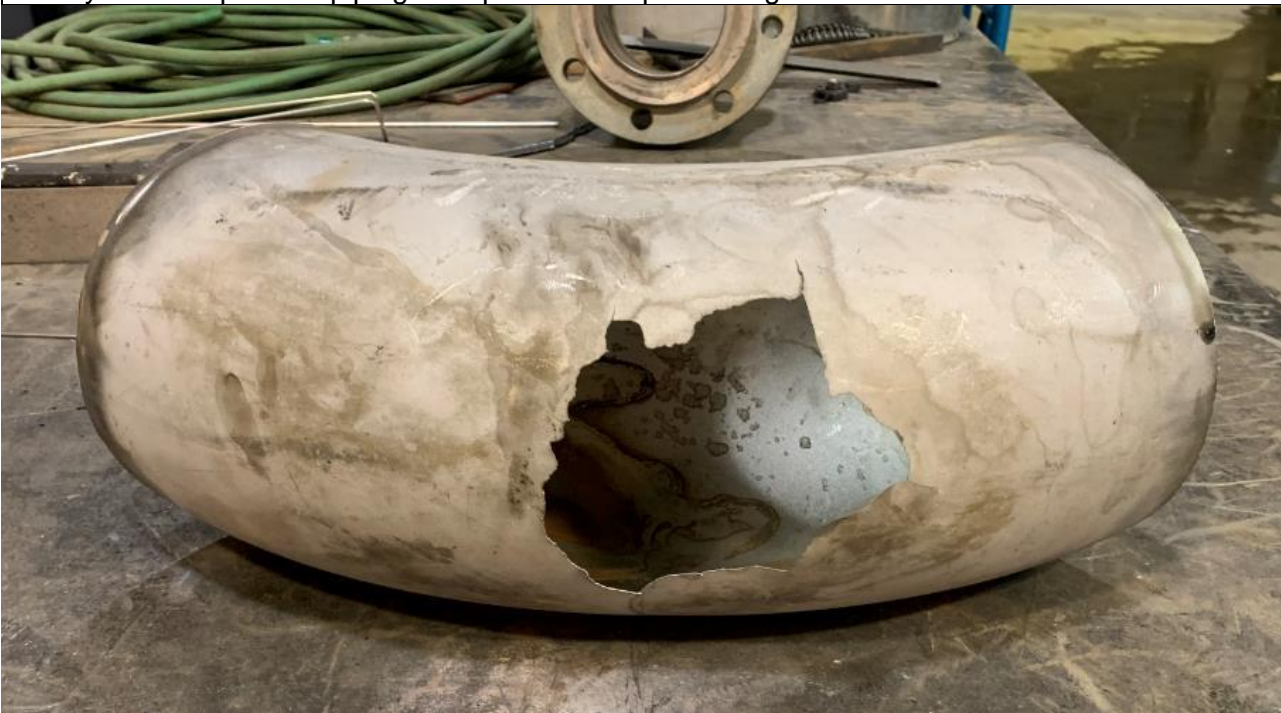
Failure scenario(s)	Hot alkaline liquor corrosion and erosion of a stainless steel (SS) schedule 10 6" - 90 degree piping elbow caused thinning of the piping wall. The thinned piping then ruptured and released a flow of black liquor from the top of the storage vessel.
		Inspection of the failed piping elbow found a large hole indicating a complete rupture had occurred. Inspection of the piping wall verified thinning of the metal had occurred at various locations with the worst at the outer radius or sweep of the elbow. Inspection of the thinning determined that the primary damage mechanism was erosion/corrosion. Industry literature (WRC 488 "Damage Mechanisms in the Pulp and Paper Industry") explains that stainless steels and nickel alloys can experience uniform corrosion when exposed to hot, alkaline liquors above certain threshold temperatures. The corrosion mechanism of this type of failure is referred to as "hot alkaline liquor corrosion". Hot alkaline liquor corrosion of stainless alloys occurs when the passive film (ultra-thin film of corrosion product on a metal's surface that acts as a barrier to additional chemical reaction) that normally protects the alloy surface fails due to excessive temperatures. Flow velocities and other physical conditions can disrupt the passive film. The Process Instrumentation Diagram for the High Solids Concentrator (HSC) firing liquor system specifically mentions that the control valve package was located close to the tank inlet to prevent flashing, thus indicating a known potential for increased turbulence. Process changes made in January 2019 contributed to higher process pressure and temperature (increased from 136°C to 146°C) contributing to lower viscosity and more turbulent flow of black liquor. It was stated by a mill employee that the control valve immediately upstream of the failed elbow was noisy, sounding like cavitation (the rapid formation and collapse of vapor pockets in a flowing liquid in regions of very low pressure) was occurring.

<p>Causes and contributing factors</p>	<p>It is highly likely that erosion/corrosion caused thinning of the pressure piping elbow resulting in a subsequent rupture of the pressure boundary. Incorrect selection of piping metallurgy, adverse flashing conditions within the piping, a change to the black liquor process and a delay in planned maintenance were contributing factors.</p>

Failed 316 SS Sch 10 6" Elbow
