Incident Summary #II-825724-2019 (#11410) (FINAL)

SUPPORTING INFORMATION	Incident Date	March 14, 2019	
	Location	Port Coquitlam	
	Regulated industry sector	Electrical - Low voltage electrical system (30V to 750V)	
	Impact	Qty injuries	1
		Injury description	Individual suffered a third degree burn to the top of one hand.
		Injury rating	Moderate
	Damage	Damage description	Damage occurred to the electrical connection lugs and the enclosure housing the lugs.
		Damage rating	Minor
	Incident rating	Moderate	
Incident overview	Arc flash occurred in the main electrical room when two individuals were attempting to install sub feed cables into the energized main service equipment. One individual sustained burns to the hand, the other individual did not sustain any injuries. There was damage due to heat and arcing to the existing electrical equipment as well as the newly installed cables.		
INVESTIGATION CONCLUSIONS	Site, system and components	<p>New sub service equipment was installed for one of the units at this building to provide more electrical capacity to the unit. The sub service equipment had fused disconnect switches installed to protect the conductors, and used parallel sub feeder

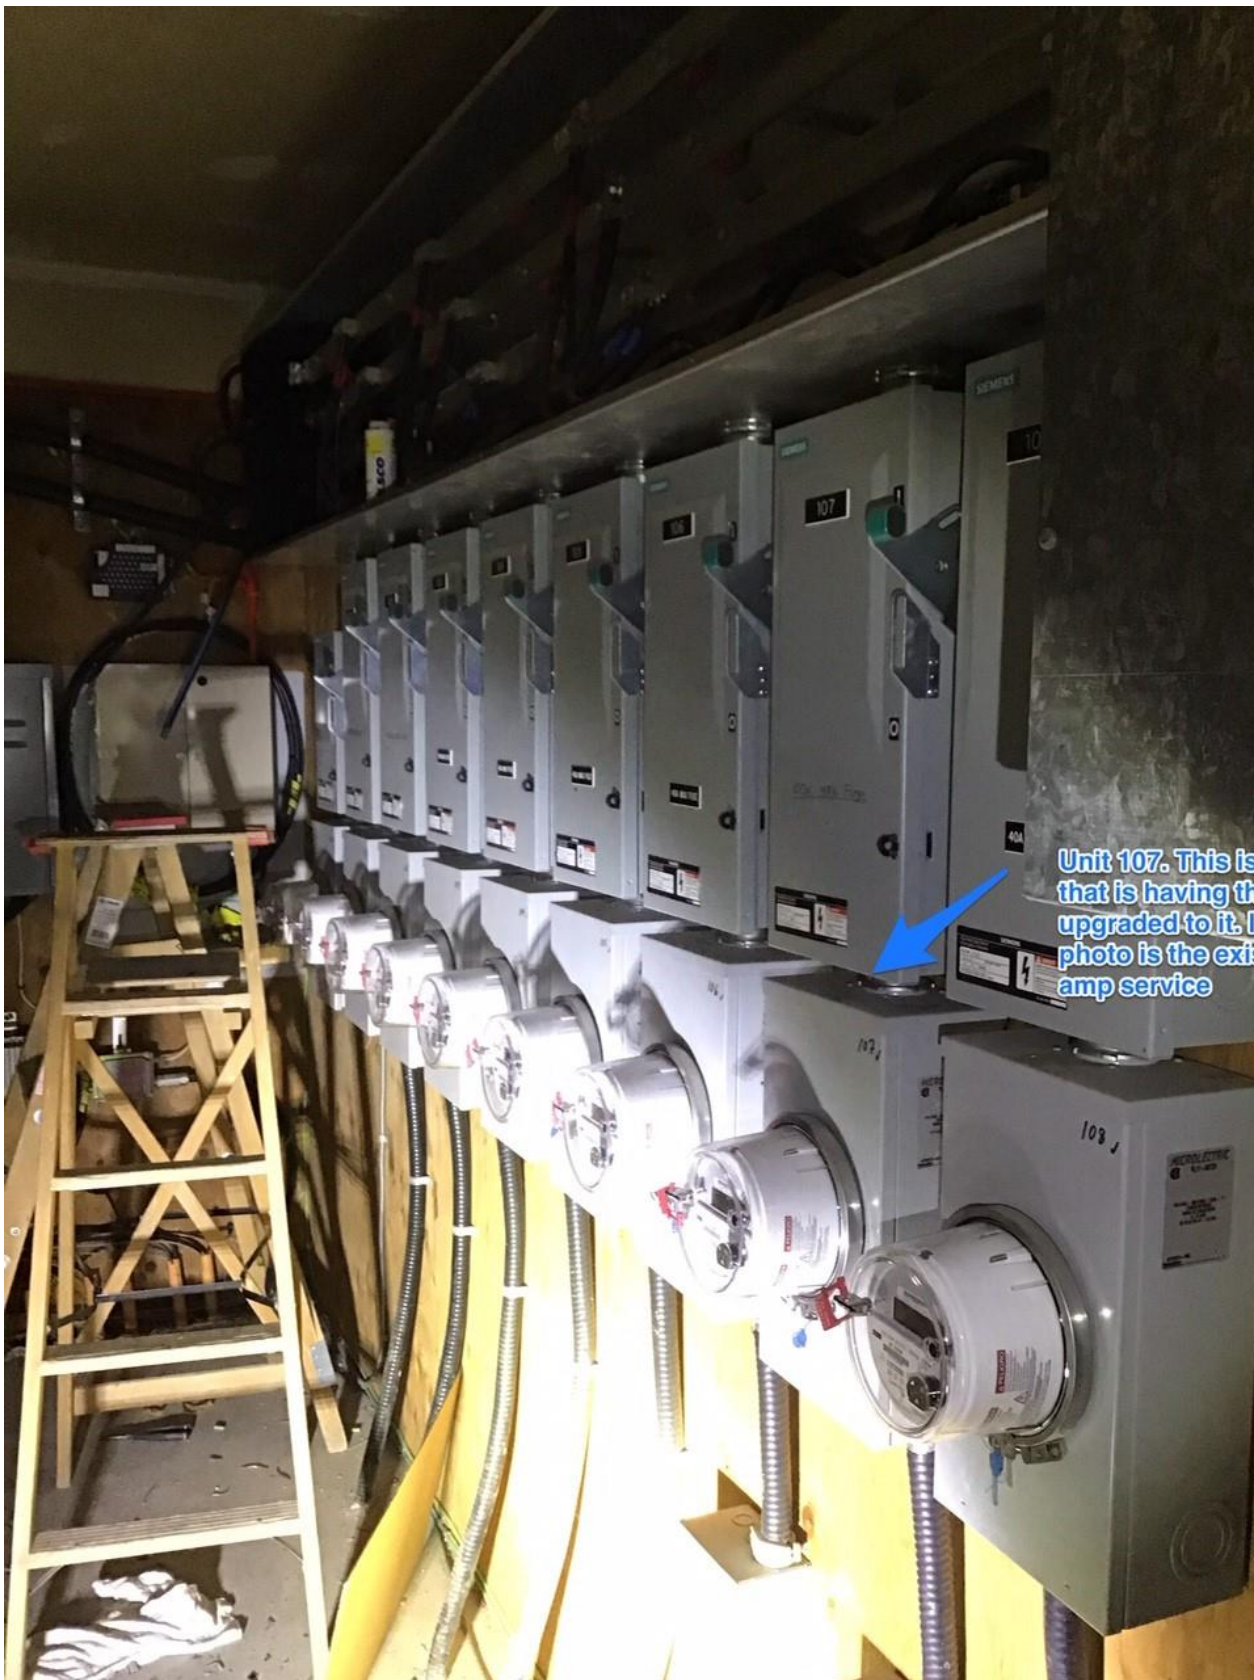
Unit 107. This is the unit that is having the service upgraded to it. In the photo is the existing 200 amp service

PHOTO 1: All of the fused disconnect switches above the meters were found in the on position.

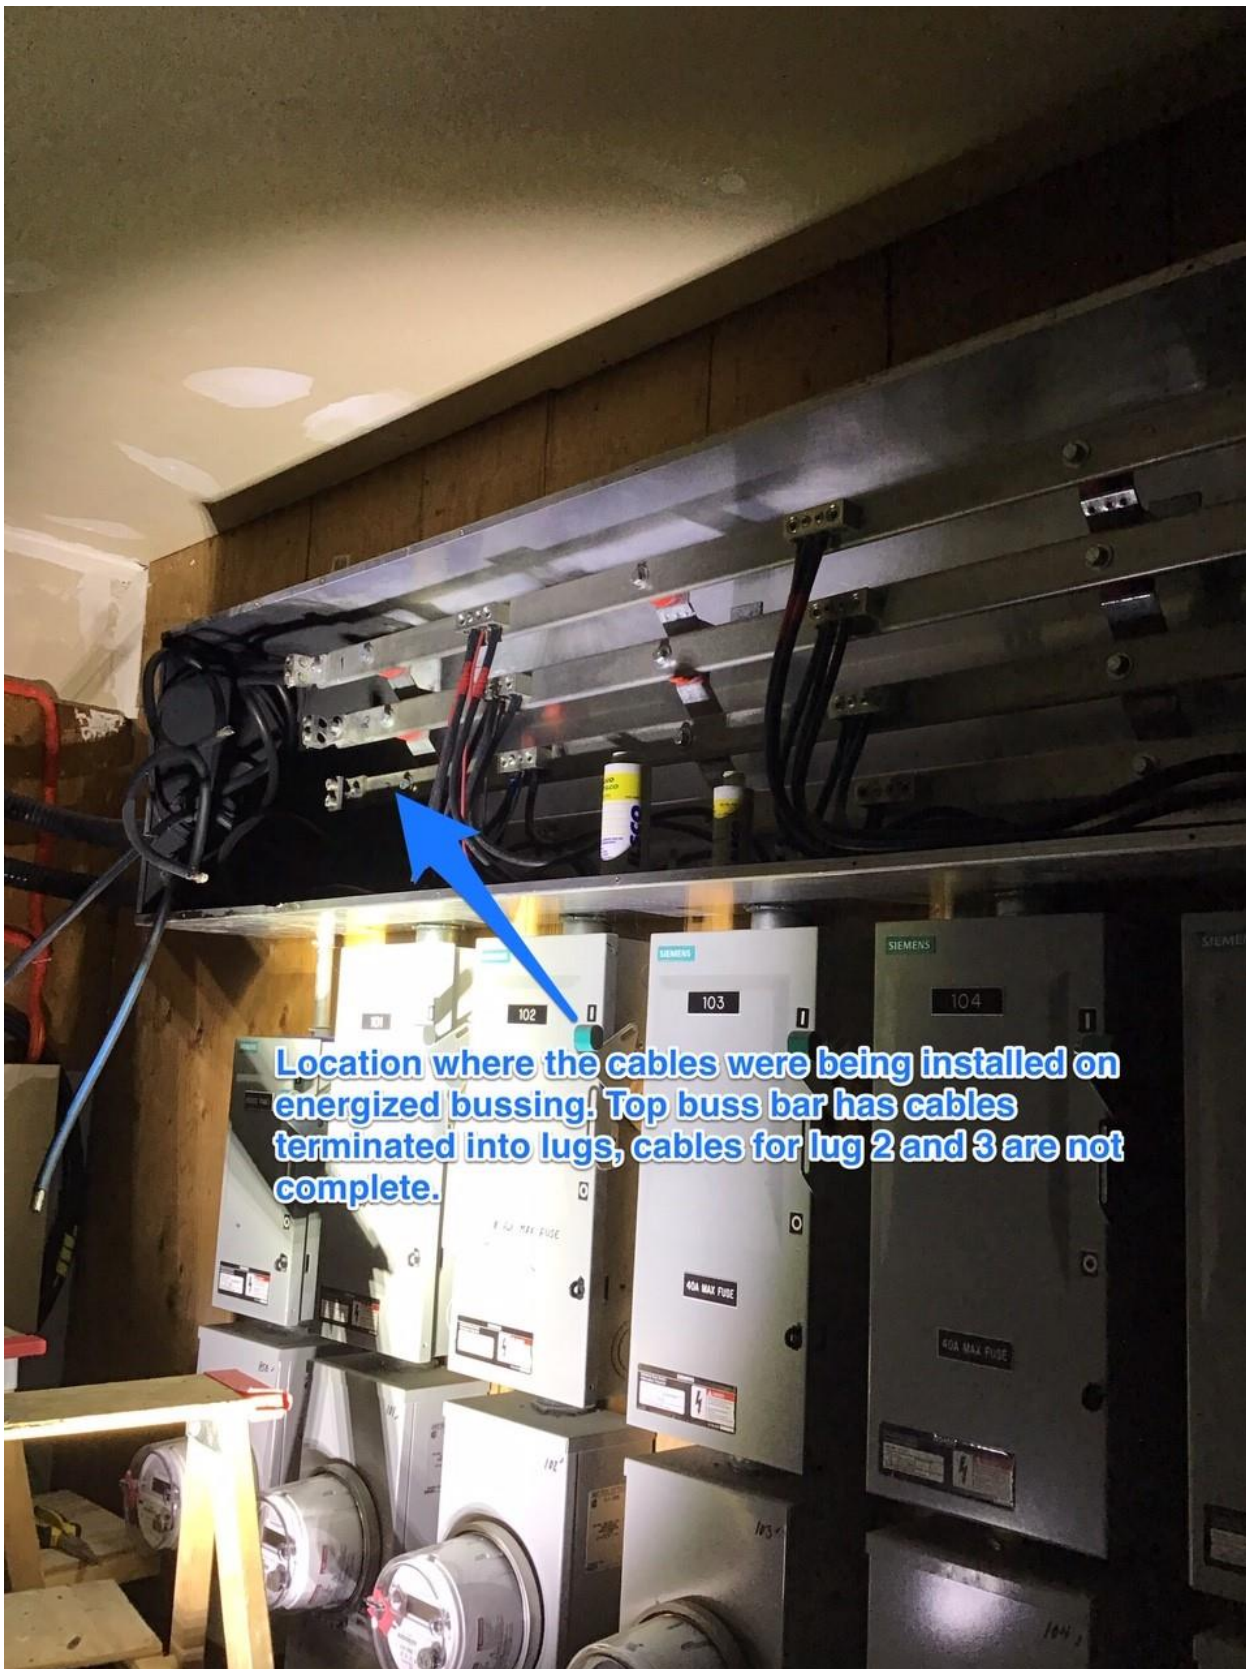
PHOTO 2: Junction box with energized bussing at time of incident, de-energized by the utility at time of photo.

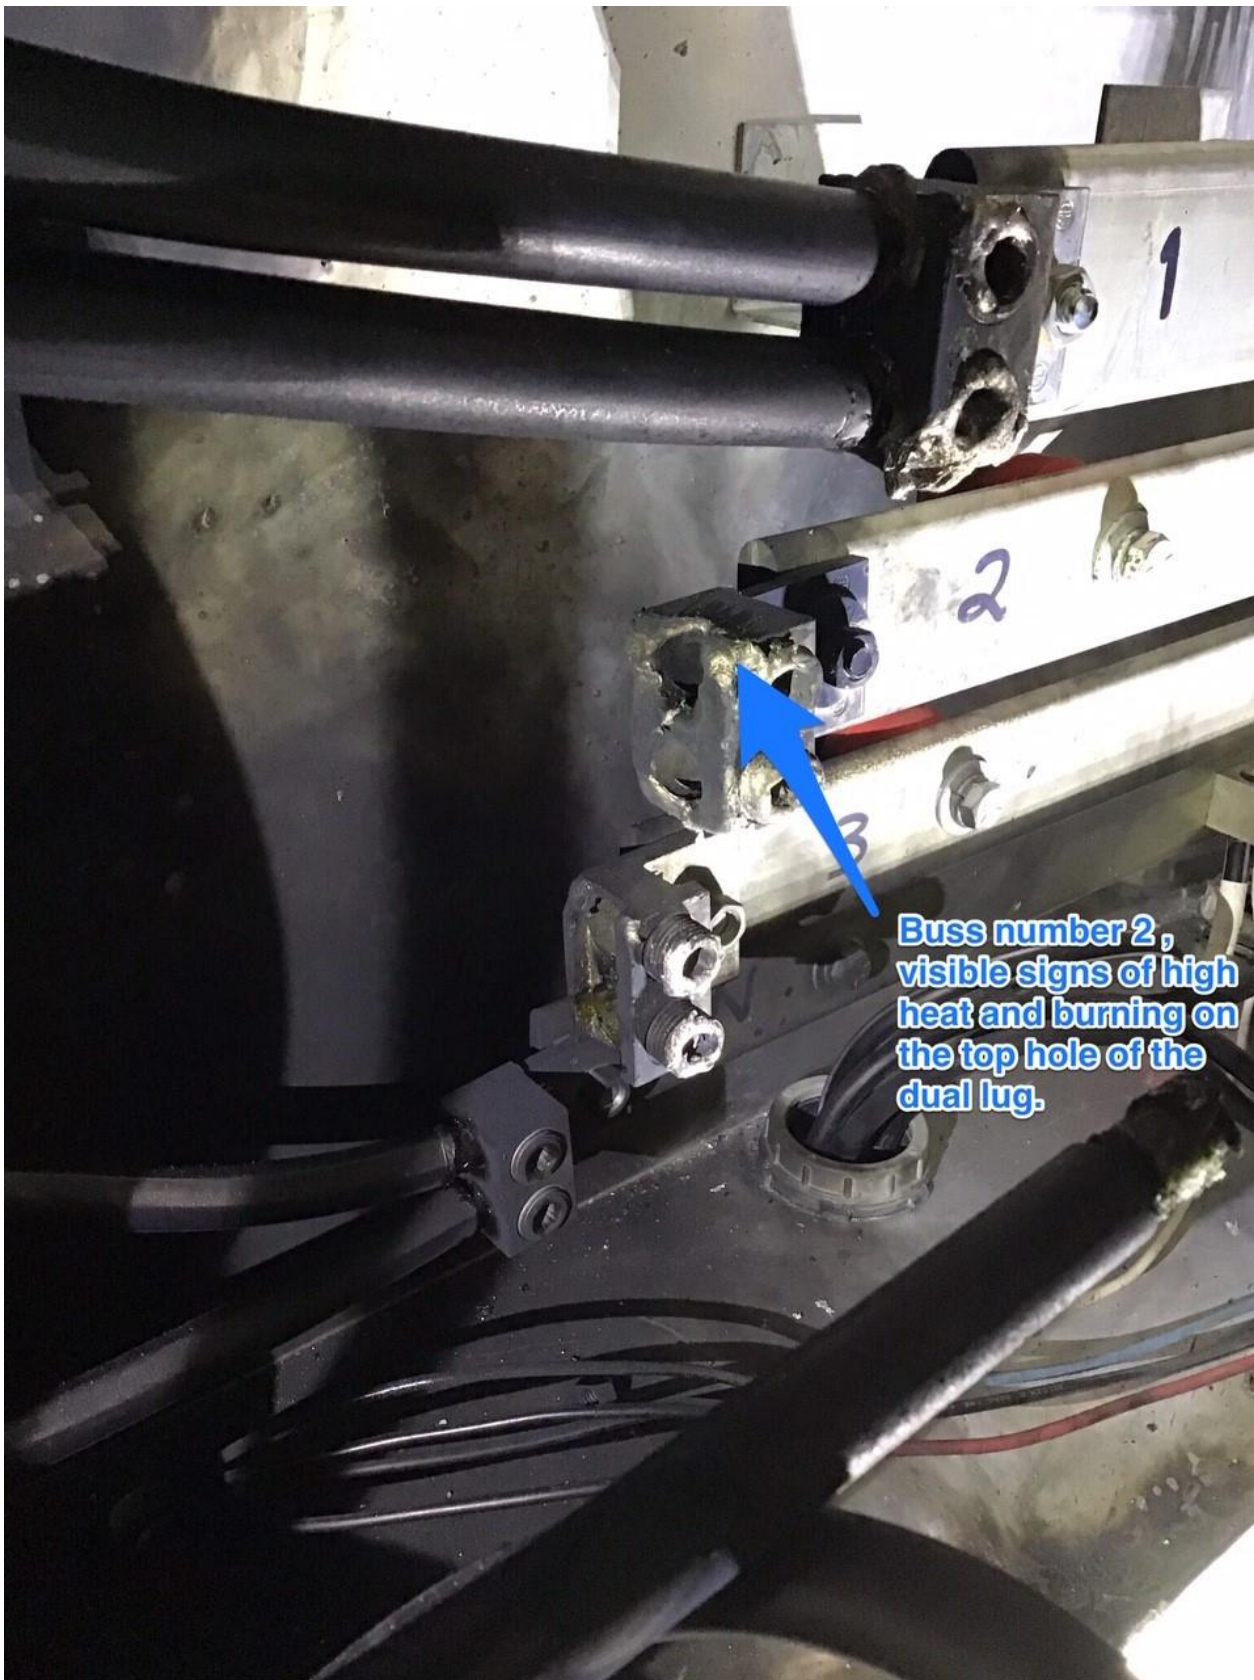
<p>Facts and evidence</p>	<p>The termination point of the cables at the main service had burning and signs of arcing at Line Two also called Phase B. This would indicate that there was a short circuit or a fault that occurred when it was attempted to be terminated. The above scenario would indicate that one of the lines was crossed, this would create an energized conductor being installed into an energized piece of equipment and would result in arcing. This appeared to be the scenario that was visible at the time of inspection when the main service was de-energized and site inspected. See Photos 3 and 5 below.</p> <p>An interview was conducted with the individual that was injured. This individual returned later that day to repair the damaged wiring and equipment in order to have the power turned back on to the building by the Utility. This individual disclosed during the interview, that he noticed damage to the insulation of the wire that was dedicated for Line Two. The damage to the insulation exposed the internal aluminum conductor and it was in contact with the exterior aluminum sheathing of the cable. This was not visible according to the individual at the time of installation because it was under the cable connector, and when the cable was attempted to be terminated there was an electrical fault between Line two and the exterior cable sheath. Which would also result in arcing and arc flash at the termination point. The damage to the cable and sheath was notice during disassembly, when the power to the building was being restored.</p> <p>During the interview process it was confirmed that both individuals doing the work were qualified journeymen electricians. A question was asked why de-energization and testing was not done. The reply was, that they were in a hurry to complete this for their customer and turning off the main service wasn't an option, because other tenants weren't notified that the power was going to be interrupted.</p>

PHOTO 3: Top hole of lug 2 has had a large portion of the lug melt.

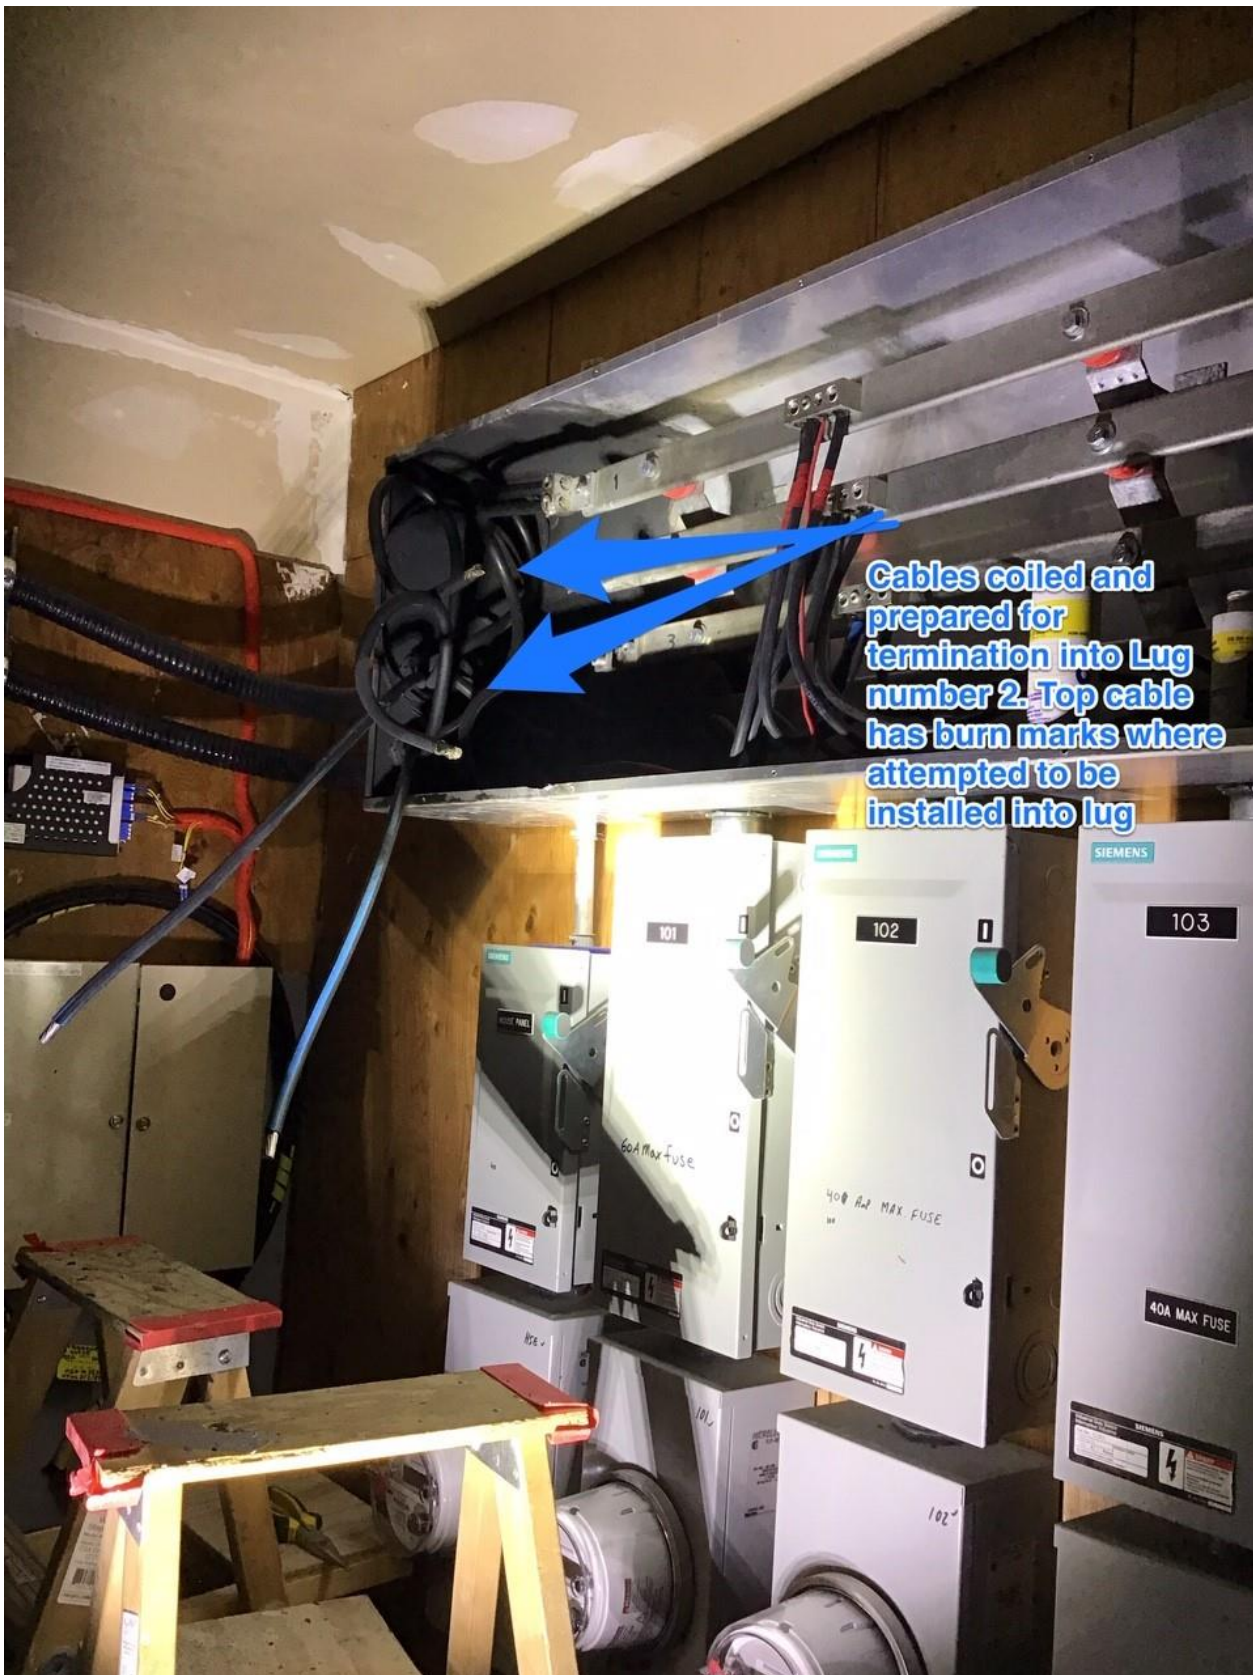
<p>Causes and contributing factors</p>	<p>It is plausible that accidental contact between the Line 2 conductor and the armoured cable aluminum sheathing would cause an arc producing scenario at the energized termination point.</p> <p>This being a multi-unit facility with other tenants and added pressure from the owners of the equipment to have the work done quickly could also be likely reason that this work was done in an energized state.</p> <p>Section 2, rule 2-304 of the Canadian Electrical Code requires that no repairs or alterations shall be carried out on energized electrical equipment except where complete disconnection of equipment is not feasible, non-compliance to this rule is also a likely cause of the failure scenario.</p>

PHOTO 4: Line 2 Cables were cut, coiled and were attempted to be terminated into Lug #2.

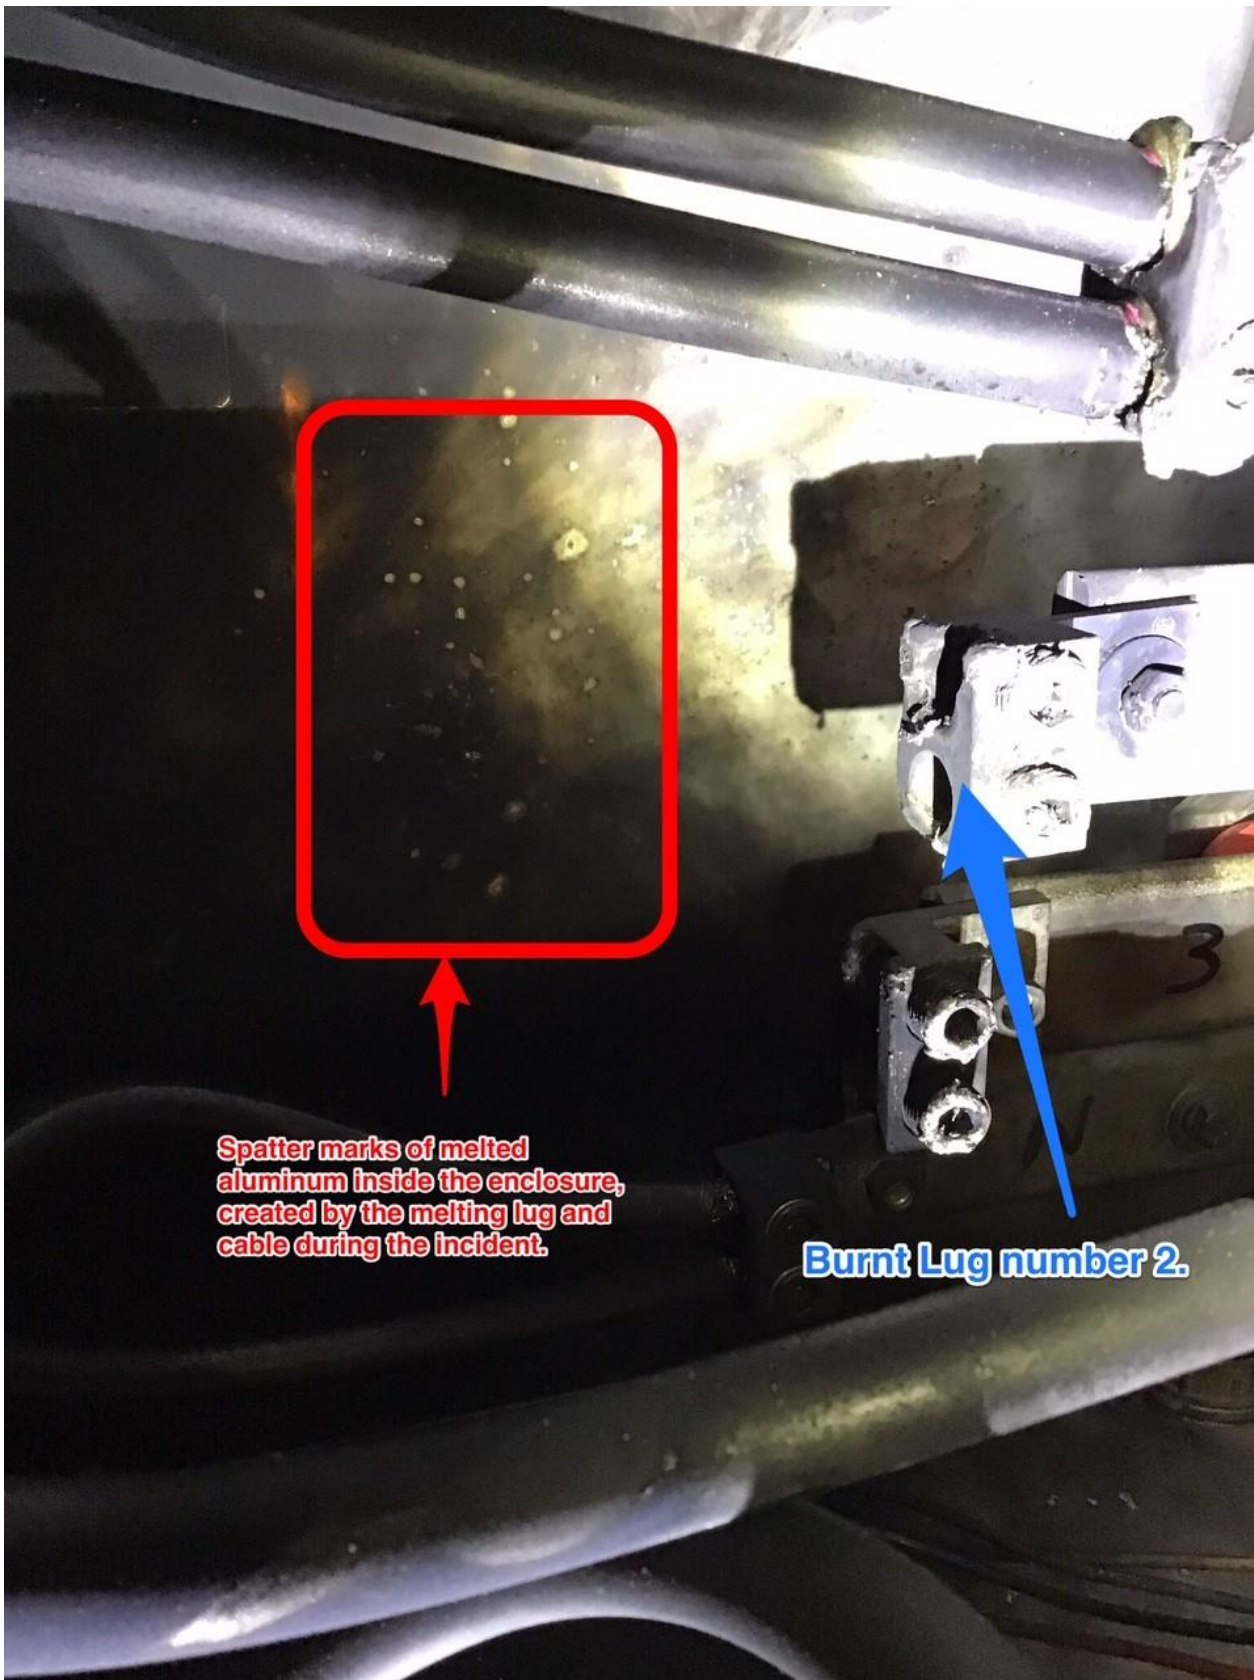
PHOTO 5: During incident high heat was created and began to melt Lug number 2
