Incident Summary #II-1042078-2020 (#18835) (FINAL)

SUPPORTING INFORMATION	Incident Date	July 17, 2020	
	Location	Vancouver / UBC	
	Regulated industry sector	Electrical - Low voltage electrical system (30V to 750V)	
	Impact	Qty injuries	0
		Injury description	No injuries
		Injury rating	None
	Damage	Damage description	Damage to a single family dwellings consumer service raceway and conductors between the meterbase and panelboard.
		Damage rating	Minor
	Incident rating	Minor	
Incident overview	Failure of the consumer service bonding path leading to equipment damage.		
INVESTIGATION CONCLUSIONS	Site, system and components	<p>Ungrounded conductors are protected by overcurrent and short circuit protection at the point where the circuit receives its supply of current. Usually consumer service conductors do not have overcurrent protection between the supply utilities service conductors and the line side of the consumer services main overcurrent device.</p> <p>The overcurrent protection for consumer service conductors is usually provided on the primary side of the supply utilities transformer feeding the service. As a result when a fault occurs on the line side (upstream) of the services

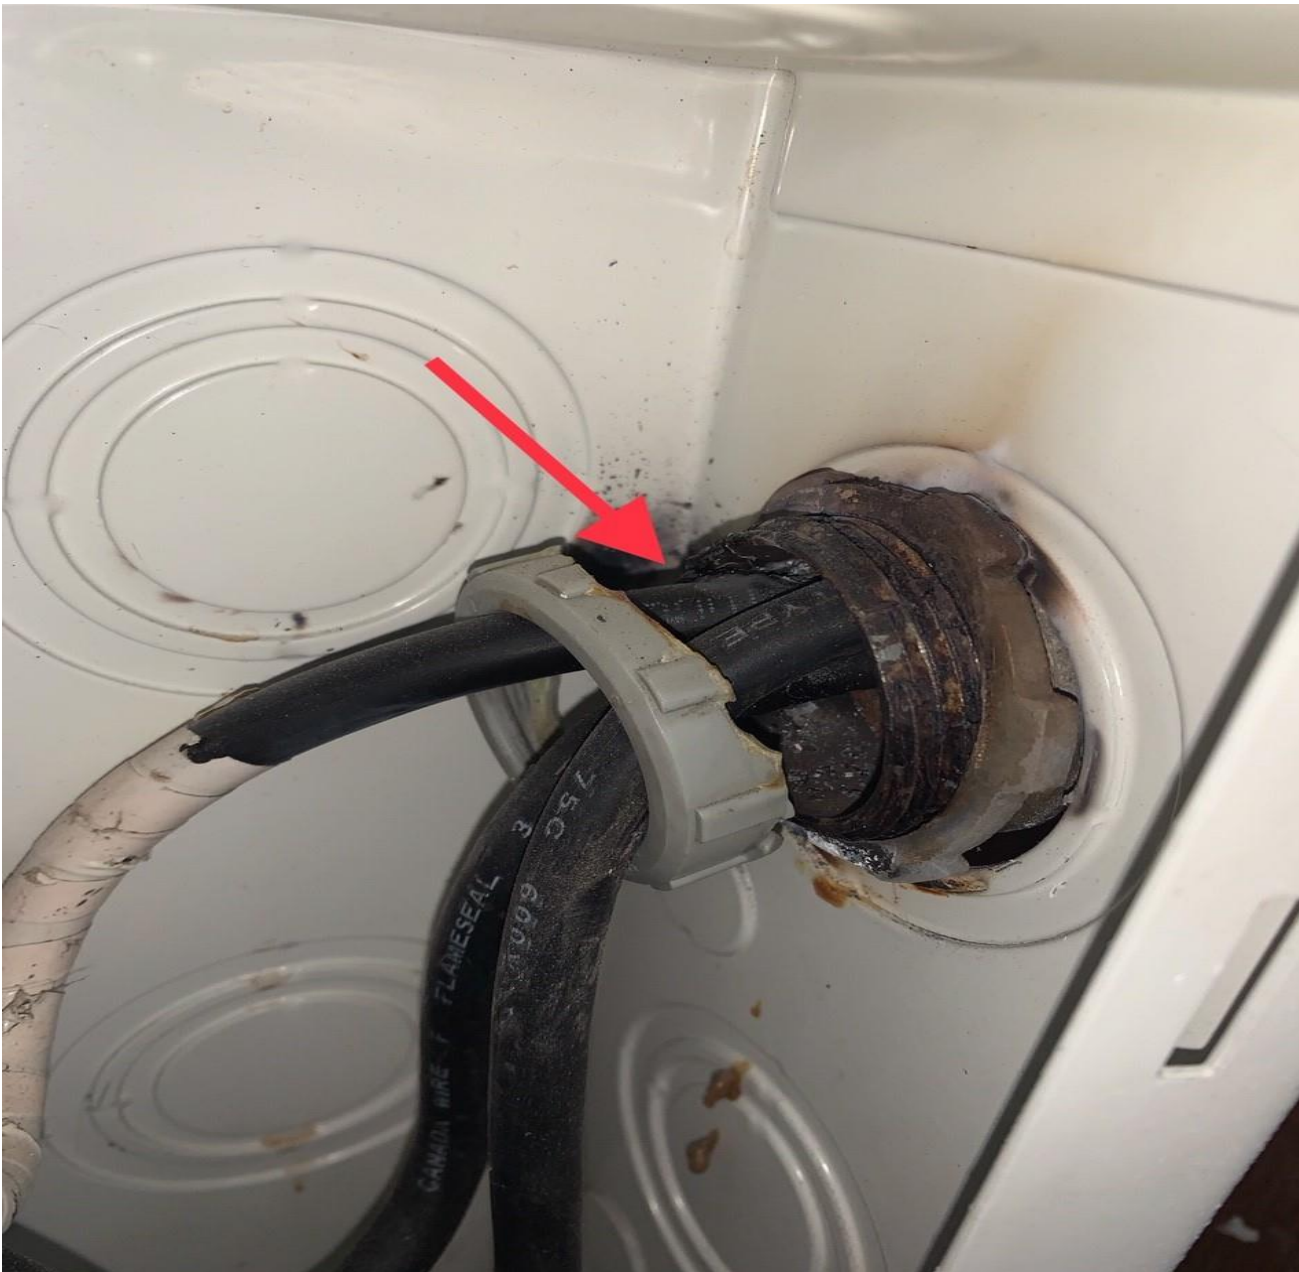
Picture #1 – Picture of when the service entrance section barrier was removed. Red arrow indicates where the damaged was to the ungrounded consumer service conductor shown in Picture #2 with a red arrow.

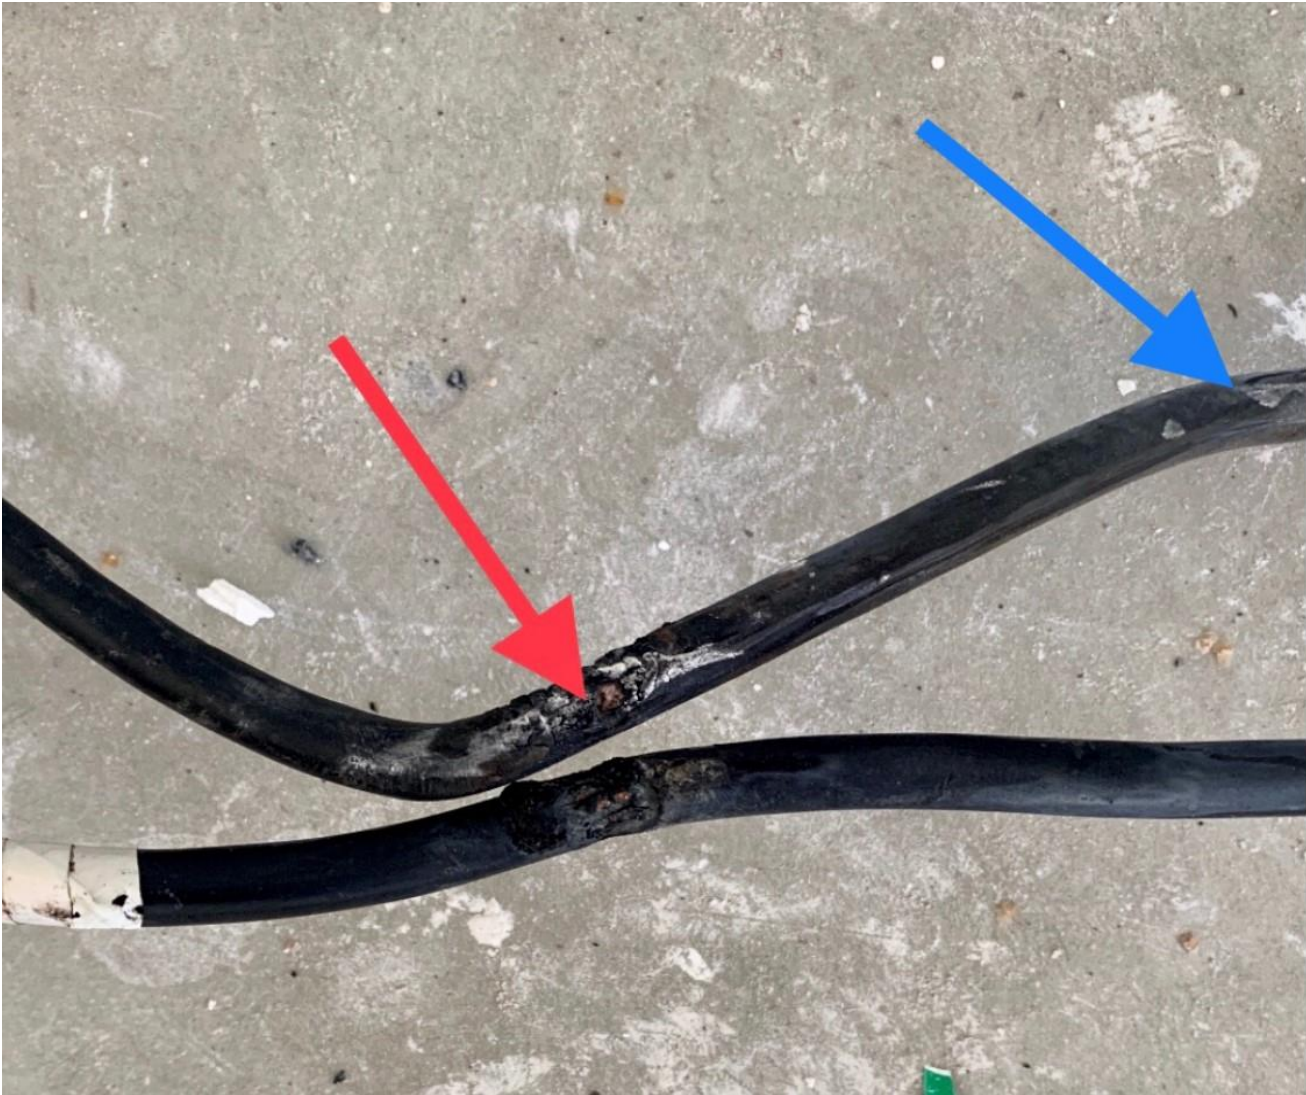
<p>Causes and contributing factors</p>	<p>It is likely that a break or damage to the consumer service conductor insulation exposed the bare copper conductor which made contact or came in close contact with the electrical metallic tubing raceway connector causing a fault.</p> <p>Due to the poor bonding connection made by the loose locknut and oversized knockout for the connector, the bare conductor and metal connector arced until the bonding path failed. This failure occurred before and without the supply utilities overcurrent protection clearing the fault.</p> <p>The conductors were possibly damaged during installation or when the panelboard may have been replaced. Movement or vibration due to the panelboard only being secured by one screw may have caused damage to the conductors.</p>

Picture #2 – Picture of the conductors after they were removed for the installation. Red arrow indicates the damage to the insulation of the ungrounded conductor where the fault occurred and the blue arrow is indicating other damage to the conductor's insulation.

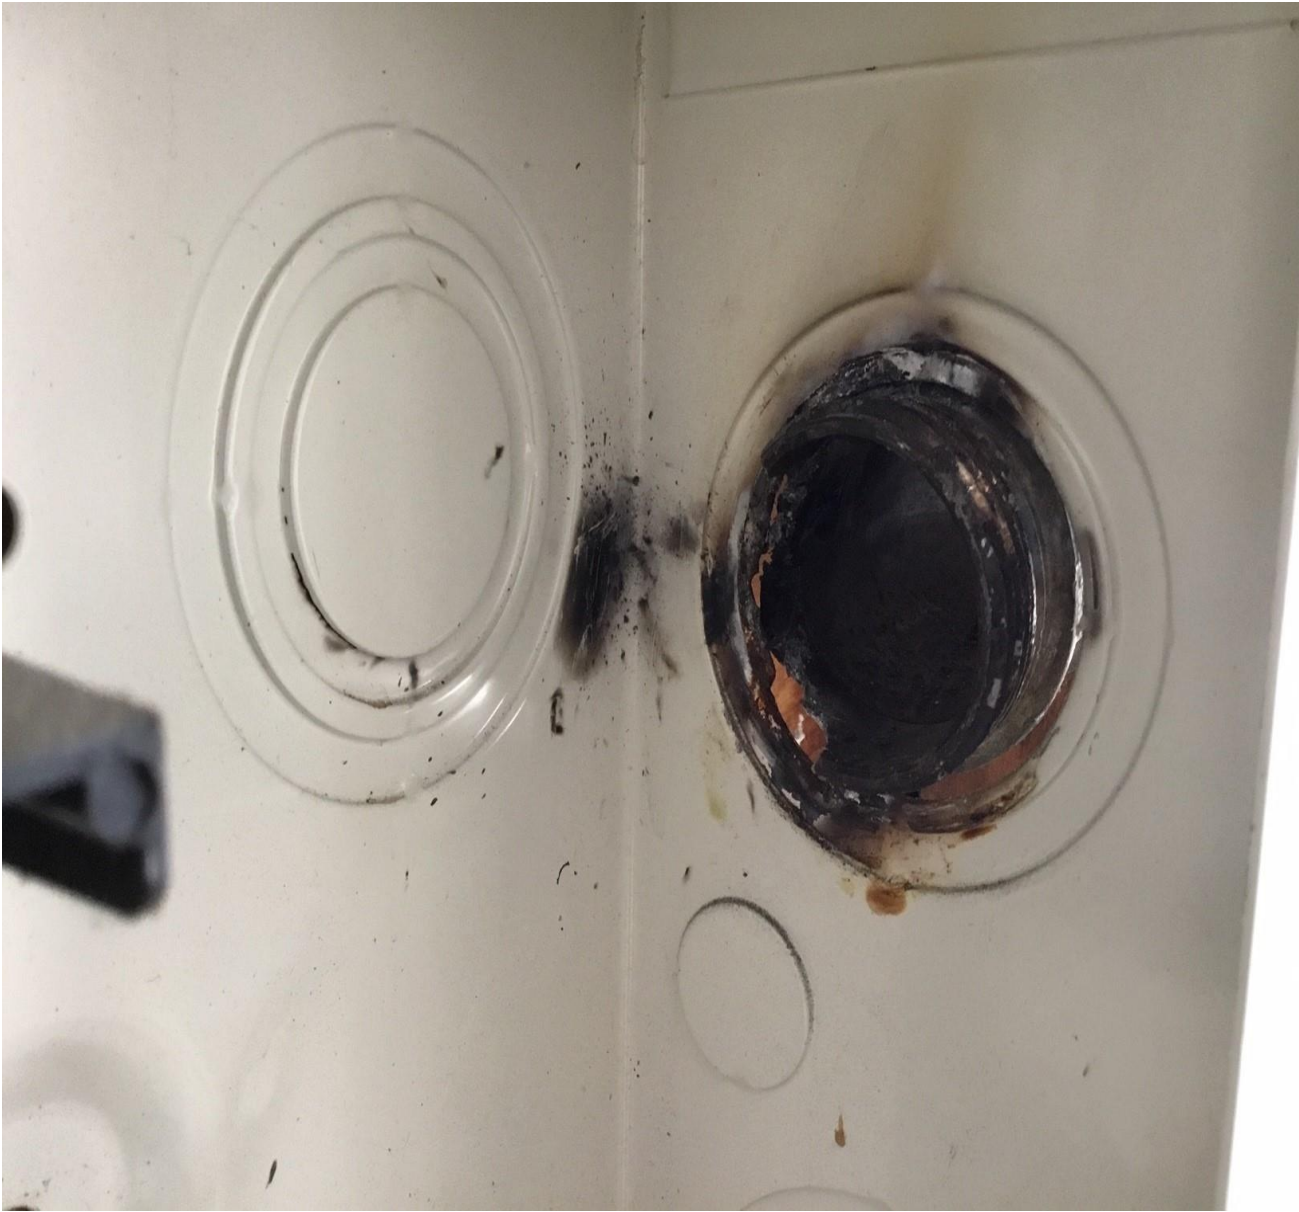
Picture #3 – Picture of the damage to the electrical metallic tubing connector after the conductors and lock nut were removed.

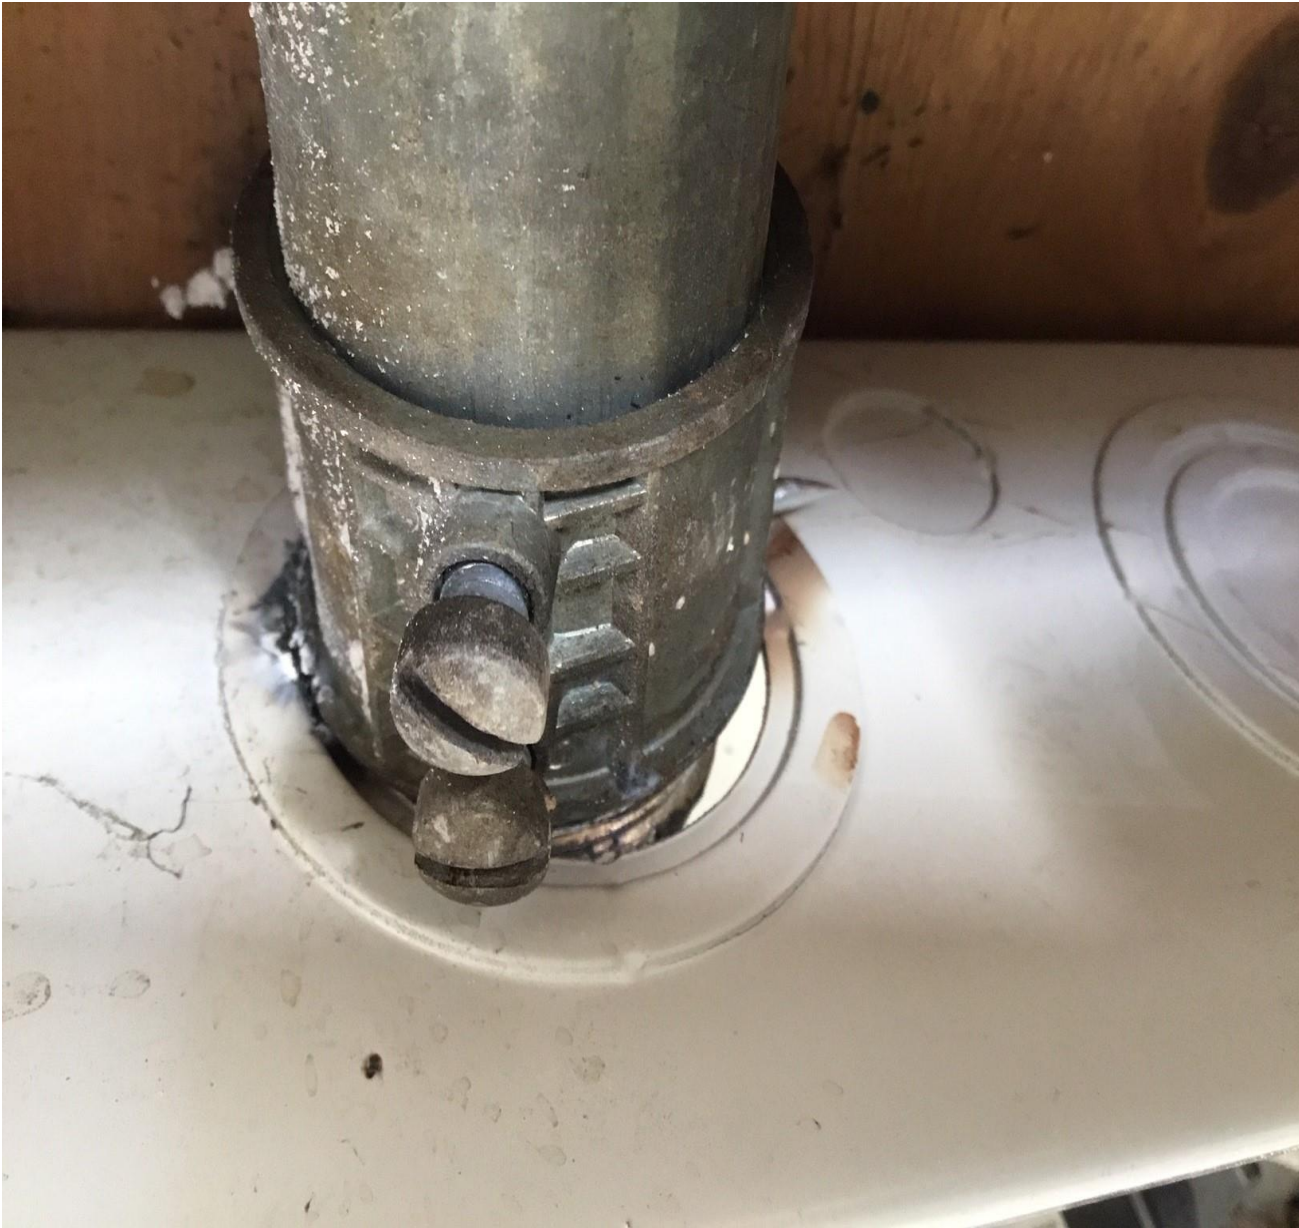
Picture #4 – Picture showing the knock out in the panelboard is oversized for the installed connector.

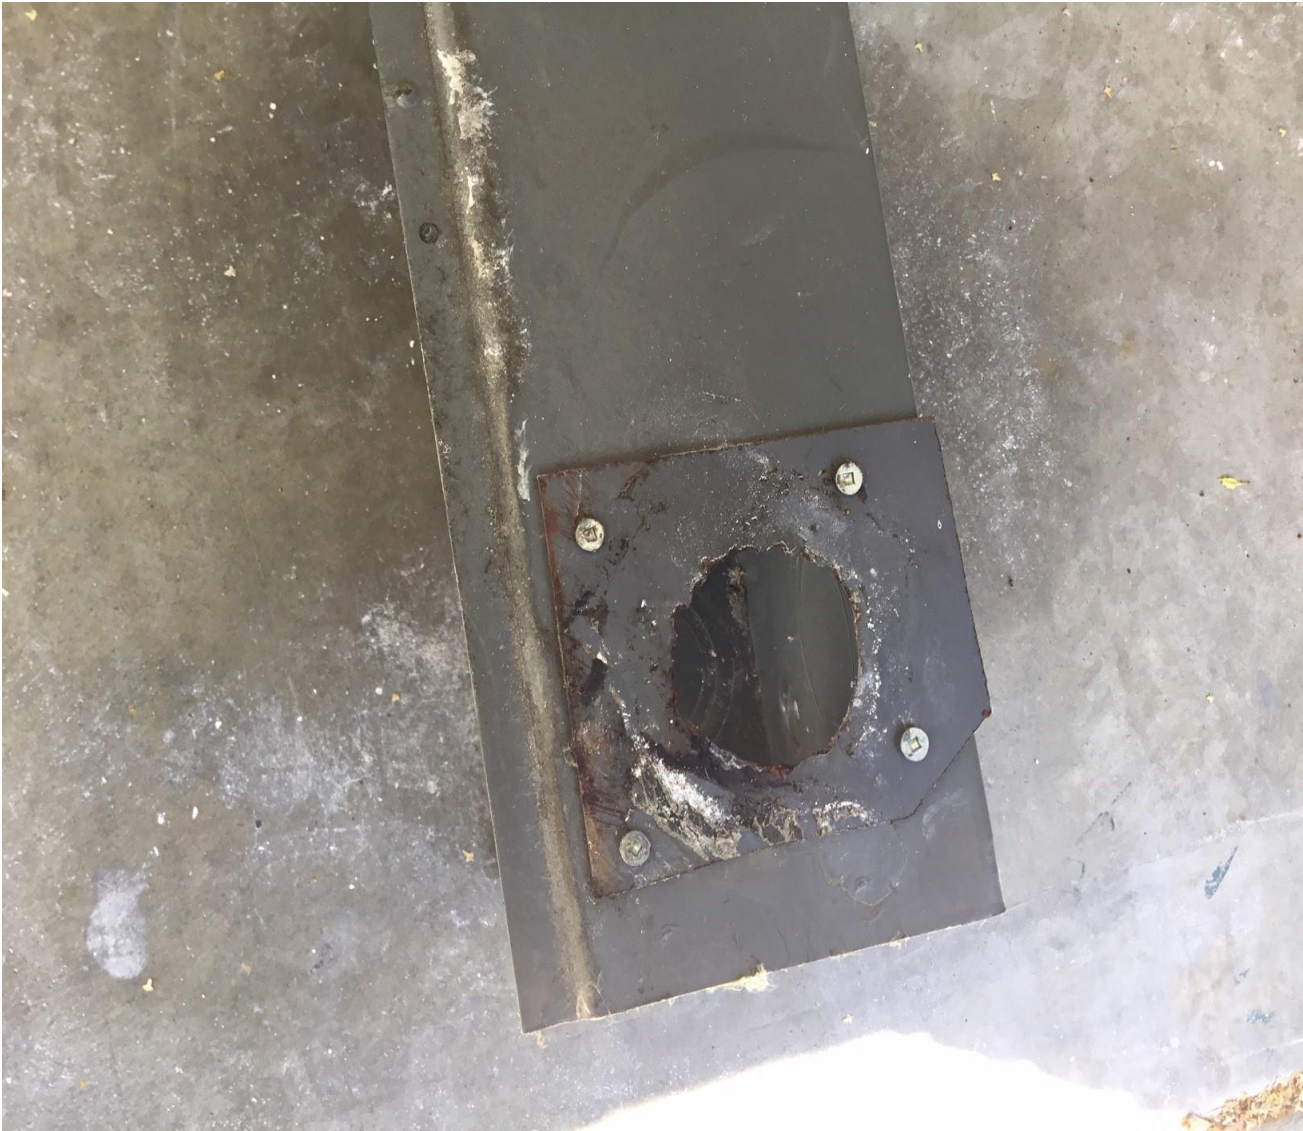
Picture #5 – Picture showing the alterations to the single meterbase.

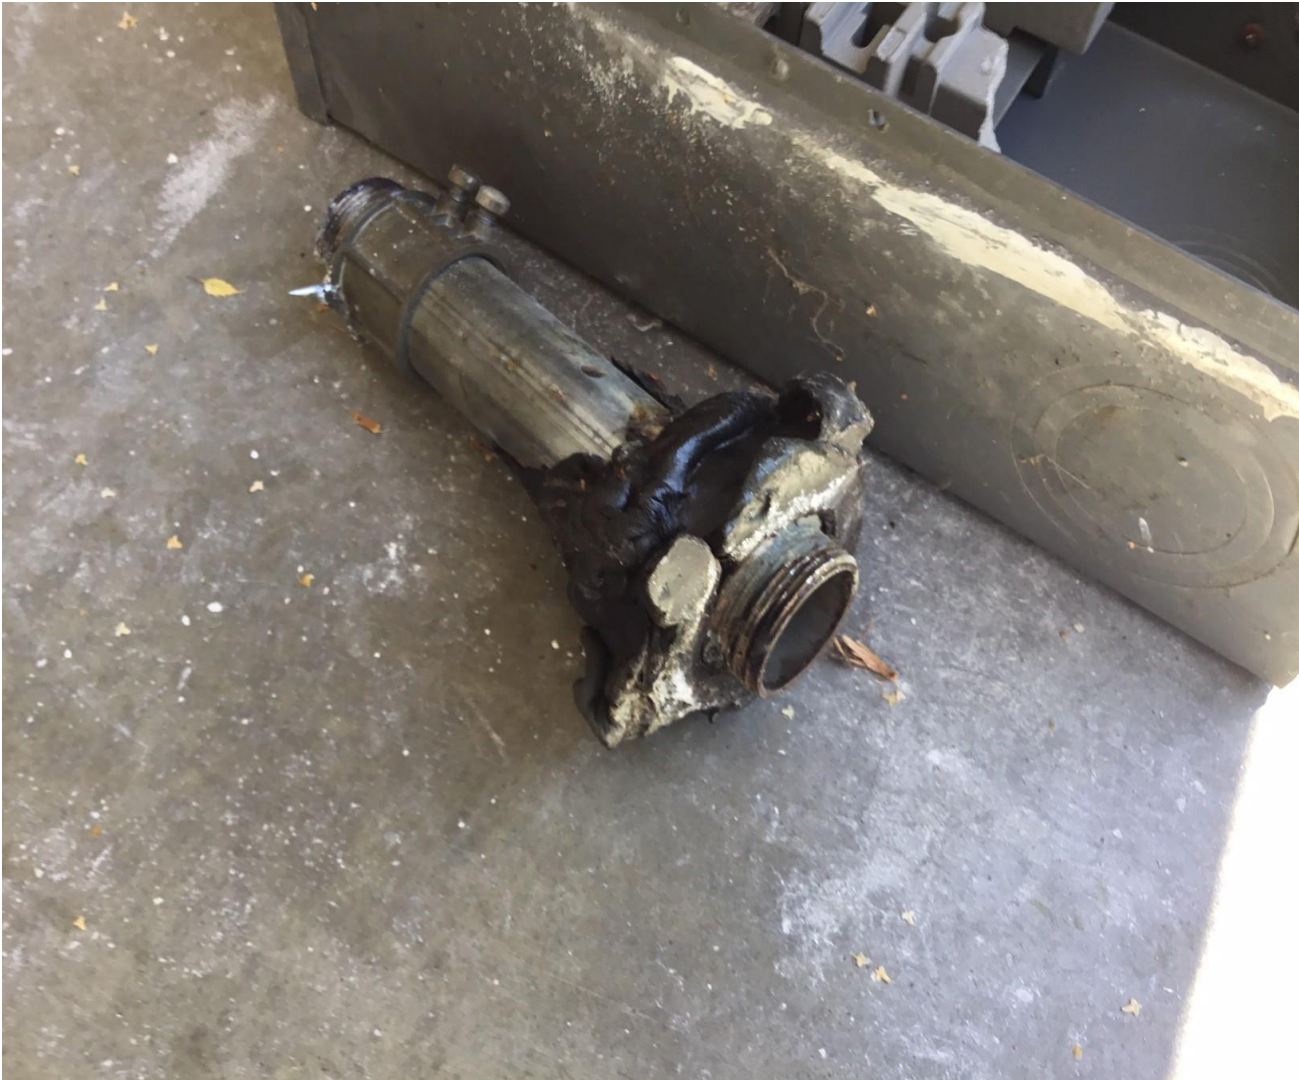
Picture #6 – Picture of the electrical metallic tubing raceway once it was removed showing the black sealant around the connector on the side that was entering into the meterbase.
