## Incident Summary (Reference #5610787) Final

SUPPORTING INFORMATION	Incident Date	January 18, 2017	
	Location	Lac La Hache	
	Regulated industry sector	Passenger ropeways, passenger conveyor	
	Impact	Qty injuries	1
		Injury description	Multiple compound fractures to both arms
		Injury rating	Major
		Damage description	NA
	Incident rating	Damage rating	None
			Major
	Incident overview	A maintenance worker (working temporarily alone) became entrapped with the rotating equipment of a tail section of a passenger conveyor for approximately 3 minutes until an assistant shut down the conveyor and extracted the maintenance worker by cutting the conveyor belting.	
INVESTIGATION CONCLUSIONS	Site, system and components	Figure 1 shows a basic illustration of the conveyor's tail section and components. The passenger conveyor tail pulley is located at the bottom end of the conveyor (tail section) within a boxed heavy gauge (10 GA) steel sheet metal enclosure. The tail drum for this unit also acts to maintain tension and alignment of the conveyor belt.

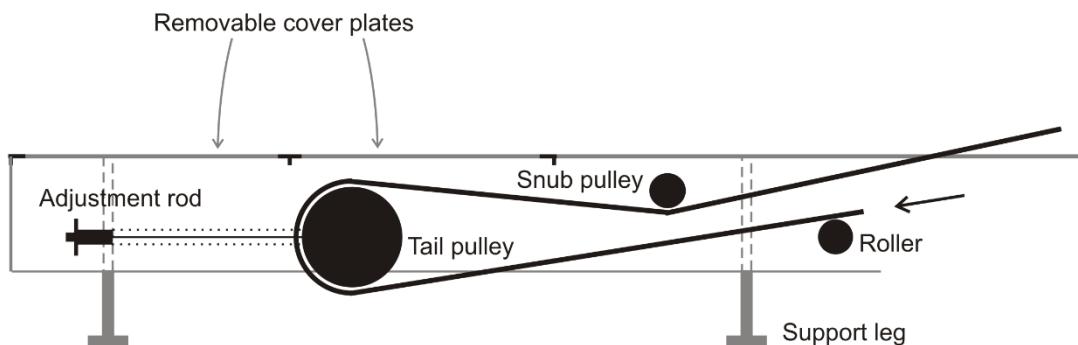
Figure 1: Illustration of the conveyor tail unit and components

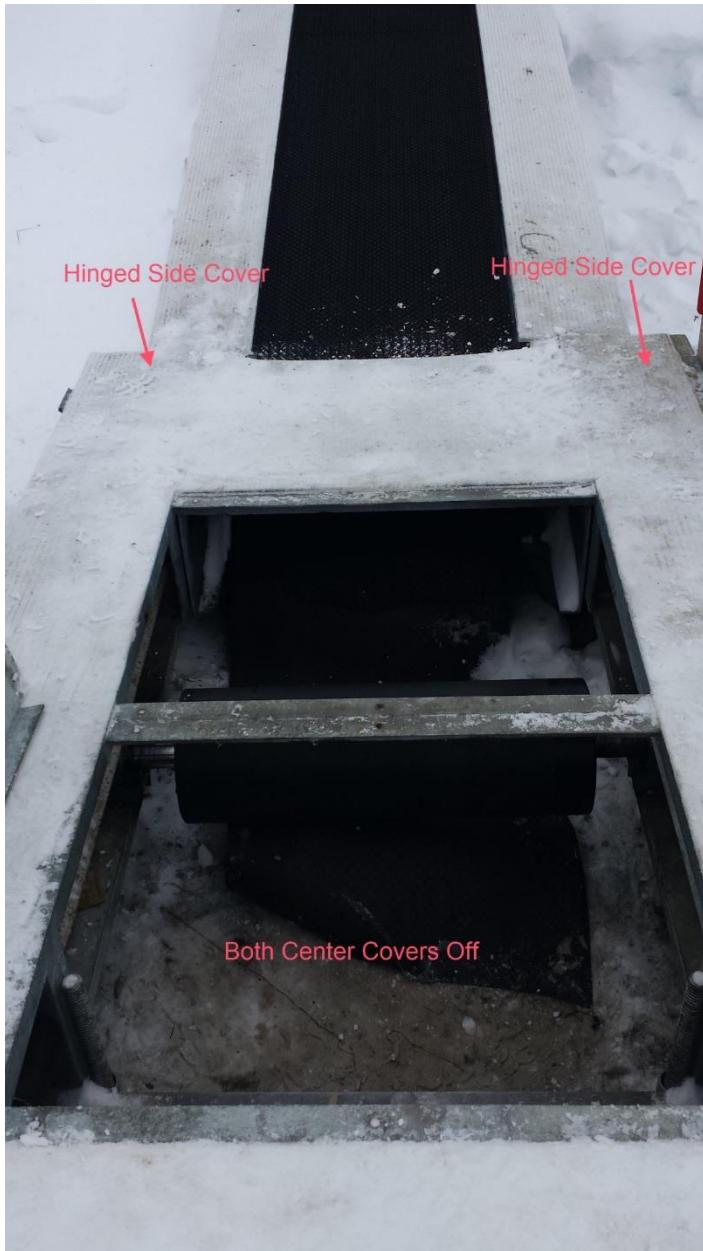
Figure 2: Photograph of the conveyor tail unit without the centre cover plates. The hinged side covers are closed and covered with some snow.

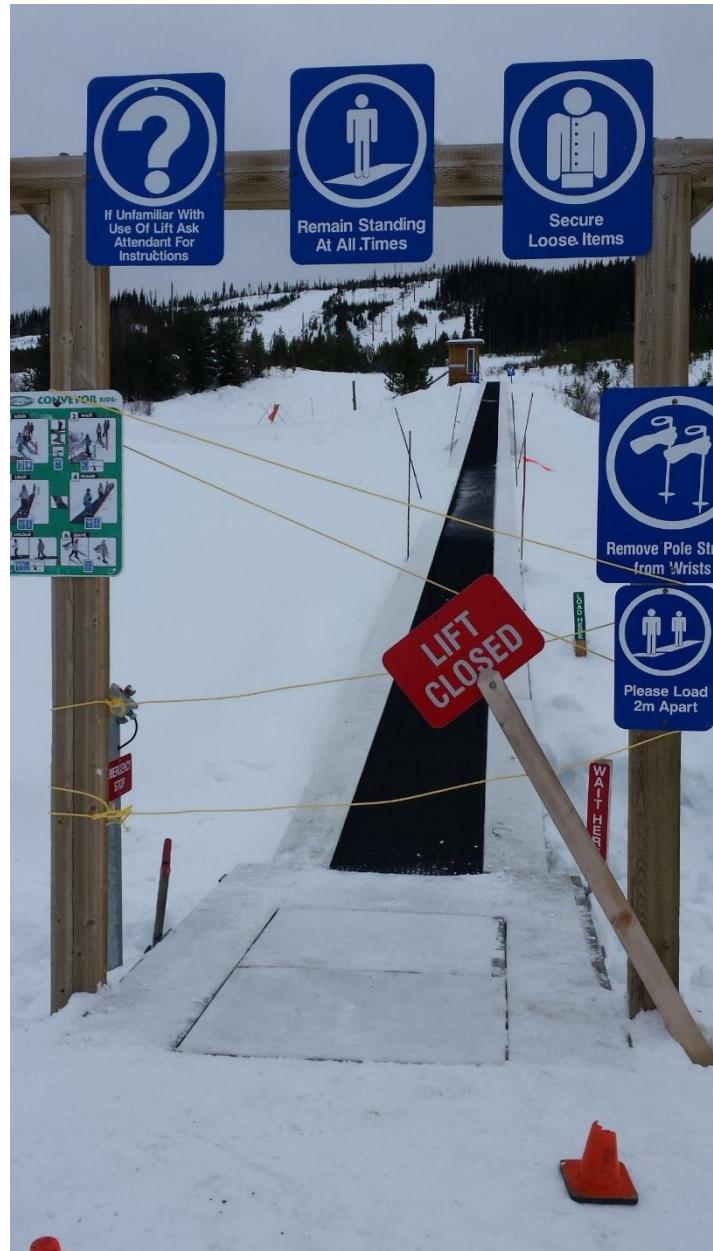
Figure 3: Photograph of the conveyor tail unit with the centre cover plates.
