Incident Summary #II-1672589-2024 (#44258) (FINAL)

SUPPORTING INFORMATION	Incident Date	February 11, 2024	
	Location	Oliver, B.C.	
	Regulated industry sector	Gas - Propane system	
	Impact	Qty injuries	0
		Injury description	N/A
		Injury rating	None
	Damage	Damage description	Flame and smoke damage to Recreational Vehicle (RV) which was a complete loss.
		Damage rating	Major
	Incident rating	Major	
Incident overview	A propane refrigerator was being used on the electric setting in an RV continuously for several years. Suddenly it stopped working. Within a day it was switched to propane and worked for a few more days. It then ignited in the RV causing a fire and smoke damage.		
INVESTIGATION CONCLUSIONS	Site, system and components	<p>The sealed system of an RV refrigerator holds:</p> <ul style="list-style-type: none"> • Water • Liquid ammonia • Hydrogen gas <p>A propane flame heats the water and ammonia to its boiling point in what is called the generator. The gaseous ammonia then rises into a condensing chamber where it cools and returns to a liquid state creating the cooling action of the refrigerator.</p> <p>The RV refrigerator can be operated using propane fuel or they also have

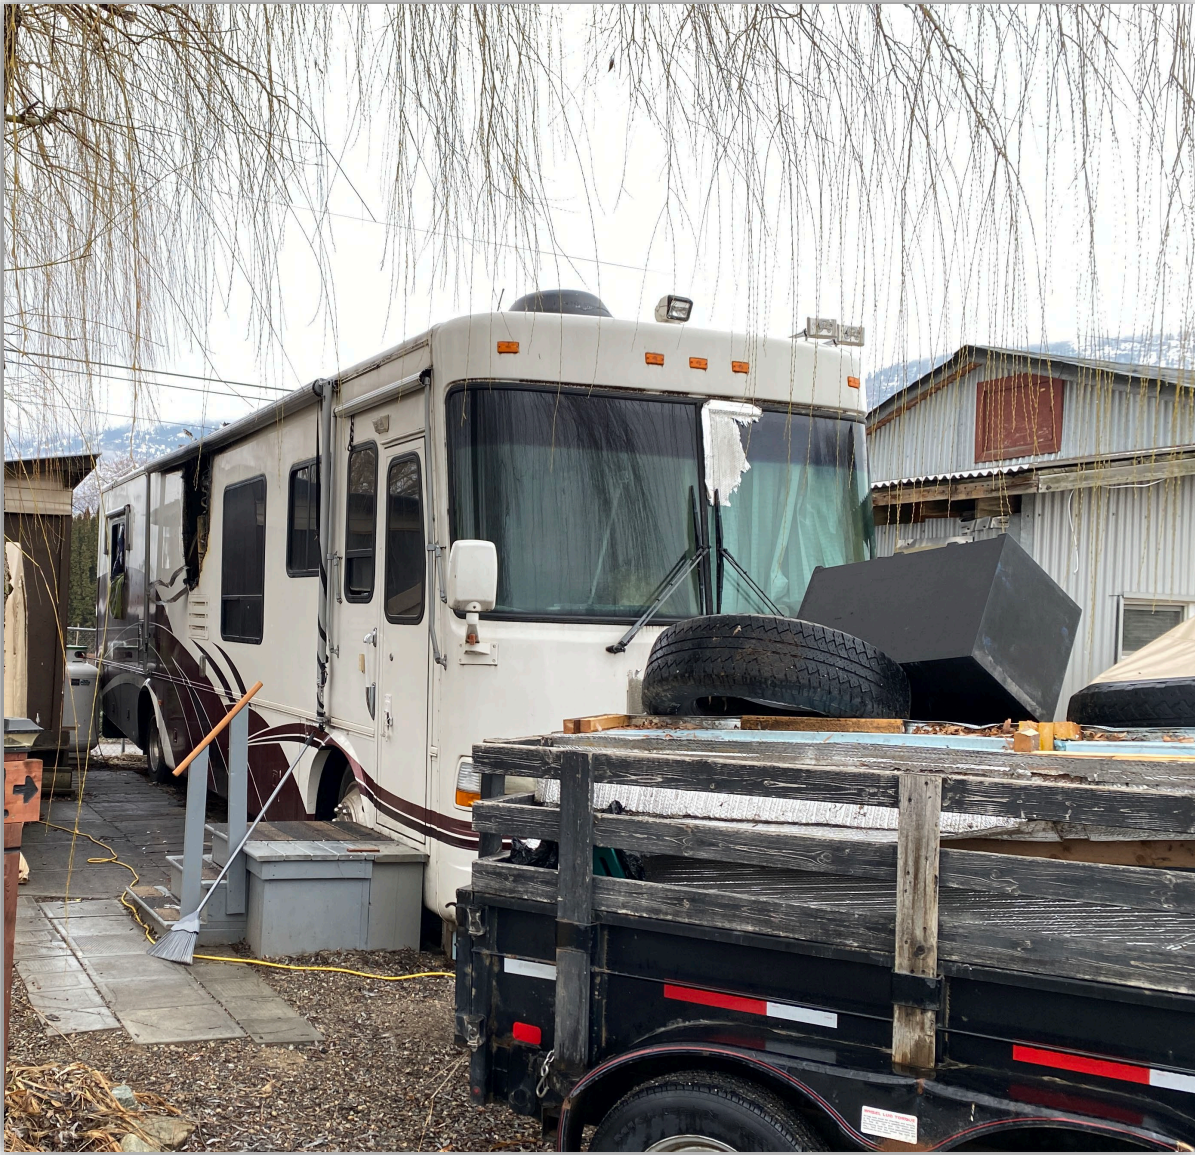
Image 1 - Incident scene at time of investigation.

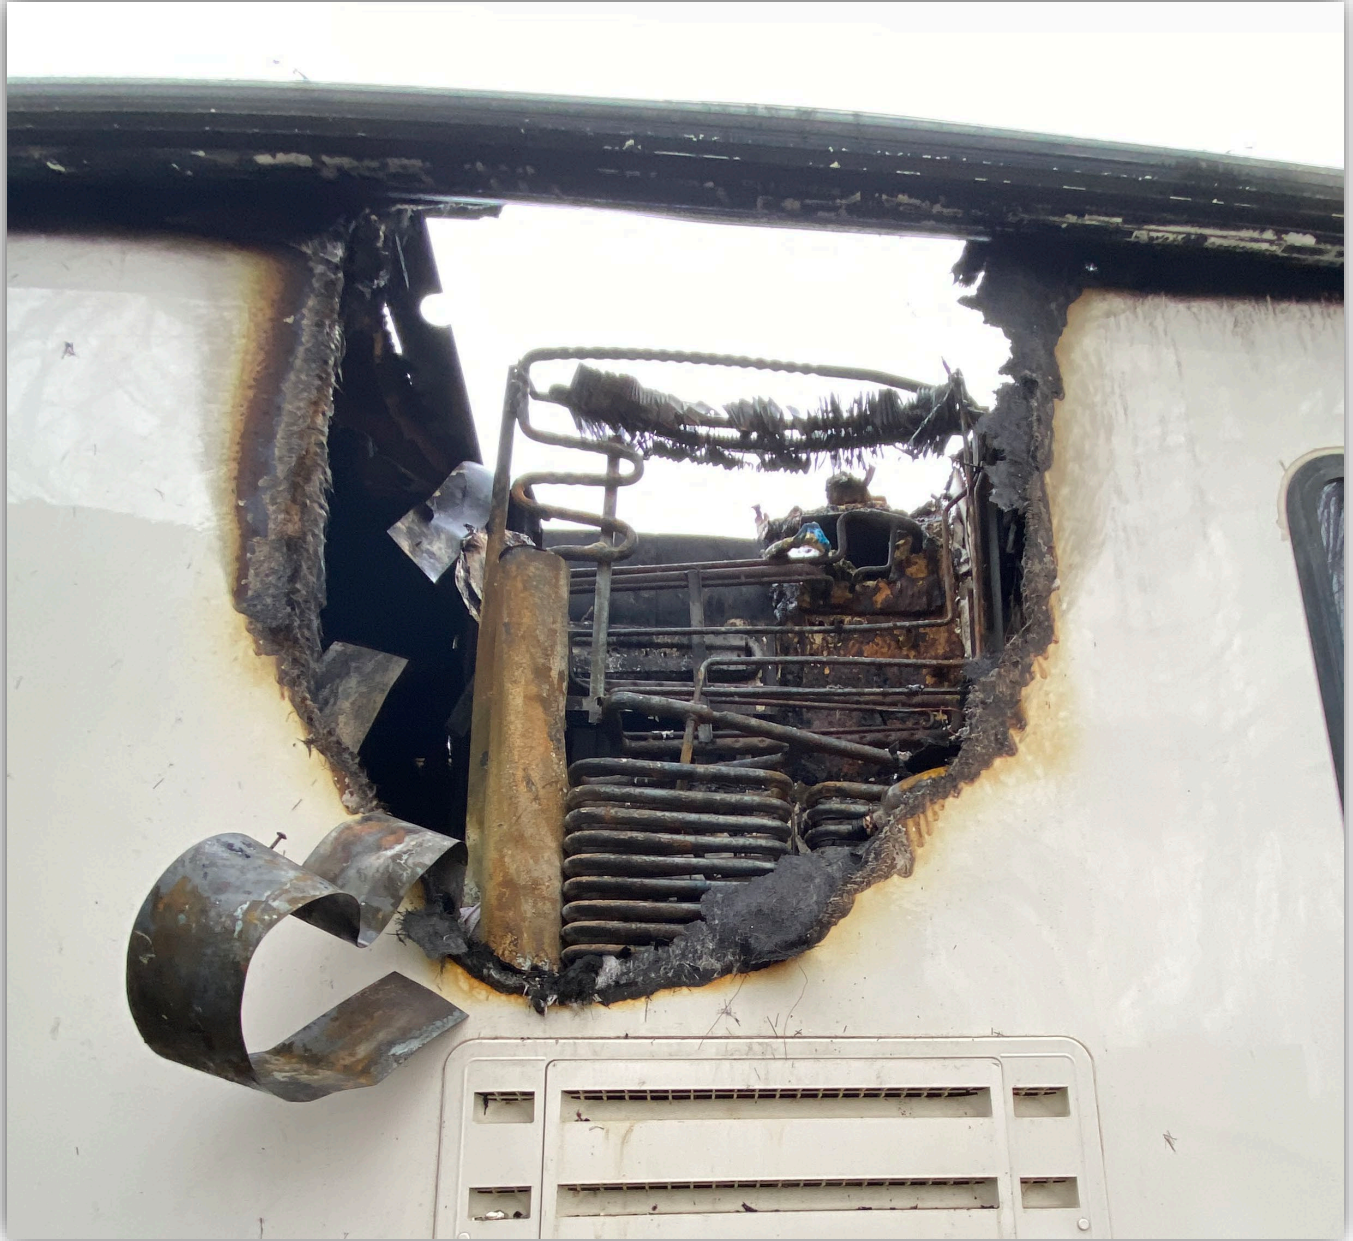
Image 2 - Exterior of the RV where the fire occurred.

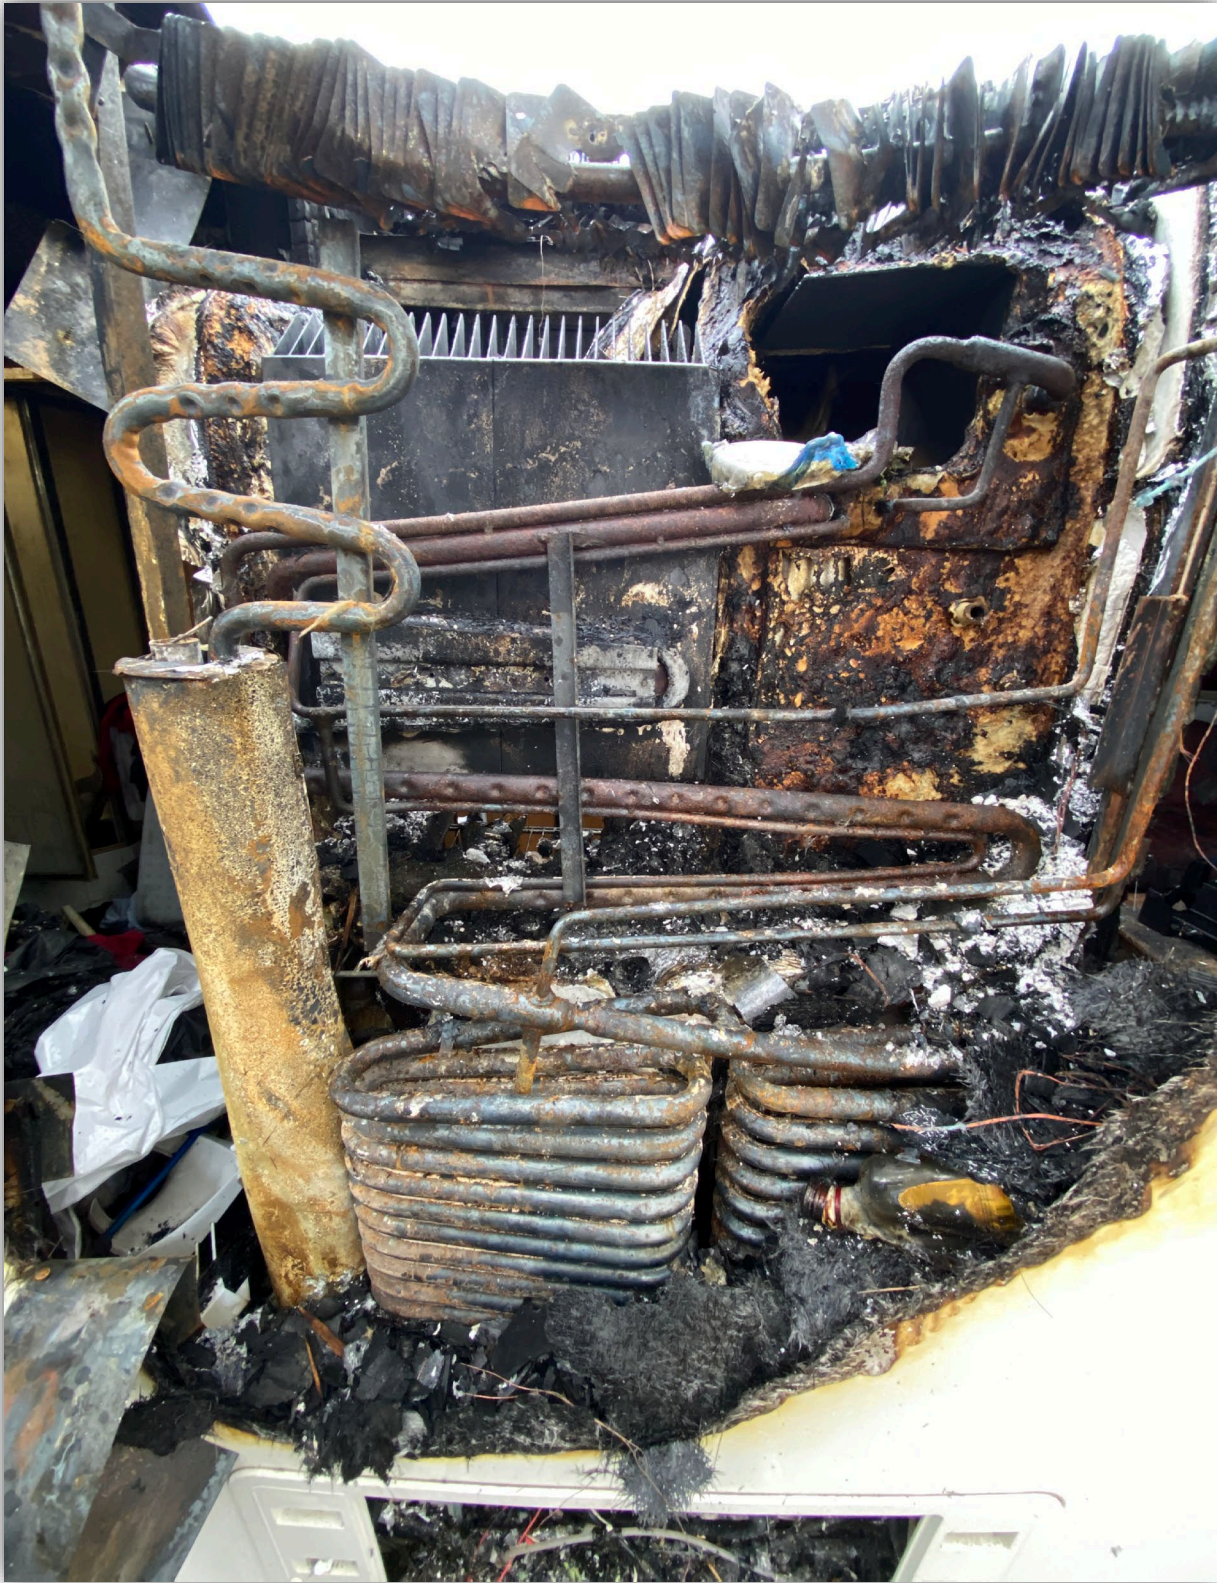
Image 3 - Rear of the fridge at time of investigation.

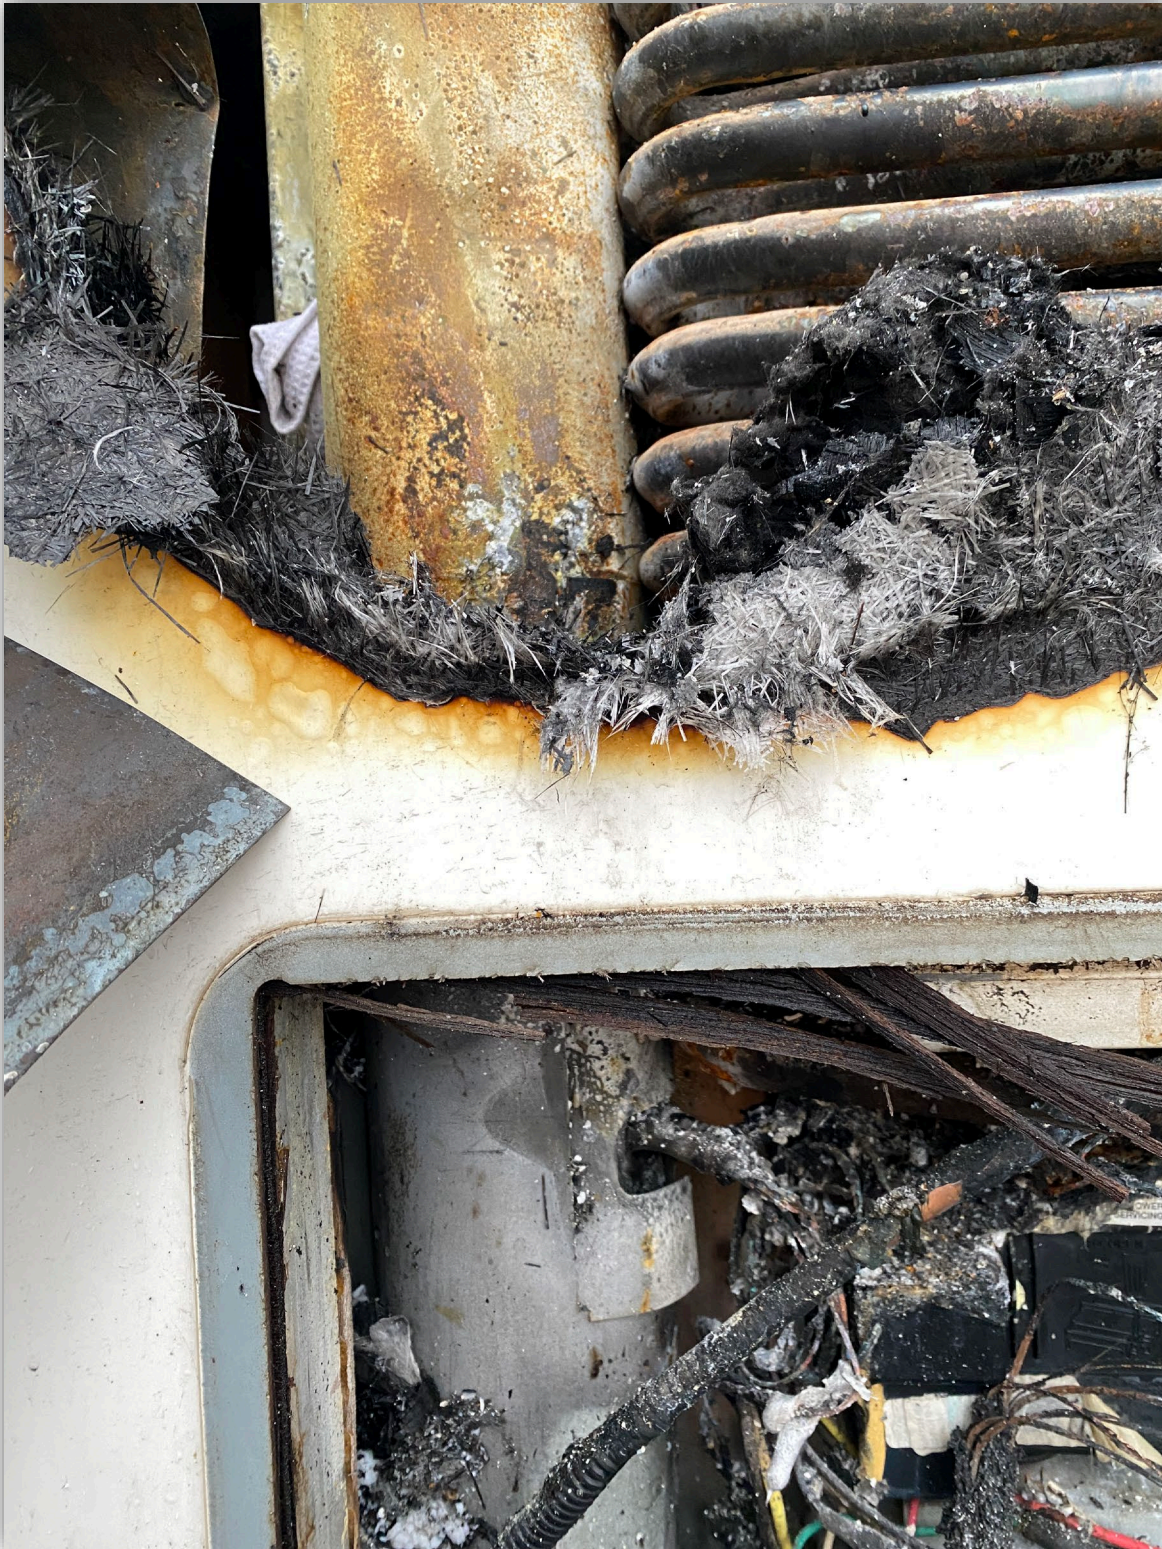
Image 4 - The combustion chamber of the fridge. Note the difference in the colors of the metal due to flame exposure. Flame patterns indicate a "V" style burn with the base of the "V" indicating the origin of the fire.

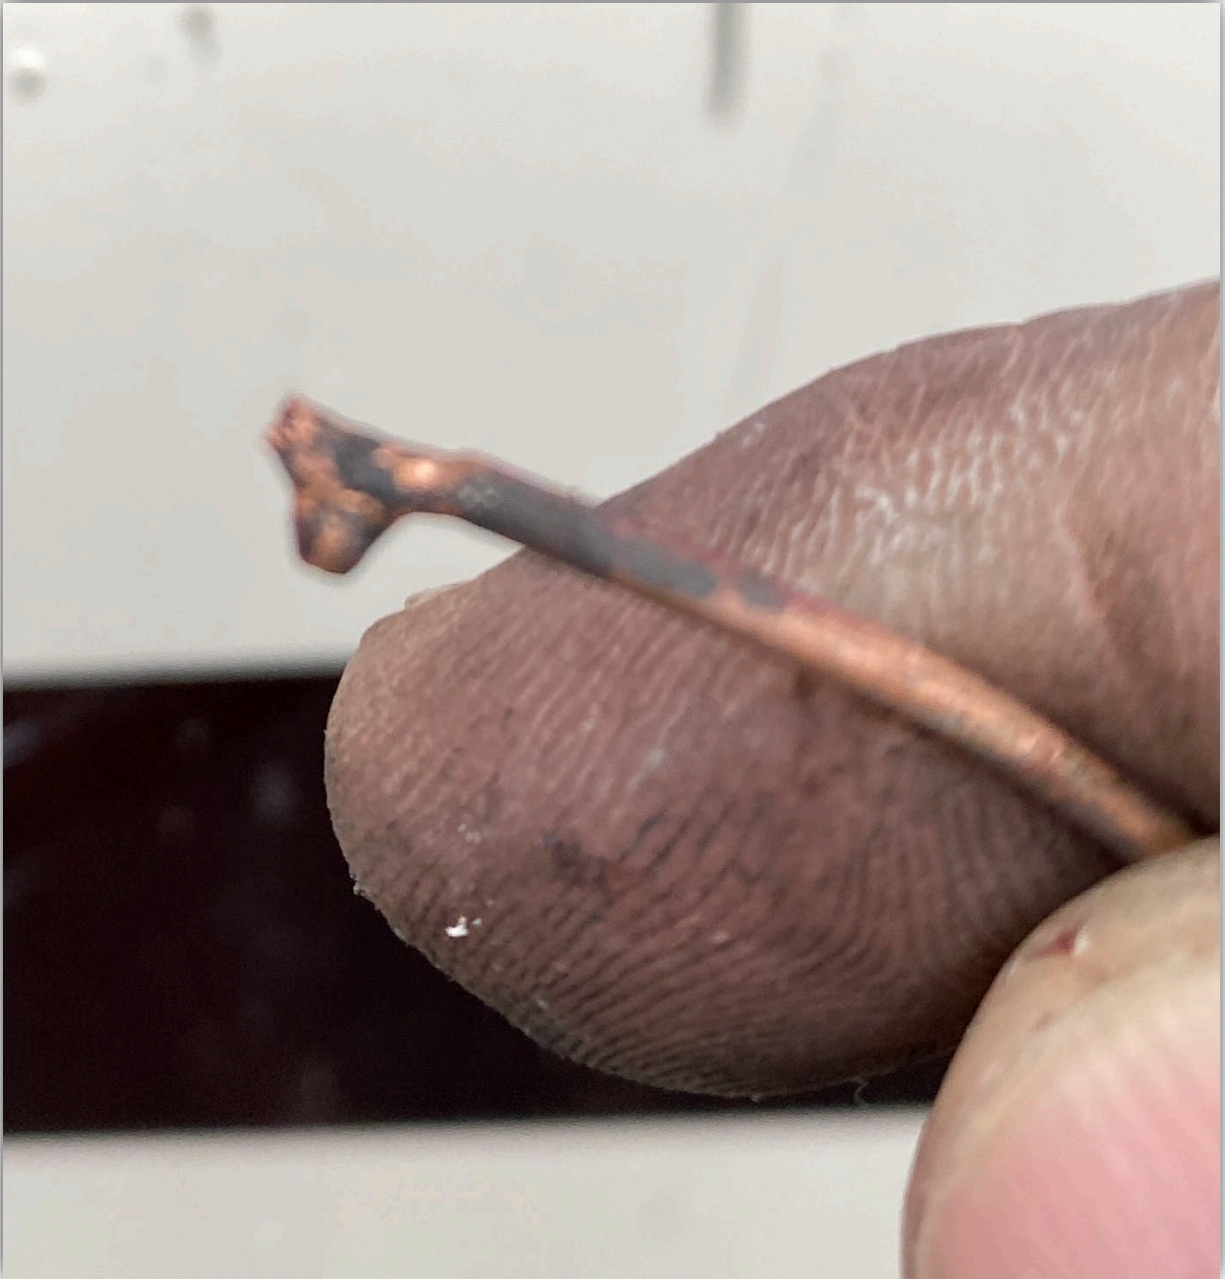
<p>Causes and contributing factors</p>	<p>It is highly probable that wire routing tight to the combustion chamber of the refrigerator over time allowed the heat of the combustion chamber to melt through the loom around the wire and the insulation around the conductor to melt.</p> <p>The bare wire came in contact with the combustion chamber of the fridge, causing an arc which blew a hole in the side of the combustion chamber. The escaping products of combustion eventually lit the side of the RV on fire causing the fire.</p>

Image 6 - Area on wire that it is believed to have come in contact with combustion chamber. Note deformation from heat caused by arcing.

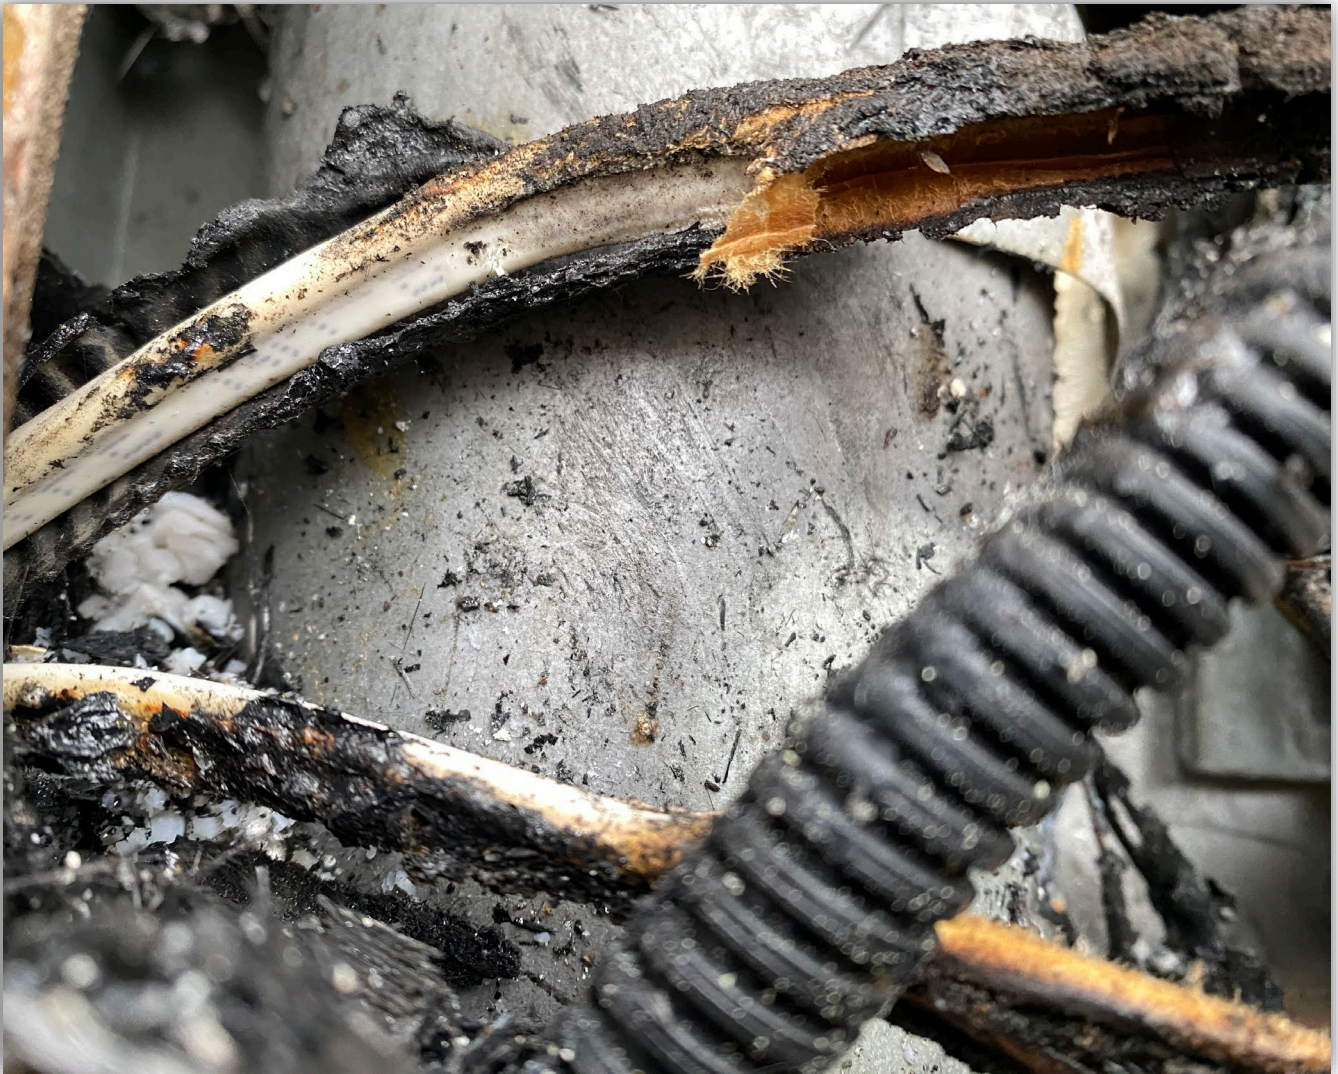
Image 7 - Exposed insulation of wire that was found to be in contact with the combustion chamber, showing that it was not low voltage wire in contact with the combustion chamber. This shows that the electrical potential would have been enough to cause the hole in the combustion chamber.

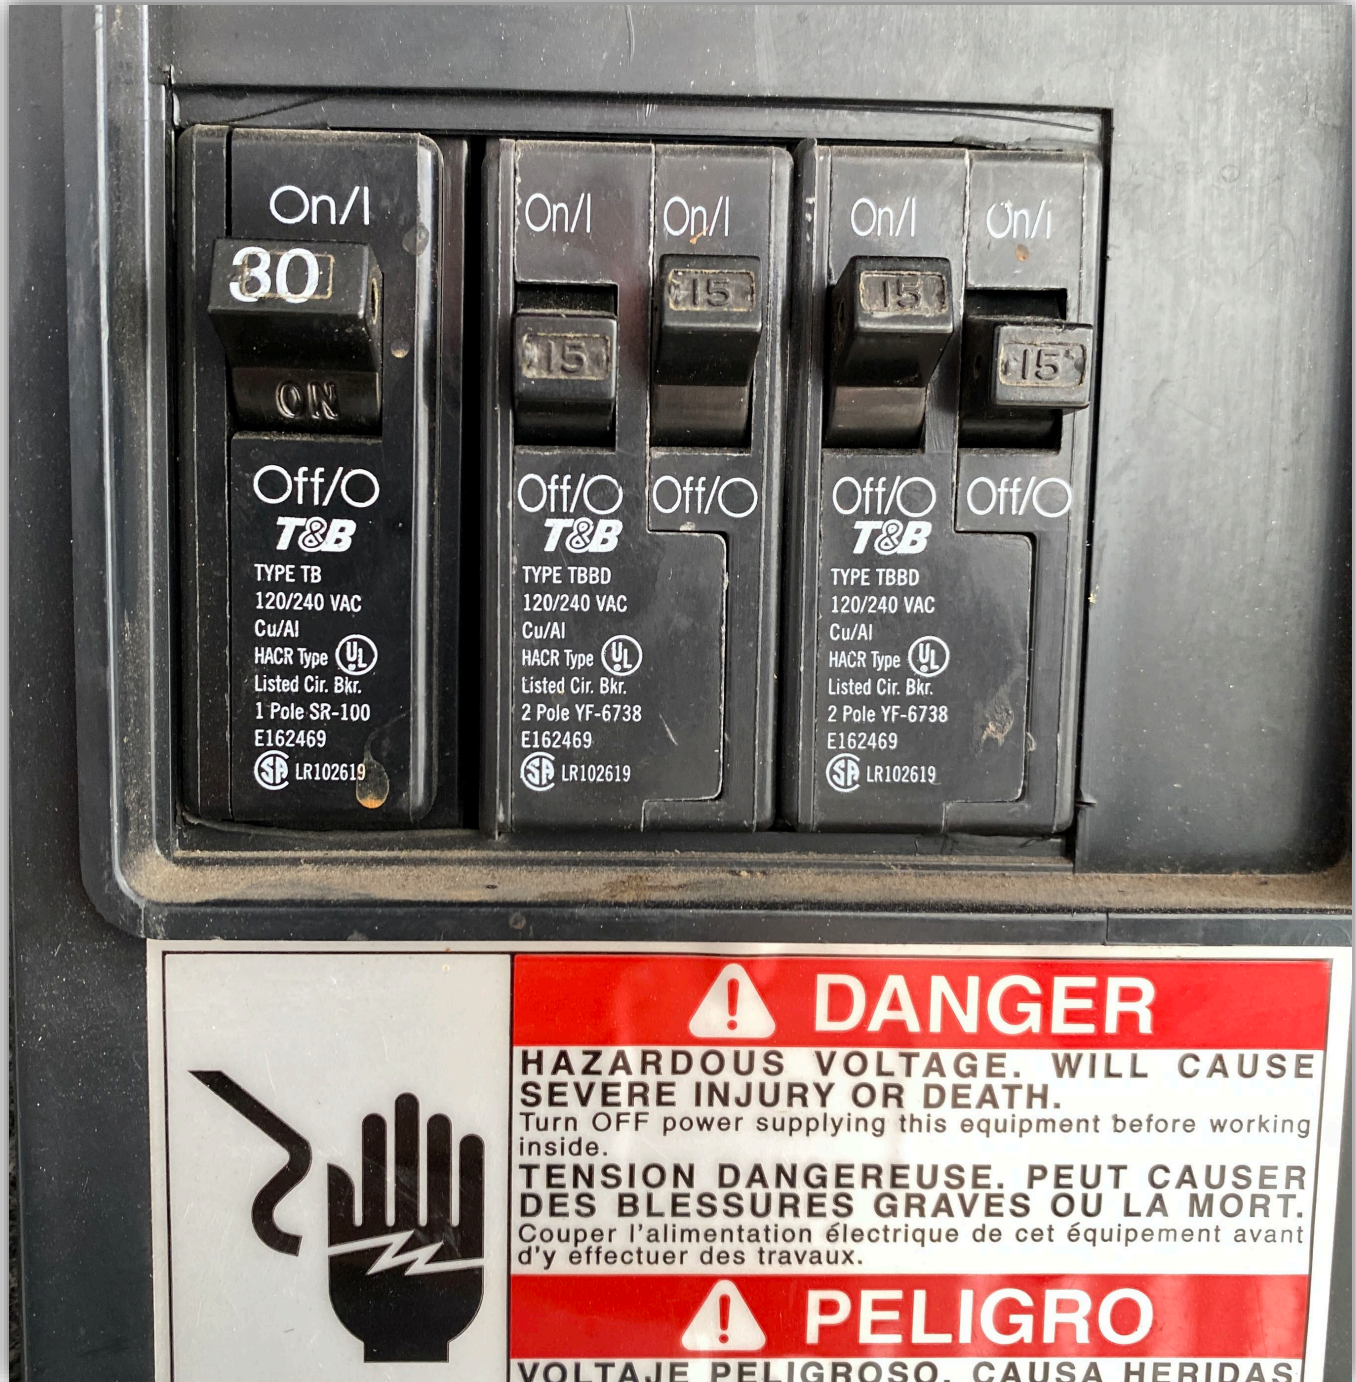
Image 8 - Breaker panel showing first, and fourth 15-amp breakers tripped.

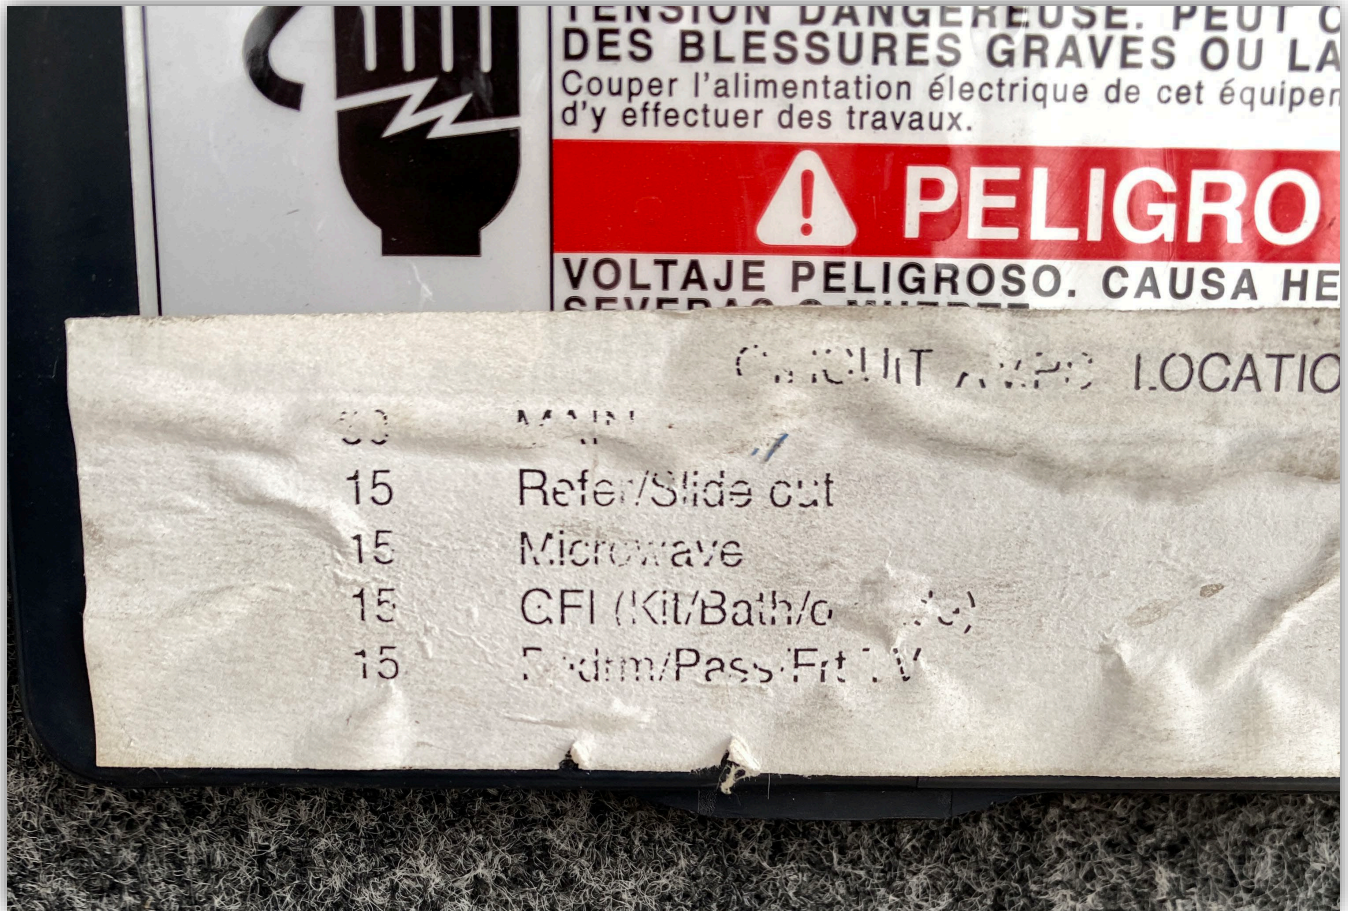
Image 9 - Breaker panel directory indicating the first 15-amp breaker served the fridge, and the fourth 15 amp breaker served the plug which served the wire that came in contact with the combustion chamber of the fridge.
