Incident Summary #II-1588204-2023 (#37431) (FINAL)

SUPPORTING INFORMATION	Incident Date	August 3, 2023	
	Location	Lower Mainland North	
	Regulated industry sector	Amusement Devices - Zip line	
	Impact	Qty injuries	1
		Injury description	A blunt force trauma injury to a zipline rider's left leg resulting in severe bleeding.
		Injury rating	Major
	Damage	Damage description	Physical damage to a metal rolling staircase including a bent rail and stairs.
		Damage rating	Moderate
	Incident rating	Major	
Incident overview	A rider on a zipline struck a metal rolling staircase used to lower riders to the ground at the landing platform.		
INVESTIGATION CONCLUSIONS	Site, system and components	<p>Zipline</p> <ul style="list-style-type: none"> The facility consists of four ziplines that all run with tandem parallel lines so two riders can ride at the same time in parallel with each other. Riders meet at basecamp, go through a safety briefing and demonstration, then take a 15-minute off-road ride to the first zipline. Portions of the four ziplines travel over 300 meters above the ground, some are over one kilometer long and riders can reach speeds up to 100 kilometers per hour (kph). Riders are

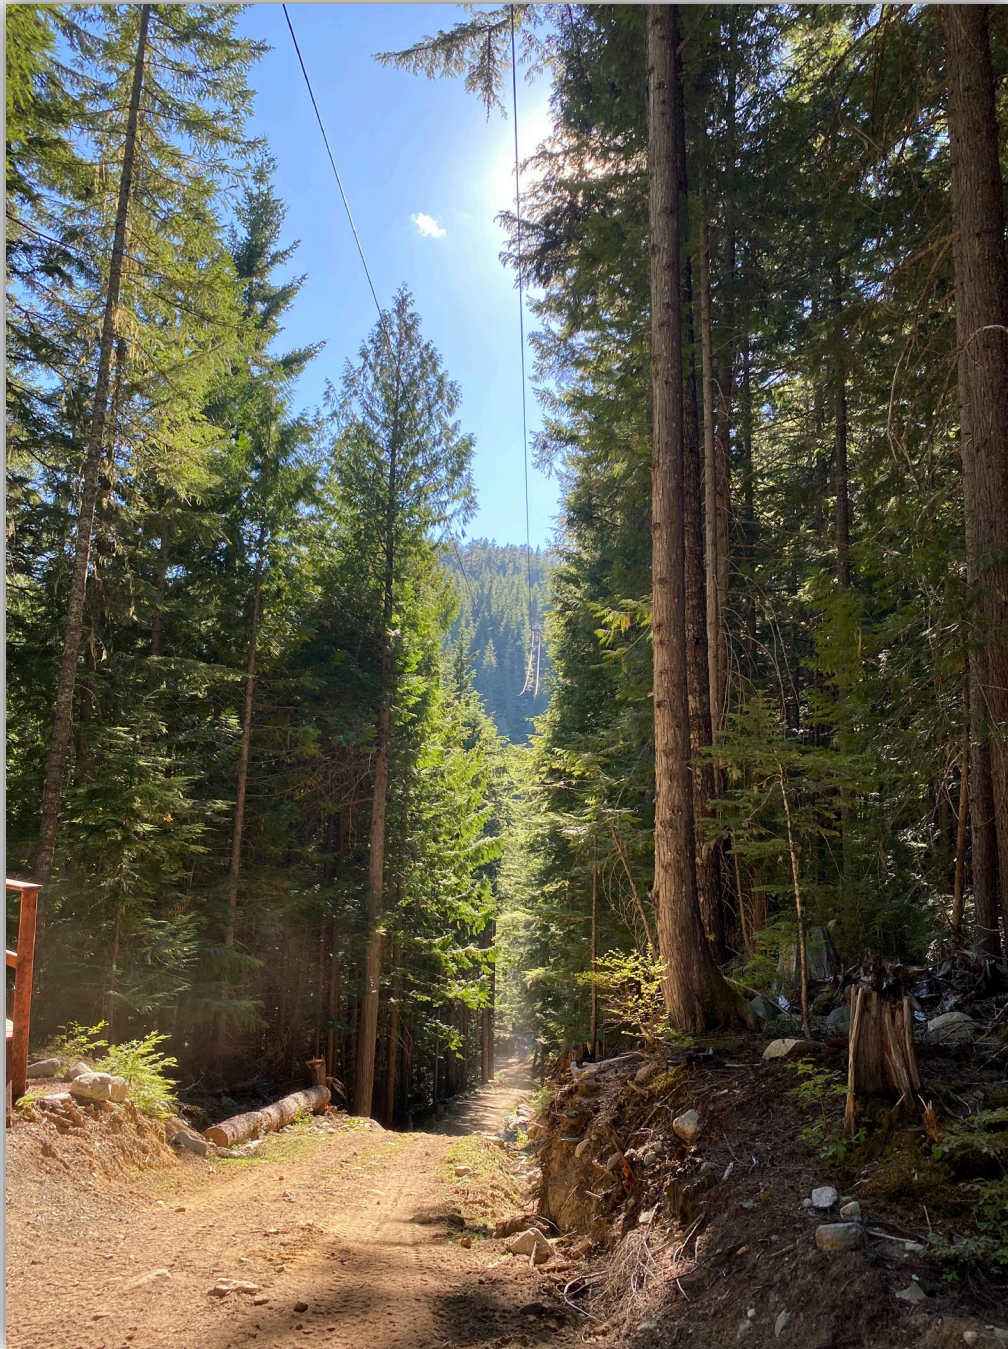
Image 3 – View of the third zipline from below.

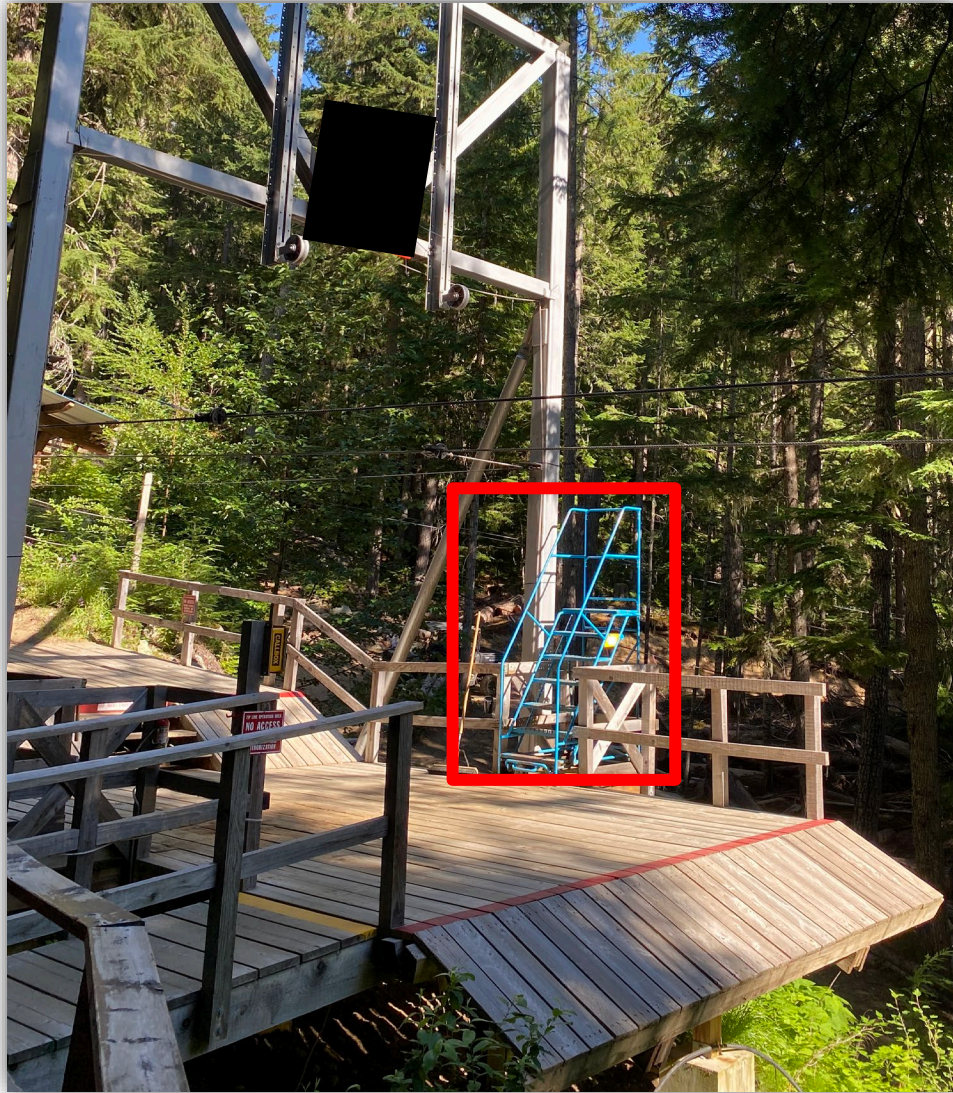
Image 4 – The third zipline’s landing platform. [RED] Blue rolling staircase in the safe stored location on the rider’s right side.

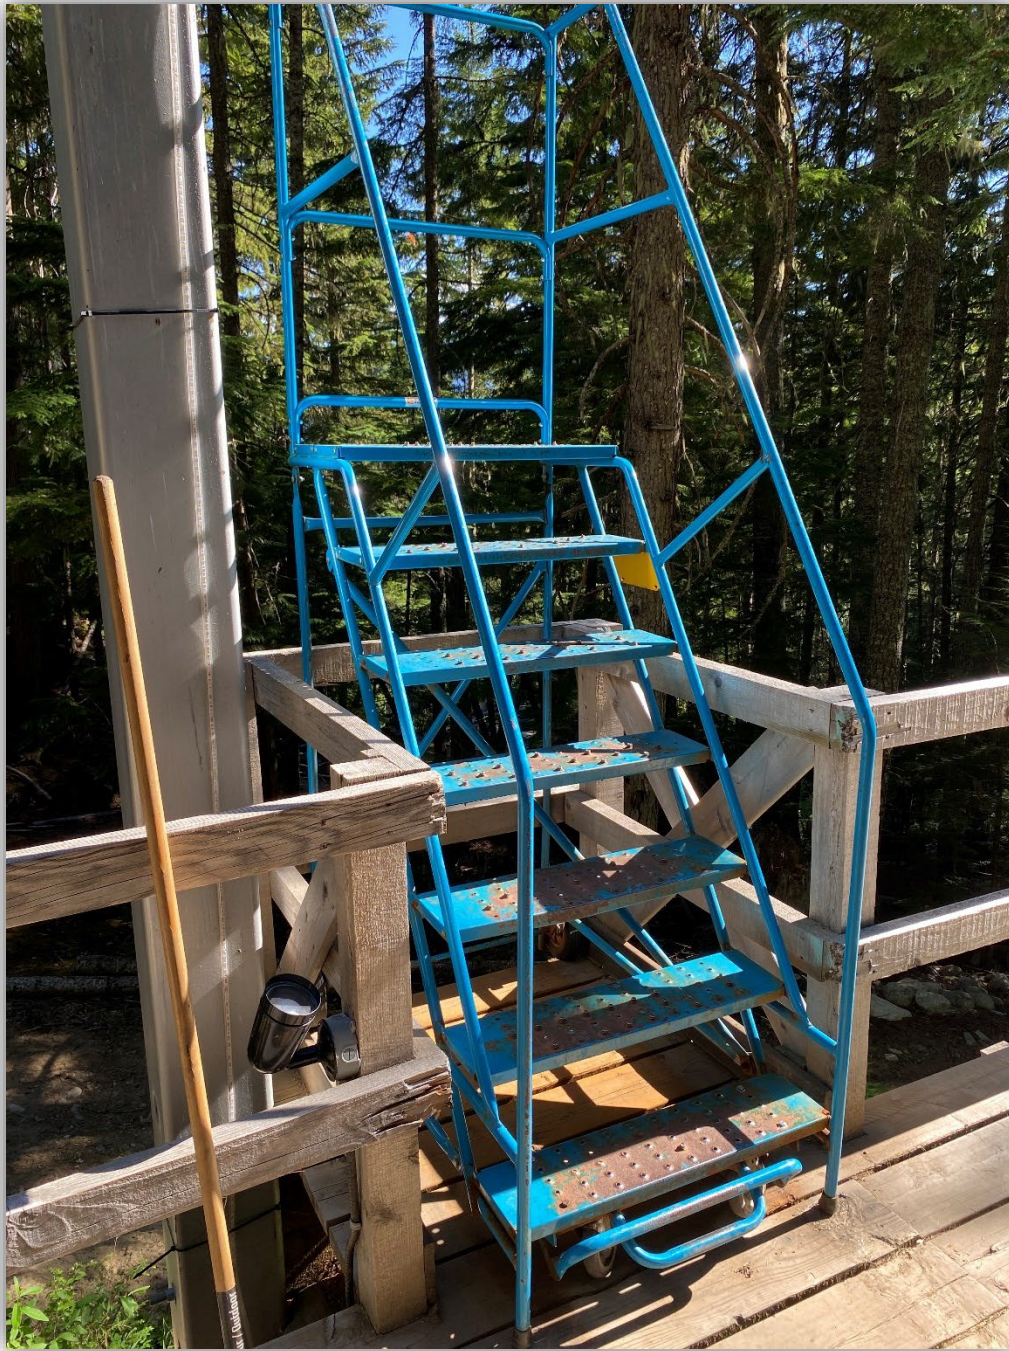
Image 6 – Rolling staircase placed in the stowed storage location out of the path of the riders.

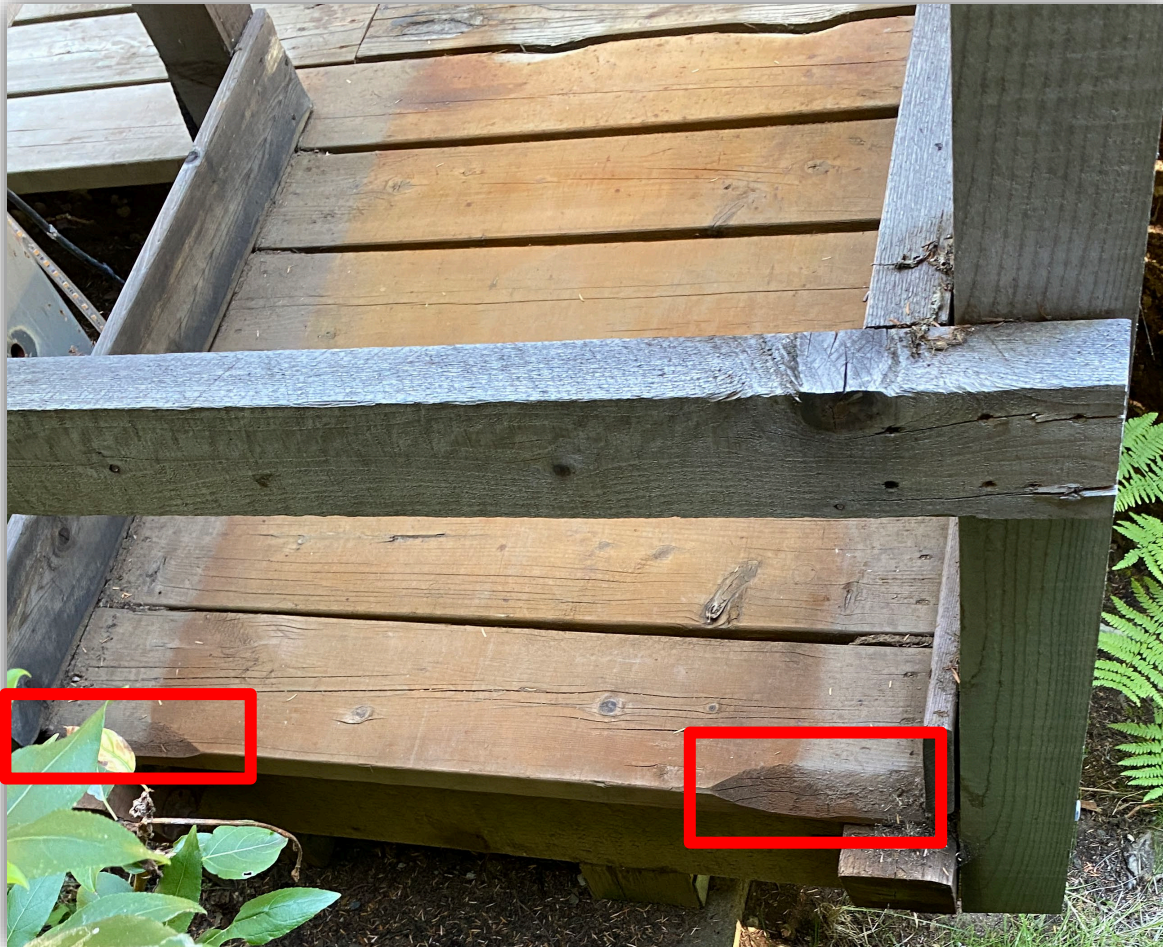
Image 7 – Staircase storage location with beveled edges [RED] for capturing staircase wheels.

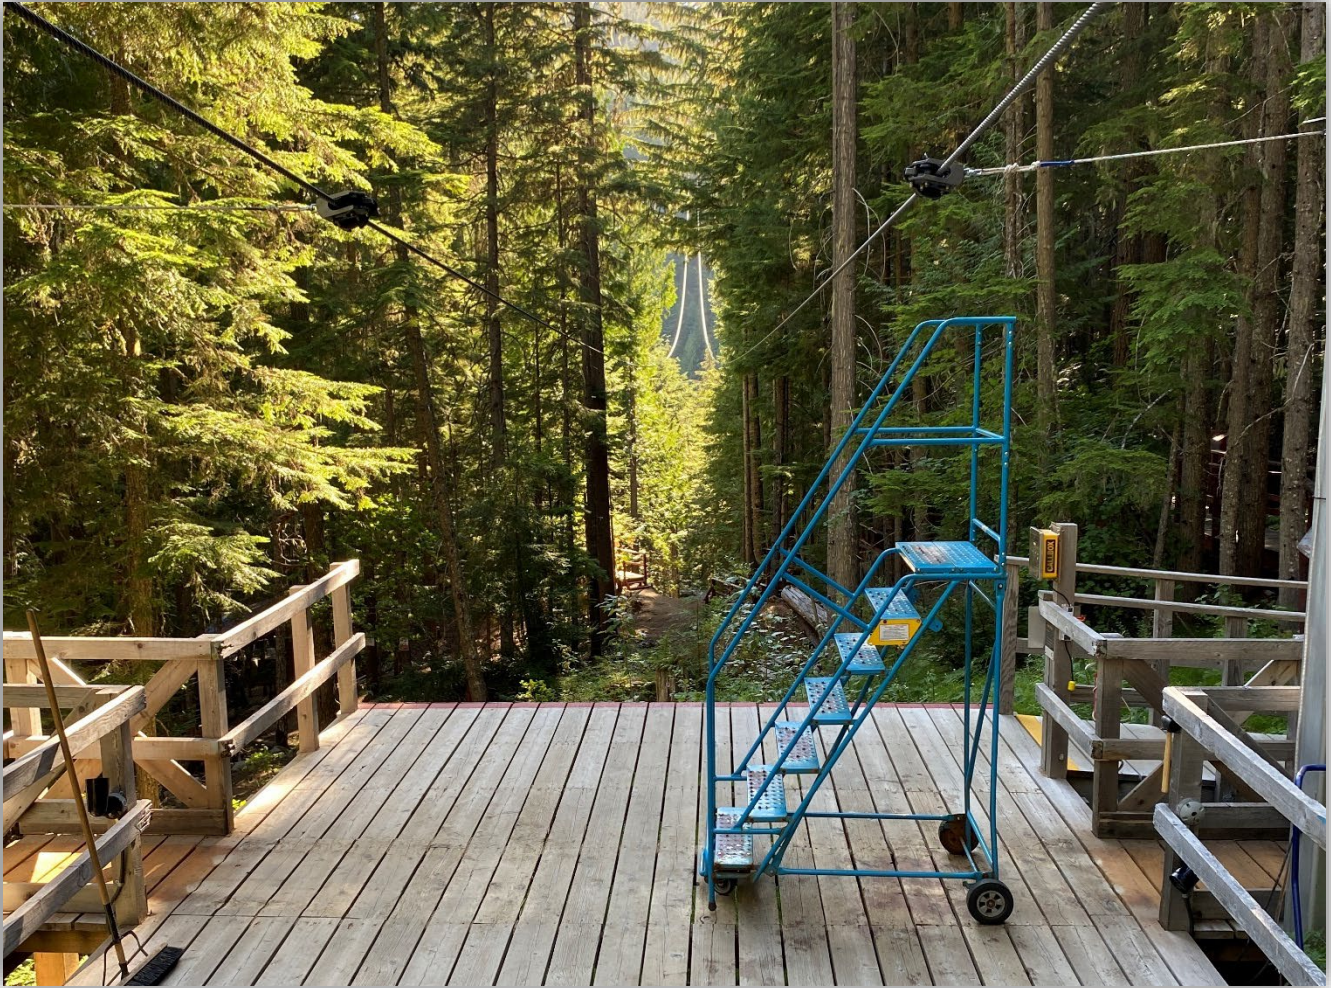
Image 8 - Landing area of the third zipline showing the rolling stairs in the location to dismount zipline riders.

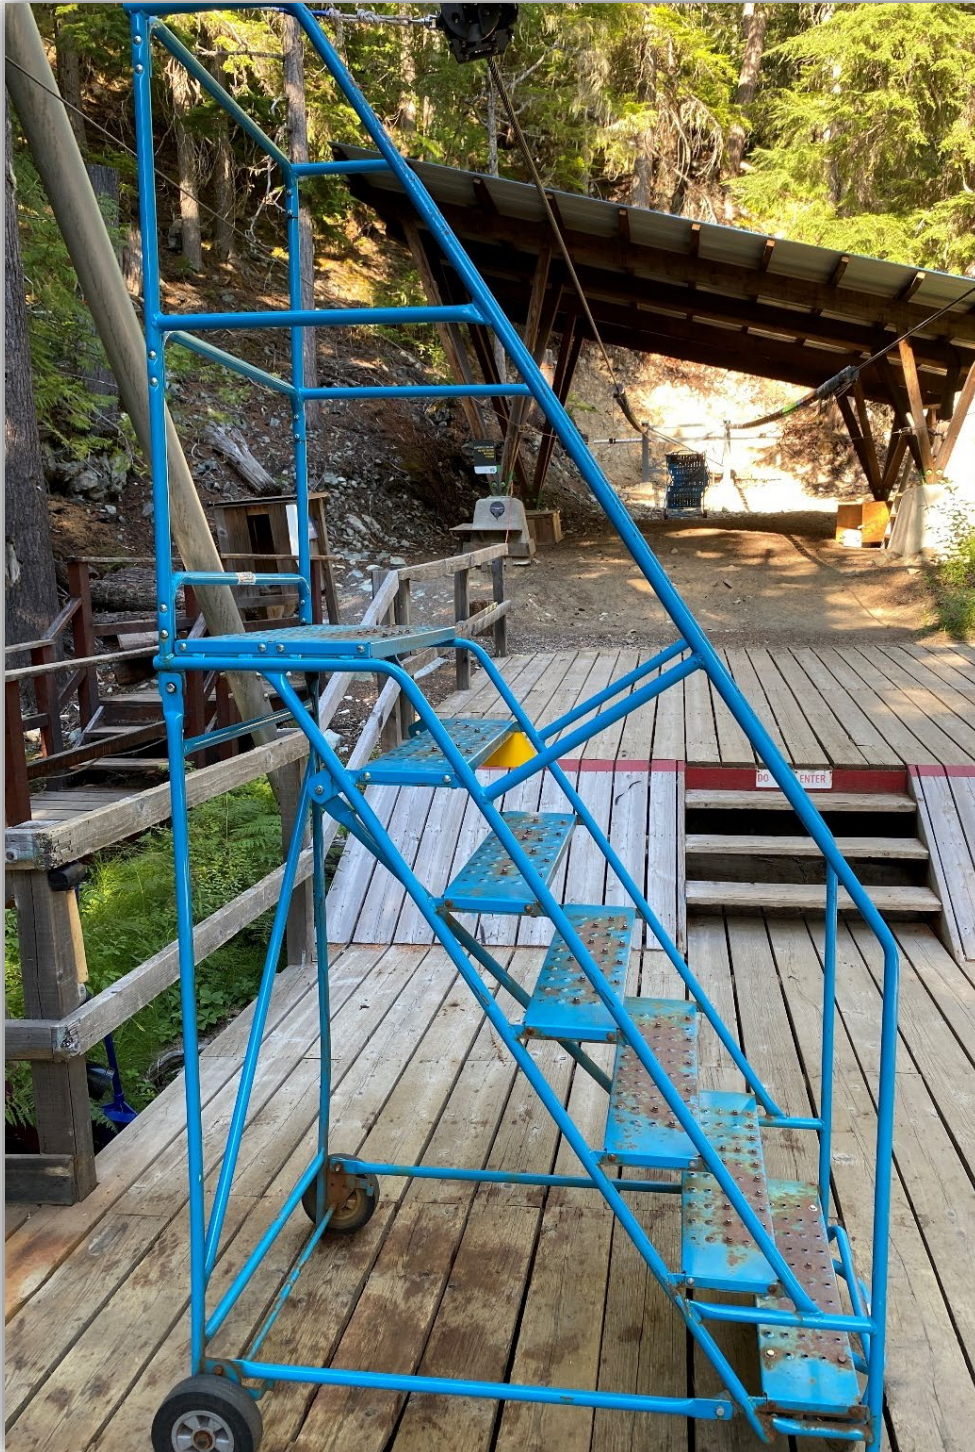
The cause of the incident was the staircase being left out when the clear to fly call was given.

Image 9 – Staircase in the location where the rider collided with it.

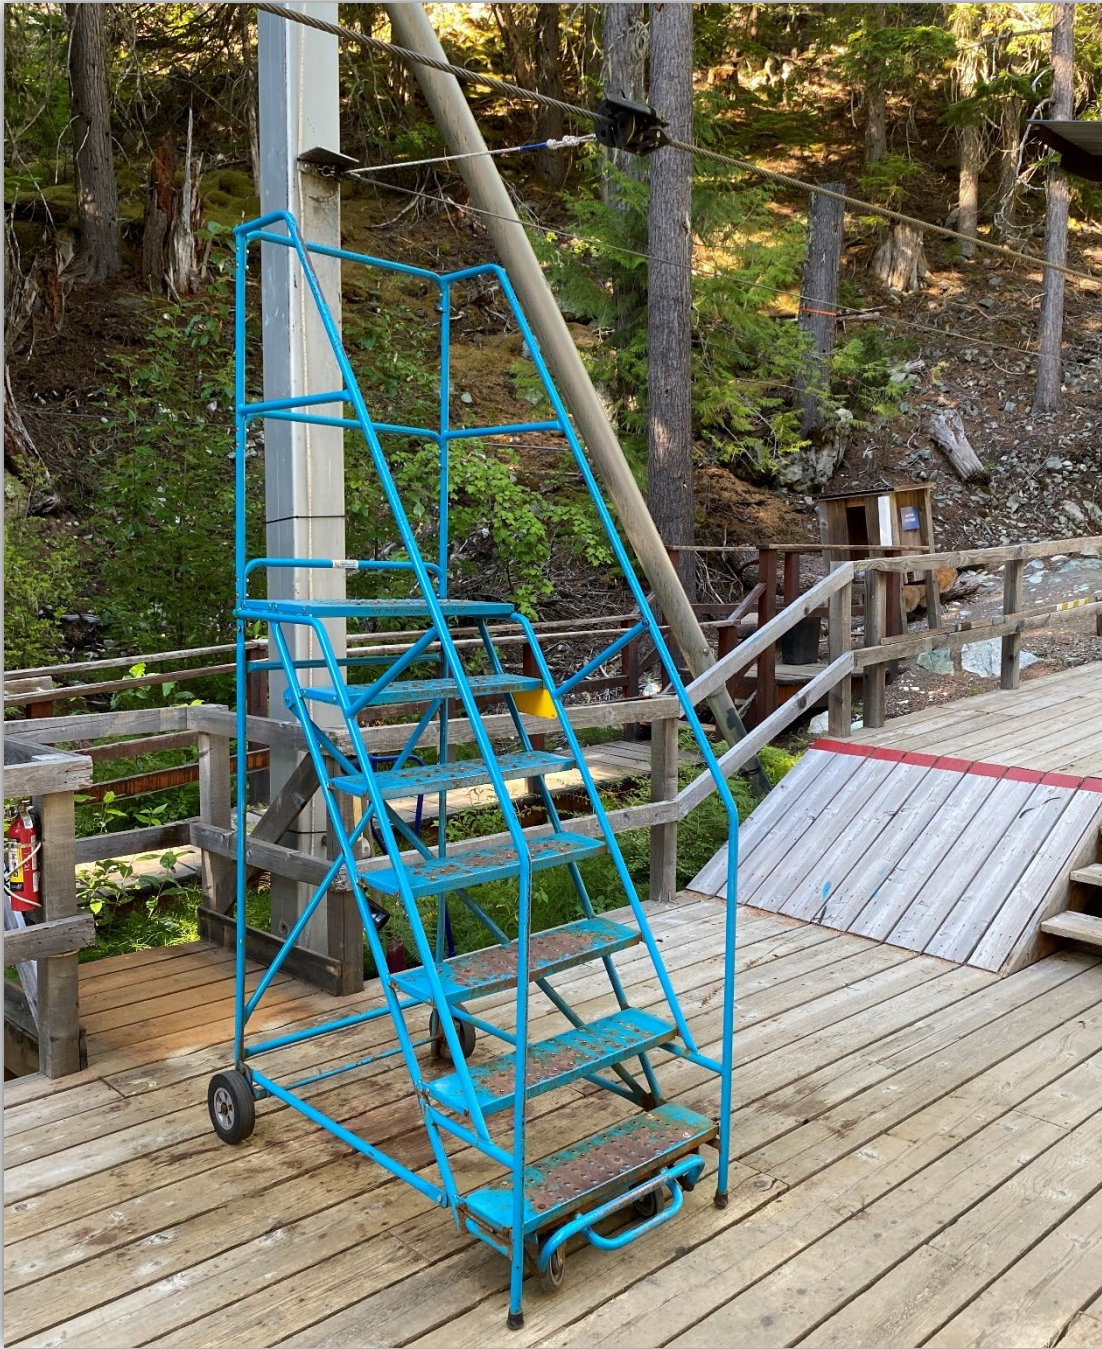
Image 10 - Staircase in the same location as when the rider collided with it.

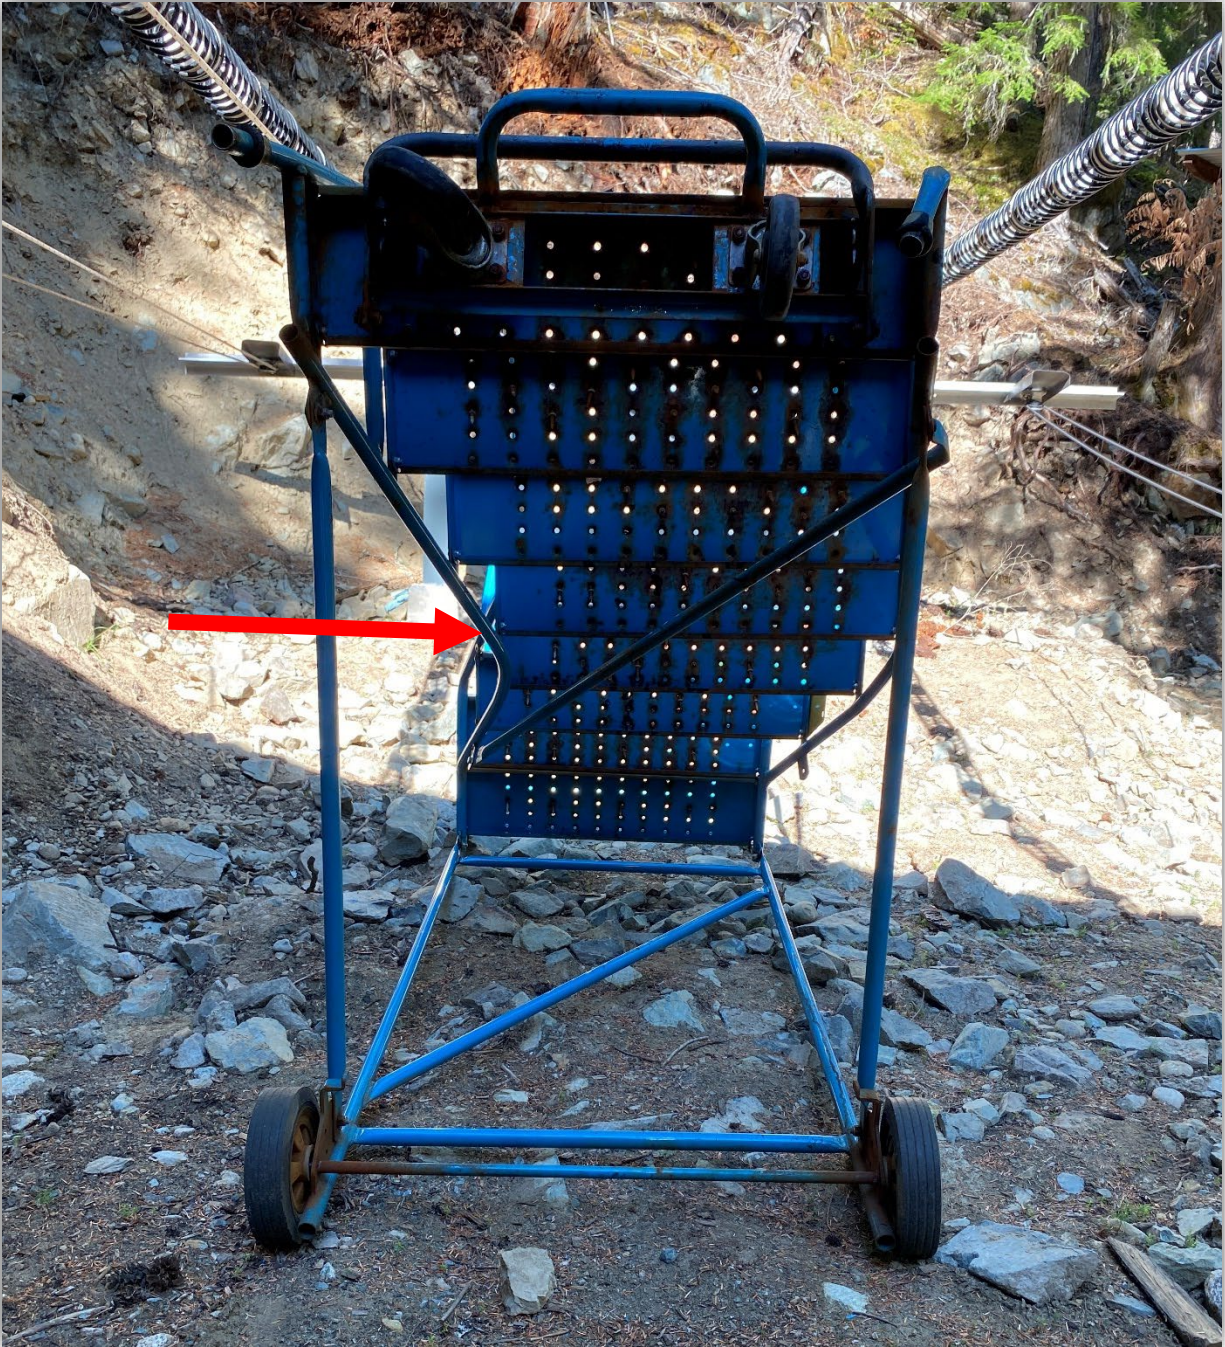
Image 11 – Damaged staircase bent by the impact from the rider.
