Re: Fire Loss at [REDACTED]
Date of Loss: November 18, 2021
Fire Pro File No: 21-4382-TH

Introduction

At the request of Technical Safety BC (TSBC), I conducted an investigation into the origin and cause of a natural gas explosion that occurred on November 18, 2021 at [REDACTED] Comox. The building involved is a multi-unit residential occupancy and it was occupied at the time of the incident. On November 24, 2021 I examined the scene and conducted interviews. The following is a summary of my findings from the investigation.

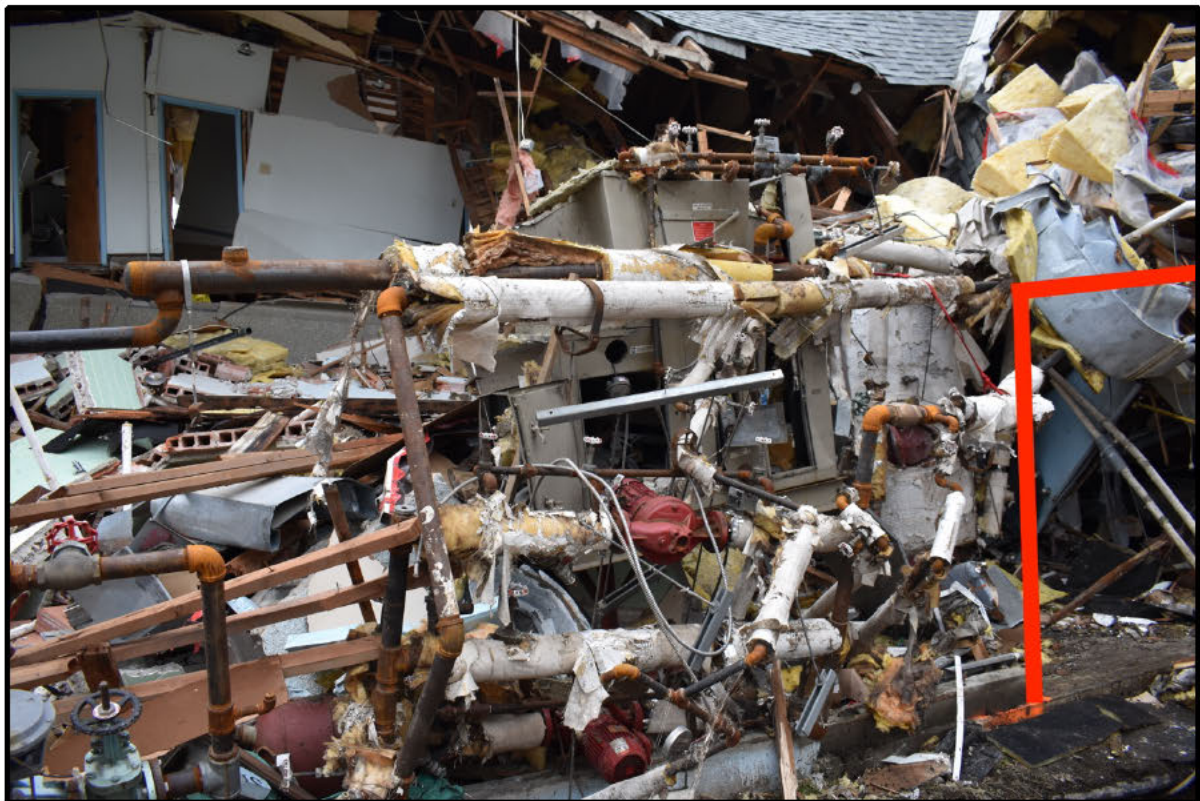
Due to the structural damage caused by the explosion, the structure could not be safely entered for a full examination. However, sufficient information could be documented from the exterior. An exemplar building adjacent to the subject structure provided additional information on the layout. However, the appliances and layout of the mechanical room are different. The building is constructed on a 4' crawl space with open passive venting located near the area of the natural gas line break (see Figure 1). This would provide for openings under the main structure.

Figure 1. The rear of the building including the mechanical room. The lines indicate the open doorway to the mechanical room.

The mechanical room is located at the rear of the building and was separated from the main part of the building by a fire rated door leading into the building and by a service entrance located to the rear of the mechanical room leading to the exterior. The exterior doors for the service entrance had not been installed at the time of the event, leaving an open doorway. The mechanical room contained the main electrical distribution system for the building, as well as the natural gas fueled hot water system.

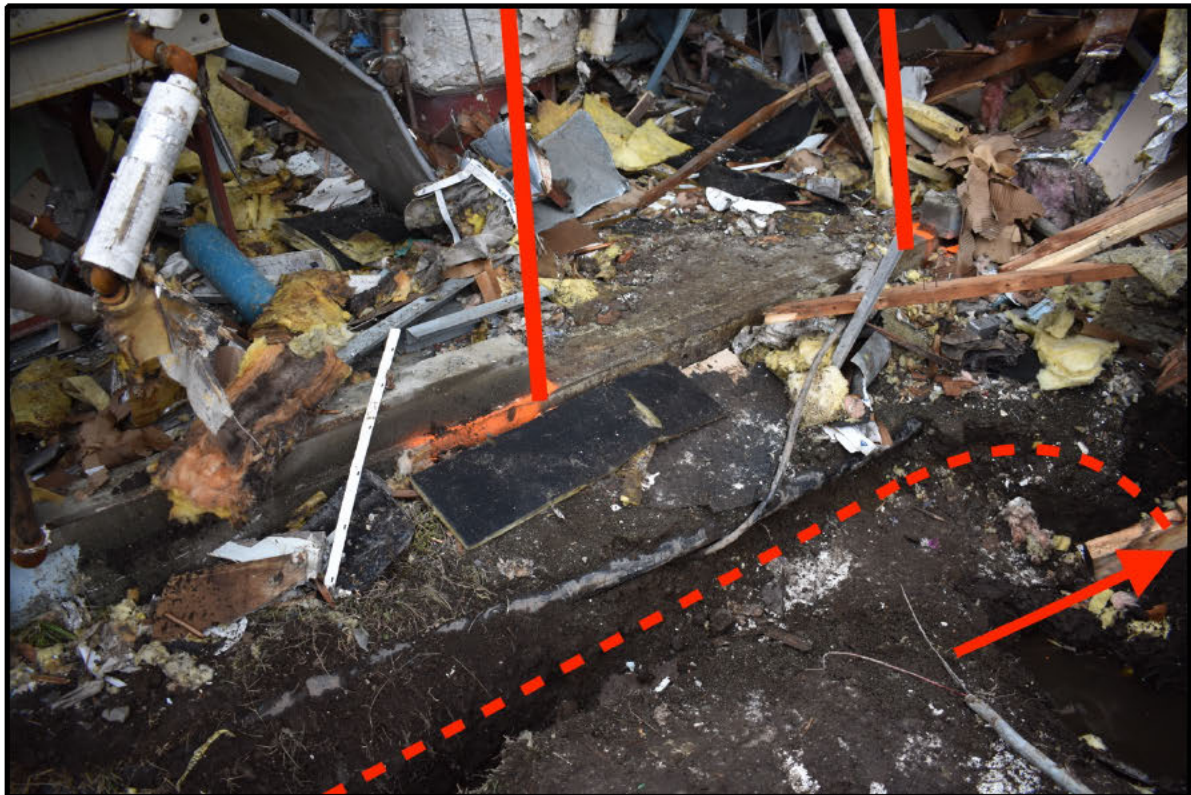
The location of the natural gas line break is approximately 7 feet away from the mechanical room's open doorway (see Figure 2).

Figure 2: Shows area of exterior to the mechanical room. The vertical lines indicate the open doorway, the dashed line shows the natural line and the arrow indicates the approximate location of the break in the natural gas line.

Natural gas was the only fuel identified in the structure capable of producing a fuel air mixture capable of producing the damage observed. Natural gas is lighter than air and easily migrates through normal airflow. In this case, the proximity of the break/leak in the natural gas line would allow the natural gas vapours to flow through the passive air openings and open doorway into the mechanical room. The natural gas/air mixture would first accumulate in the upper portions of the room. When the air/fuel within the proper mixture came in contact with a competent ignition source, ignition of all of the air/fuel mixture would be almost instantaneous. This would result in an overpressure inside the structure and would cause the damage observed.

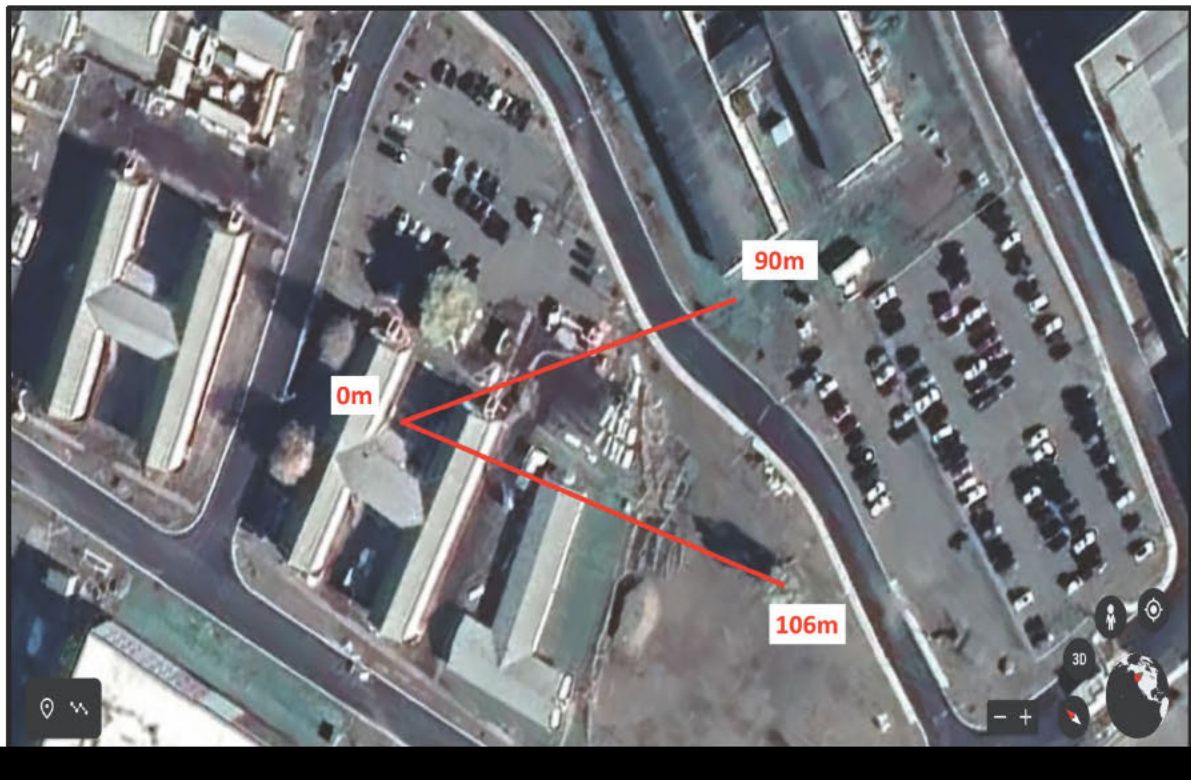
Some debris had been removed and cleaned prior to my arrival, including debris found away from the source structure and mechanical room. Debris from the explosion was measured up to 106 meters away from the location of the mechanical room (see **Figure 3**).

Figure 3: Shows satellite overview of the site. Note: 90m and 106m are distances some debris was found away from the line break (which is approximately 5 feet from the mechanical room).

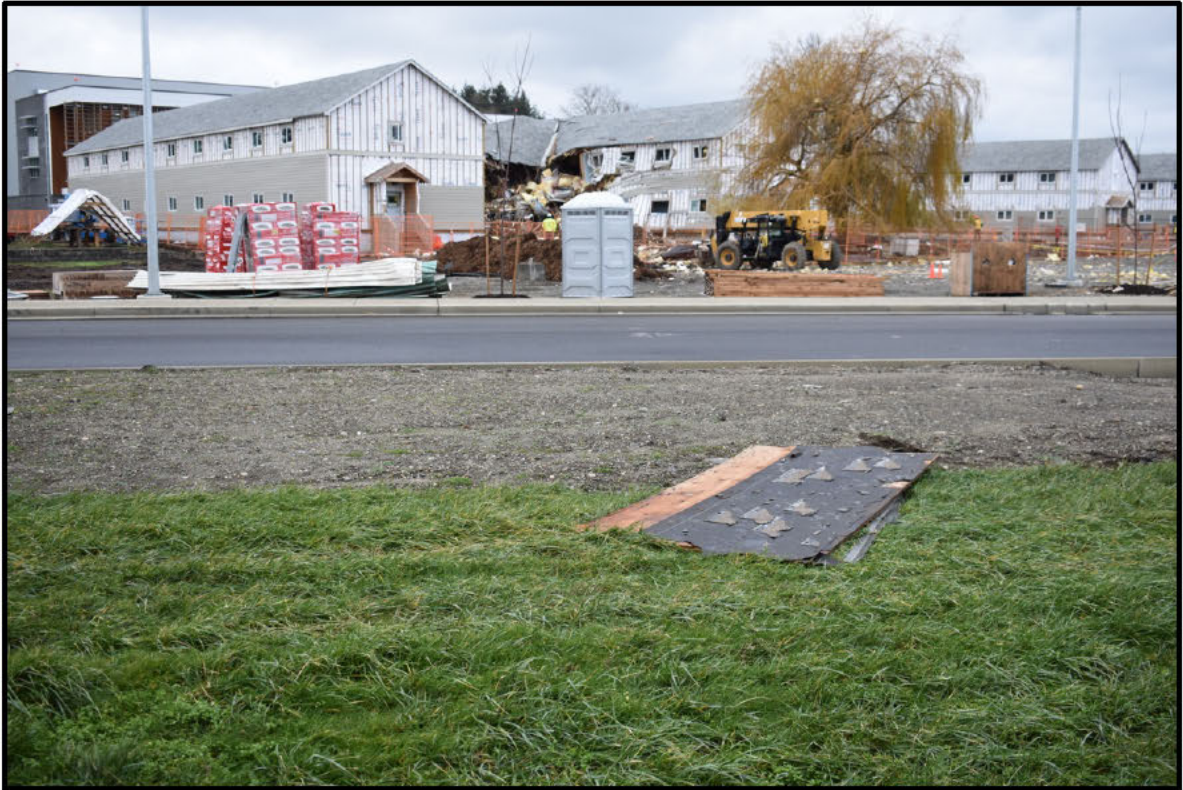
A relatively large piece of plywood, likely used as siding for the exterior wall for the mechanical room, was located 90 meters from the mechanical room (see **Figure 4**). As well, smaller pieces of debris, including wood chips and building materials, were located 106 meters away (see **Figure 5**).

Figure 4: Taken at 90m indicator. Piece of plywood removed from the explosion site.

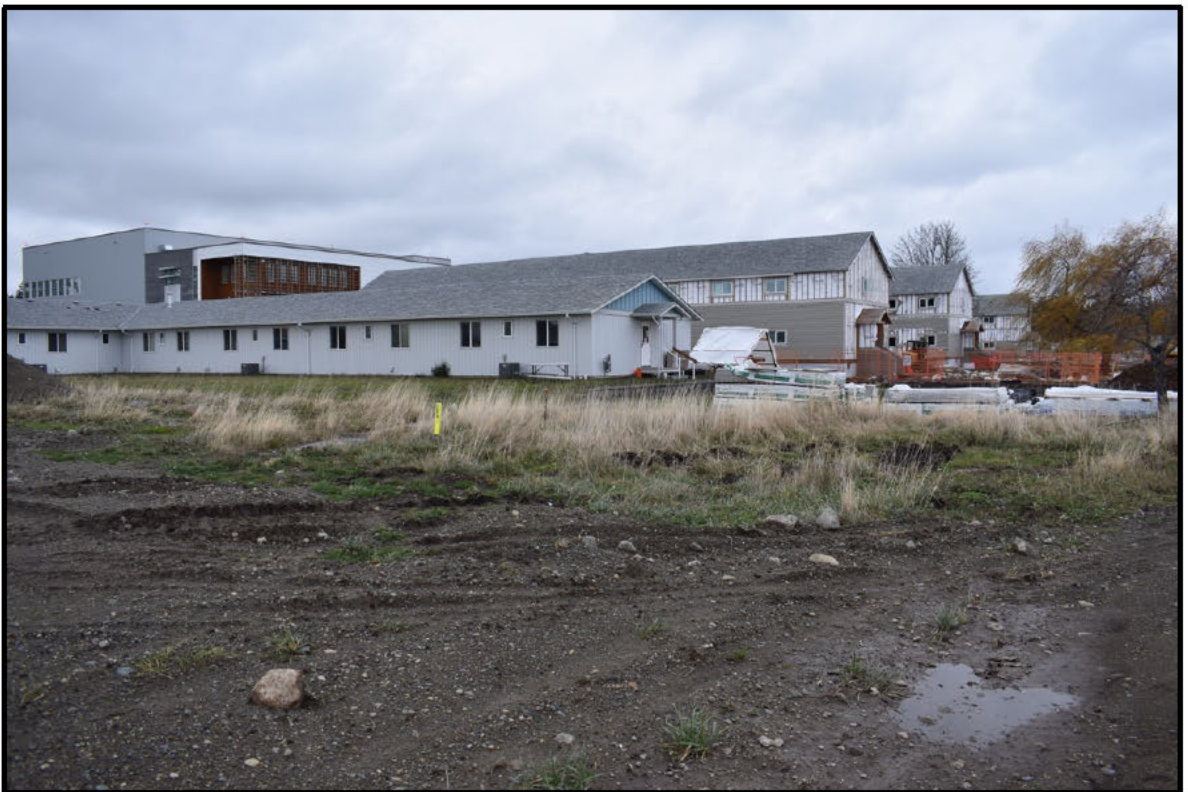
Figure 5: Taken at the 106m indicator where smaller pieces of wood found; however, most had been cleaned/removed prior to our arrival.
