Incident Summary #II-1531785-2023 (#34231) (FINAL)

SUPPORTING INFORMATION	Incident Date	April 5, 2023	
	Location	Chilliwack	
	Regulated industry sector	Electrical - Low voltage electrical system (30V to 750V)	
	Impact	Qty injuries	0
		Injury description	N/A
		Injury rating	None
	Damage	Damage description	Damage to underground service cable, and overhead utility service conductors.
		Damage rating	Moderate
	Incident rating	Moderate	
Incident overview	At a residential property a concrete forming stake was driven into an underground service cable causing an electrical fault that resulted in overhead utility lines melting, falling to the ground, and leaving the property without power.		
INVESTIGATION CONCLUSIONS	Site, system and components	<p>The residential property consists of a single-family dwelling located on the south side of the property, and a new detached shop that was under construction at the time of the incident on the northwest corner of the property (Image 1). The electrical service to the property is fed from a utility pole mounted 50 KVA transformer with overhead 4/0 AWG size *neutral supported cable service conductors ran 100 feet to a 30-foot-long private pole. There

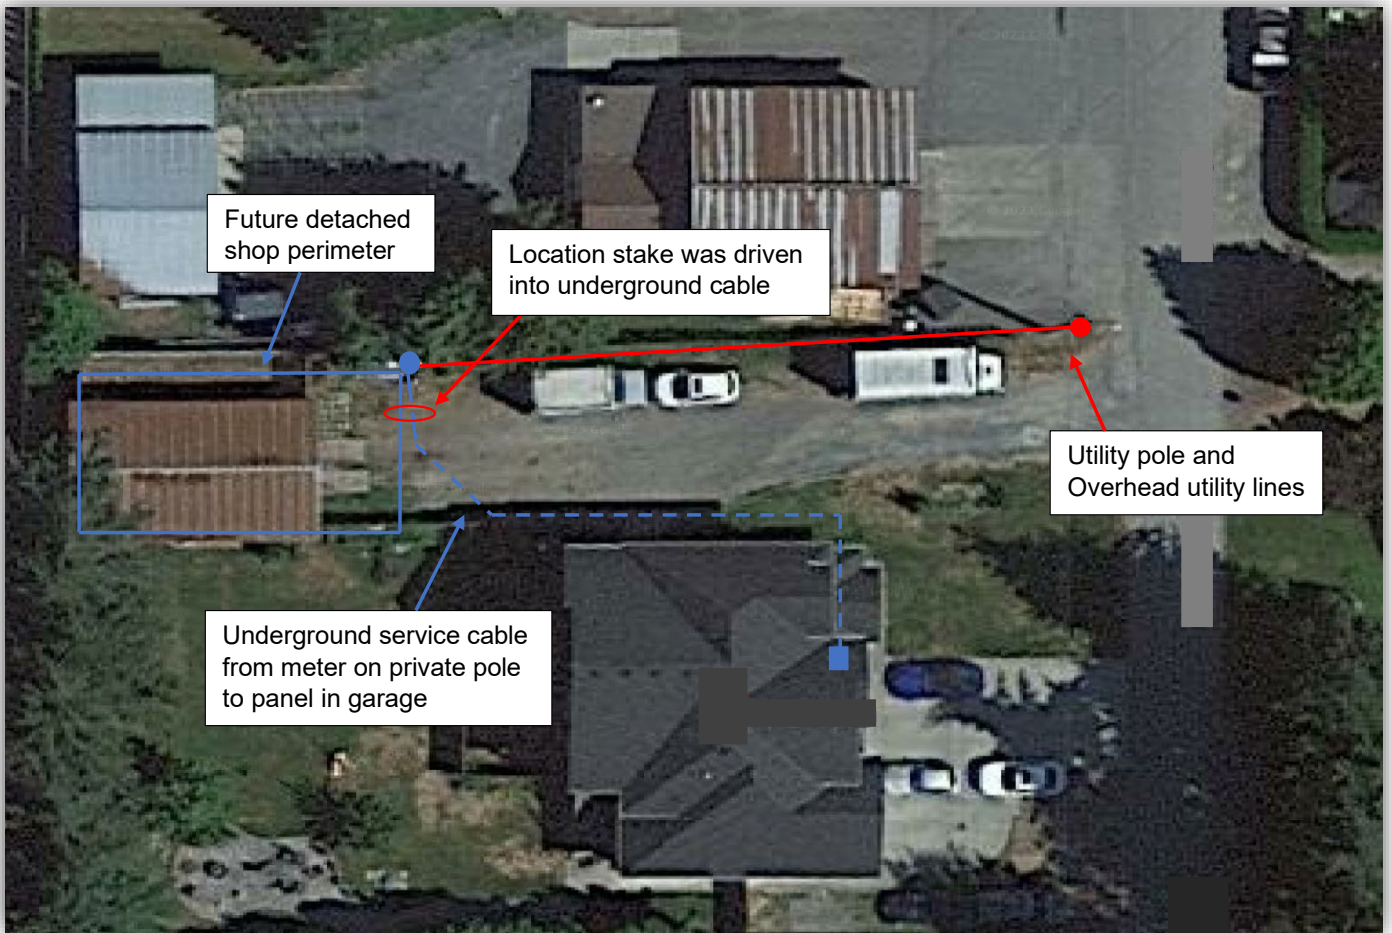
Image 1 – Overview of property.

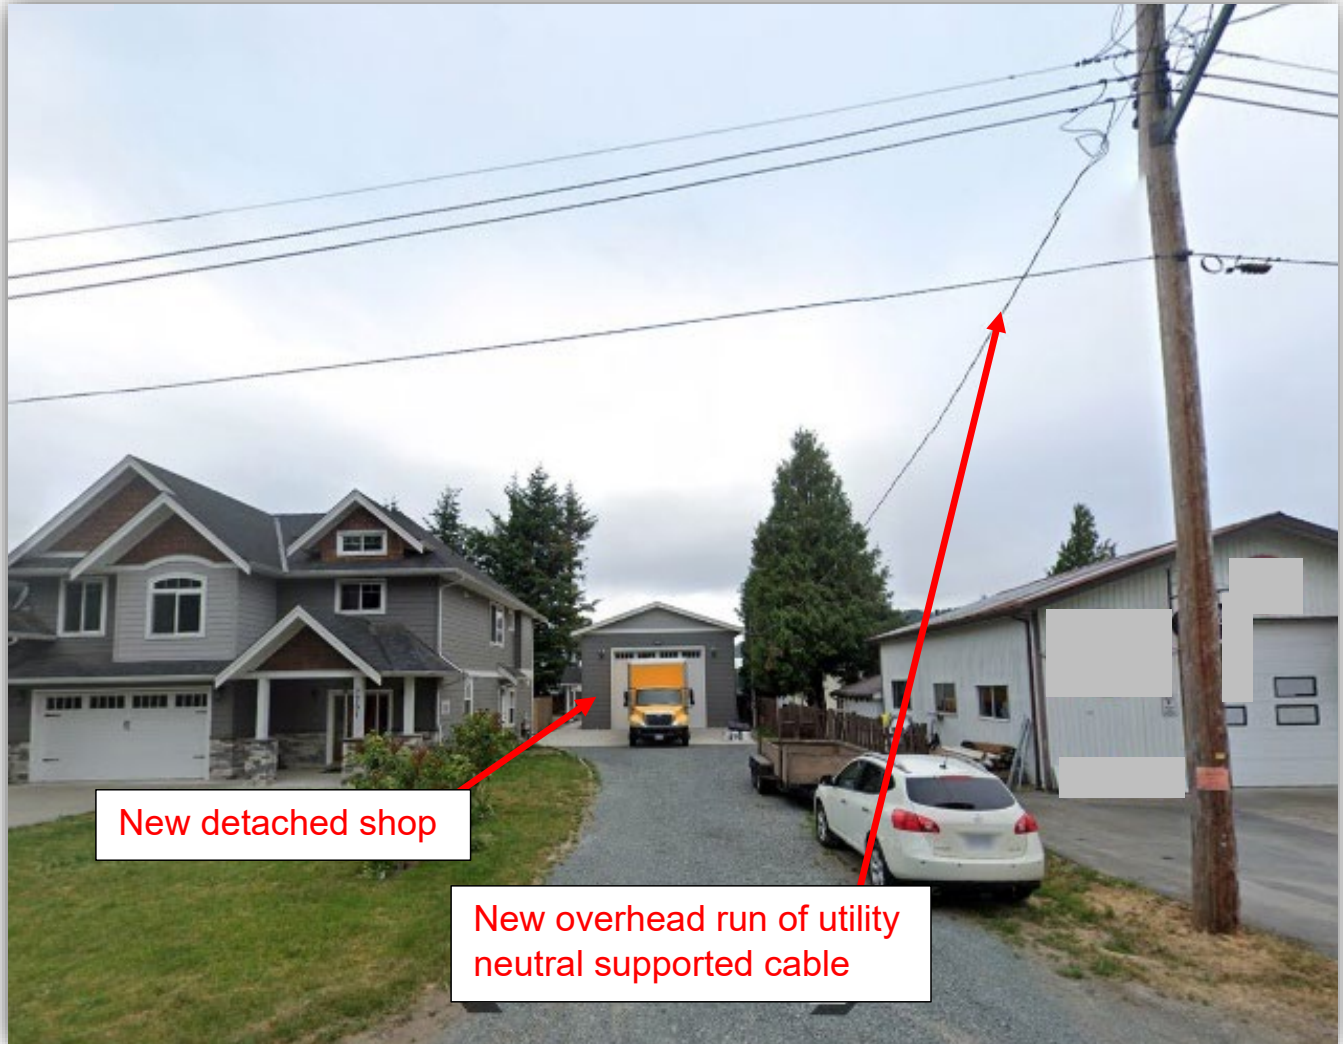
Image 2 - Street view of property.

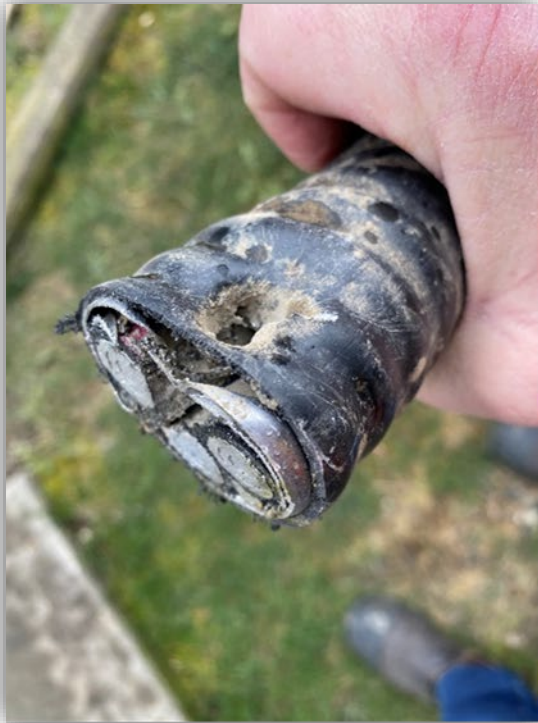
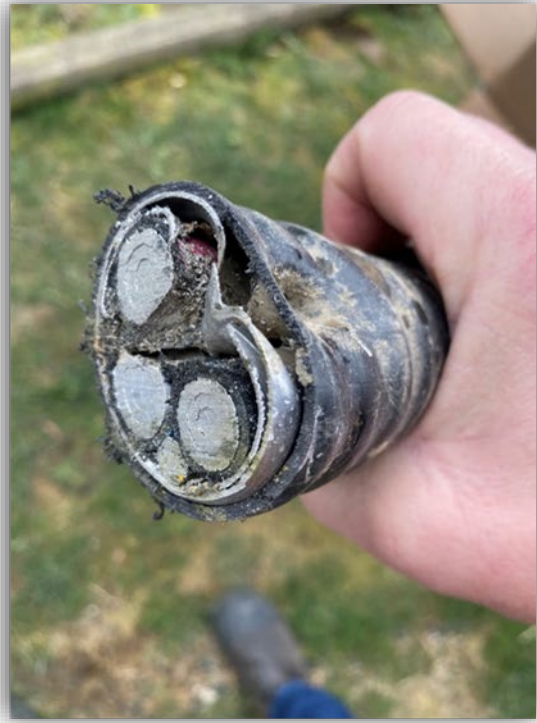
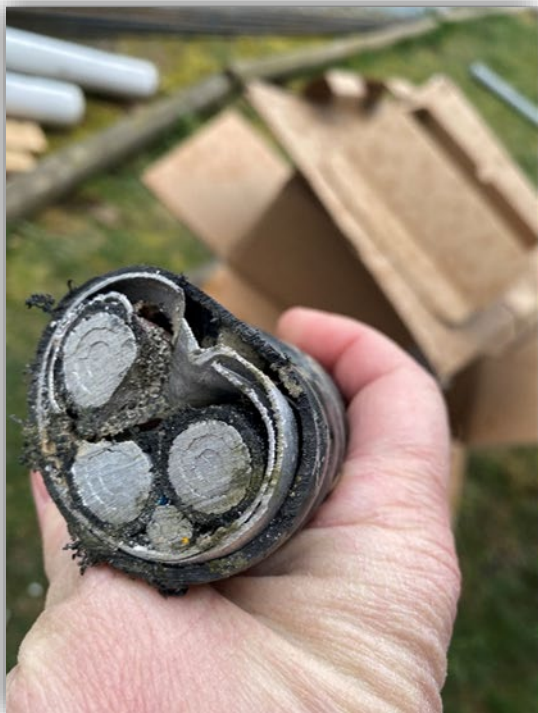
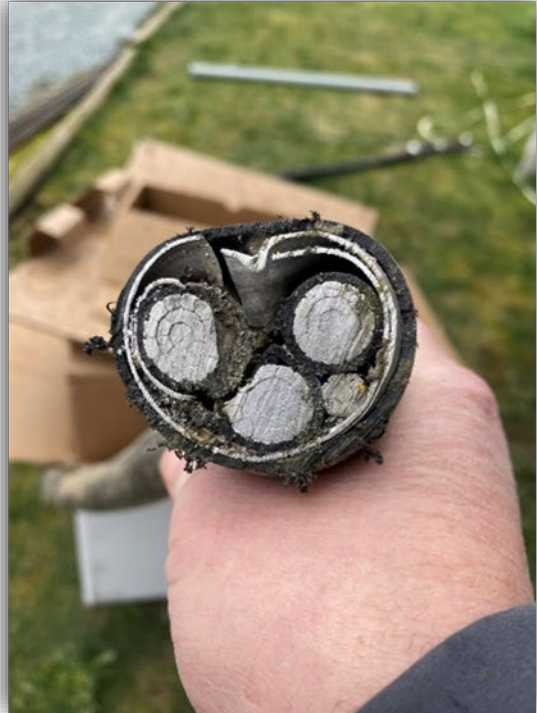
It's very likely that the metal concrete forming stake that pierced the underground service cable, met the neutral and a line conductor causing the electrical fault that resulted in downed utility overhead lines, and a power outage to the property.

Image 3 – Damaged cable from the concrete forming stake.

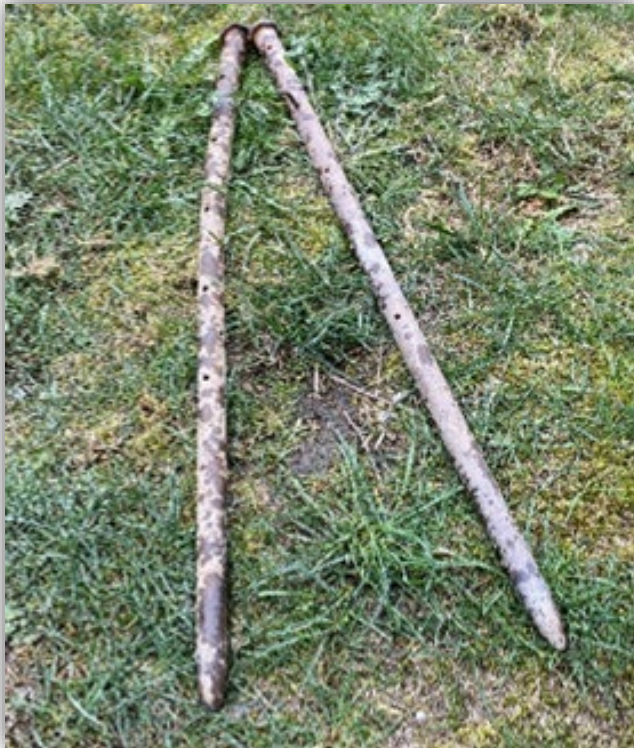
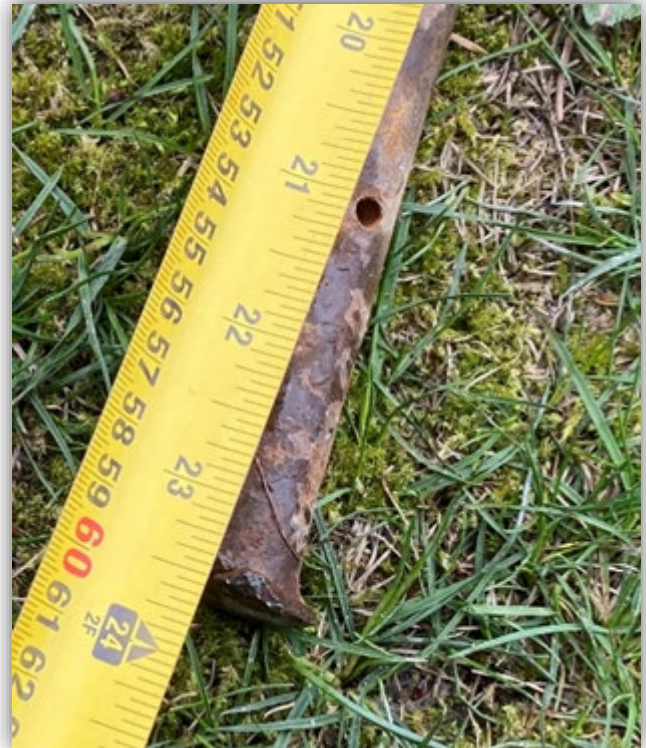
Image 4 – Metal stakes used for concrete forming braces and the length of metal stakes.

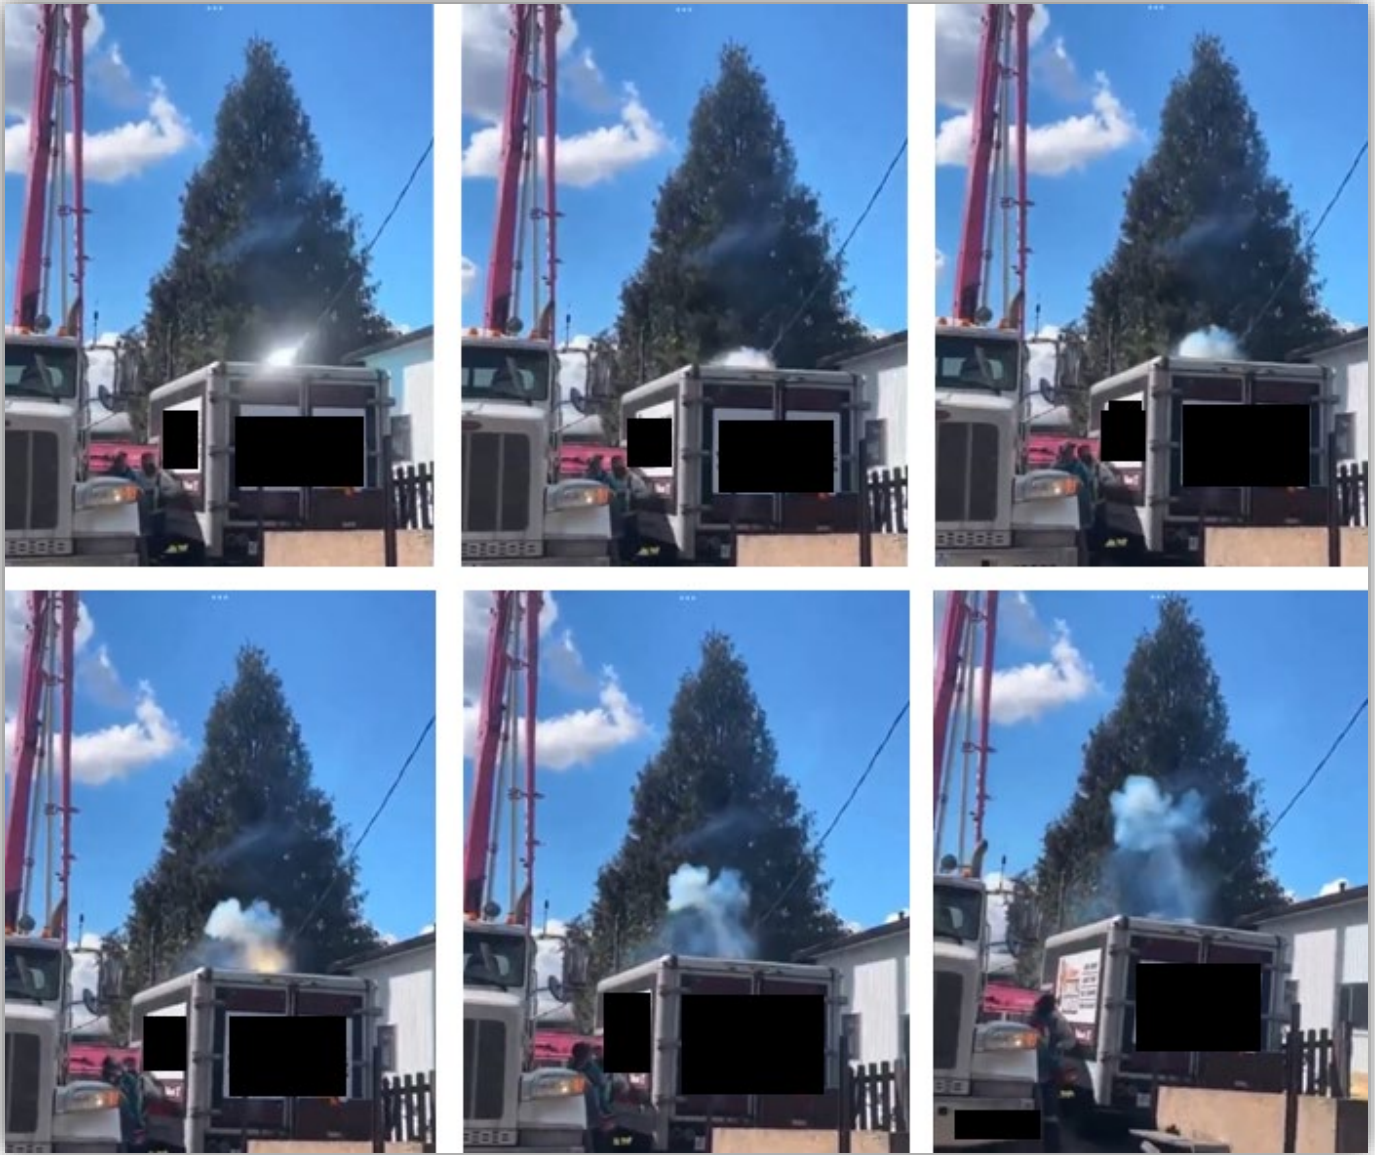
- When the concrete pump truck was set up suddenly the overhead utility lines started smoking and sparking and within seconds they broke apart and fell to the ground.

Image 5 – Screenshots of smoking and sparking utility lines from a phone video taken by a site worker.
