Incident Summary #II-974332-2020 (#16492) (FINAL)

SUPPORTING INFORMATION	Incident Date	January 29, 2020	
	Location	Coquitlam, BC	
	Regulated industry sector	Electrical - Low voltage electrical system (30V to 750V)	
	Impact	Qty injuries	1
		Injury description	Thermal burns sustained to the crane operator's face, hands and body.
		Injury rating	Moderate
	Damage	Damage description	The tower cranes control panel was damaged to the point complete replacement was required and other damages requiring repairs.
		Damage rating	Moderate
	Incident rating	Moderate	
Incident overview	A tower crane operator working on an energized control panel, caused an unintended release of electrical energy, injuring themselves and causing damage to the equipment.		
INVESTIGATION CONCLUSIONS	Site, system and components	<p>A tower crane is a fixed crane used on building sites to lift, lower and move materials. The crane is a manufactured piece of equipment that is electrically powered and controlled by an operator who sits in the operator's cab in the case located at the top of the tower crane, this provides the operator with a good overall view of the site. The tower cranes height can be extended with a cli

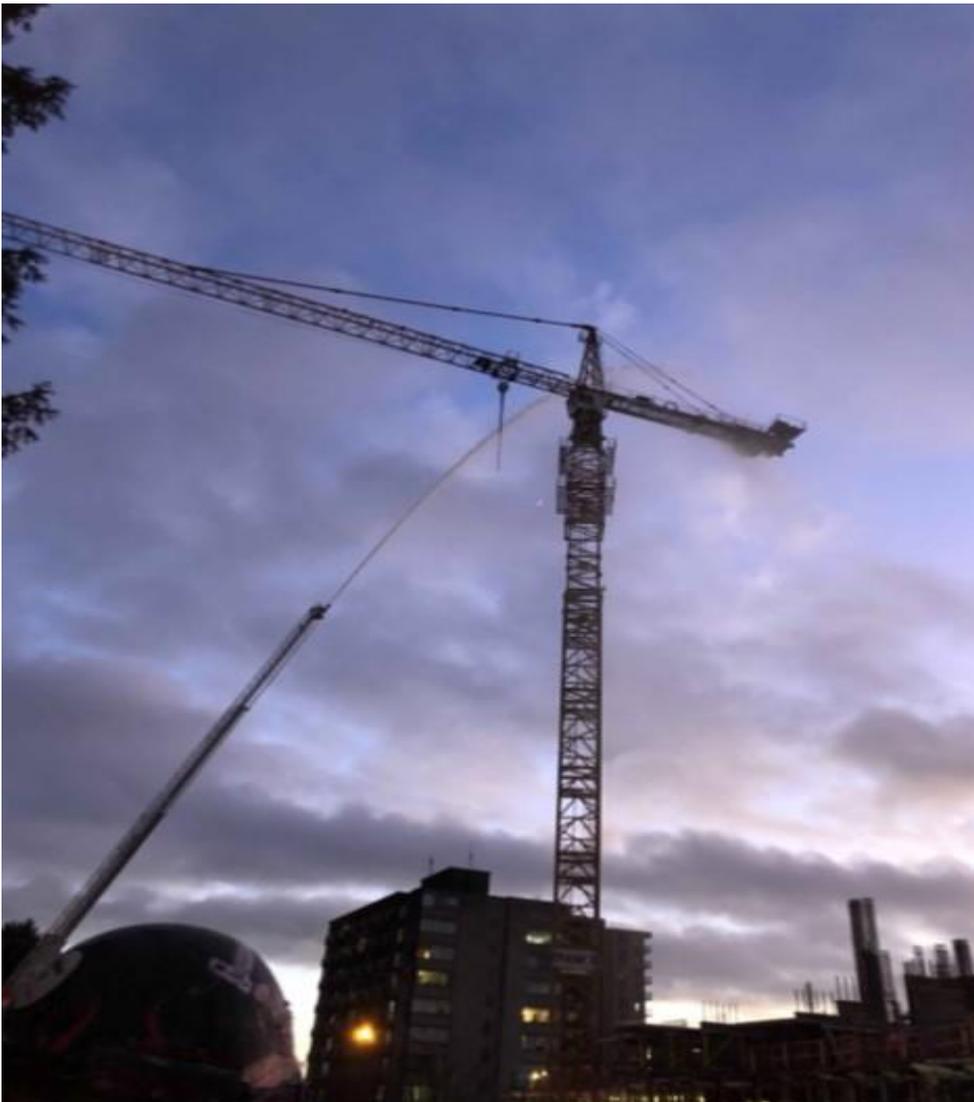
Overall photo of the crane after the incident occurred; fire being extinguished by the fire department.

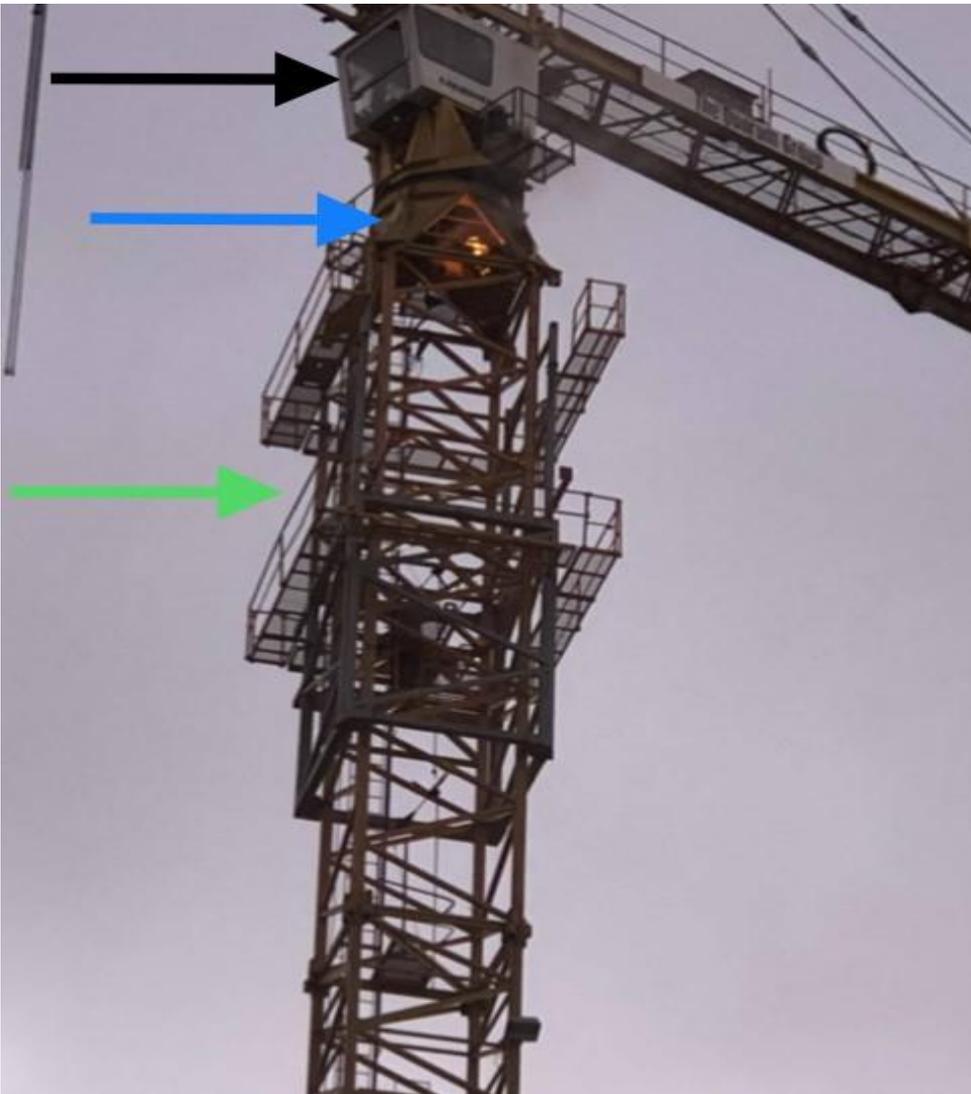
Overall photo of the crane during the fire which resulted from the incident. The black arrow indicates the tower crane operators cab where the control panel is located and where the incident occurred. The blue arrow indicates the slewing ring deck where the manufacturers disconnect is located which turns the control panels power on and off. The fire in the photo is from the operators jacket which was on fire and thrown to the ground when they dropped from the operators cab to the slewing ring deck below. The green arrow indicates the tower cranes climbing unit, the crane operator at the time of the incident was investigating the tools required to connect the electrical equipment for the climber.

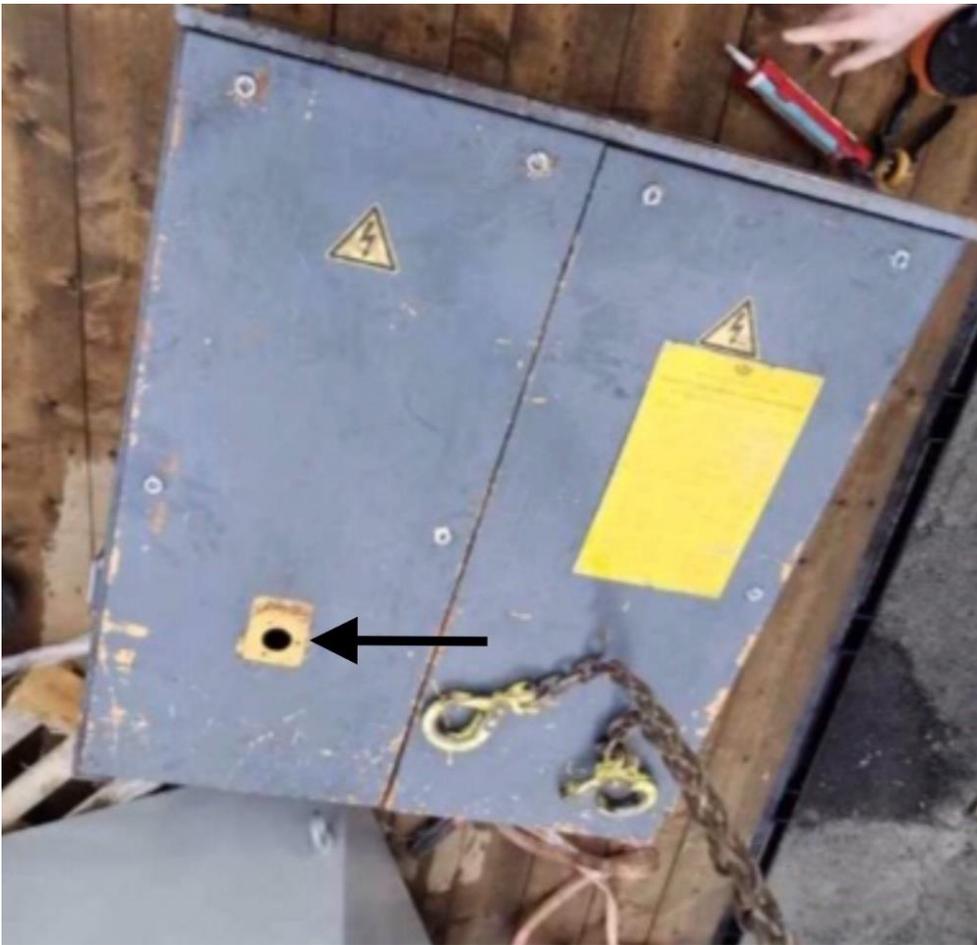
This photo is of the damaged control panel after it was removed from the tower crane with the control panel doors installed. The black arrow indicates the location of the control panels disconnect operating handle.

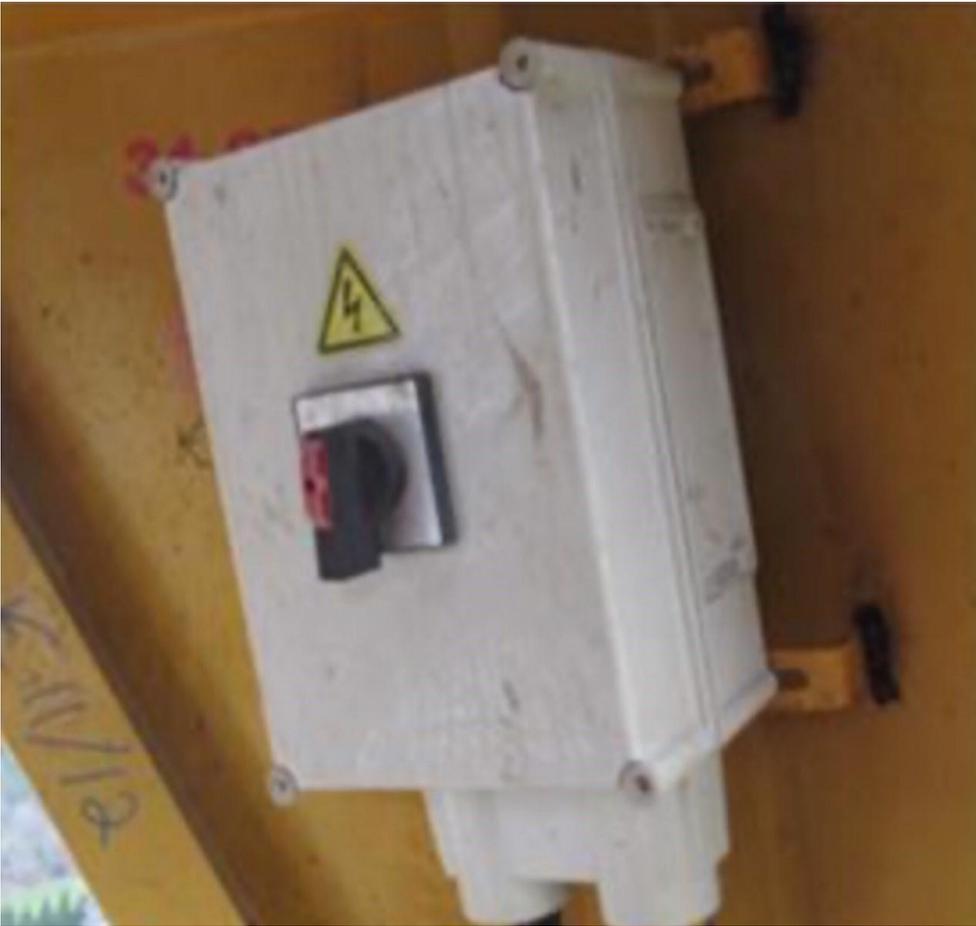
This photo is of the tower cranes manufactures disconnect switch located on the slewing ring level that turns power to the control panel where the incident occurred on and off.
