Incident Summary #II-927063-2019 (#15727) (FINAL)

SUPPORTING INFORMATION	Incident Date	October 23, 2019	
	Location	Delta	
	Regulated industry sector	Gas - Natural gas system Boilers, PV & Refrigeration - Boiler and pressure vessel system	
	Injury	Qty injuries	0
		Injury description	One worker was in the boiler room at the time of the explosion but sustained no reported injuries
		Injury rating	None
	Impact Damage	Damage description	An explosion damaged a steam boiler and vent stack. The front and rear doors of the boiler bent and deformed, the brick refractory insulation on the rear door cracked and broke into pieces. The boiler vent stack split open and the vent cap on the roof blew off and landed several meters away. (Images 3-8)
		Damage rating	Major
Incident rating	Major		
Incident overview	An explosion occurred inside a steam boiler and vent stack in the mechanical room of a large industrial bakery.		
INVESTIGATION CONCLUSIONS	Site, system and components	<p>The firetube steam boiler is designed to provide steam for heating and manufacturing processes. The boiler creates heat from the combustion of a gas/air mixture produced by a natural gas burner and combustion air fan. The

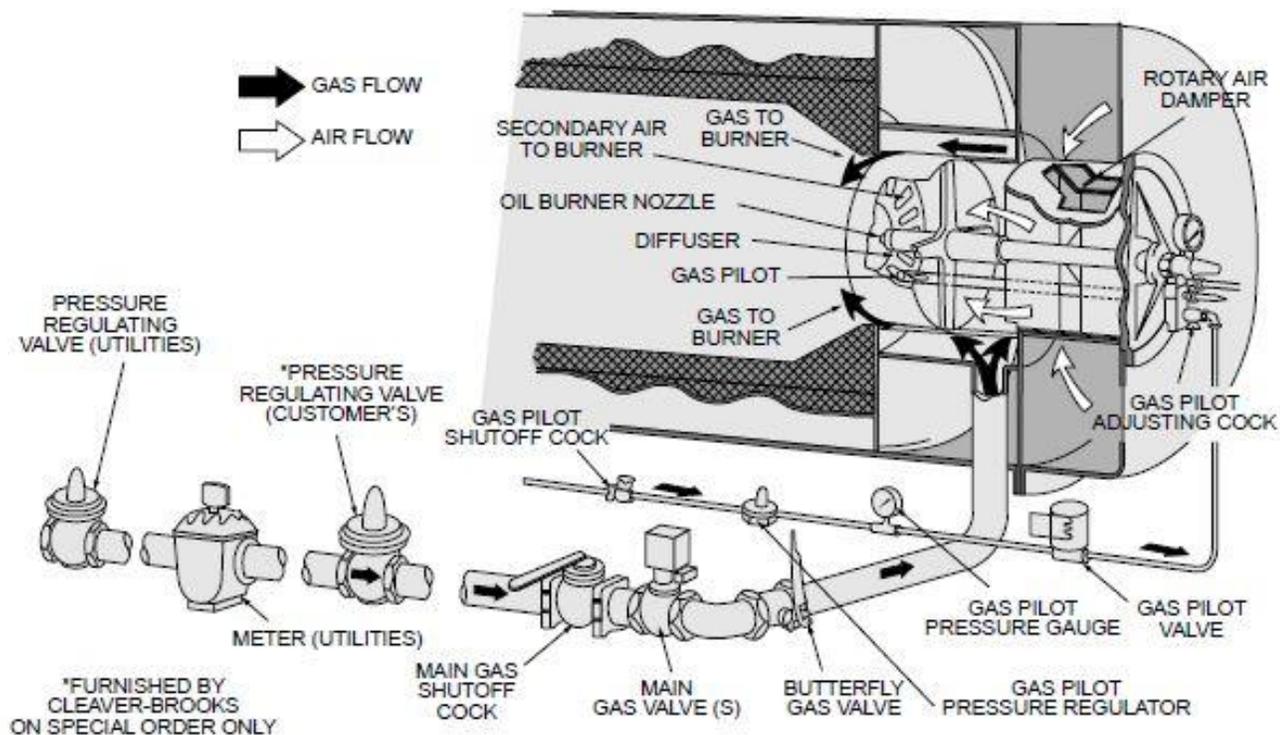
A boiler technician with experience installing, servicing and repairing this style of boiler stated that the burner ring provides a precise gap around the outside of the diffuser allowing the gas to pass through it and mix evenly with the air. This provides a uniform air/fuel mixture that can be smoothly ignited from the pilot flame producing a stable main flame. If conditions with the air and fuel inside the boiler are not correct, the flame produced by the burner may come into contact with the metal burner ring. If this happens the metal will overheat, melt and burn back, deteriorating the housing and changing the shape and volume of the opening. When the burner ring deteriorates, a higher volume of the gas will exit through the larger opening, changing how the gas is mixed with the air and potentially altering the air/fuel mixture present at the location of the pilot flame. This could lead to the main flame failing to ignite during the 10 second trial for ignition period programed in the digital burner controller, and result in unburnt fuel accumulating in the flue passages and venting.

Image 1 - From the boiler manual, showing air and gas flow paths to boiler combustion chamber. The gas flows through the burner ring gap around the diffuser to mix with the air.

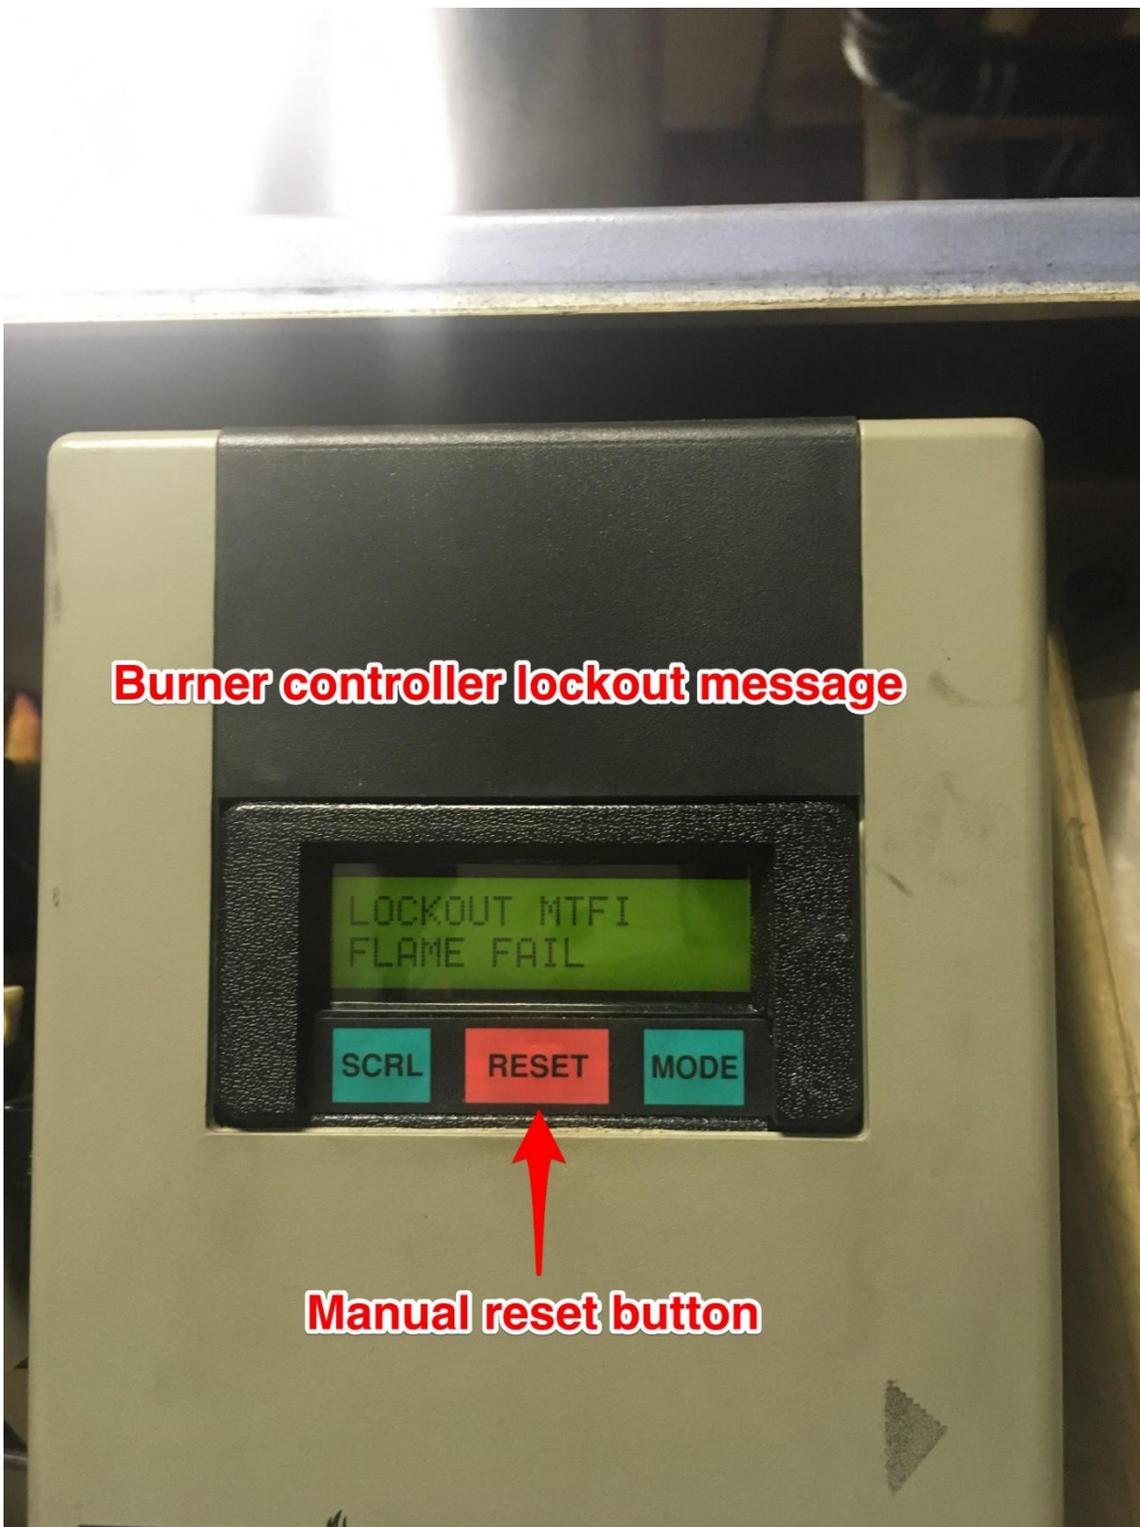
Image 2 - Digital burner controller showing a “main flame trial for ignition failure” after the incident

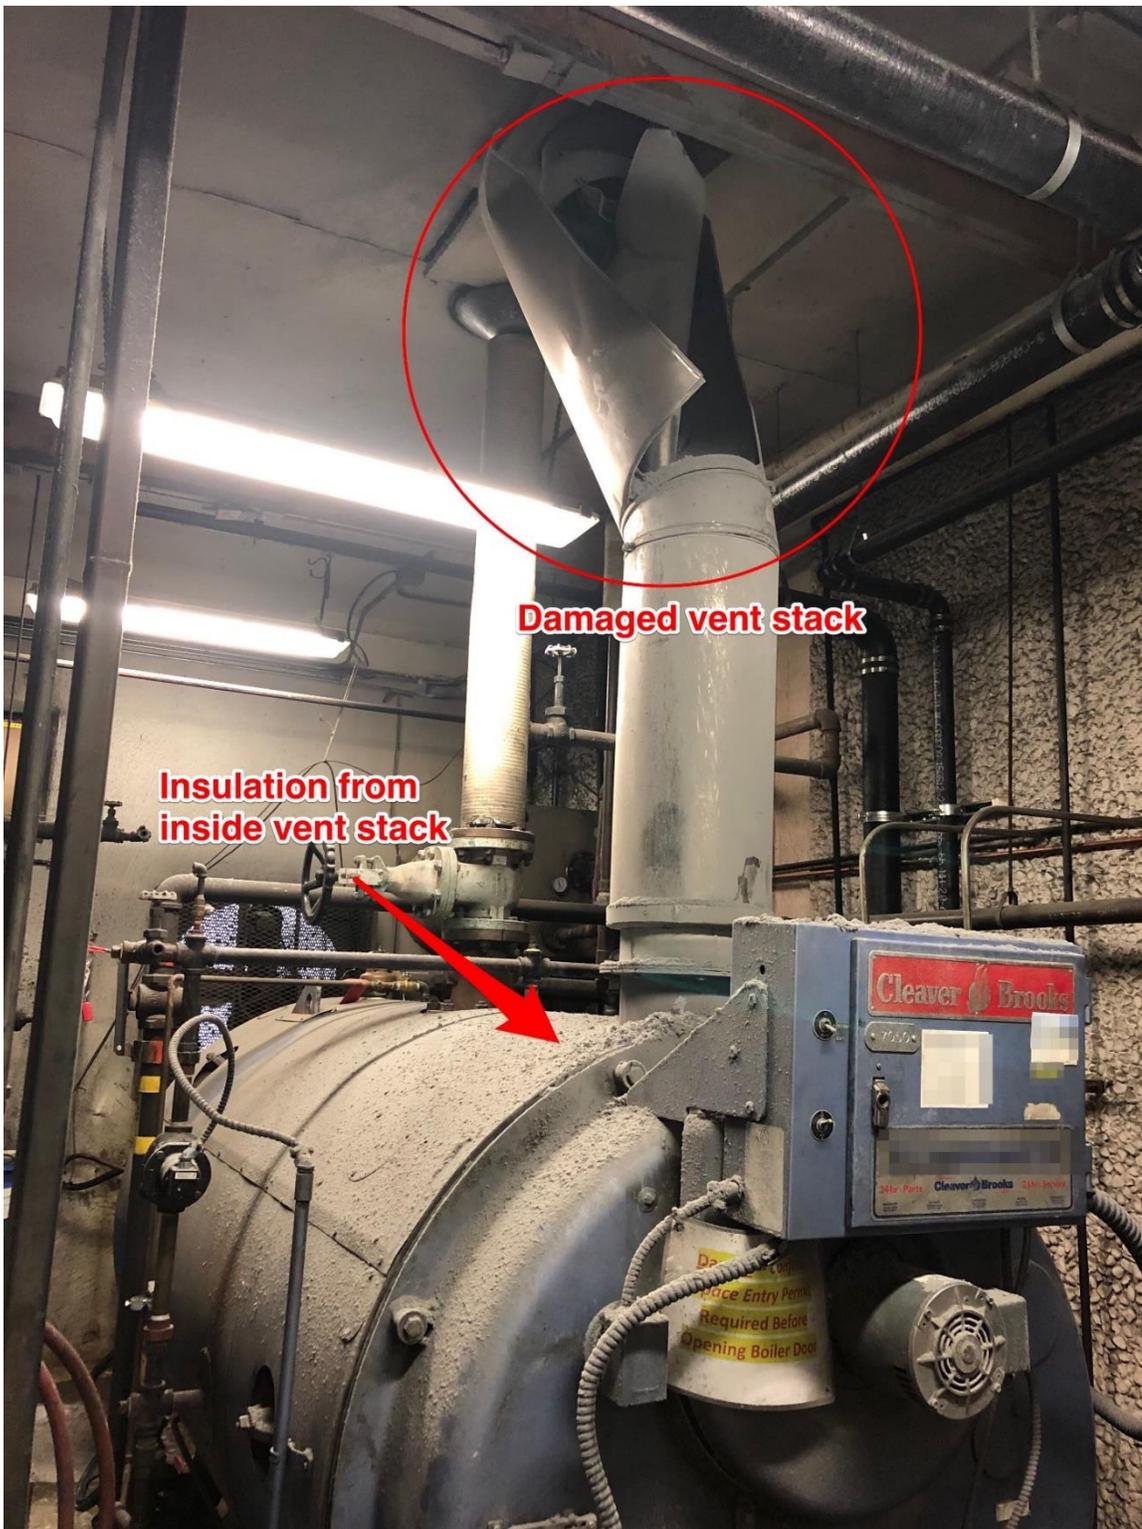
Image 3 - Boiler in mechanical room

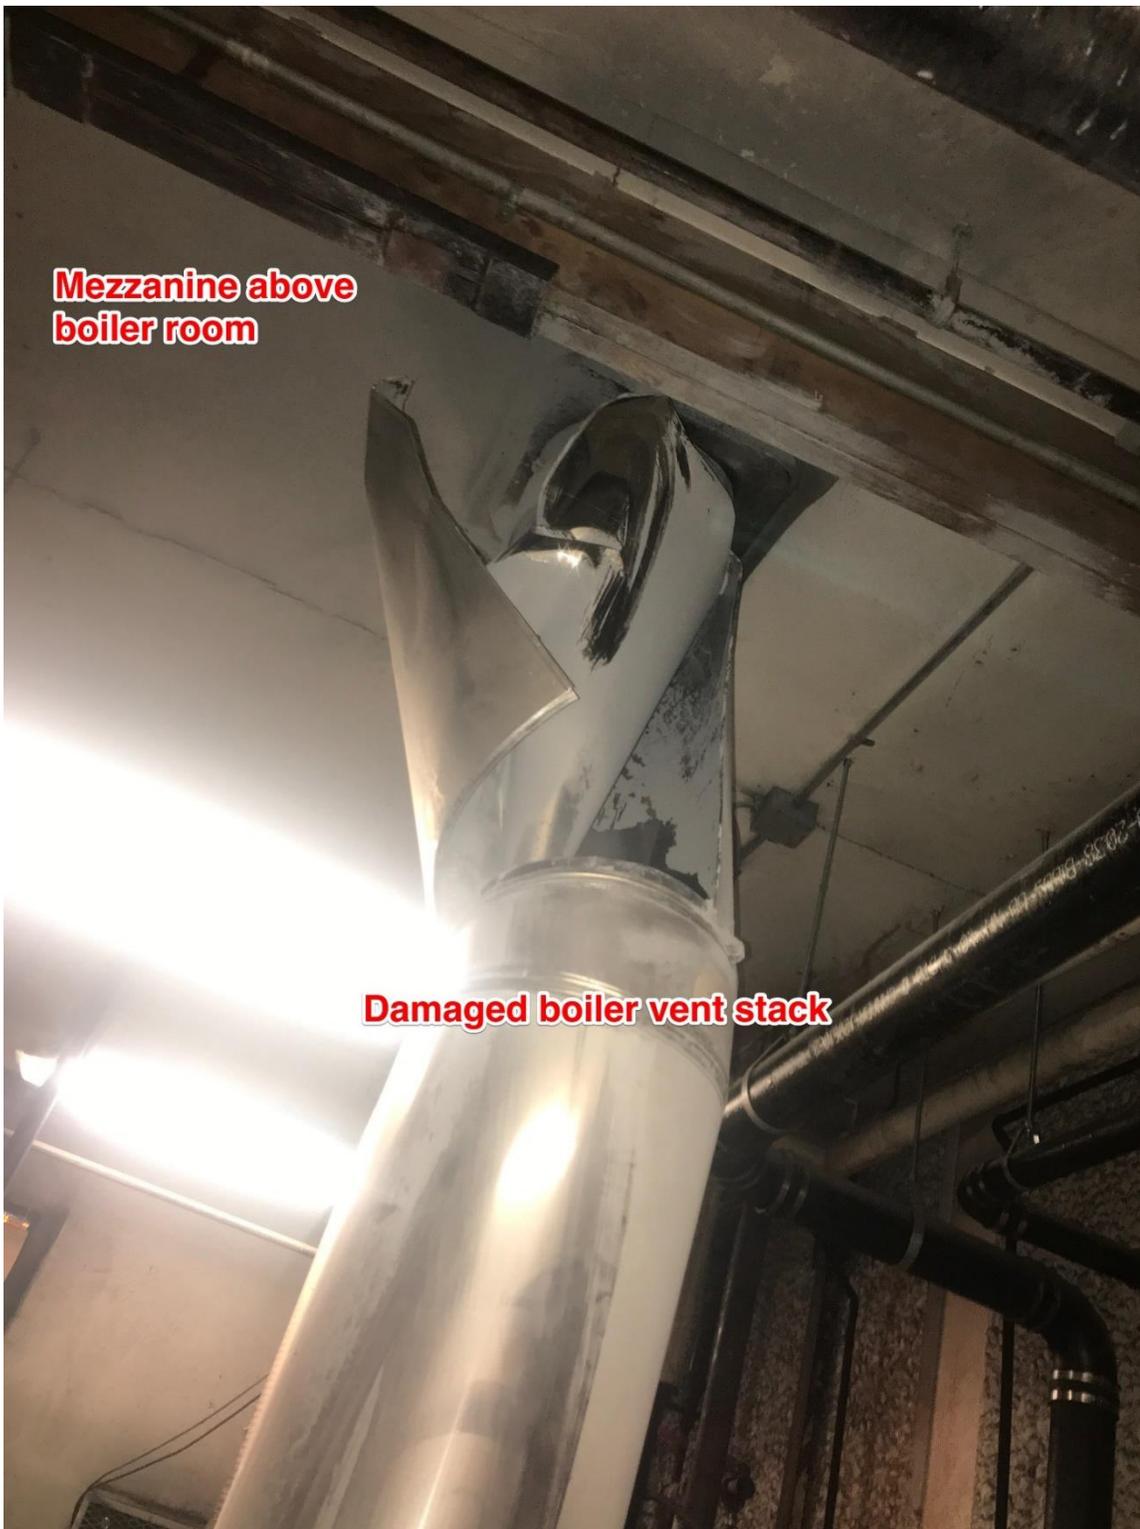
Image 4 - Boiler vent stack above boiler

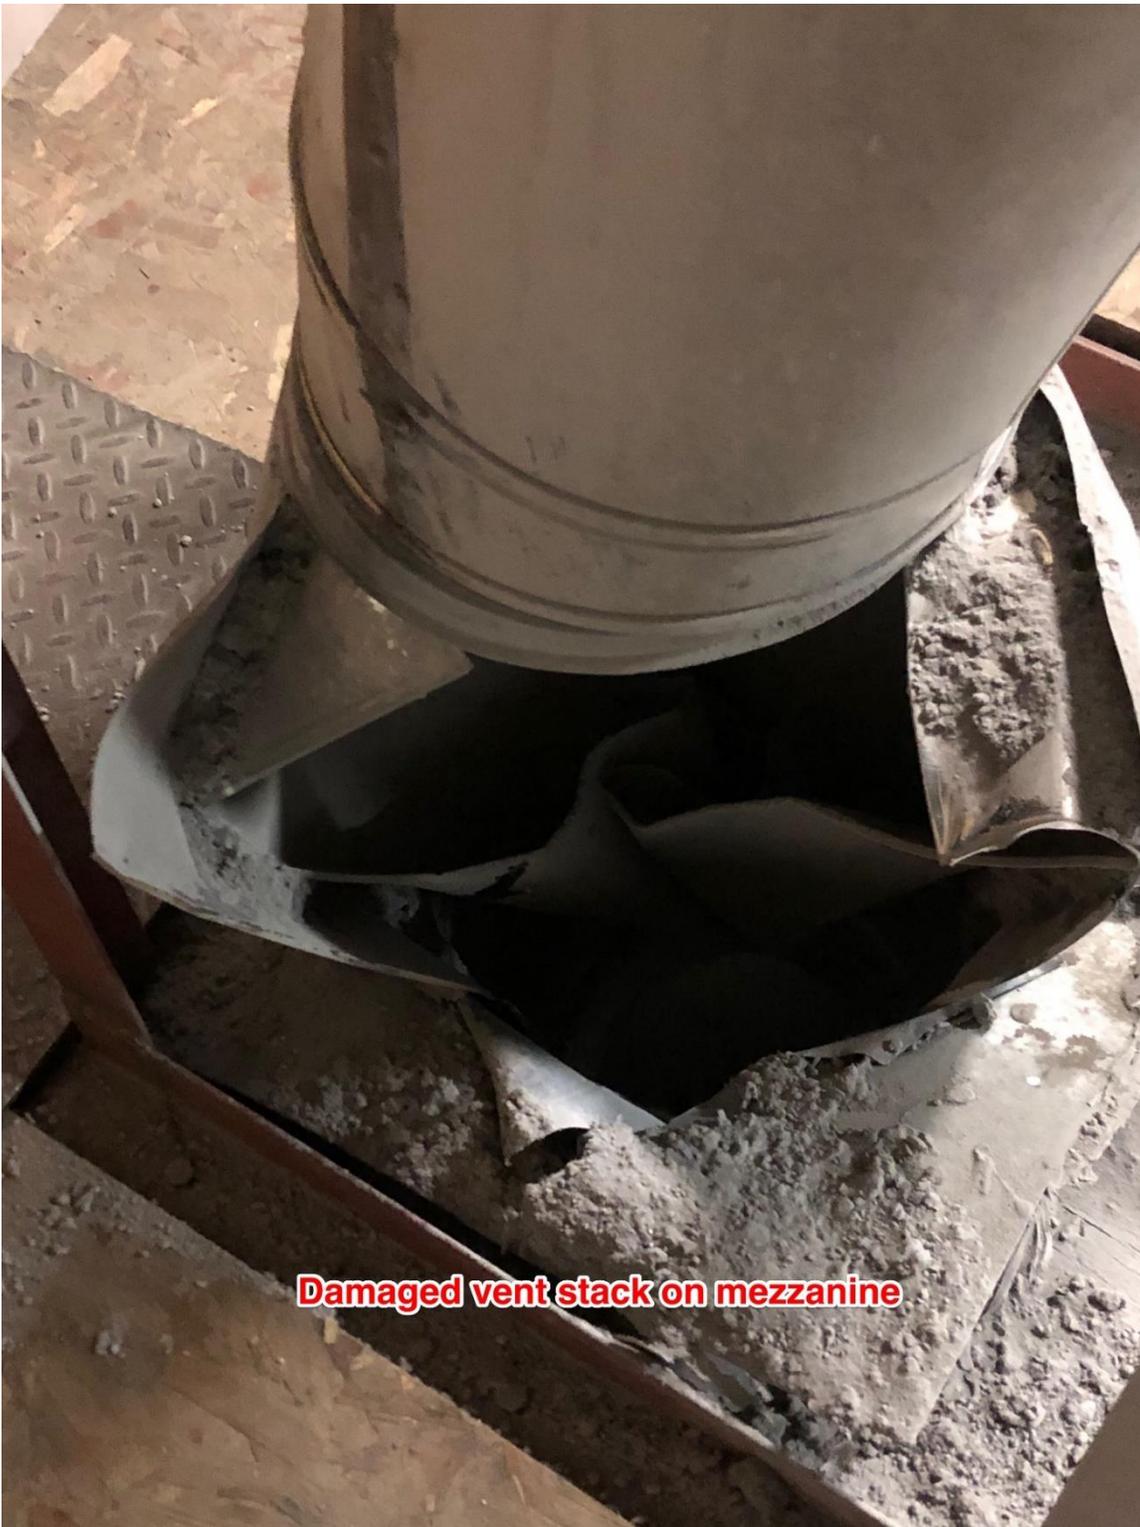
Image 5 - Boiler vent stack at mezzanine above boiler room

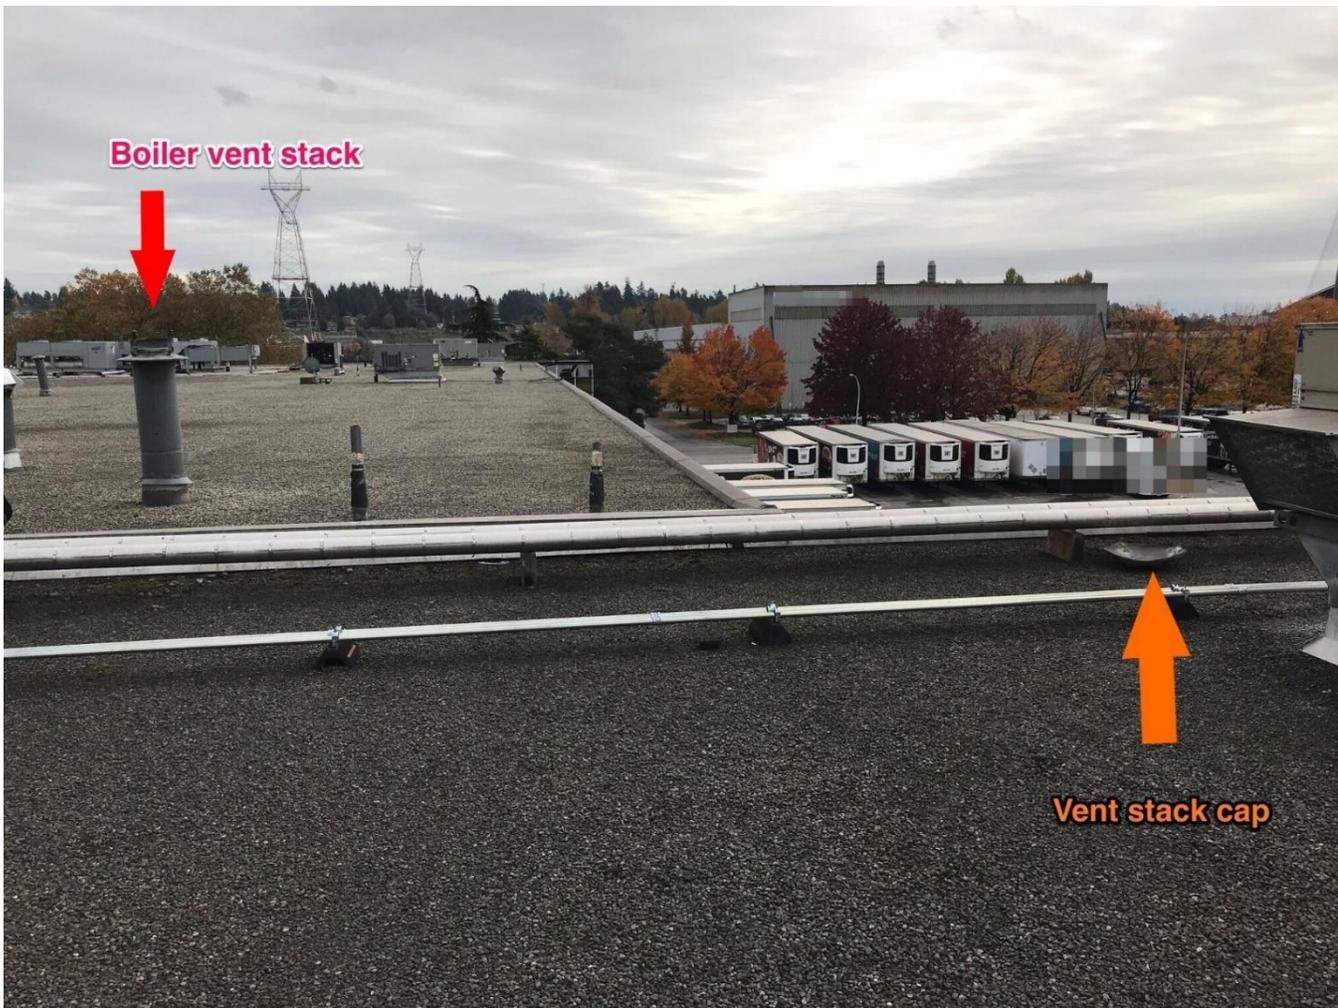
Image 6 - Location of vent cap after it was blown off the boiler vent stack by the explosion

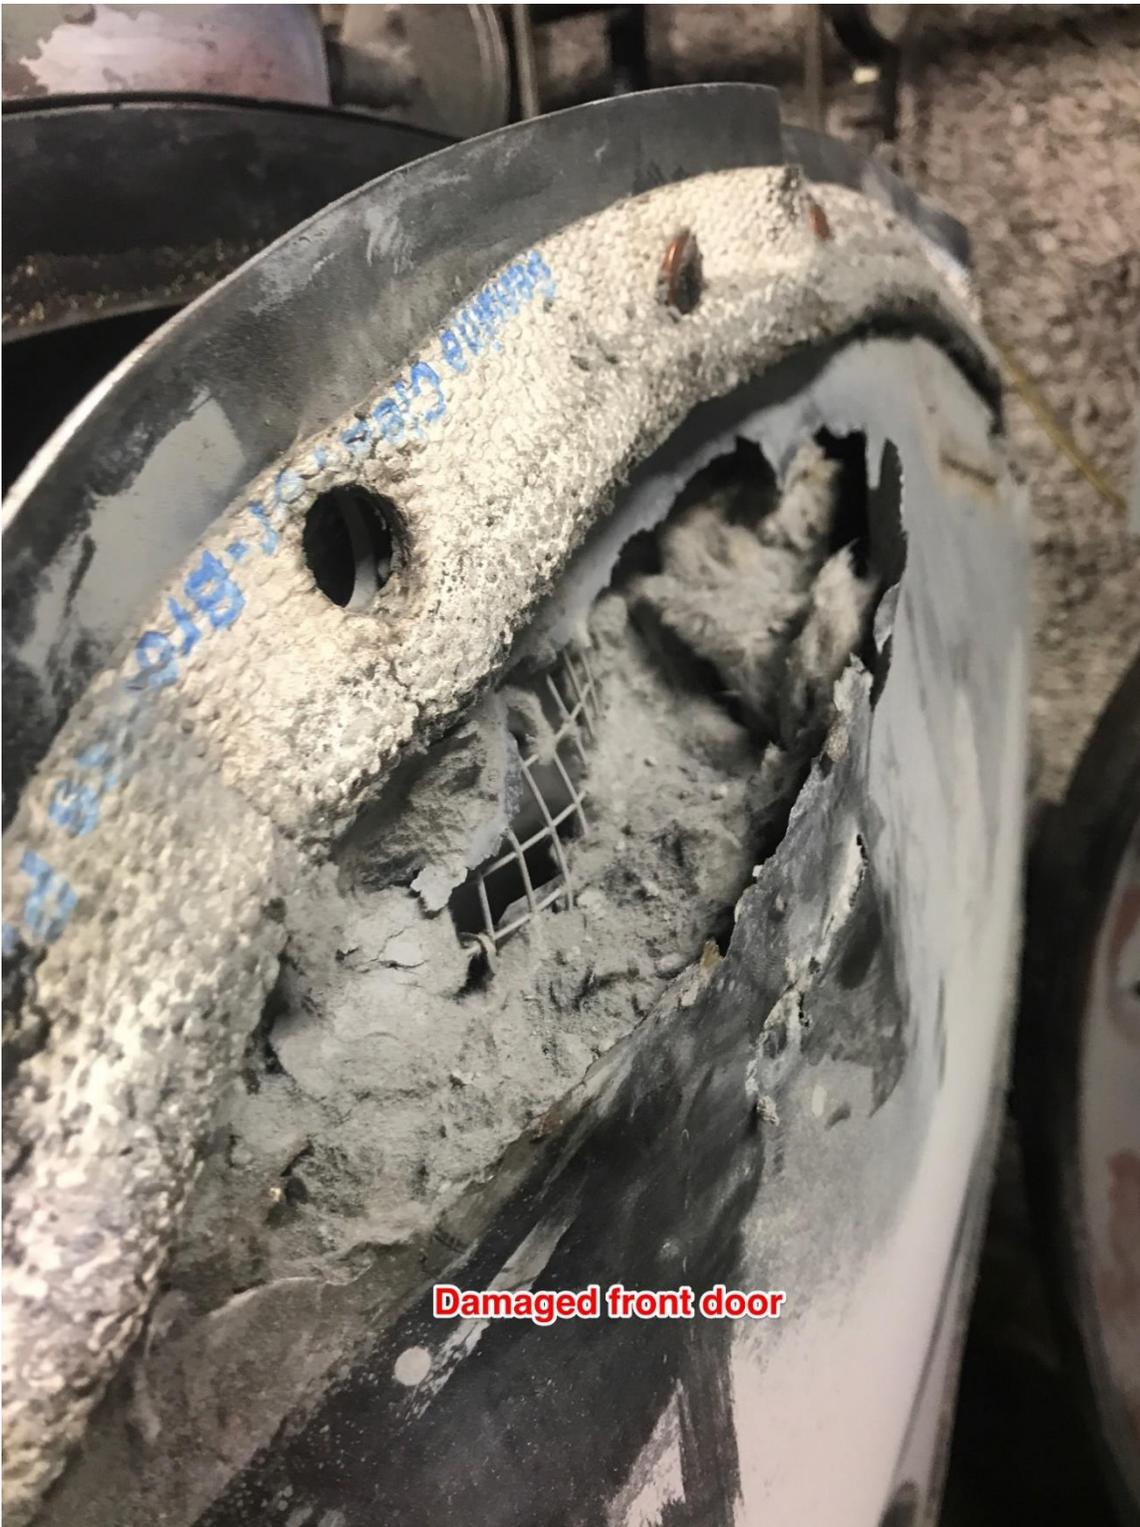
Image 7 - Damage to boiler front door

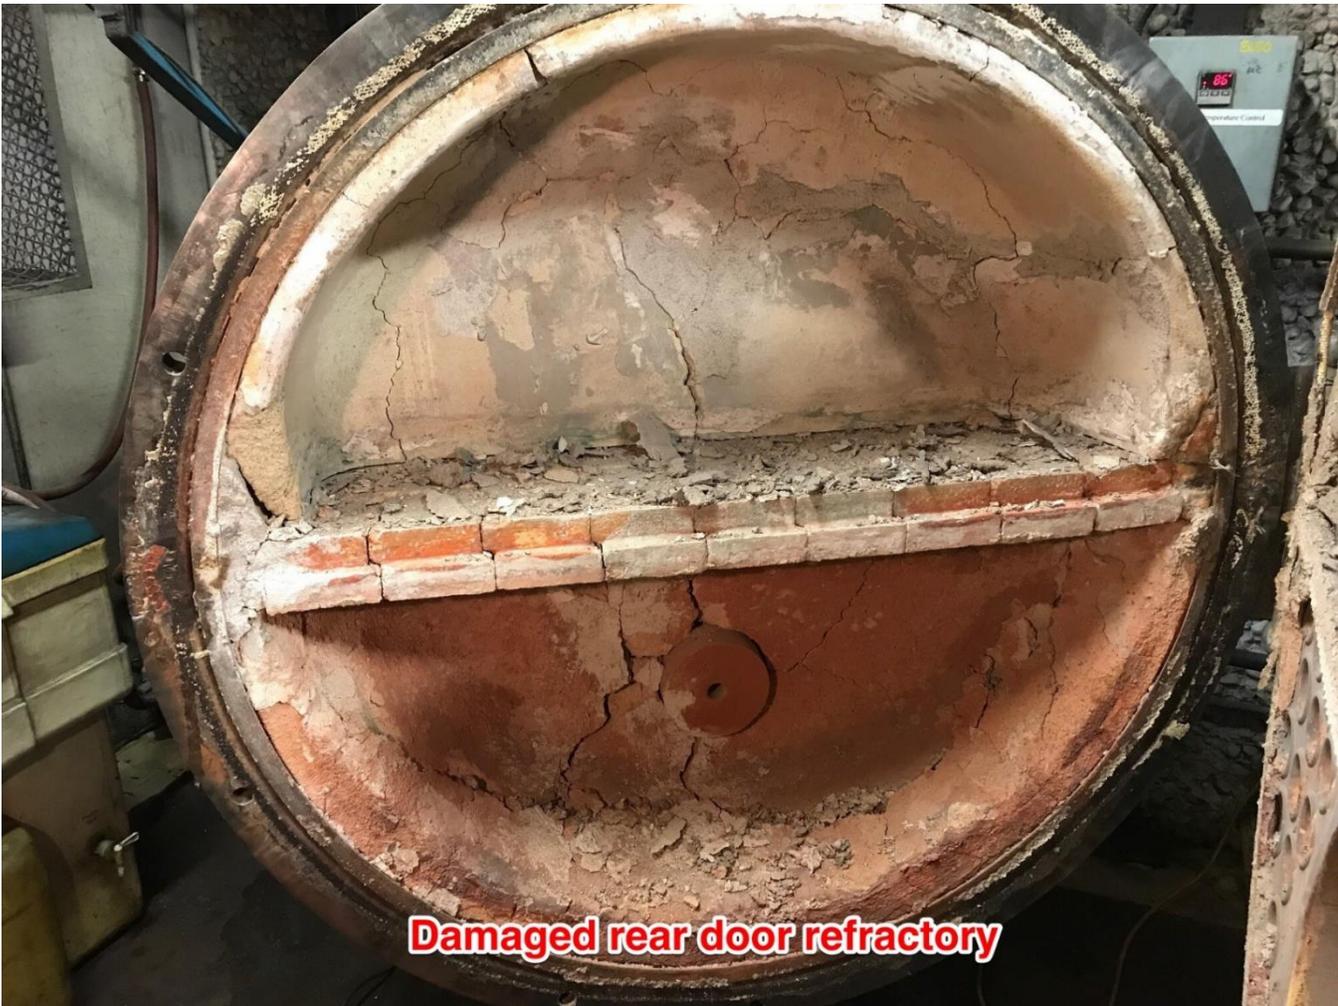
Image 8 - Cracked and broken rear door refractory insulation

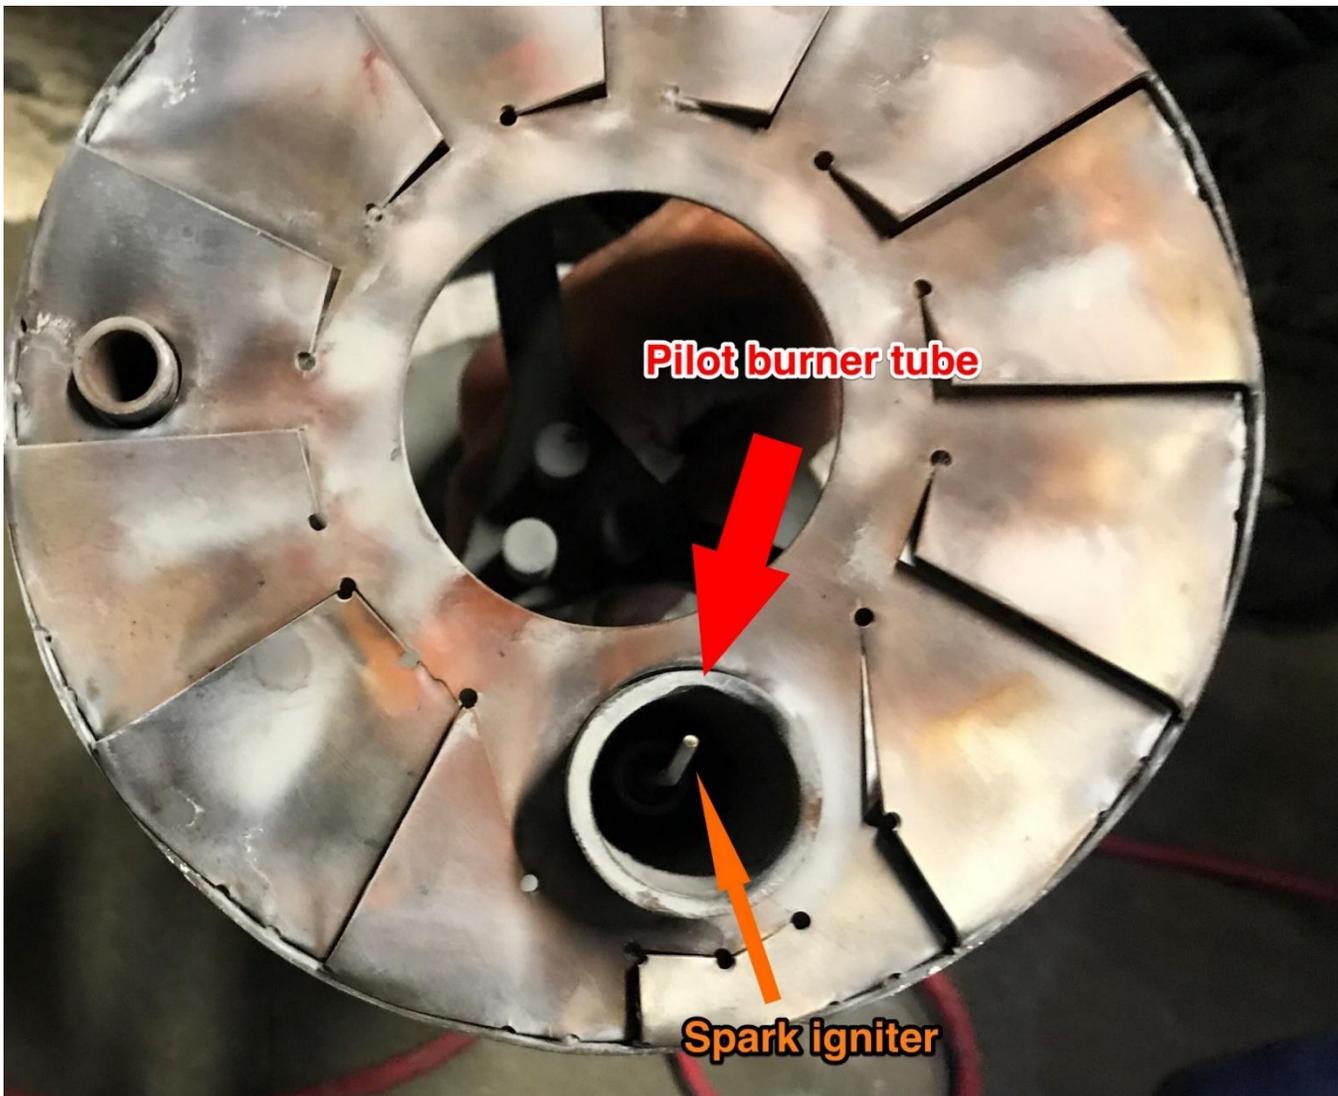
The skipped maintenance procedures resulted in a spark gap of 5/16" that was measured after the incident (**Image 9**). The spark gap exceeds the 3/32" gap size outlined in the work order instructions and the maximum size of 3/16" stated in the boiler manual. The annual service and maintenance inspection in March 2019 by the boiler contractor also failed to identify or adjust the excessive pilot spark gap.

Image 9 – Excessive spark gap in burner tube and diffuser that imparts a rotary swirling motion to the combustion air prior to entering the flame.

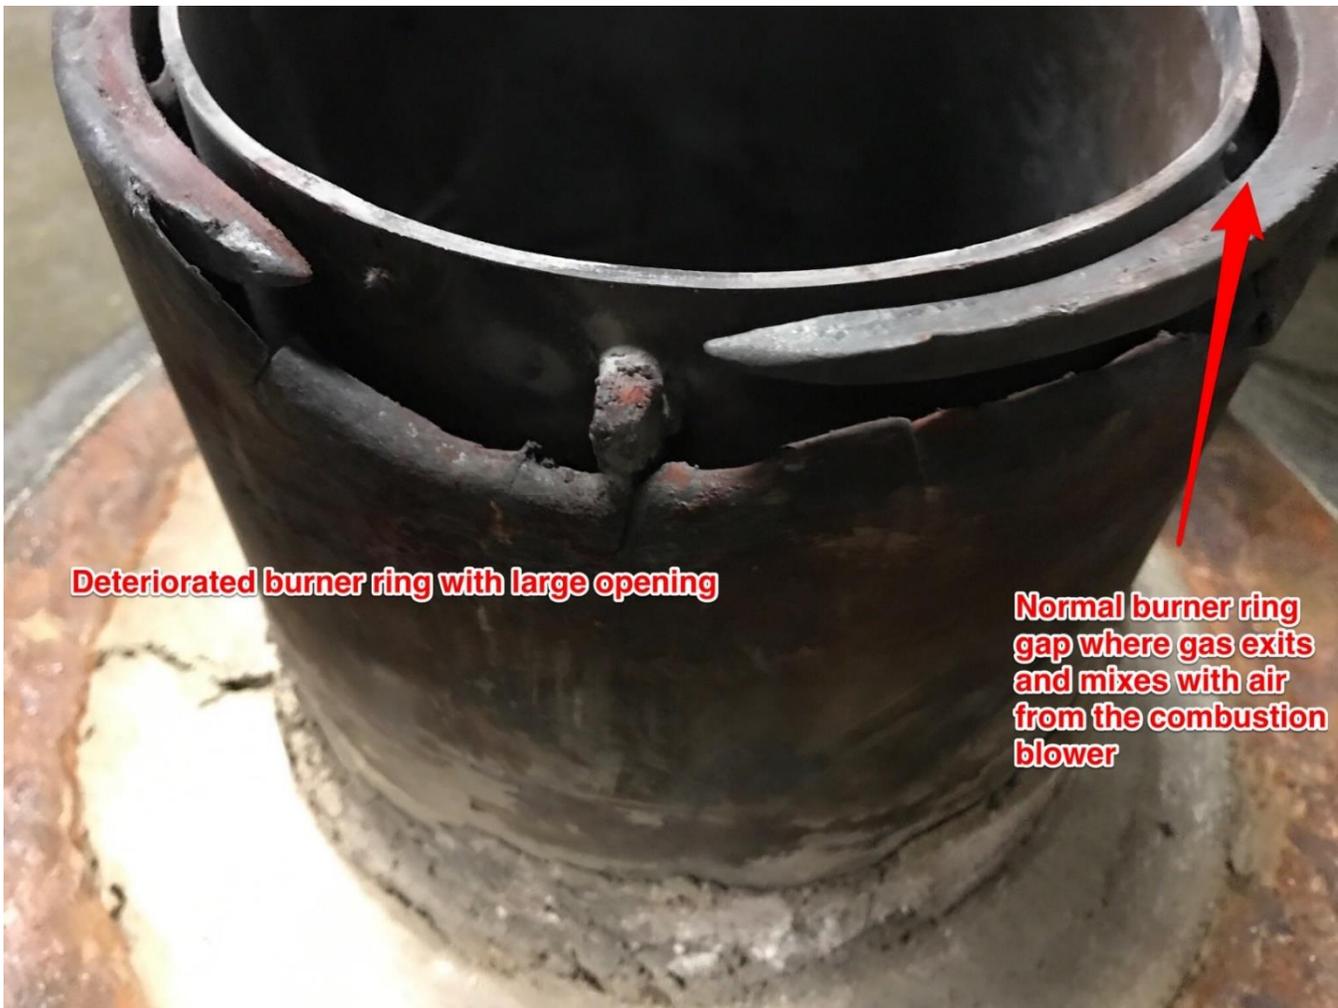
An independent boiler contractor company was hired to complete the annual service and maintenance for the boiler in March 2019. When the technician arrived to the facility, the boiler had already been shut down and opened up by the facilities employees. The technician's service report noted that the gas housing (burner ring) was damaged (**Images 10-11**) and recommended the replacement of it "*as soon as possible*". The technician contacted his office to see if a new burner ring was in stock for replacement that day, but one was not available and needed to be ordered. The technician stated that he was told that he had to have the boiler operating by the end of the day so production could resume. He stated that he felt a lot of pressure to put the boiler back into operation after identifying the deteriorated burner ring. He feared he may get in trouble, or the company he worked for may lose the service contract if he did not re-install the deteriorated part and put the boiler back into operation. He felt concerned with the financial ramifications to the customer and the hundreds of shift workers that would not be able to work if the boiler wasn't running and production had to stop. He made the decision to reinstall the deteriorated burner ring and worked onsite for 11 hours so he could place the boiler back into operation and production could resume. The technician's service report, noting the findings and the recommendation for the burner ring replacement, was emailed to the customer. The boiler remained in operation in that hazardous state for over seven months until the incident occurred.

Image 10 - Burner housing with deteriorated ring and large gas port opening. The air diffuser gets positioned in the middle circular area of the burner housing.

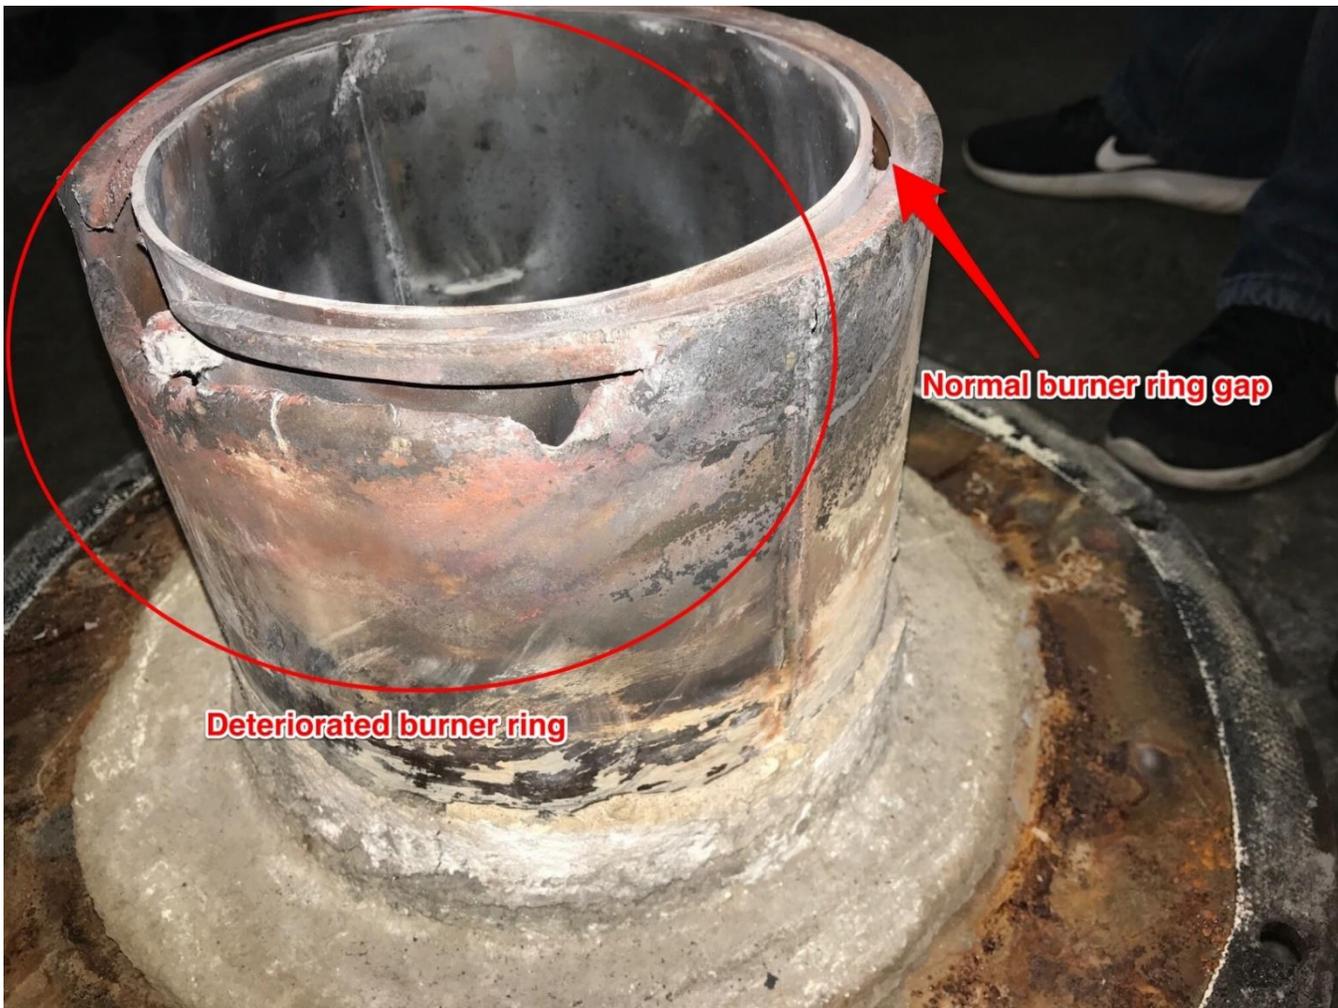
Image 11 - Burner housing with deteriorated ring and large gas port opening

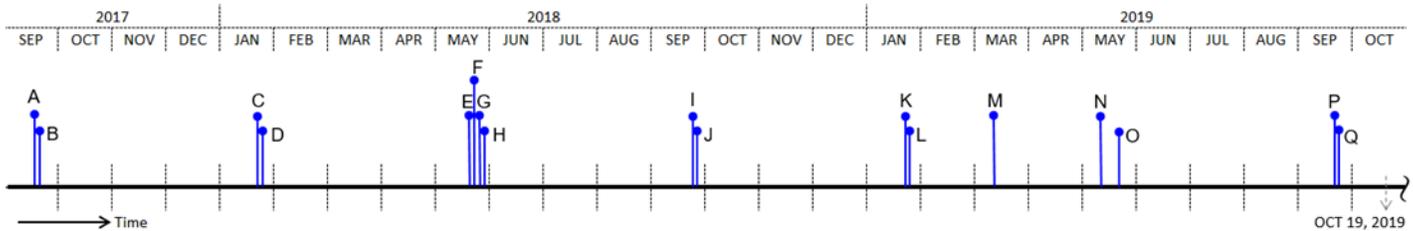
Figure 1 - Event timeline (September 2017 to October 2019). Red X indicates explosion.

<p>Facts and evidence</p>	<p>Review of the maintenance records for the last two years of the boiler's operation identified multiple work orders for scheduled maintenance procedures that were skipped and signed off by the maintenance supervisor. Notes on the work orders indicate the procedures were skipped as to not interrupt the facilities production (Figure 1). The skipped maintenance procedures were for boiler electrode</p>

- A. Work order (WO) (17-002855) Boiler electrode cleaning and adjustment**
WO Note: "Cannot do during [Preventative Maintenance] (PM) period. Always in use."

- B. WO 17-002855 Signed off by supervisor**
Decision to continue production and skip maintenance was accepted.
- C. WO 17-004993 Boiler electrode cleaning and adjustment**
WO Note: "Boiler is always in use during this PM cycle. No opportunity for a shutdown. No event of ignition failure. Boiler inspection is coming soon."

- D. WO 17-004993 Signed off by supervisor**
- E. WO 17-006973 Boiler electrode cleaning and adjustment**
WO Note: "Cannot do electrode inspection this PM period. Always running production."

- F. WO 17-006973 Signed off by supervisor**
- G. WO 17-006276 Main gas valve leak test**
WO Note: "Cannot do this main gas valve check this PM period. Always running production & cannot shut down boiler for gas leak test."

- H. WO 17-006276 Signed off by supervisor**
- I. WO 17-008899 Boiler electrode cleaning and adjustment**
WO Note: "Cannot shut down boiler to check electrode. Running productions. No failure to ignite within the last two weeks."

- J. WO 17-008899 Signed off by supervisor**
- K. WO 17-010711 Boiler electrode cleaning and adjustment**
WO Note: "Cannot check boiler electrode for this PM period. Running production on three lines, cannot shut down boiler."

- L. WO 17-010711 Signed off by supervisor**
- M. Service report WO#10687** Annual service and inspection completed by third-party contractor.
Service report note: "Gas housing damaged and requires replacement as soon as possible, parts need to be ordered... Back door in poor condition, should be replaced or rebuilt. Mod motor making grinding noise and should be replaced."

- N. WO 17-012492 Boiler electrode cleaning and adjustment**
No comments or indication that cleaning and/or adjustment was completed.
- O. WO 17-012492 Signed-off by supervisor**

- P. WO 17-014238 Boiler electrode cleaning and adjustment**
WO Note: "No recent failures of ignition recorded. Cannot perform electrode check due to production, boiler in use."

- Q. WO 17-014238 Signed off by supervisor**

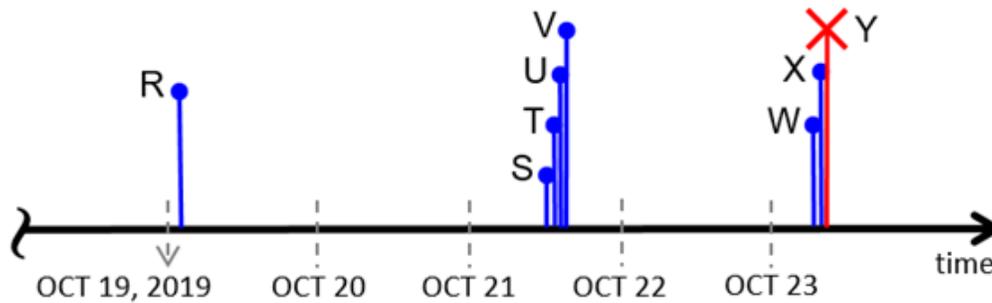
Figure 2 - Event timeline (October 19-23, 2019) Red X indicates explosion

Statements from the Senior Engineering Manager and Engineering Supervisor state that between October 19–23, 2019 the boiler went into a safety shutdown and locked out four times requiring manual resets to restart the boiler (**Figure 2**). The burner control lockouts were due to the main flame extinguishing during operation and failures to ignite the main burner off of the pilot flame. The boiler was not shut down to investigate, identify or repair any faults.

- R. Boiler operation stopped by safety control. Controller manually reset and boiler placed back into operation.
- S. Boiler operation stopped by safety control. Controller manually reset and boiler placed back into operation.
- T. Engineering supervisor notified the Senior Engineering Manager of the boiler flame failure and lock-out condition.
- U. Engineering supervisor observed an inconsistent gas supply to pilot flame and informed the Senior Engineering Manager.
- V. Senior Engineering Manager visually observed the gas flame. The boiler was allowed to continue operating without further testing or examination
- W. Boiler operation stopped by safety control. Controller manually reset and boiler placed back into operation.
- X. Boiler operation stopped by safety control. Controller manually reset and boiler placed back into operation.
- Y. Explosion occurred
