Incident Summary #II-1648621-2023 (#42362) (FINAL)

inc	Incident Summary #II-1648621-2023 (#42362) (FINAL)					
SUPPORTING INFORMATION	Incident Date		December 8, 2023			
	Location		Ladysmith			
	Regulated industry sector		Electrical - Low voltage electrical system (30V to 750V)			
		Qty injuries	0			
	t Injury	Injury description	Canine – deceased.			
	Impact	Injury rating	None			
	Im	Damage description	Melted heater, fire damage to walls and floor in room of origin. Fire spread to walls and basement damaging structural components.			
		Damage rating	Moderate			
	Incident rating		Moderate			
	Incident overview		A fire started in the vicinity of a baseboard heater. The fire damaged the floor and walls in the room of origin and spread through a vent in the floor to the basement. A 10-month-old Canine in the room perished.			
	Site, system and components		A baseboard heater (BB heater) is an electric heater that uses a resistor/element and convection to heat a room.

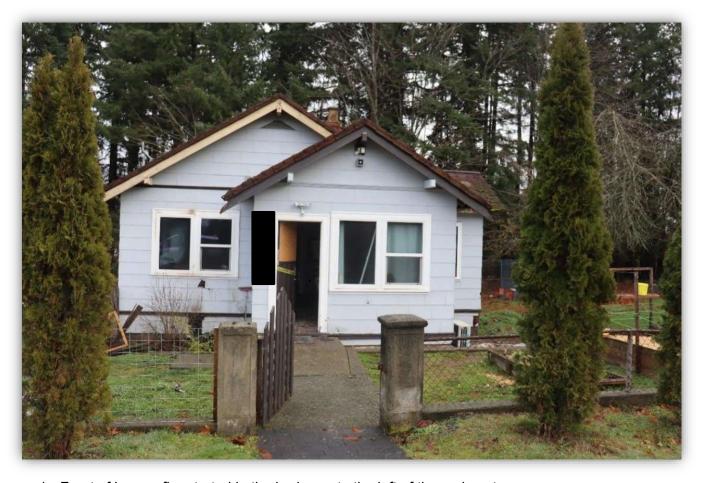
Image 1 - Front of house, fire started in the bedroom to the left of the main entrance.

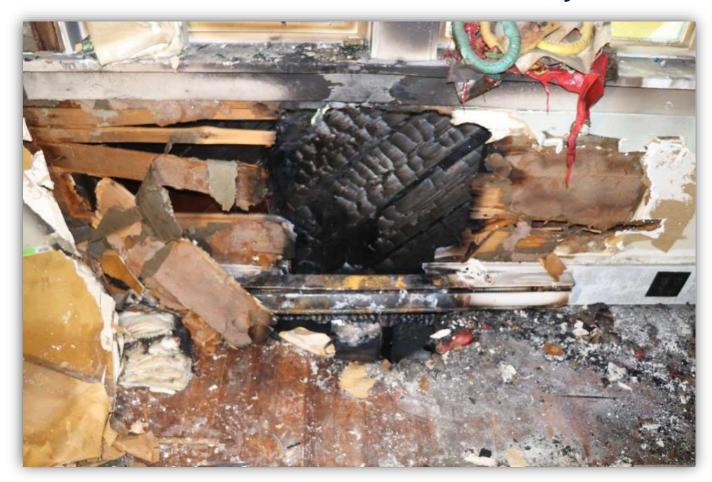
It is thought by investigators, that flammable material contacted the heater which ignited and was able to spread to the plastic bottles stored on the shelves underneath the heater through the floor vent, as the furnace duct was disconnected from the vent.			
			No other electrical sources were found in the vicinity of the fire origin, in the bedroom nor in the basement under the bedroom.

Facts and evidence	Independent fire investigators examined the scene and noted that based on the smoke pattern on the wall, that the curtains were open when the fire started. The heater was mounted directly to a fir baseboard which complied with the manufacturer's instructions. Investigators stated that the fire originated at the heater and likely had flammable material up against it.
Causes and contributing factors	It is plausible that flammable material contacted the heater, which ignited and spread to the basement through the vent in the floor.

Image 2 - Origin of the fire.

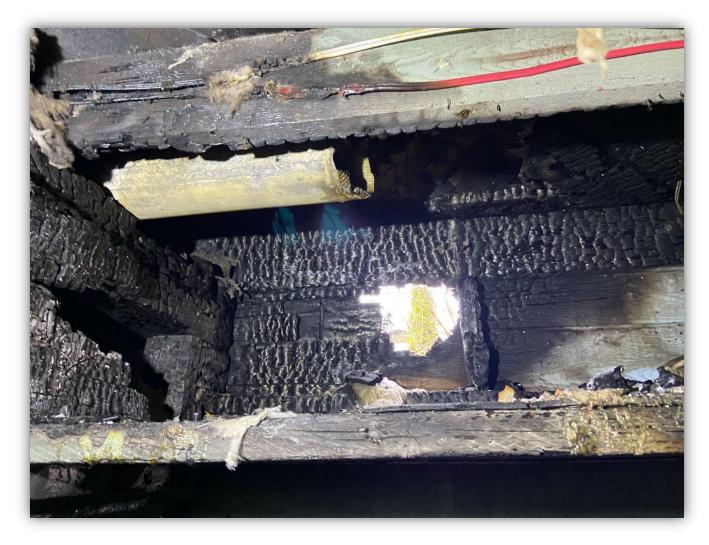
Image 3 - Shelving in the basement under the bedroom, the shelving contained plastic bottles.

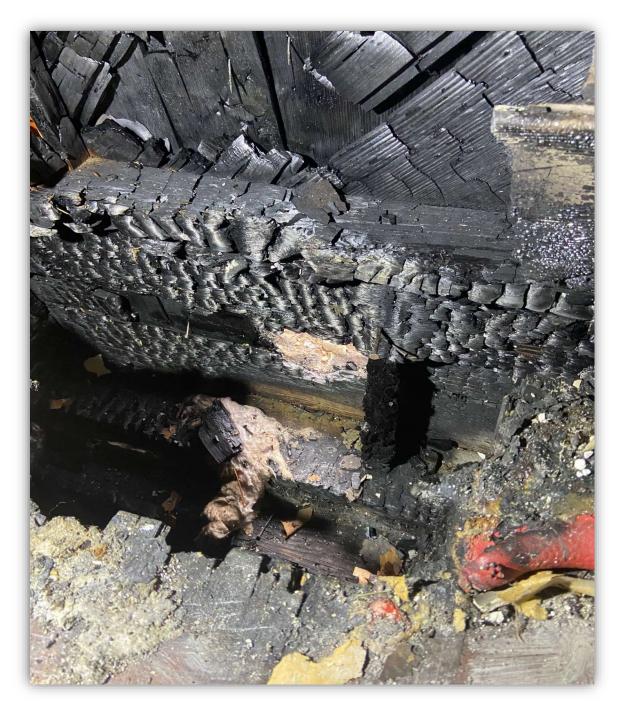
Image 4 - Looking from bedroom through hole in floor to the basement.
