Incident Summary #II-1199310-2021 (#22131) (FINAL)

SUPPORTING INFORMATION	Incident Date	May 23, 2021
	Location	Maple Ridge
	Regulated industry sector	Gas - Natural gas system
	Impact	Qty injuries
		3
		Injury description
		Multiple occupants reported symptoms of carbon monoxide (CO) exposure including headaches, nausea, vomiting, loss of focus, and drowsiness at various times over a period of 3 plus years. One occupant sought medical attention for the CO symptoms.
		Injury rating
		Moderate
	Damage	Damage description
		Products of combustion including CO and corrosive condensate spilled into multiple interior spaces; corrosion to electrical distribution equipment; disintegration of the electrical room ceiling from condensate moisture; bowing and splitting of the flooring in the dwelling above from moisture.
INVESTIGATION CONCLUSIONS	Site, system and components	Damage rating
		Moderate
		Incident rating
INVESTIGATION CONCLUSIONS	Site, system and components	Moderate

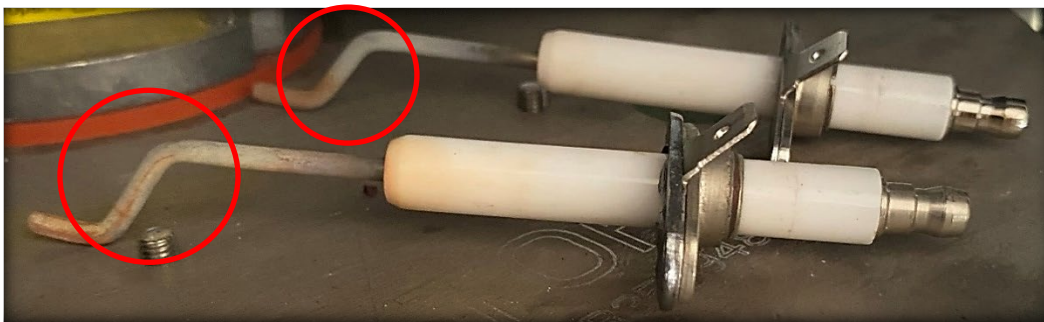
Failure scenario(s)	<p>The boiler (Image 3) was installed in a system where it was oversized and as a result would repeatedly take short amounts of time to meet the heating demand (known as short cycling). The boiler used a single prong ignitor that had residual stress in the metal offset bend (Image 1). The ignitor experienced advanced wear and tear from the short cycling occurrences. From this wear and tear the residual stress was very likely released and the arc gap between the ignitor prong and the metal burner mesh increased beyond the manufacturer's recommended gap distance (Image 5). On multiple occasions, the boiler was not initially igniting the natural gas. This delayed ignition led to a build up of unburnt gas and explosive detonations when ignition would finally occur. The venting system on multiple occasions separated within the interior space from the force of the boiler's detonations (Image 4). This released products of combustion including moisture and CO into the ground floor rooms that then infiltrated the above dwelling through its floor (Image 7).</p>

- There are no records available from the manufacturer of a dual prong ignitor being installed at this site.
- Both ignitors from [\(Image 1\)](#) look to be of the Kanthal advanced powder metallurgy (APM). The unmarked one, is a new vendor who only produced Kanthal APM. The Sapco ones looks like the newer style and is expected to be Kanthal APM as well.

A gas contractor representative stated that the boiler was utilizing a single prong ignitor [\(Image 1\)](#) as of May 23, 2021. A second previously used single prong ignitor was found inside the boiler cabinet. There is no evidence that an ignitor other than a single prong type had been utilized at any time for this boiler. The manufacturers manual specifies a spark gap setting of between 3.2 and 4.7mm.

Image 1 - Single prong ignitors used with the boiler. Offsets indicated in the circles.

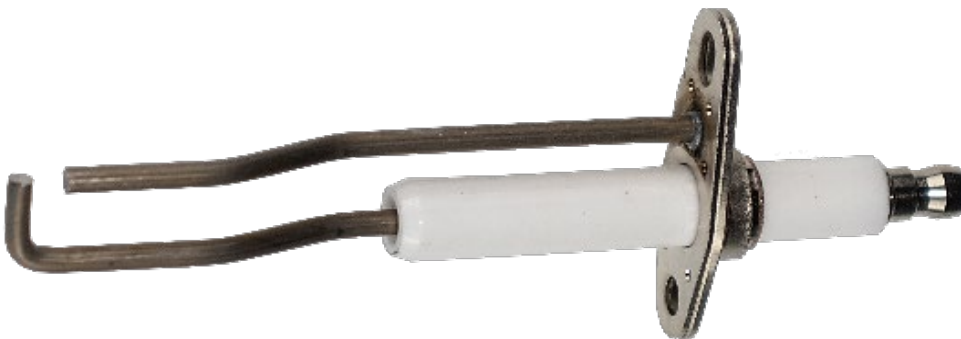
- The boiler manufacturer identified issues with the original ignitors and issued a discontinuation of P-340 single prong ignitors (that applies to the SL G3 boiler at this site as well as other indicated models) on January 22, 2021, that included the following wording:
"Effective immediately, the P-111B double-prong ignitor (Figure 1) replaces the P-340 single-prong ignitor. The P-111B is the new standard for the SL-series boilers as it combines an improved metallurgic formula for longevity with the convenience of a factory-set spark gap."
Link: [P-111B change](#)

Image 2 - Dual prong type ignitor indicated in boiler manufacturers product change.

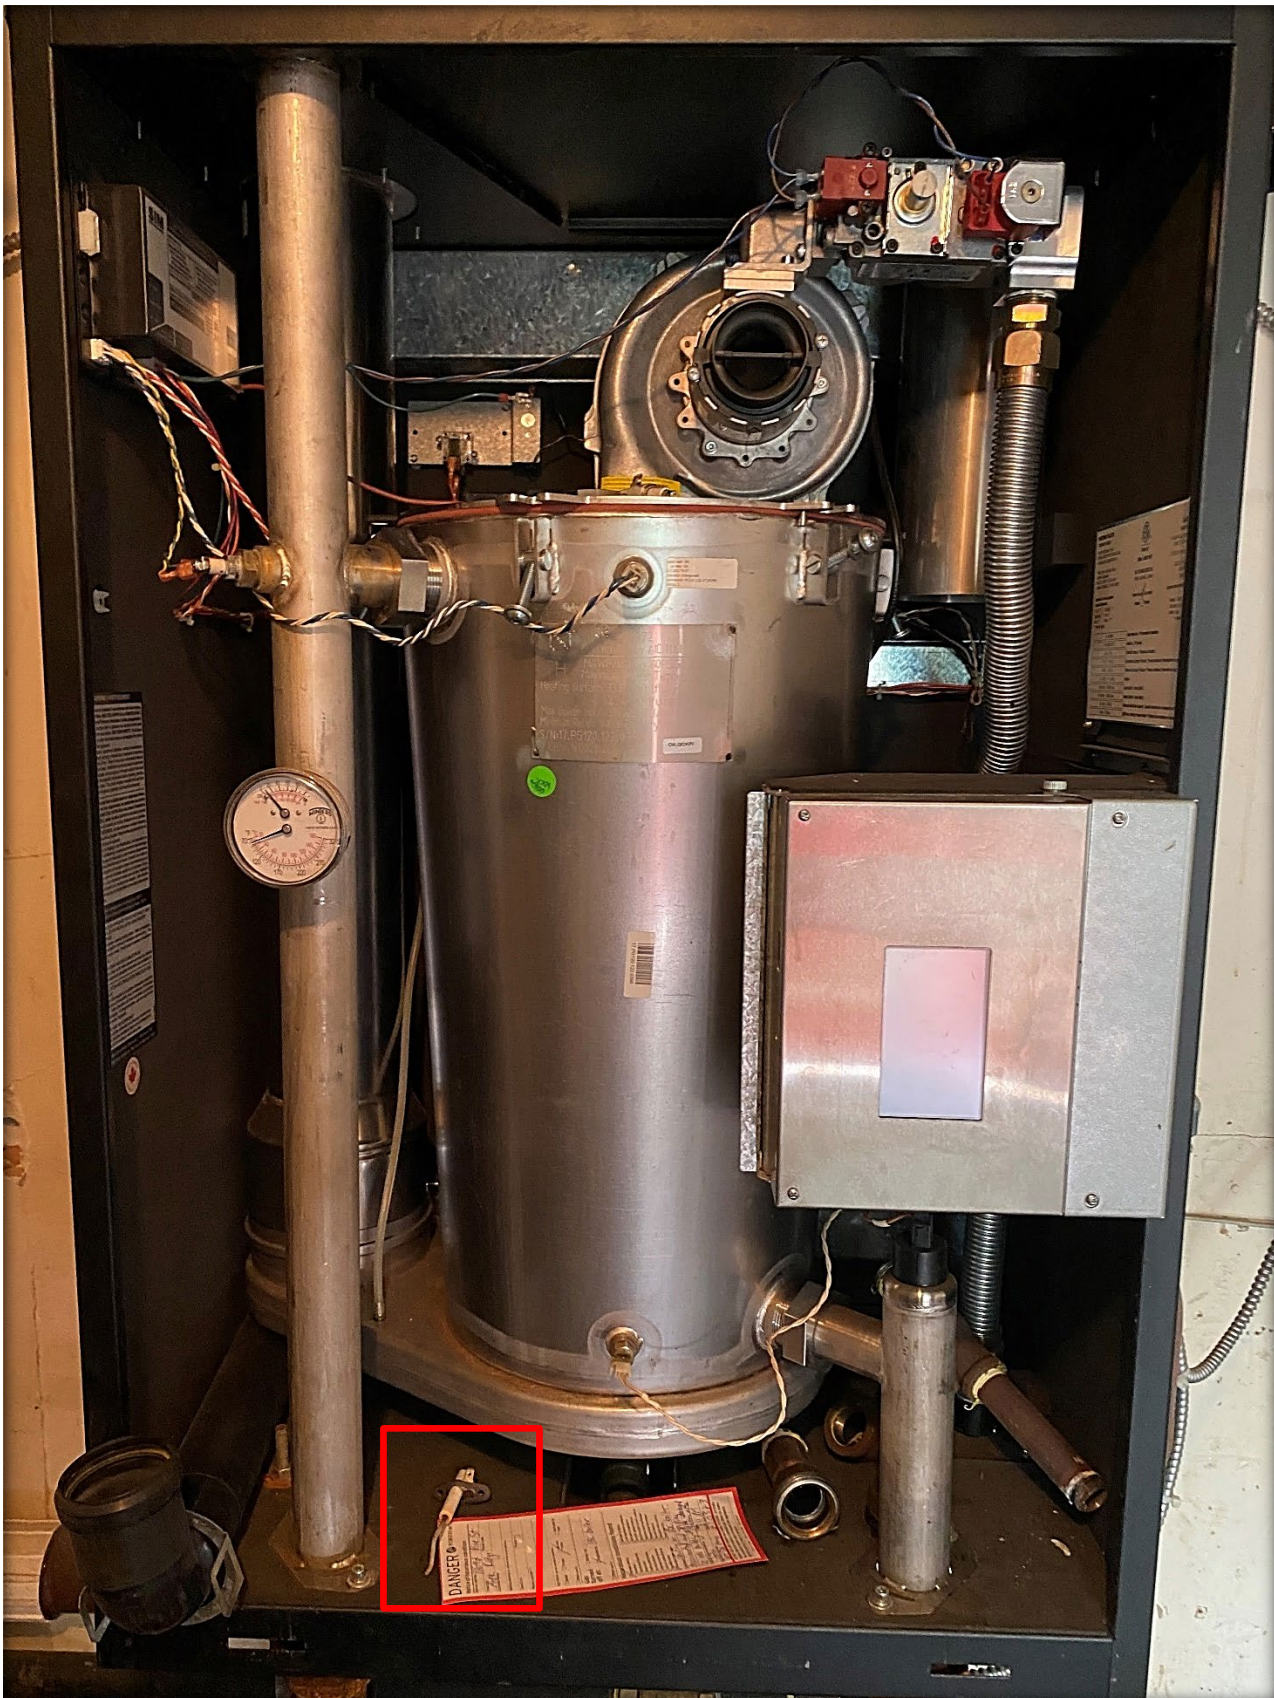
Image 3 - Hydronic boiler. Note the extra used single prong ignitor in the red rectangle.

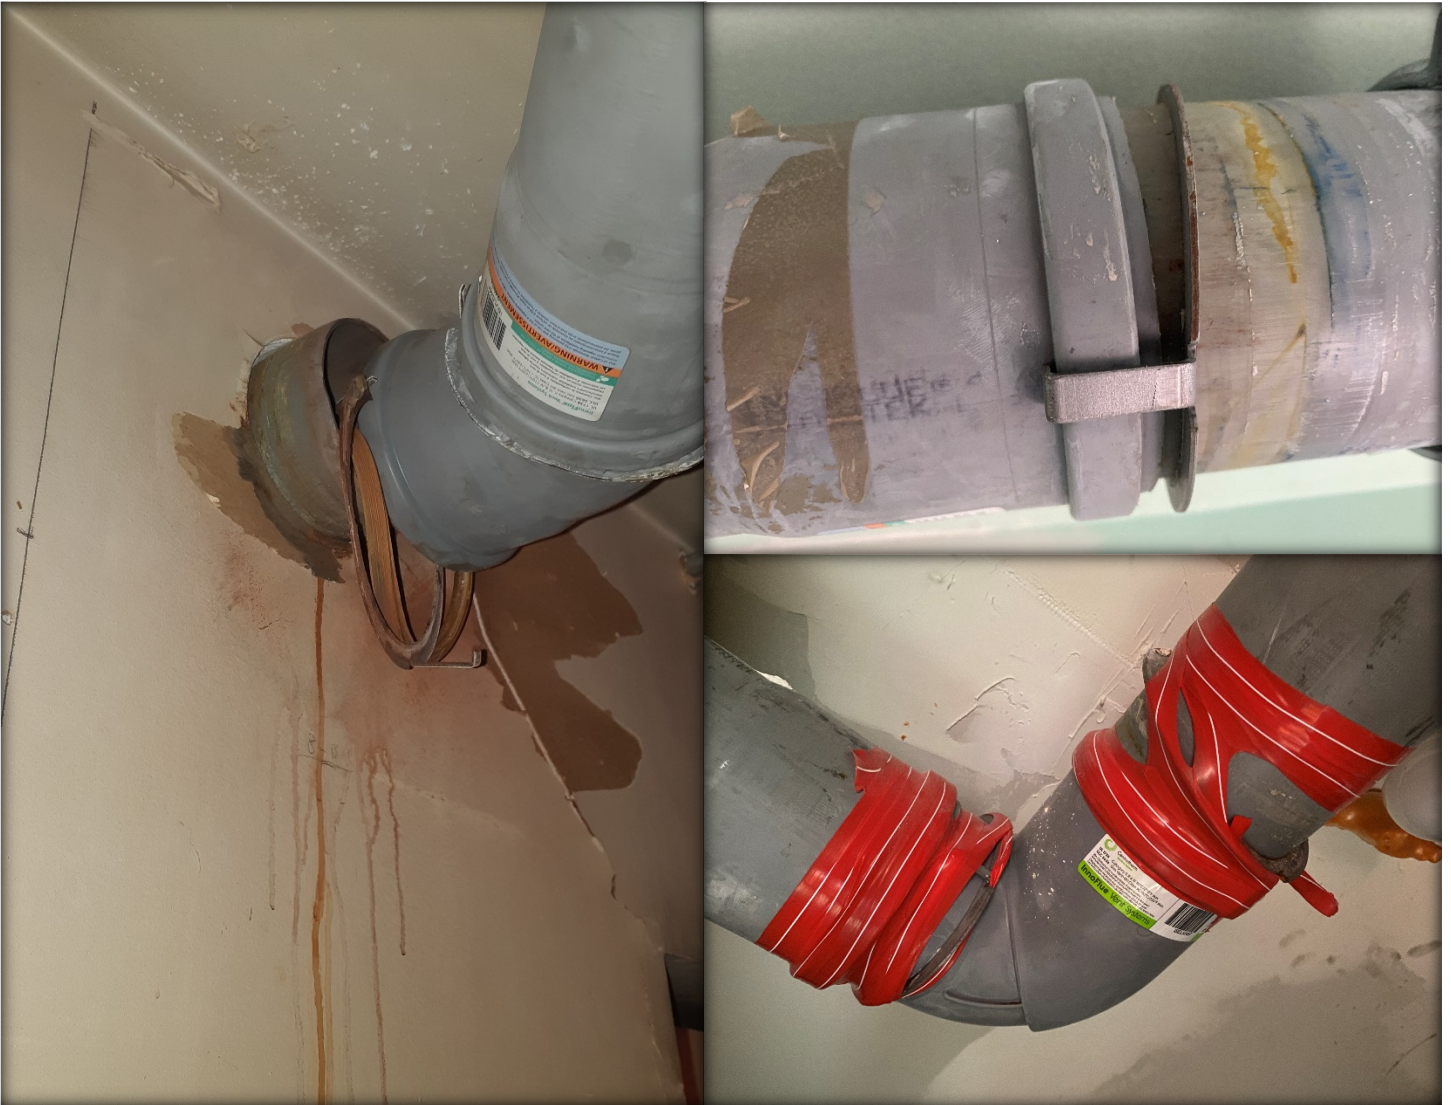
<p>disengaged in the electrical room from delayed ignition detonations. Boiler exhaust and condensate was damaging the ceiling.</p> <p>May 23, 2021 - The utility gas technician stated they had reports from multiple tenants of large booms (sounding like a shotgun) leading up to May 23rd and gas smells in the building. The fire department stated that they noted a gas smell, measured 14 parts per million of carbon monoxide and decreased oxygen levels in the mechanical room. The utility gas technician confirmed that they shut the gas to the boiler off.</p>
<p>Causes and contributing factors</p>	<p>The incident was very likely caused by the use of an inadequate single prong ignitor. The appliance venting system repeatedly disengaging in multiple locations from the delayed ignition detonations was a contributing factor.</p>

Image 4a, b, c – Boiler venting disengaged from delayed ignition detonations and with improper tape repairs.

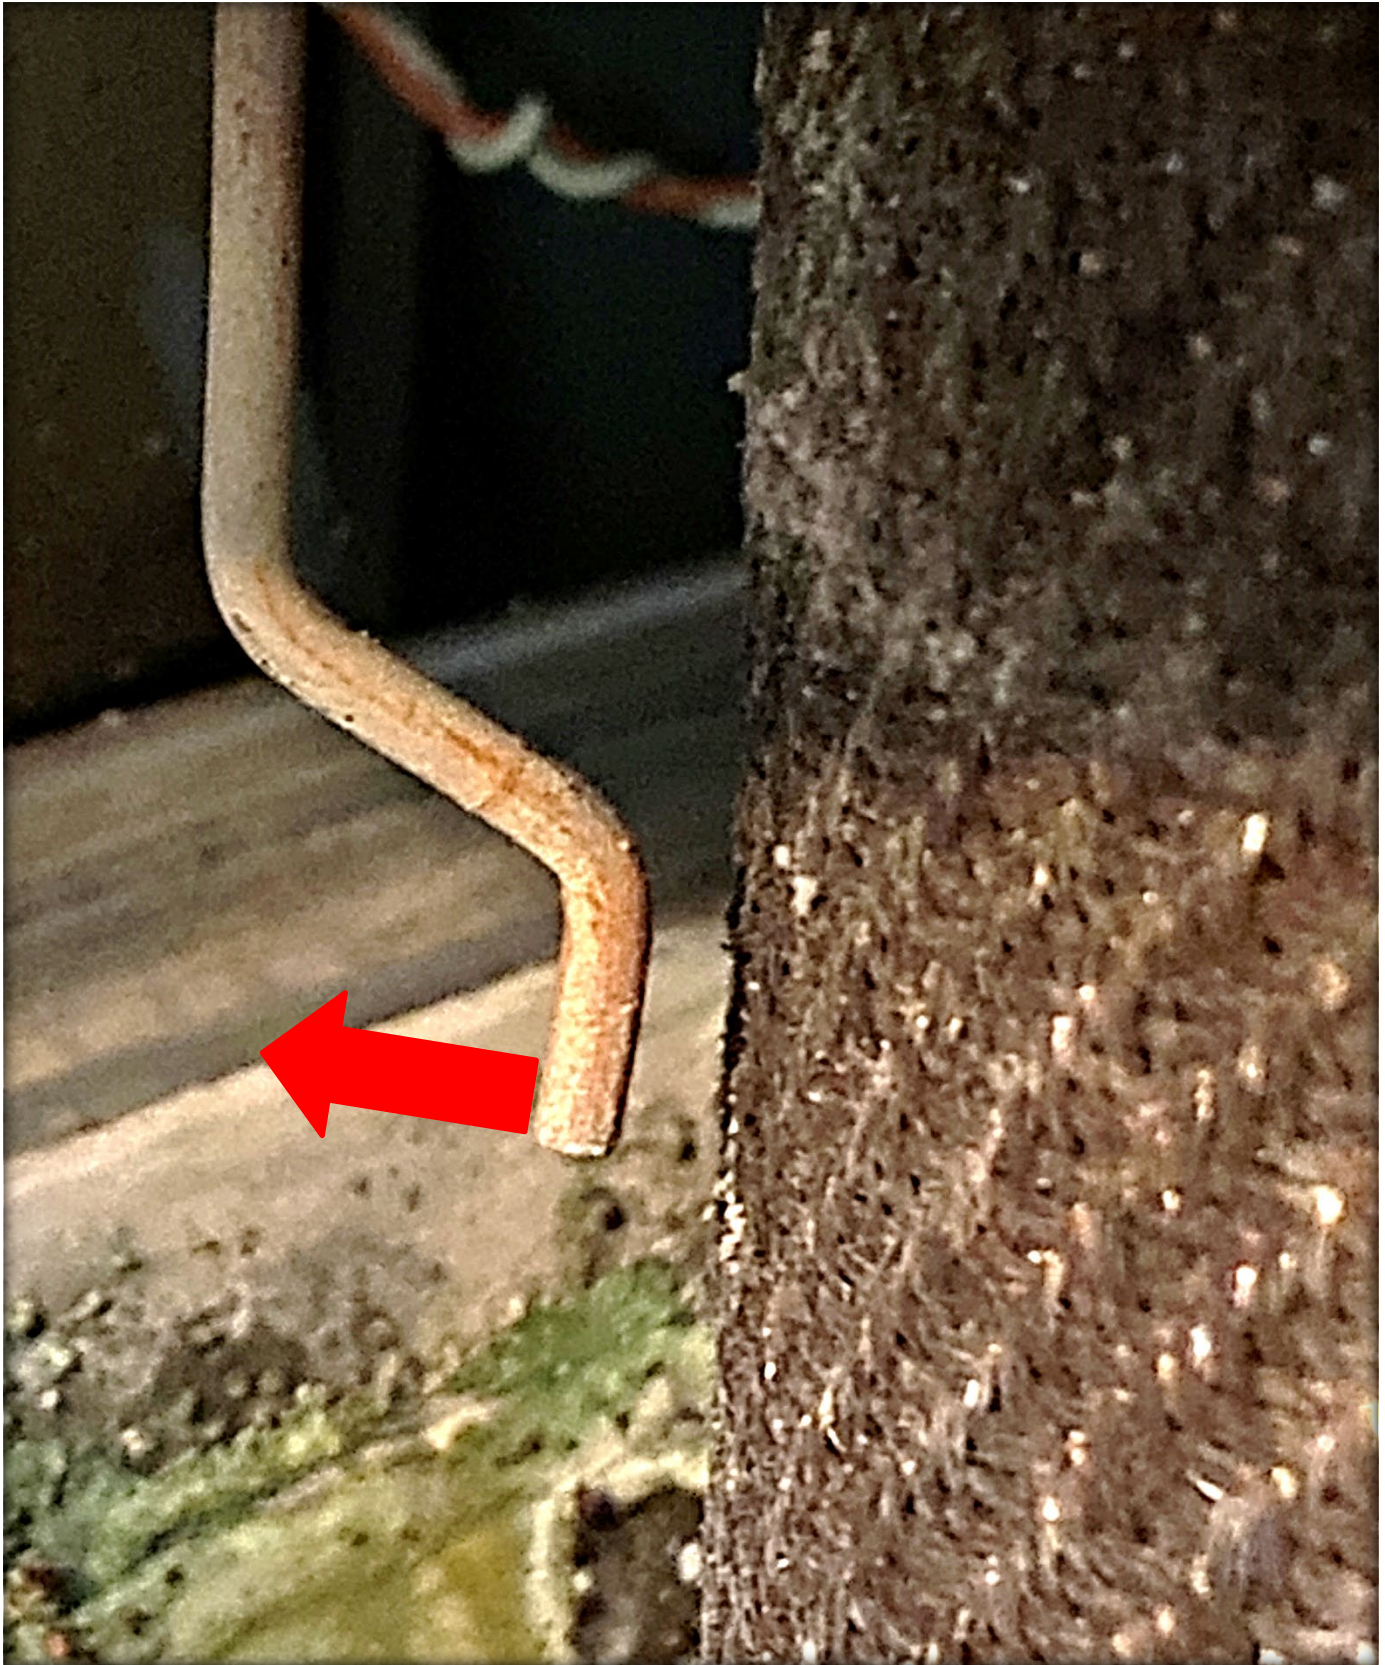
Image 5 - Single prong ignitor configuration and direction of warping away from the burner mesh due to release of stress in the metal (arrow). This warping would cause an increased arc gap.

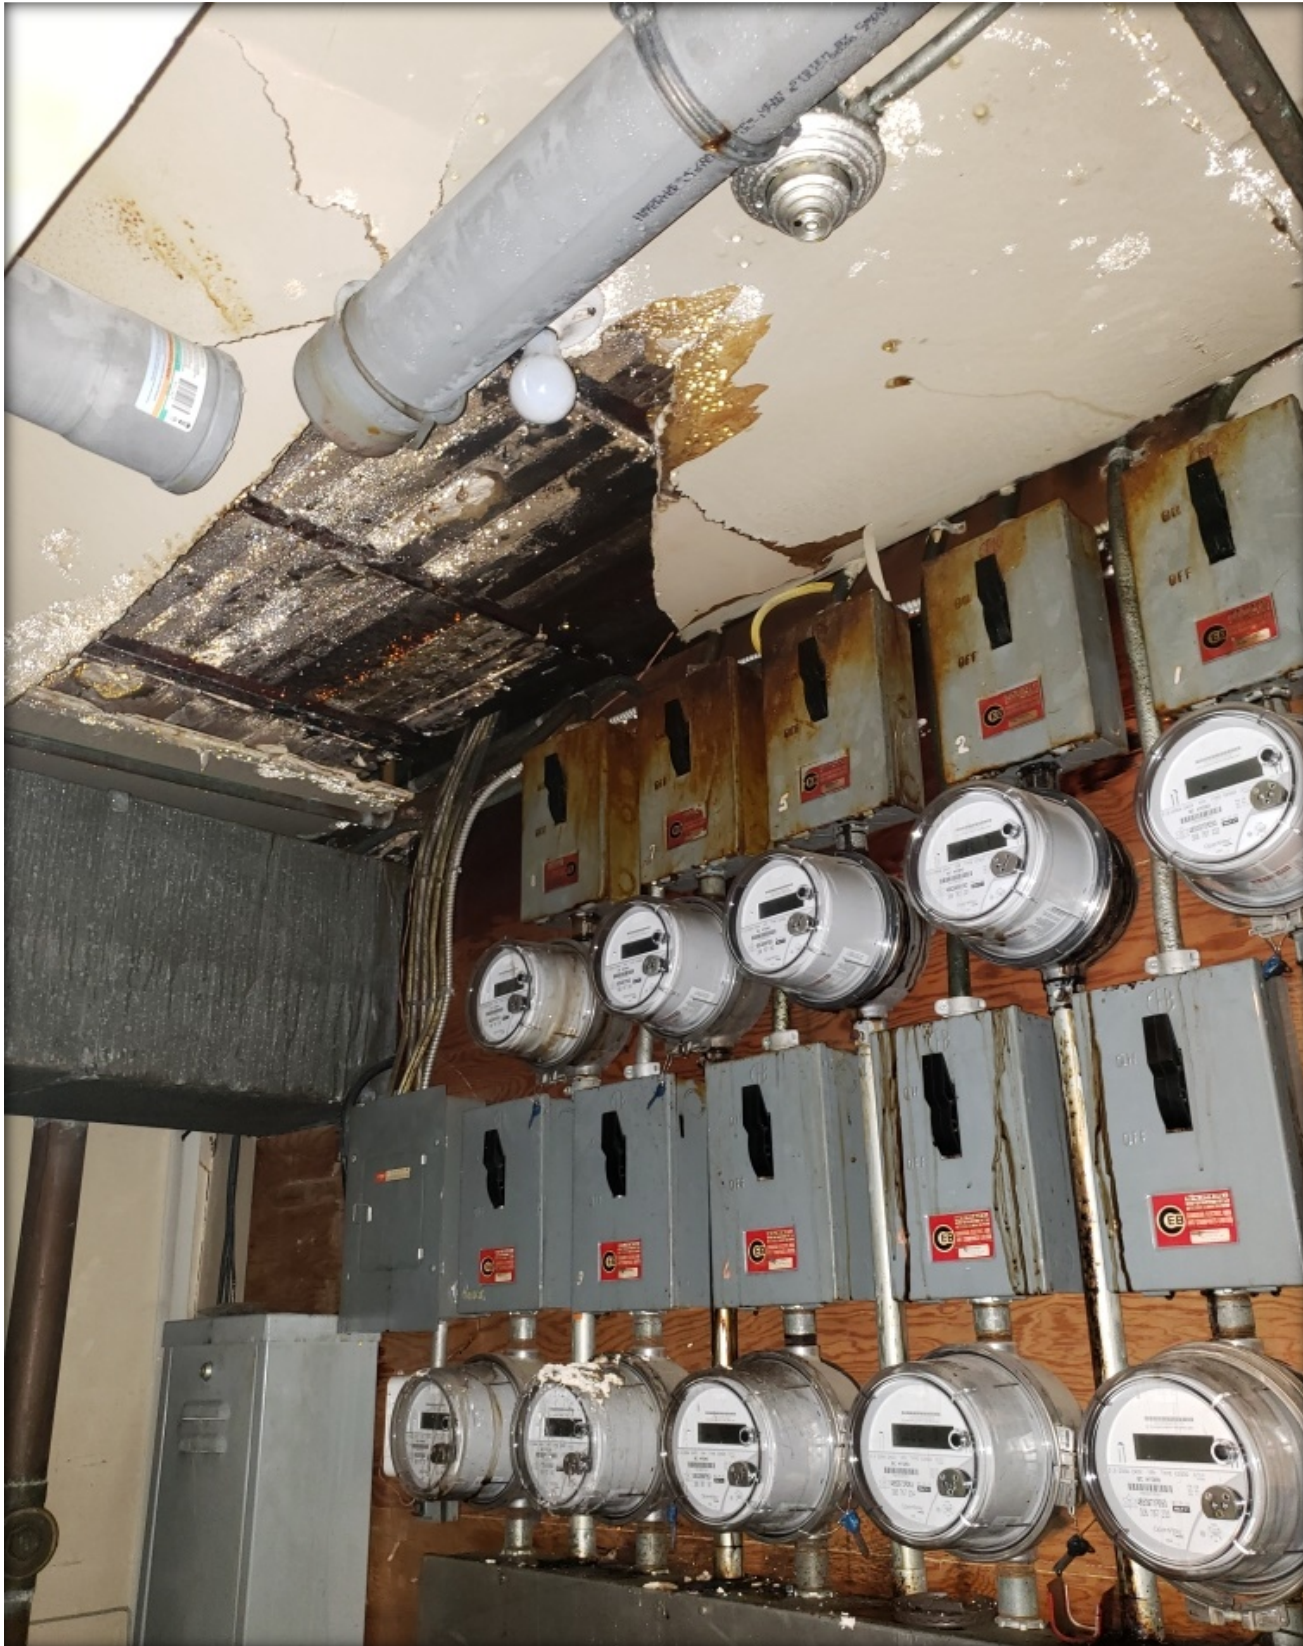
Nov 01, 2020 - A building occupant stated that the fire alarm was triggered in the middle of the night from boiler exhaust in the basement. The boiler vent had

Image 6 - Photo from Nov 2020 showing damage from products of combustion and condensate to the electrical room ceiling/electrical equipment and the corner vent piece fallen from explosive detonations.

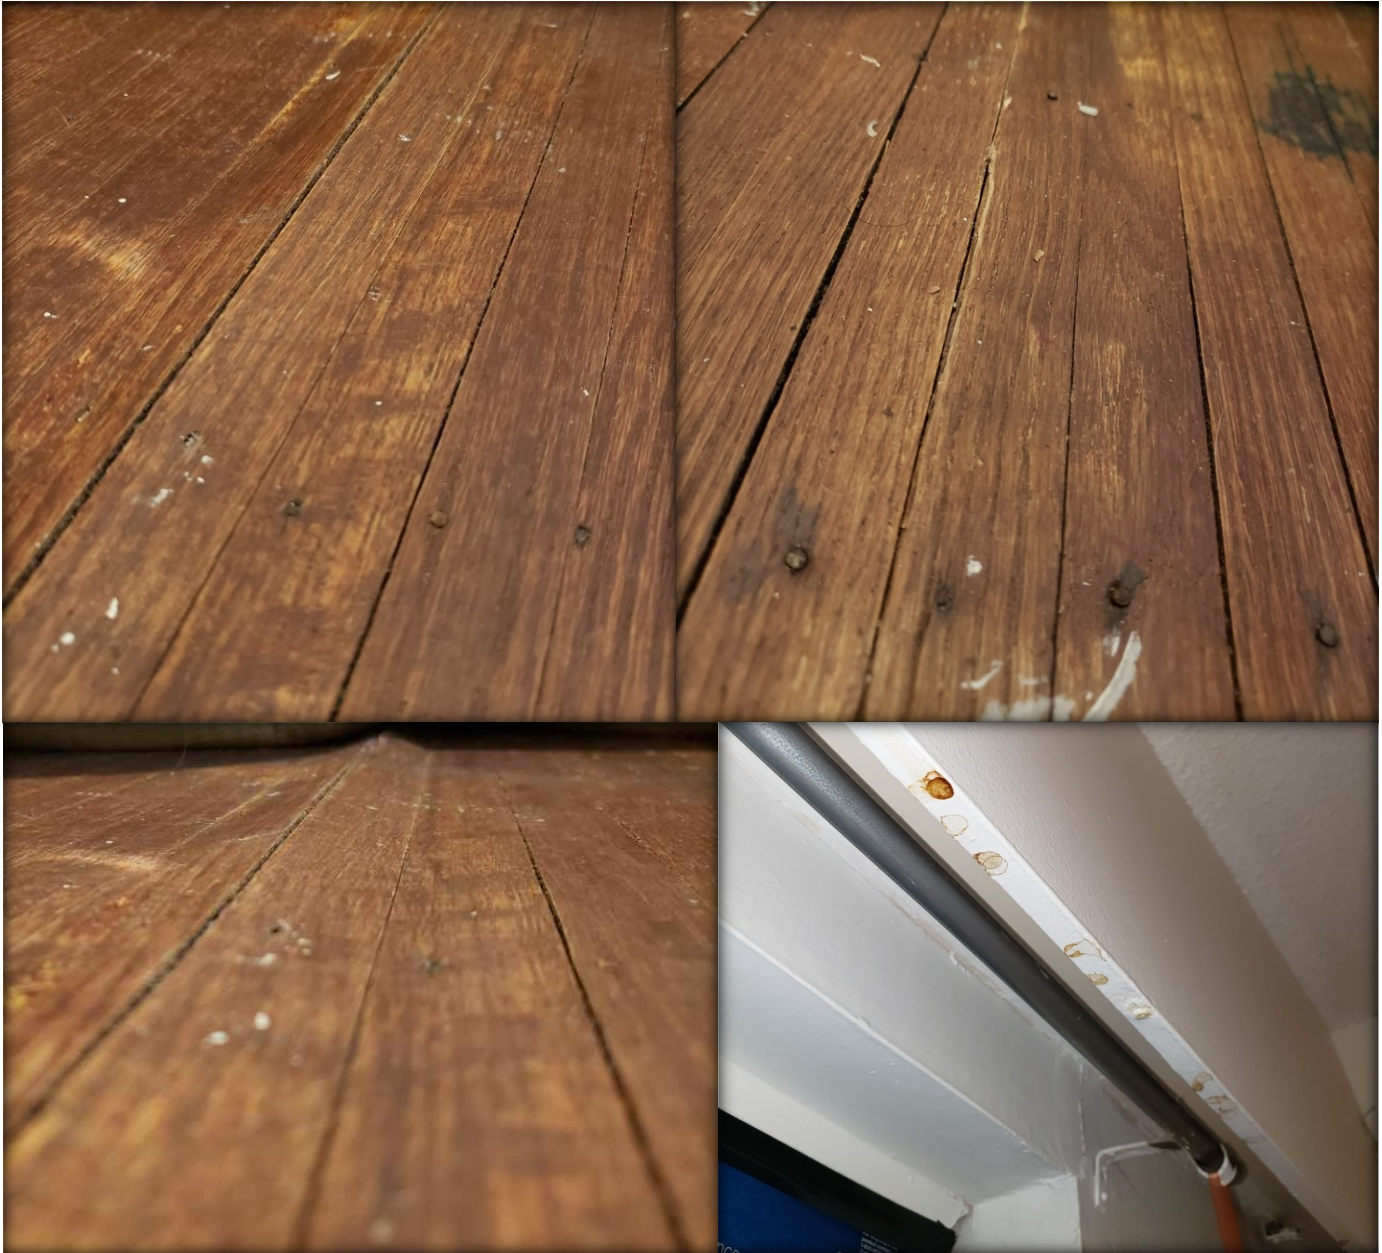
Image 7a, b, c, d – Residence flooring bowed from rising products of combustion and condensate moisture; condensation drops on the ceiling of the residence above the electrical room.
