## Incident Summary (#5612302)

SUPPORTING INFORMATION	Incident Date		Feb 21, 2017	
	Location		Mission	
	Regulated industry sector		Low voltage electrical system (30V to 750V)	
	Impact	Injury	Qty injuries	0
			Injury description	n/a
			Injury rating	None
	Damage	Damage	Damage description	Electrical arcing damage to a meter base and electrical meter. Minor damage to the siding of the house.
			Damage rating	Major
	Incident rating		Major	
	Incident overview		<p>The occupant of the house was getting ready for work in the morning when she heard a humming noise and noticed the lights flickering off and then on again. A neighbor pounded on the door and alerted the home owner that their electrical meter was on fire.</p> <p>The fire was out when they exited the house to see what had happened.</p> <p>The utility was contacted and disconnected the power to the house.</p>	
INVESTIGATION CONCLUSIONS	Site, system and components		<p>Utility metering equipment is typically installed at every house that is connected to the utilities system.</p> <p>The metering in this case consisted of a meter base with a meter that was plugged into the base.</p> <p>The meter base enclosure is where the utility an

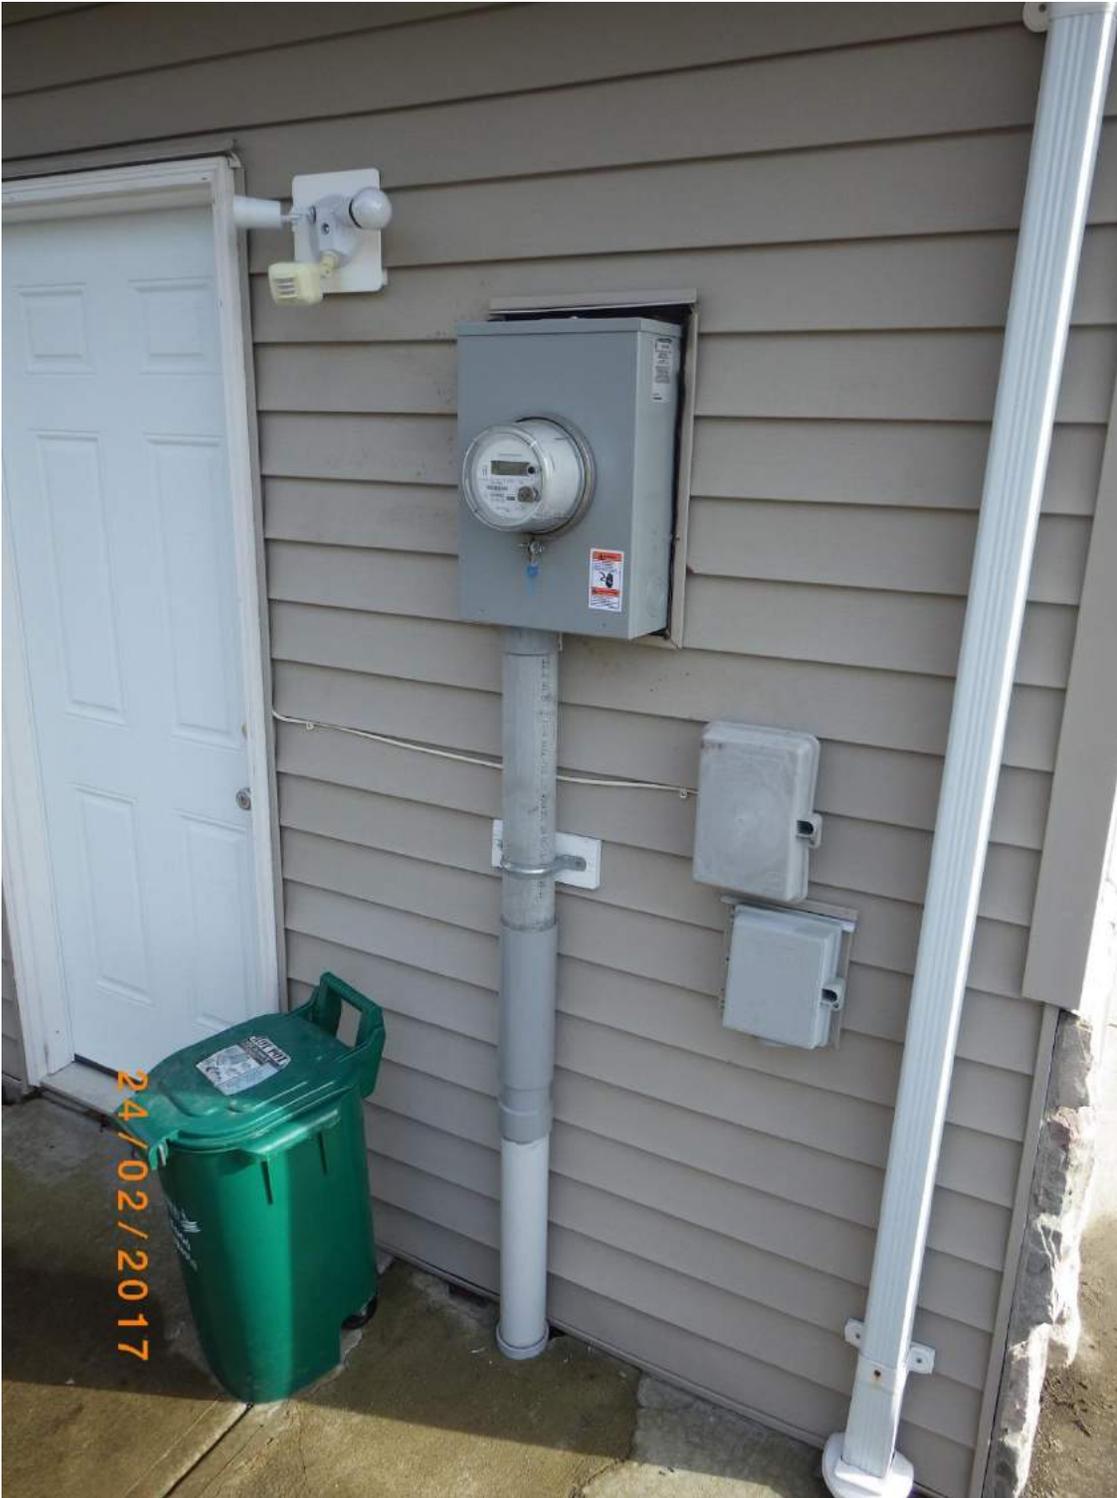
Figure 2

This is the west side of the house where the electrical meter base and meter are located. This photo shows the new meter base and meter after repairs were made by an electrical contractor.

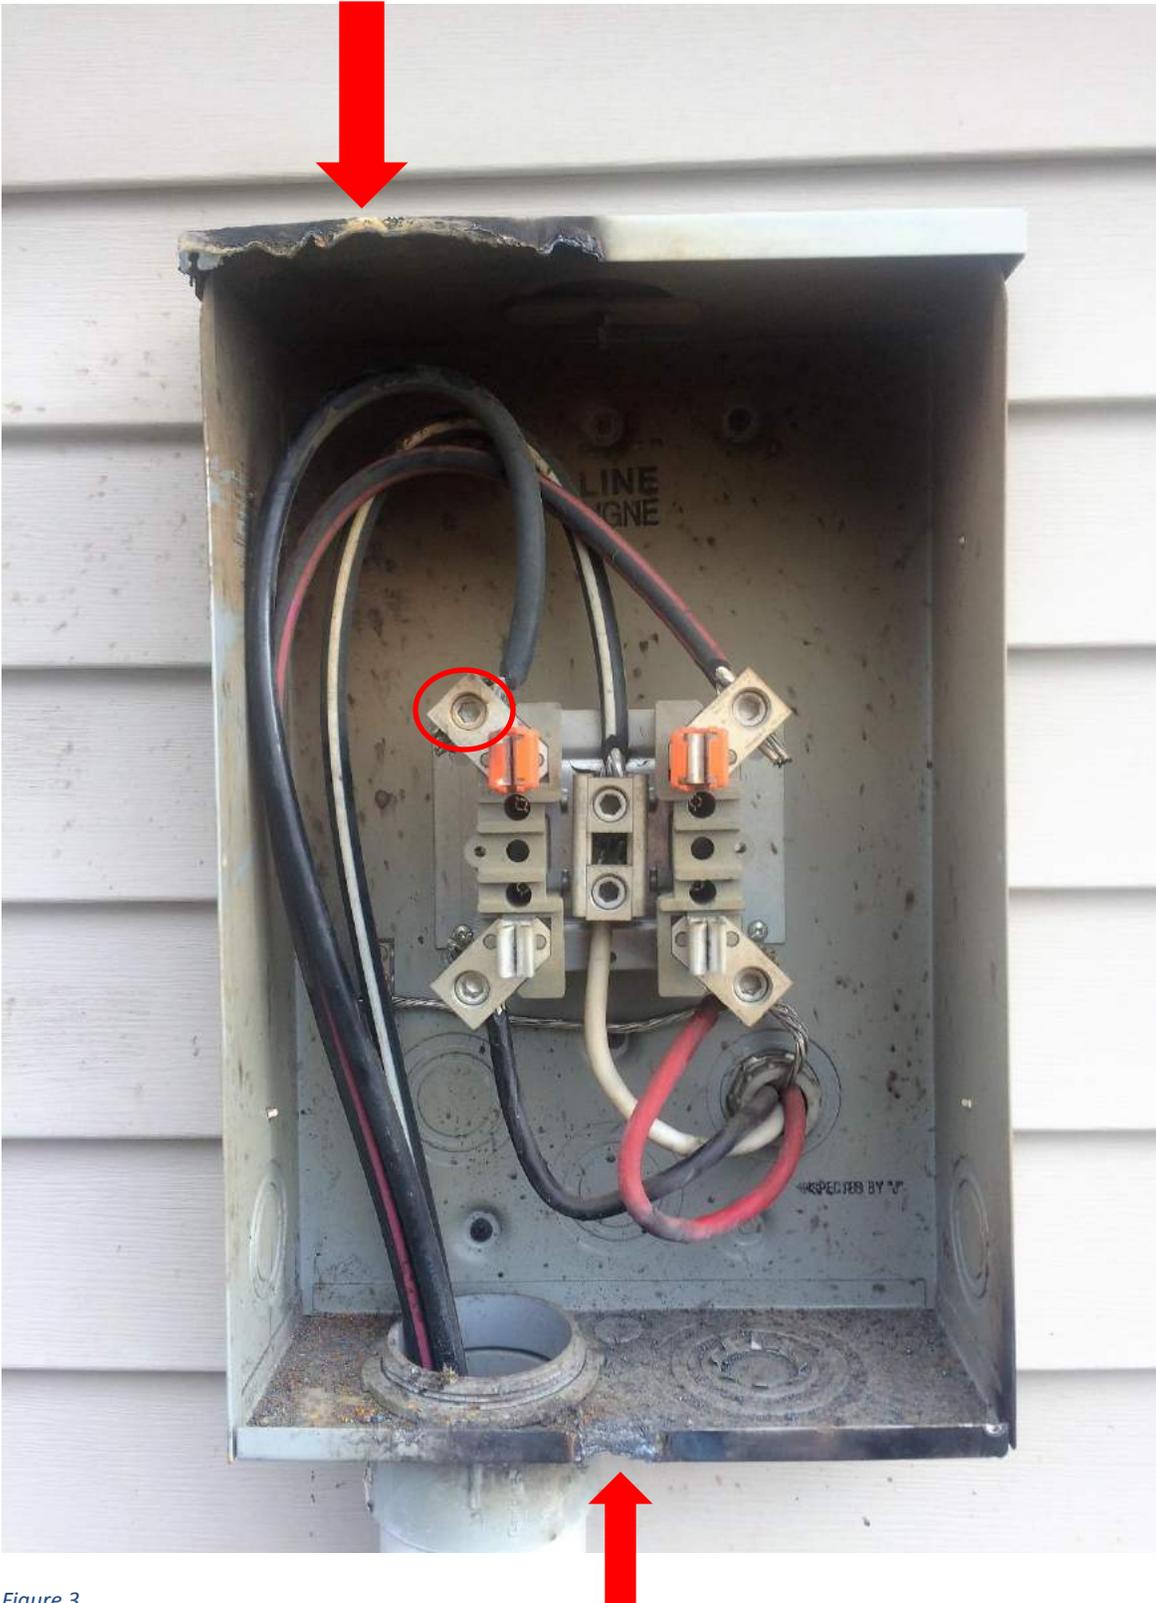
Figure 3

Causes and contributing factors	The cause of this incident is very likely a hex socket that was left in an energized conductor termination lug inside of the meter base. The socket was very likely left in the lug by a utility installer after it was used to tighten the termination prior to the service being energized.
---------------------------------	--

Photo of the meter base taken by the contractor prior to replacing it. The red outline shows the termination lug that the hex socket was left in. The red arrows show the locations where the enclosure was damaged by the fault current.

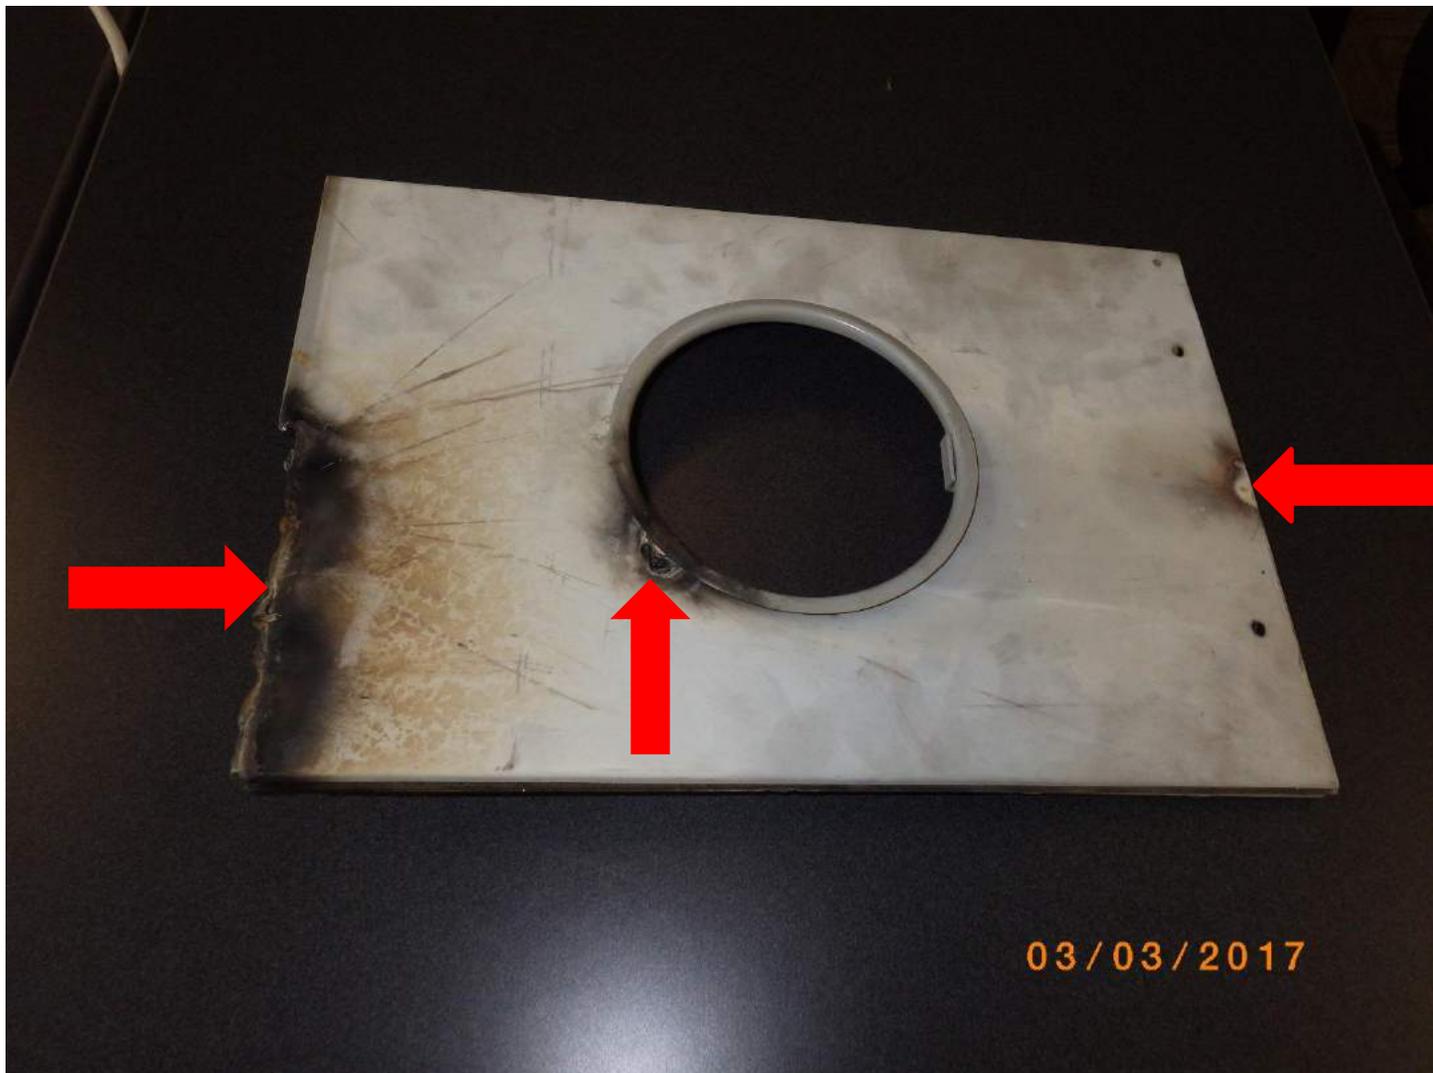
Figure 4

This photo shows the front of the meter base cover. The red arrows show where the electrical fault caused damage to the cover. The hex socket was located inside the meter base behind the center arrow.

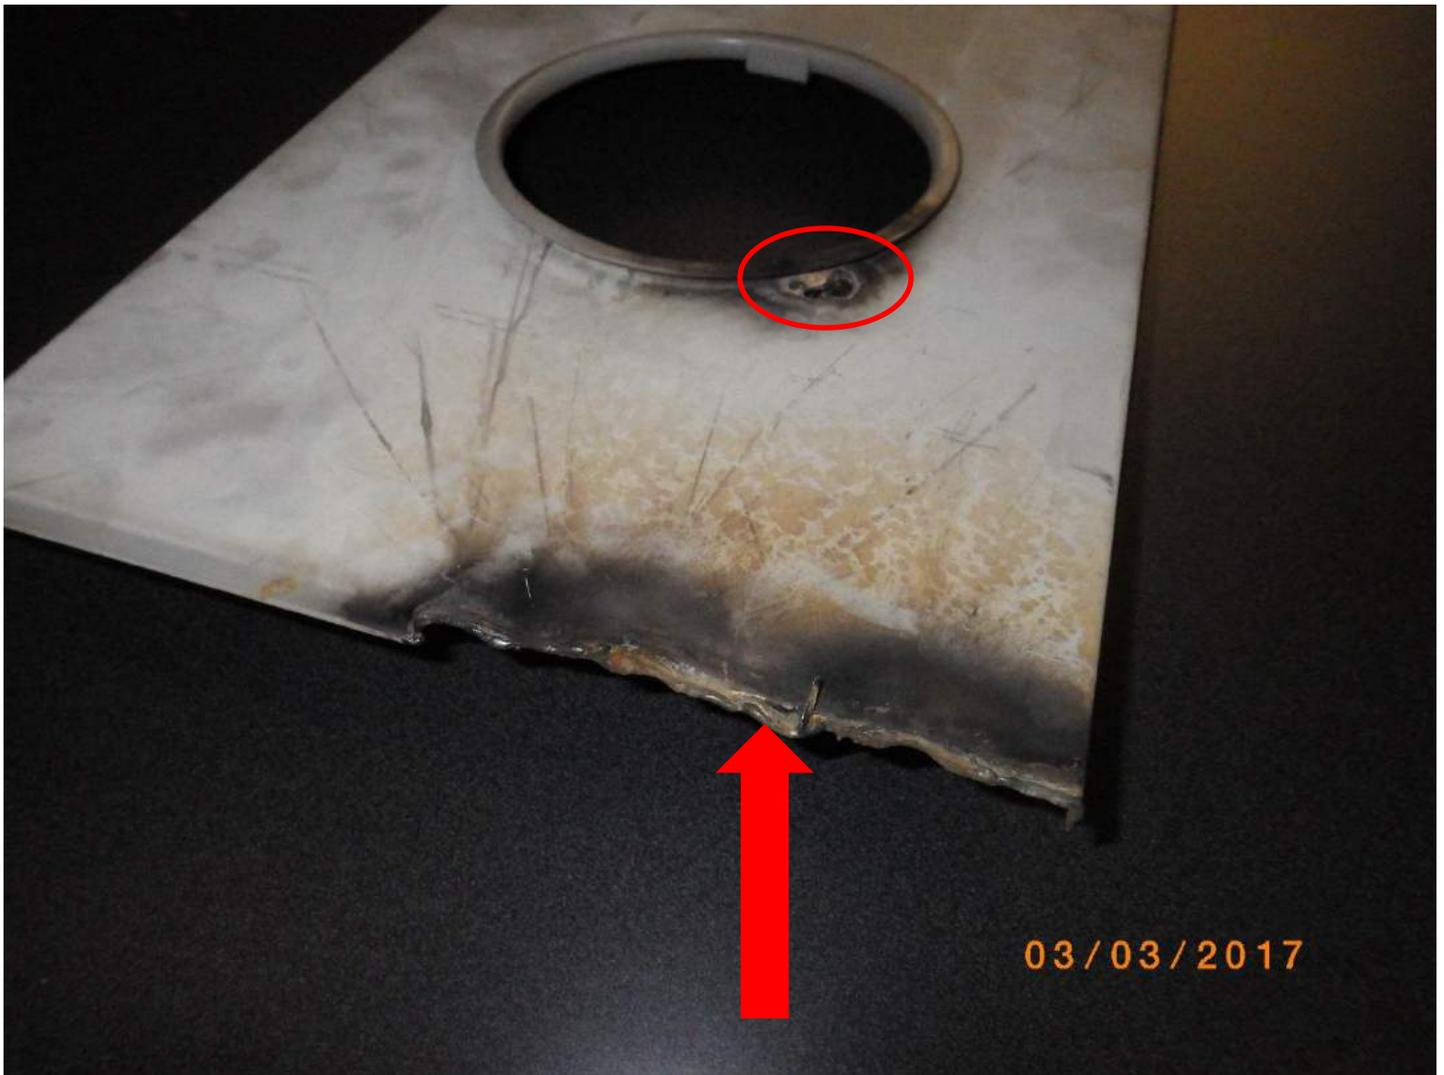
*Figure 5*

This photo shows the damage to the meter base cover. The location of the hex socket was behind the area shown outlined in red. The red arrow shows the top of the cover where the cover was in contact with the enclosure and created a path for current to flow.

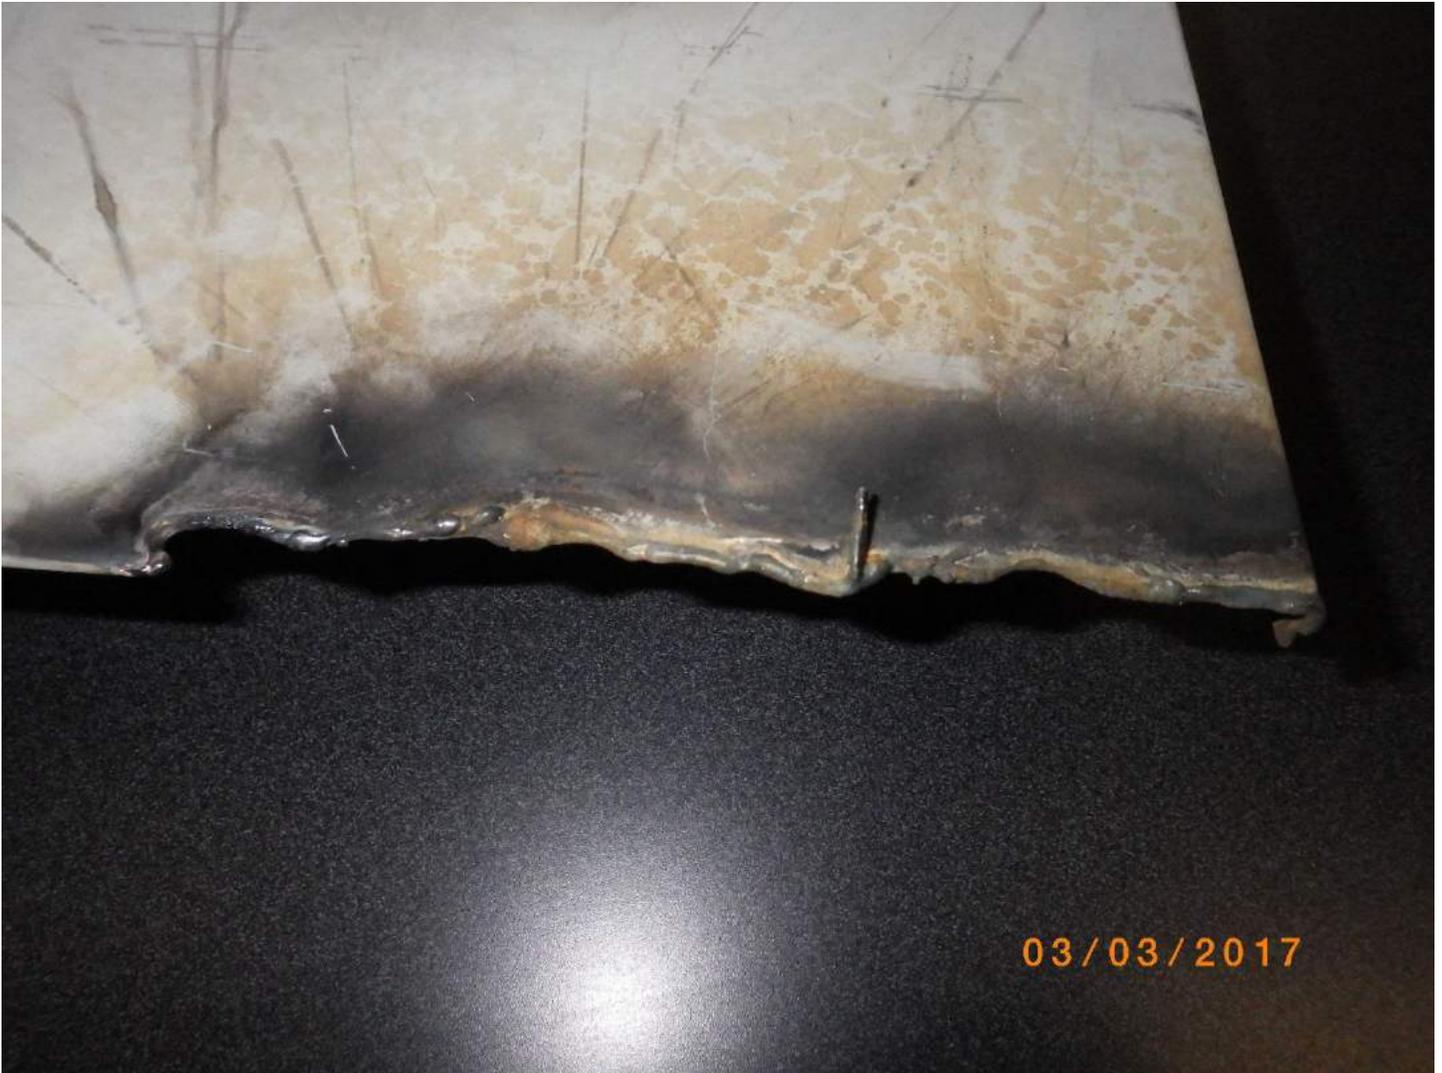
*Figure 6*

A closer look at the damage to the top front side of the meter base cover.

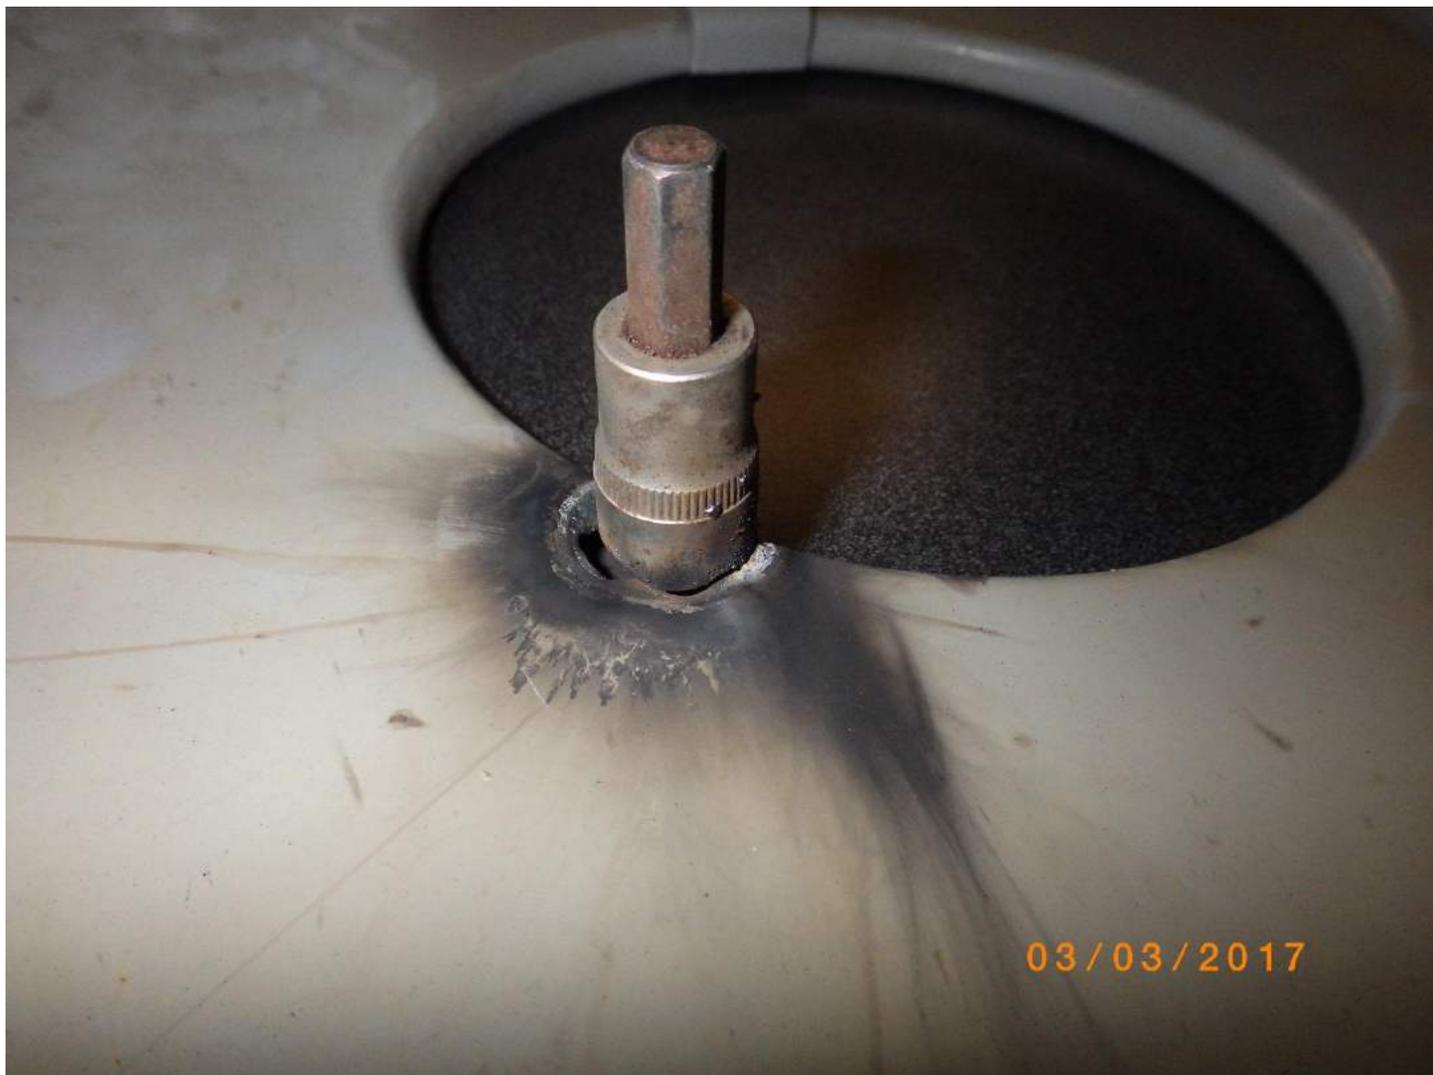
*Figure 7*

This photo shows the back of the cover and the 5/16" hex socket that was left in the conductor termination lug inside the meter base. The socket was welded to the inside of the meter base cover.

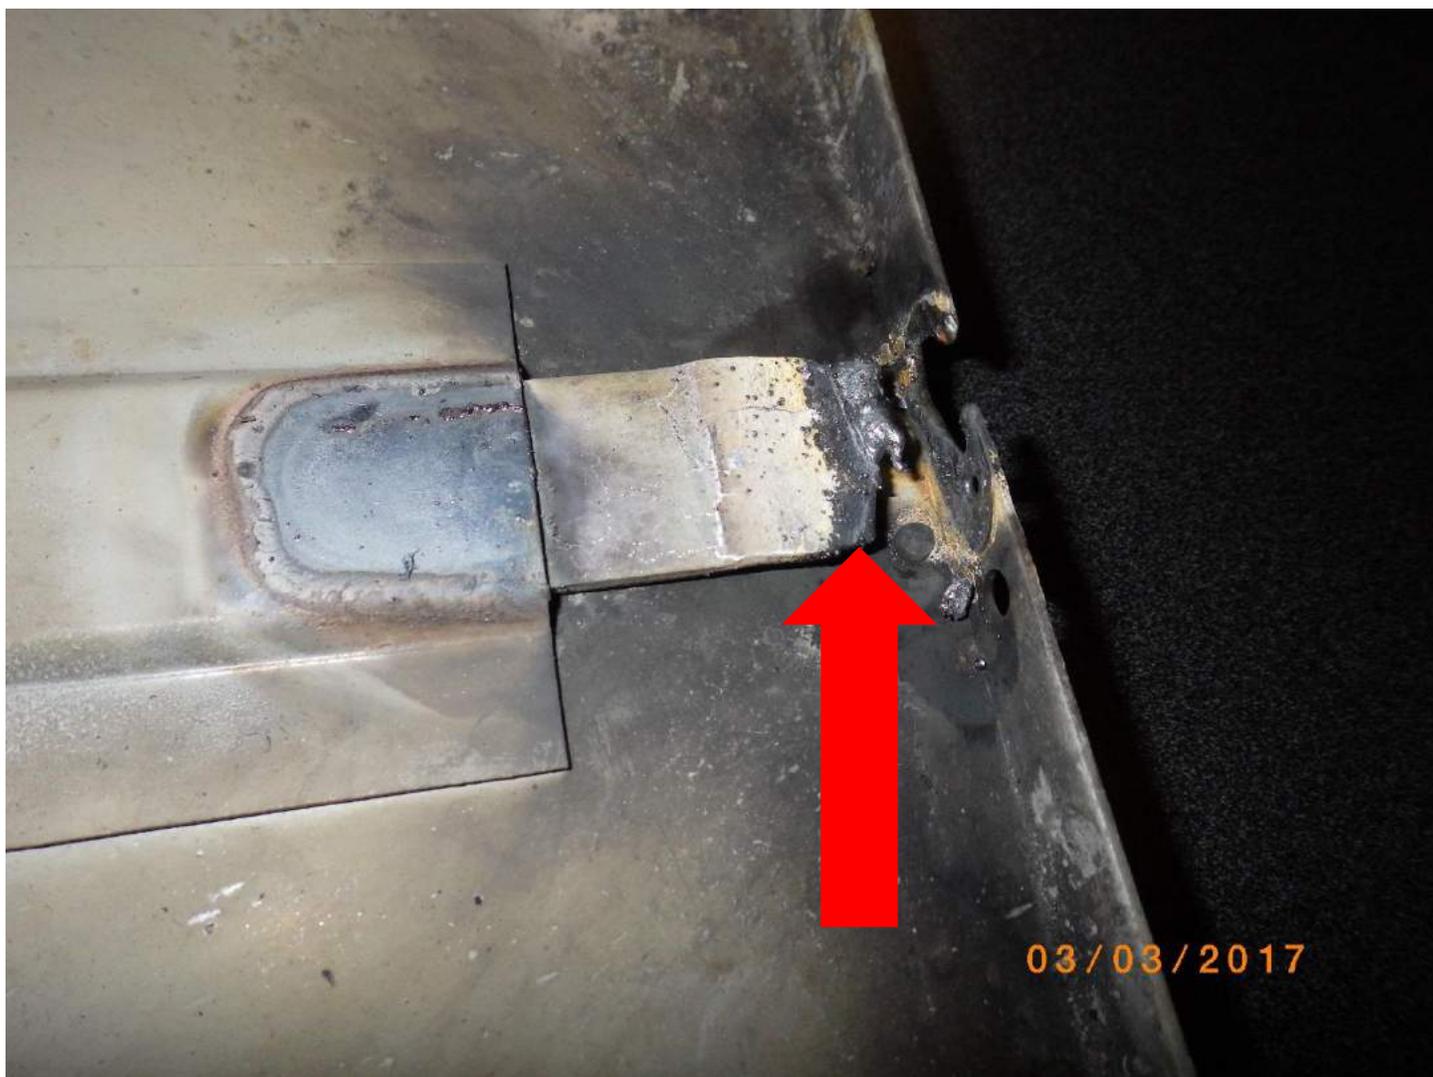
*Figure 8*

This photo shows the bottom of the meter base cover. The red arrow shows the melted latching tab that holds the cover in place after installation. The bottom of the cover was melted away.

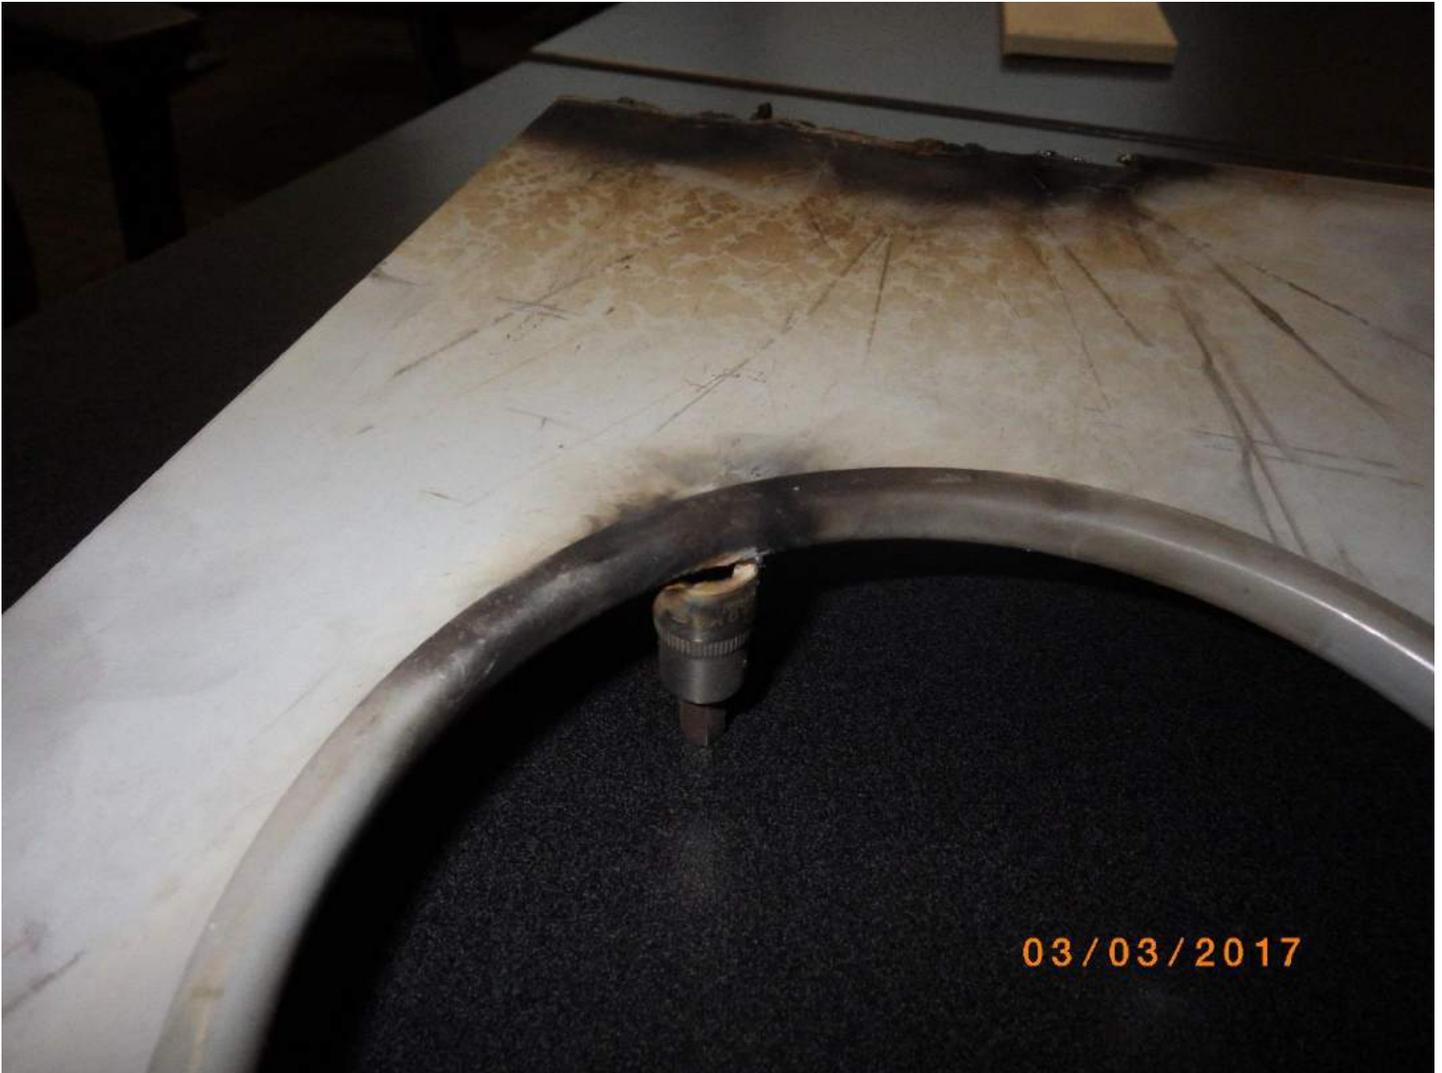
*Figure 9*

This photo shows the front of the cover with the socket still welded in place.

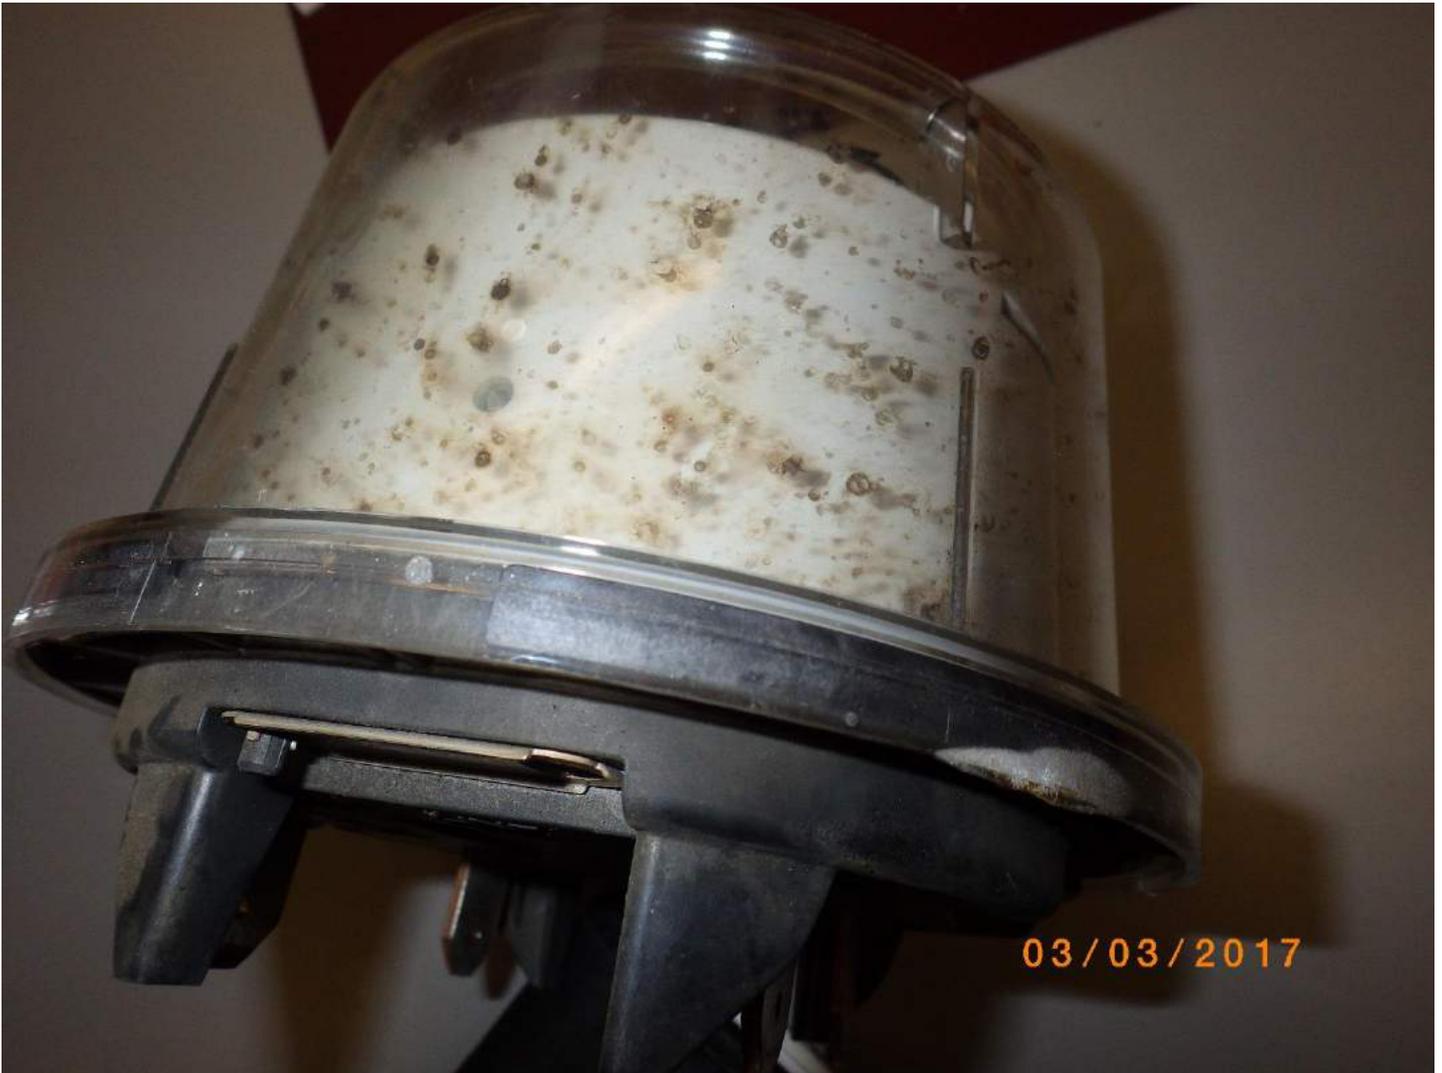
*Figure 10*

This photo shows the damage from arcing on the cover done to the external plastic cover on the meter.

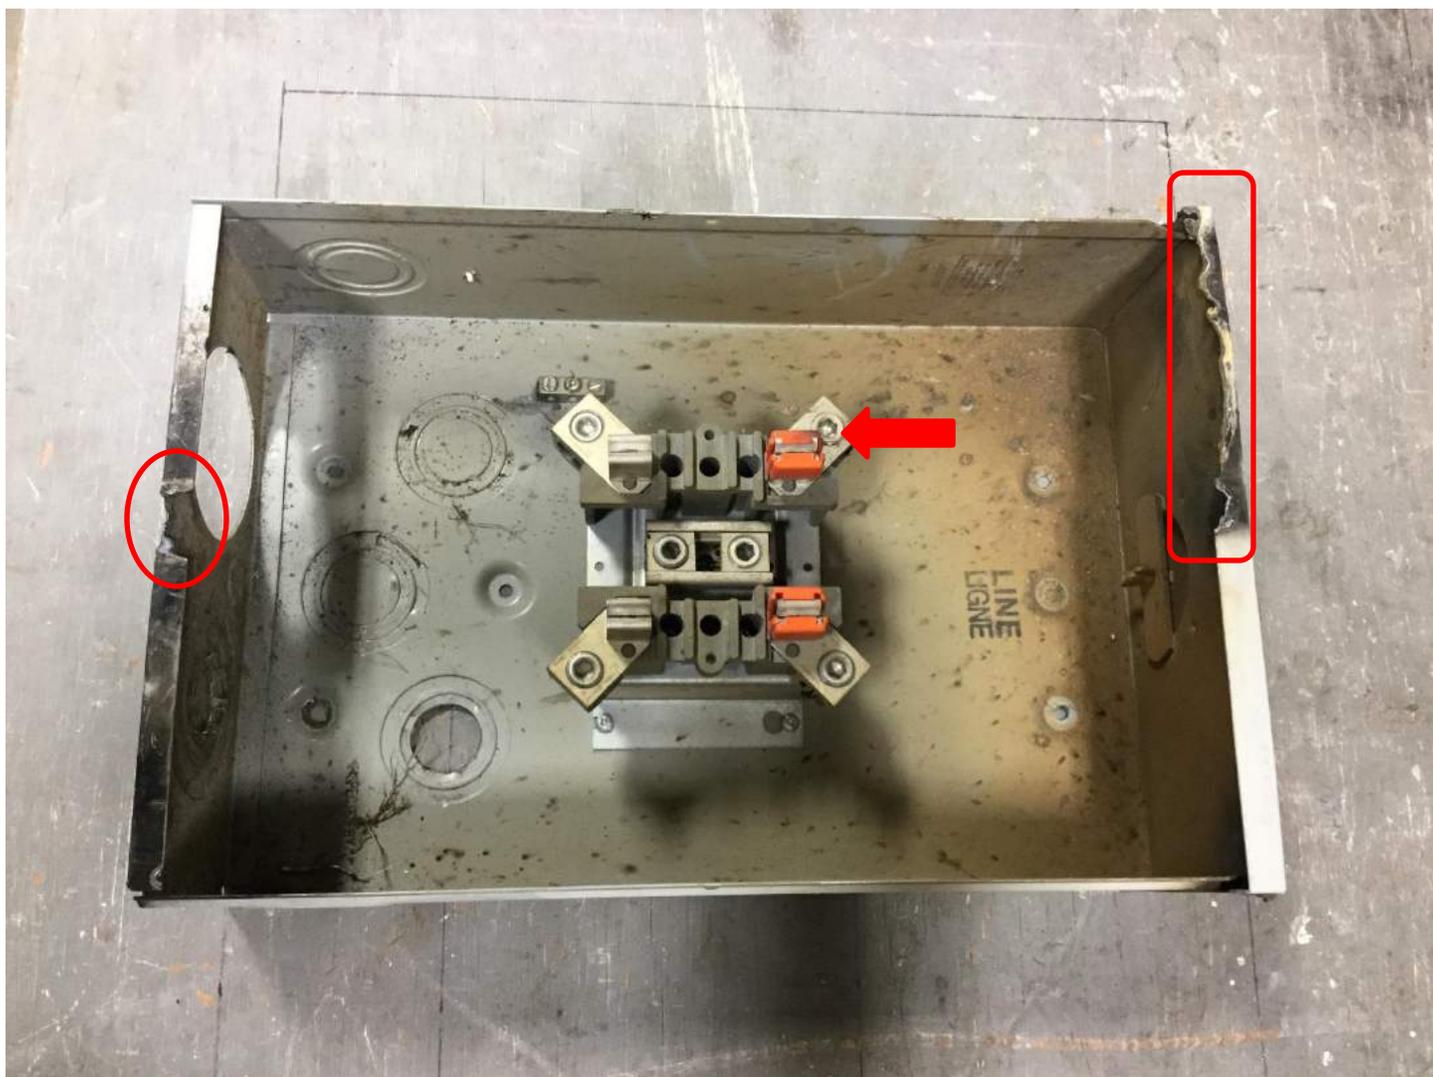
Figure 11

This photo shows the meter base enclosure and the internal components that the service conductors were connected to. The red arrow shows the termination lug that the socket was in at the time of the incident. The red outlines show the top and bottom of the meter base where the enclosure made electrical contact with the cover during the fault and the ground fault current damaged the equipment.

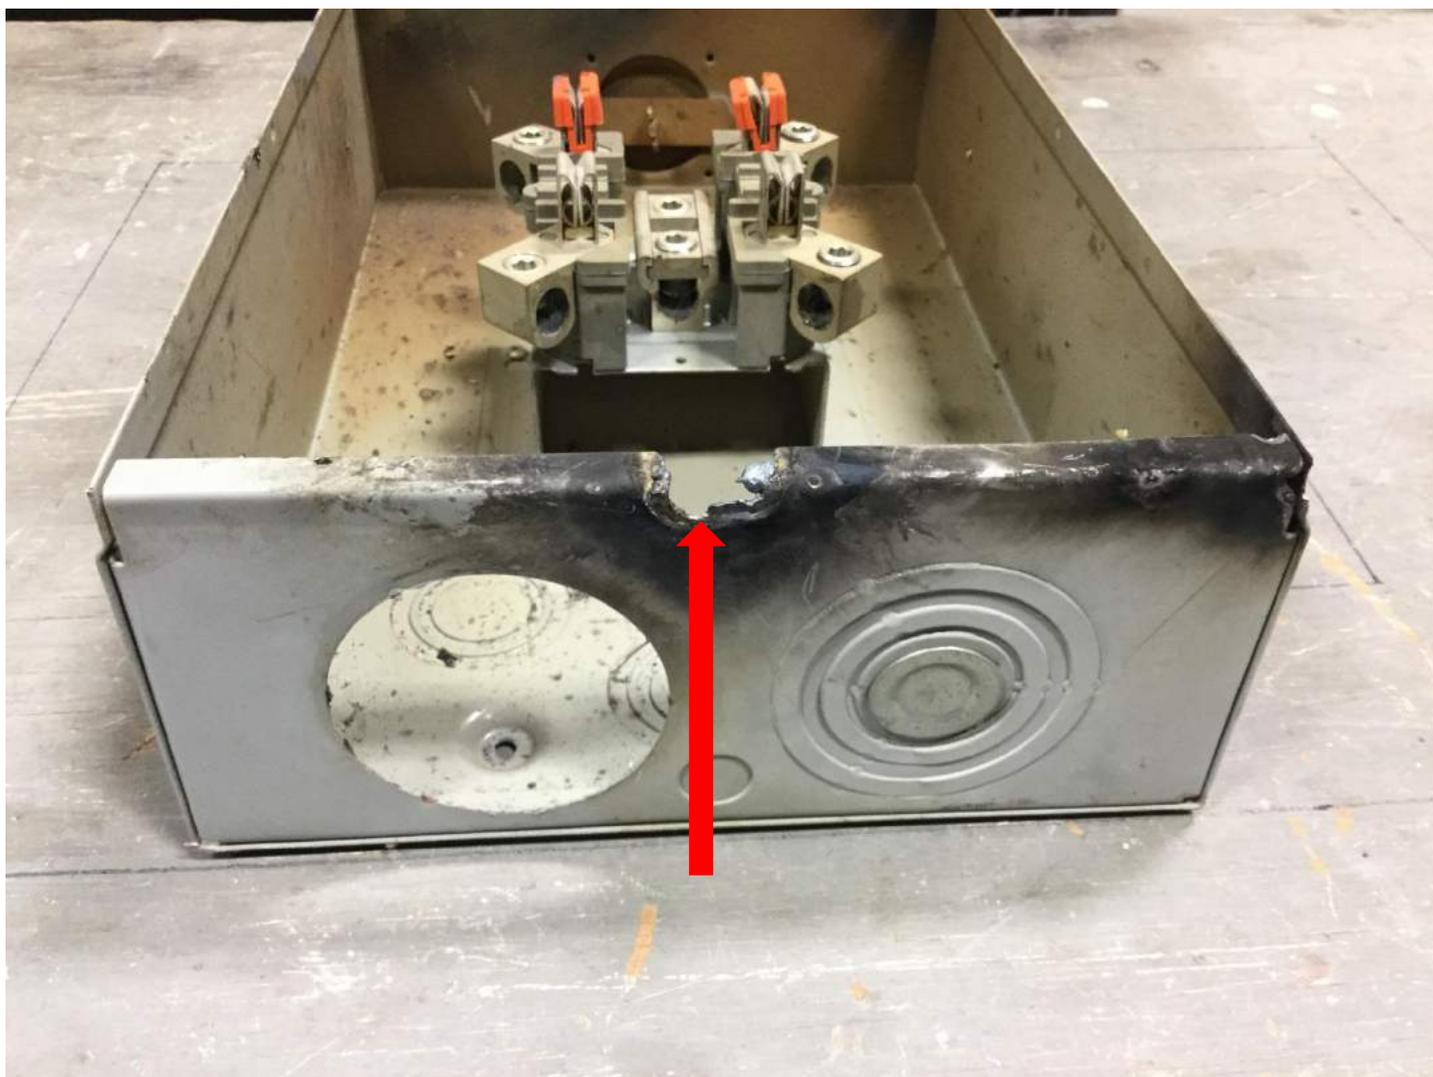
*Figure 12*

This photo shows the bottom of the meter base enclosure and the damage caused by the fault current. The center area shown by the red arrow is where the cover latch secures the cover to the meter base enclosure. The material was melted away in this location.

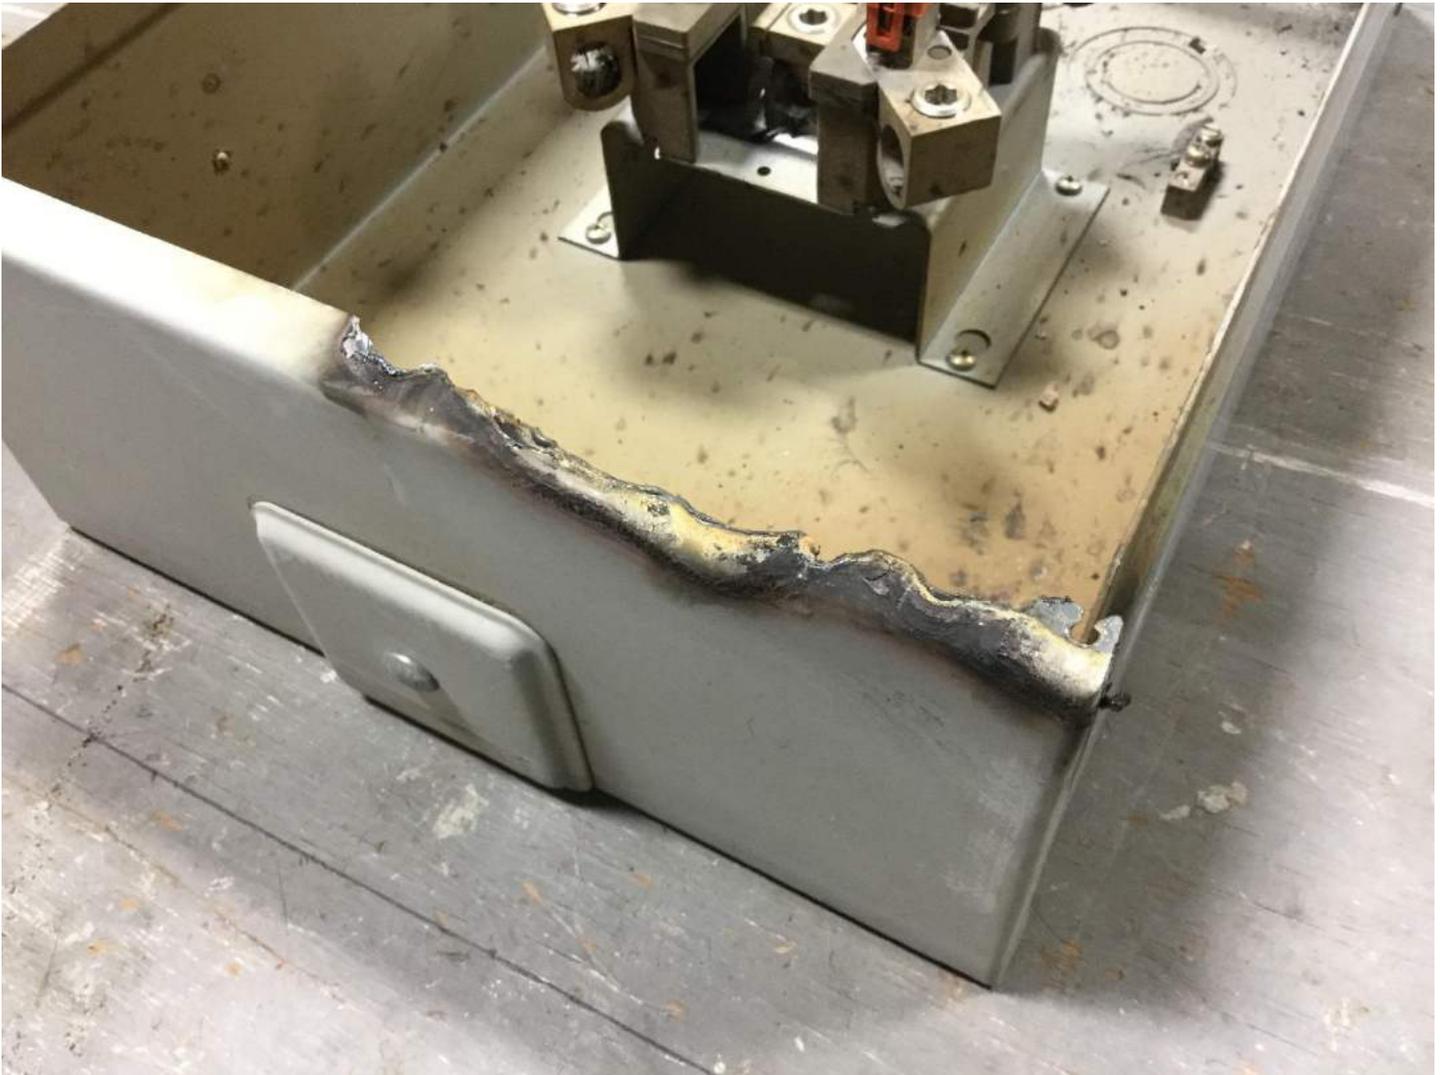
*Figure 13*

This photo shows the top of the meter base that was damaged by the fault current.

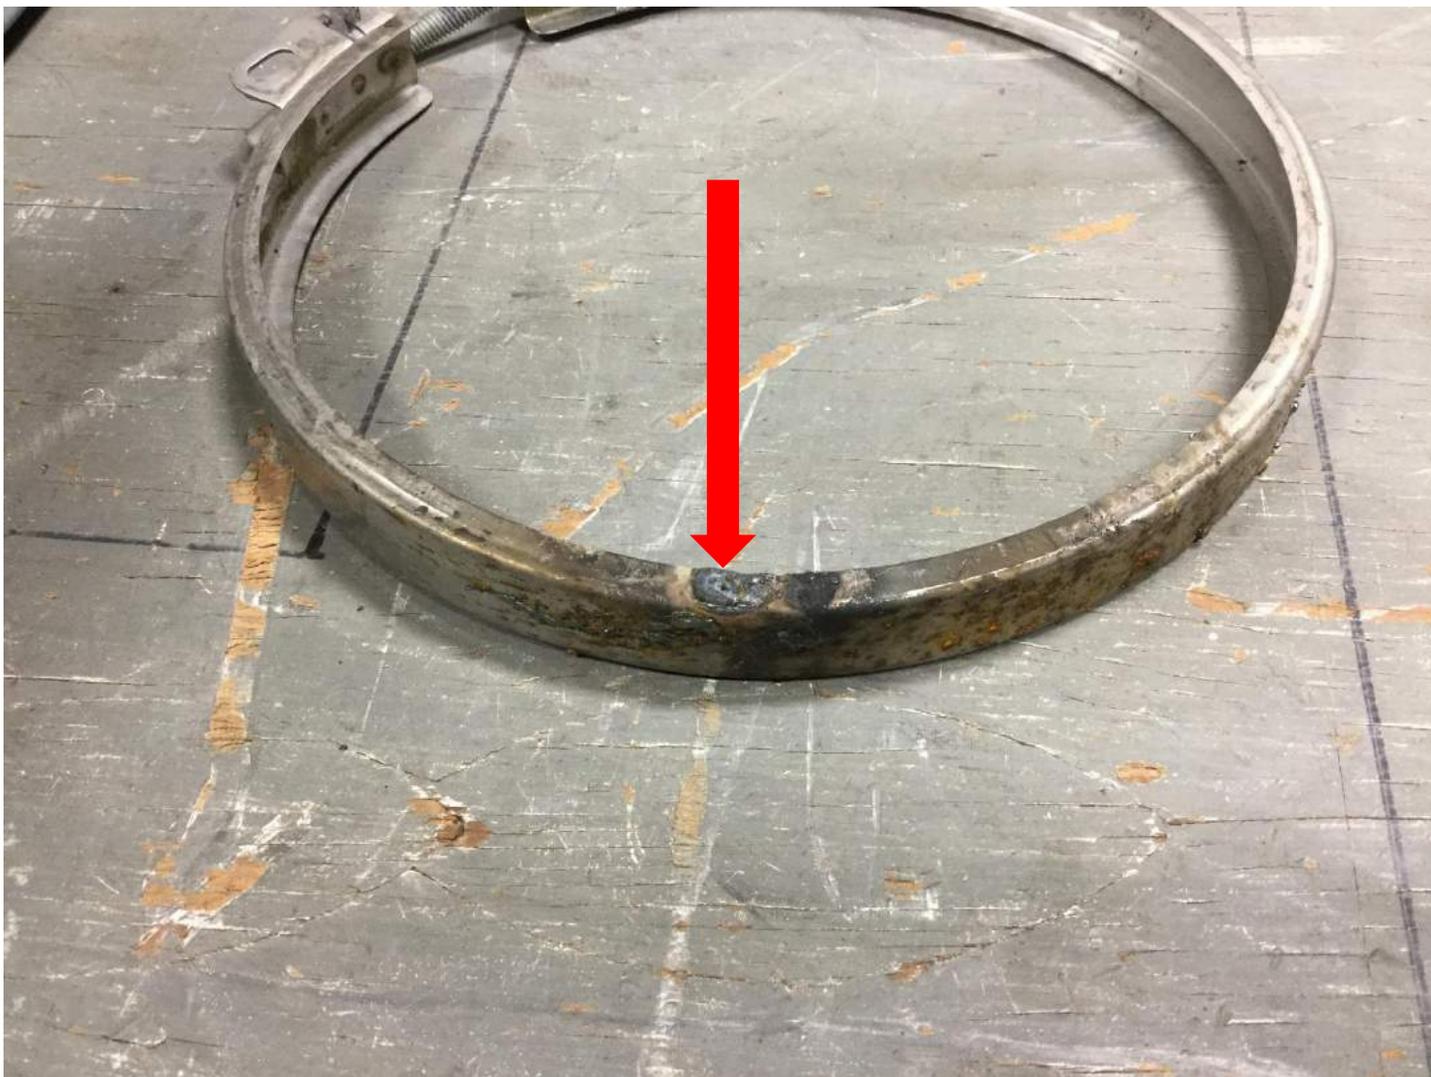
*Figure 14*

This photo shows the ring that secures the meter to the meter base. The red arrow shows where the ring was located in relation to the hex socket that was left in the termination lug.
