Incident Summary (II-773843-2018) (Incident ID: 9705)

RESIDENTIAL HOUSE STRUCTURE FIRE

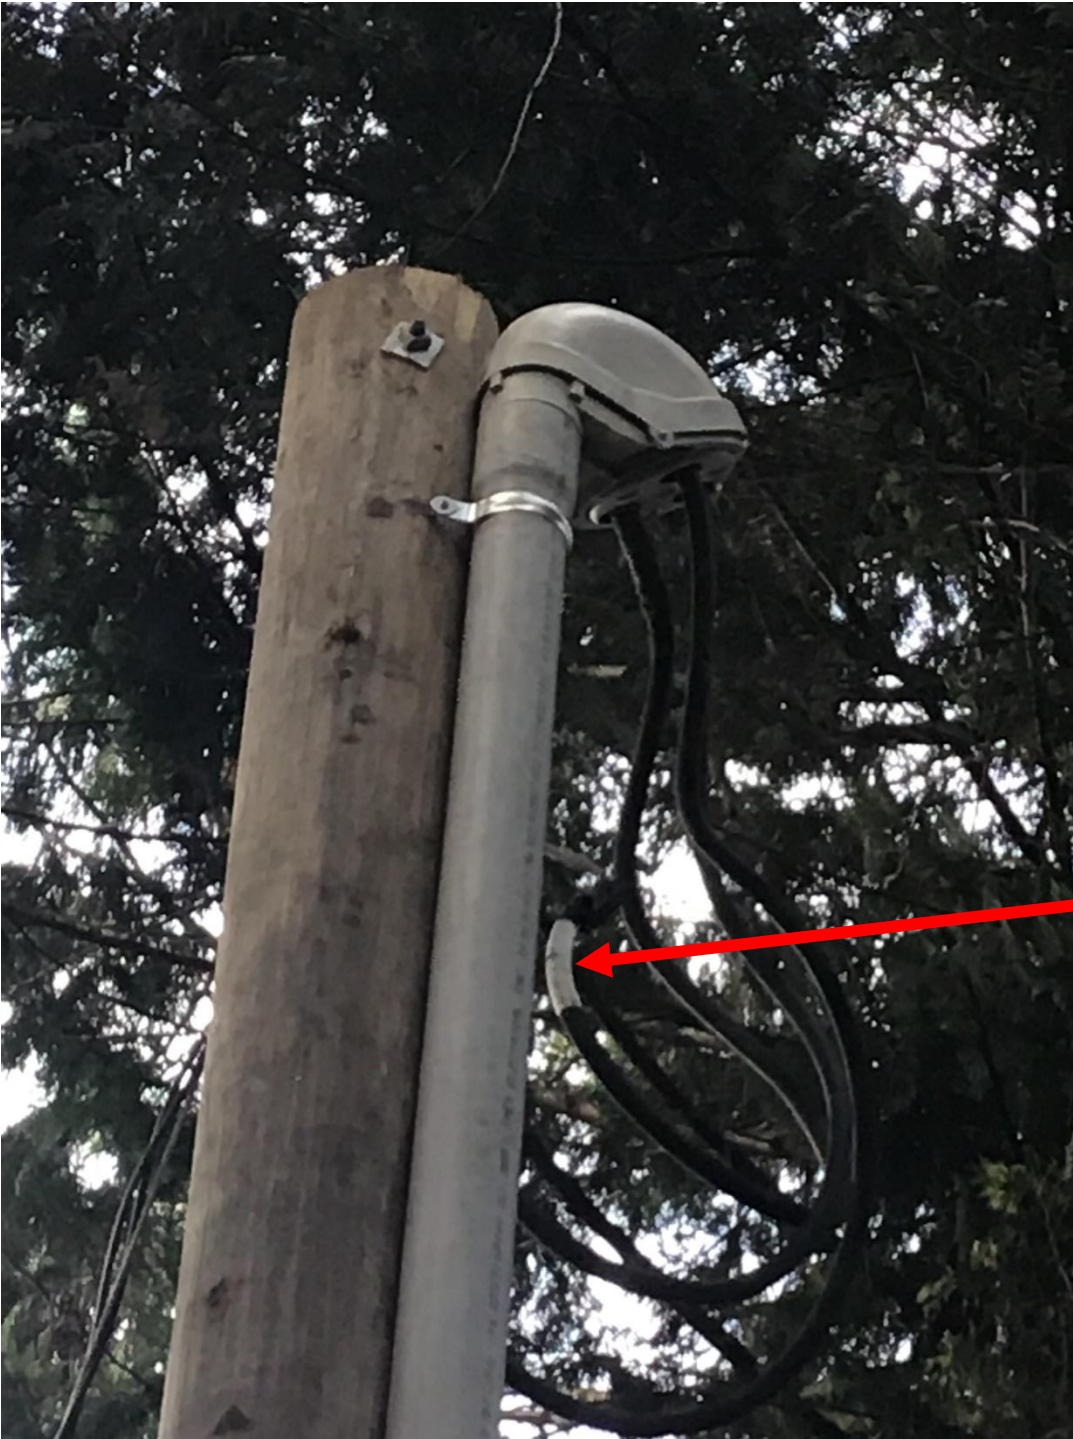
drawing too much current at 240 volts, causing the motor winding insulation to break down and the motor to short out and spark.
Facts and evidence	<p>It was identified by the fire investigator working on behalf of the home insurer that at the overhead electrical service conduit the contracted installer had miss-identified and terminated the dwelling conductors to the overhead service conductors incorrectly. This was proven by doing a 'continuity' test of all dwelling conductors as connected.</p> <p>It was identified by the fire prevention officer that the fire started in the location of the bathroom exhaust fan. No other ignition sources were identified in the origin location.</p> <p>As declared by the fire investigator, the source of the fire was the failure of the exhaust fan motor when 240 volts was applied to it over a short duration of time.</p>
Causes and contributing factors	It is very likely the exhaust fan failed due to the incorrect service conductor connections, resulting in excess voltage being applied to the motor for a long enough duration that the excess current generated excess heat which compromised the motor winding insulation, causing it to short out and spark, igniting the subsequent fire.

Figure 2 –Location where dwelling service conductors were incorrectly terminated to the overhead line conductors from the utility transformer. The red arrow shows the service neutral conductor that was incorrectly identified with white tape by the installer. This caused the utility to re-energize an ungrounded line conductor that was terminated to the dwelling's service neutral conductor which caused the over voltage condition at the bathroom exhaust fan within the dwelling.

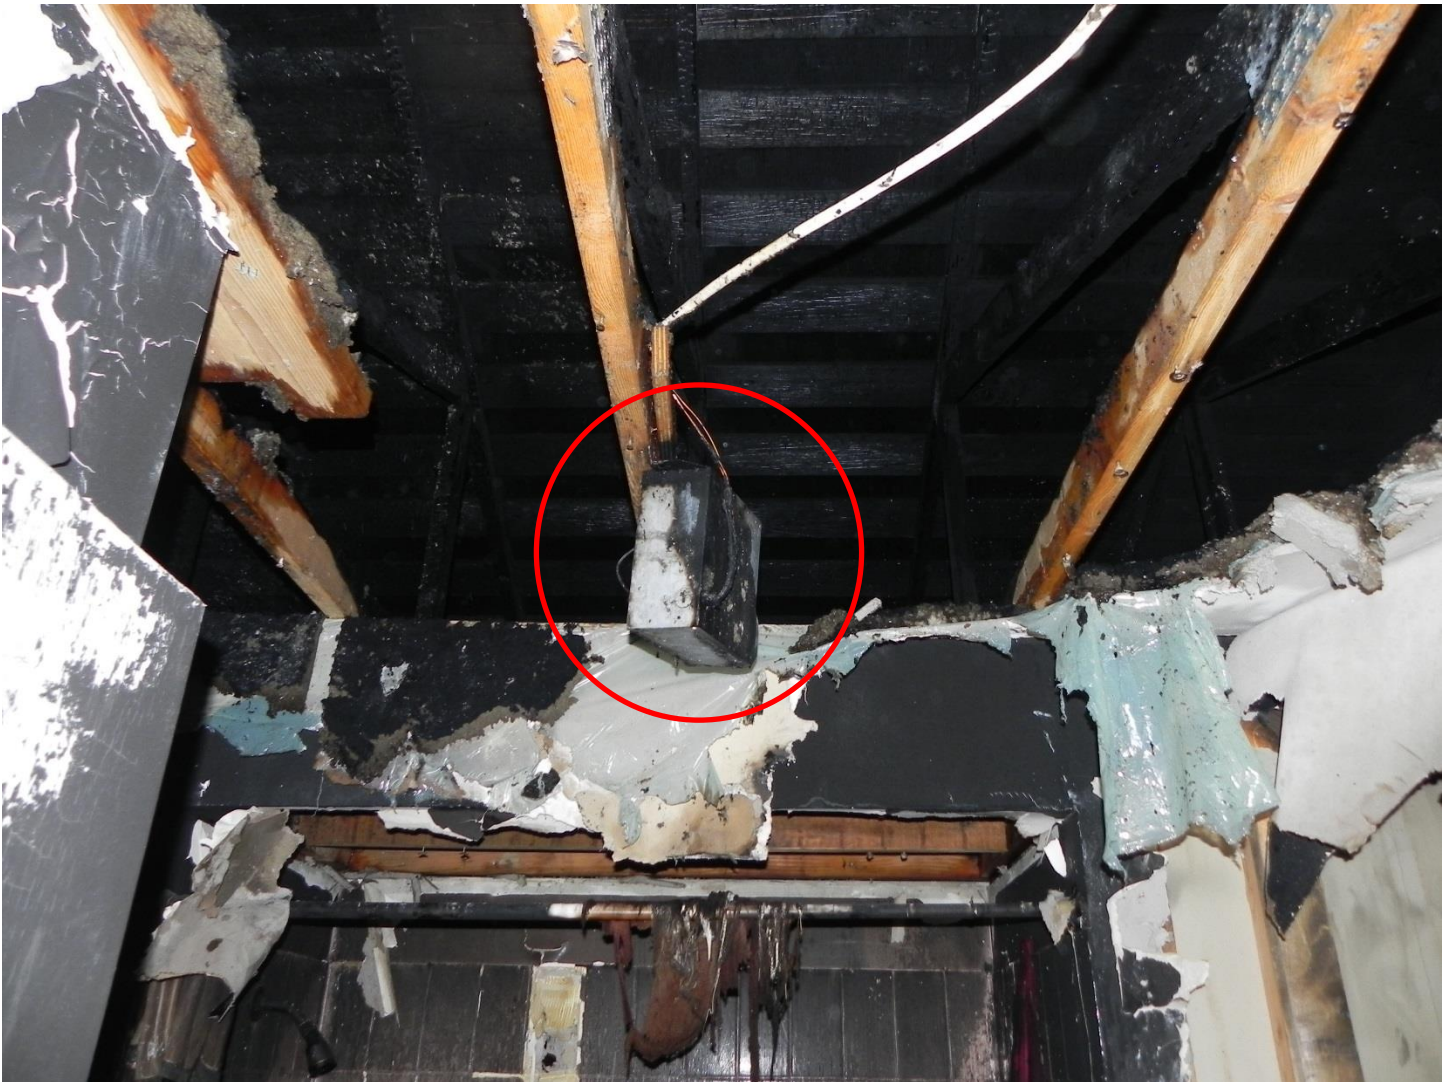
INVESTIGATION CONCLUSIONS	Site, system and components	<p>The bathroom exhaust fan motor is operated by a general purpose wall switch and the motor turning the exhaust fan is rated to operate at 120v AC. In a dwelling of combustible construction it is typically directly wired with non-metallic sheathed cable (NMSC) that includes an ungrounded conductor, a grounded (common) conductor and a bare bonding conductor.</p> <p>The dwelling had a typical 120/240v single phase service provided by a utility transformer at the road, that consisted of two ungrounded conductors and one grounded (neutral) conductor, providing either 240 volts or 120 volts to the dwelling.</p>	
	Failure scenario(s)	<p>Power was disconnected to the dwelling by the utility provider due to a private service pole on the property that was identified a safety hazard and needing replacement.</p> <p>The pole was replaced, the service raceway was re-installed onto the new pole, but the service conductors from the dwelling protruding from the overhead electrical service conduit were miss-identified at the time of installation and were terminated to the overhead lines from the utility transformer with one of the overhead ungrounded conductors from the transformer terminated to the dwellings grounded (neutral) conductor and the utilities common conductor terminated to one of the dwellings ungrounded conductors.</p> <p>Power was restored to the dwelling by the utility. At the same time inside the house the master bathroom fan switch was in the 'ON' position. The fan motor received 240 volts across the motor windings which generated excess heat due to the motor</p>

Figure 3 –Origin of the dwelling fire. Bathroom exhaust fan is suspended from a non-metallic sheathed cable branch circuit. Picture provided by local fire department fire prevention officer.
