## Incident Summary – POSSE Reference File #5616797

SUPPORTING INFORMATION	Incident Date		February 28, 2017	
	Location		Trail, BC	
	Regulated industry sector		Electrical – low voltage electrical system (30 to 750 volt)	
	Impact	Injury	Qty injuries	0
			Injury description	N/A
			Injury rating	None
	Damage		Damage description	A three conductor motor feeder cable sustained damages resulting from a failure within the cable. Damage to cable was significant enough to warrant replacement of the entire section of motor feeder from the equipment disconnecting means to the motor termination box.
			Damage rating	Moderate
Incident rating		Minor		
Incident overview		<p>Facility maintenance staff stated that all aspects of the equipment and process were operating normally. During the morning of the incident, operations staff noted a loss of regulated air pressure throughout the process, commenced a survey to determine the cause and discovered one of three operational air compressors had tripped open/off-line. Staff opened the access doors to the compressor cabinet and discovered that the motor feeder cable had failed/ruptured and created a localized fire within the compressor cabinet. The proc

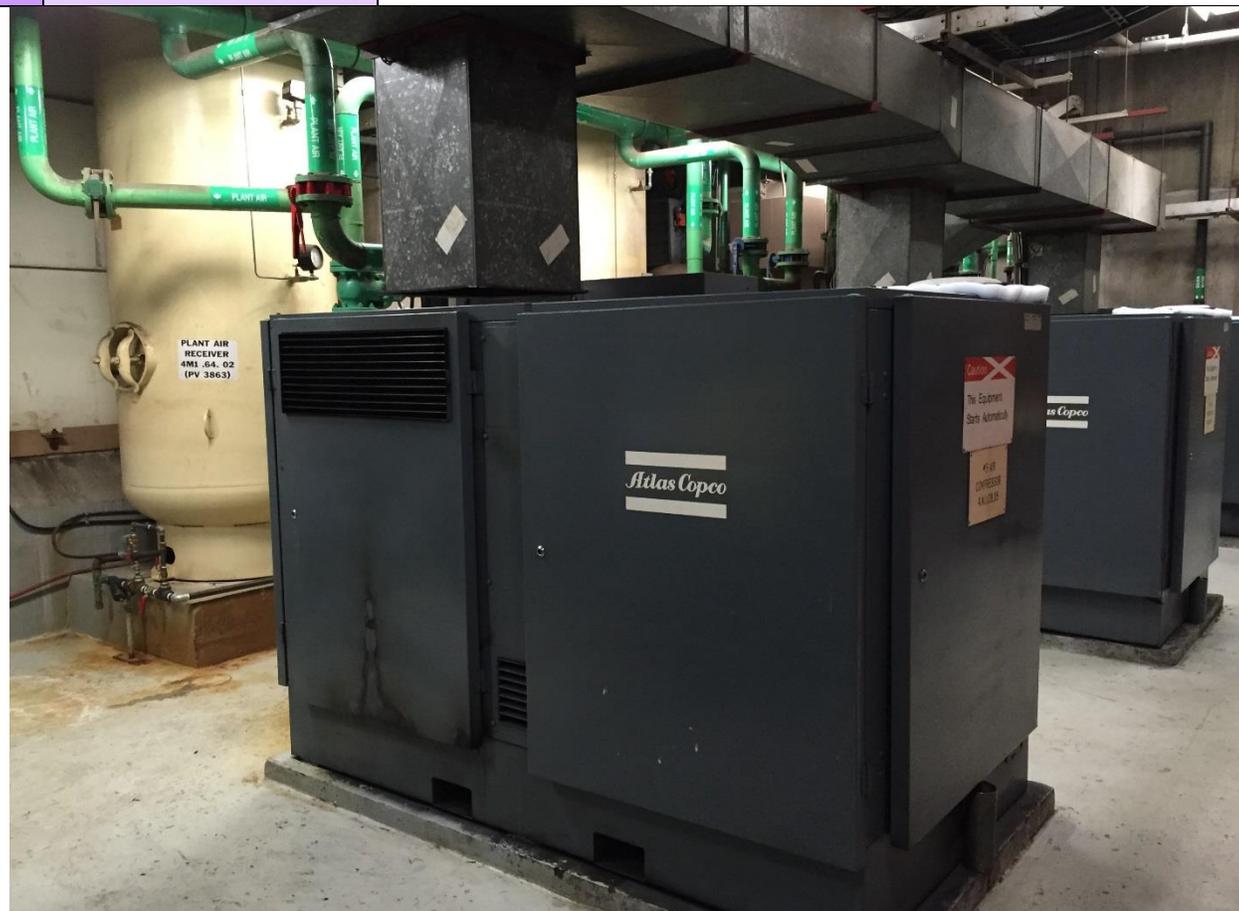
#3 AIR COMPRESSOR, E&M PLANT. ELECTRICAL SUPPLY: 600 VOLT, 3 PHASE VIA 3 CONDUCTOR, SIZE #350KCM TECK90 TYPE CABLE.

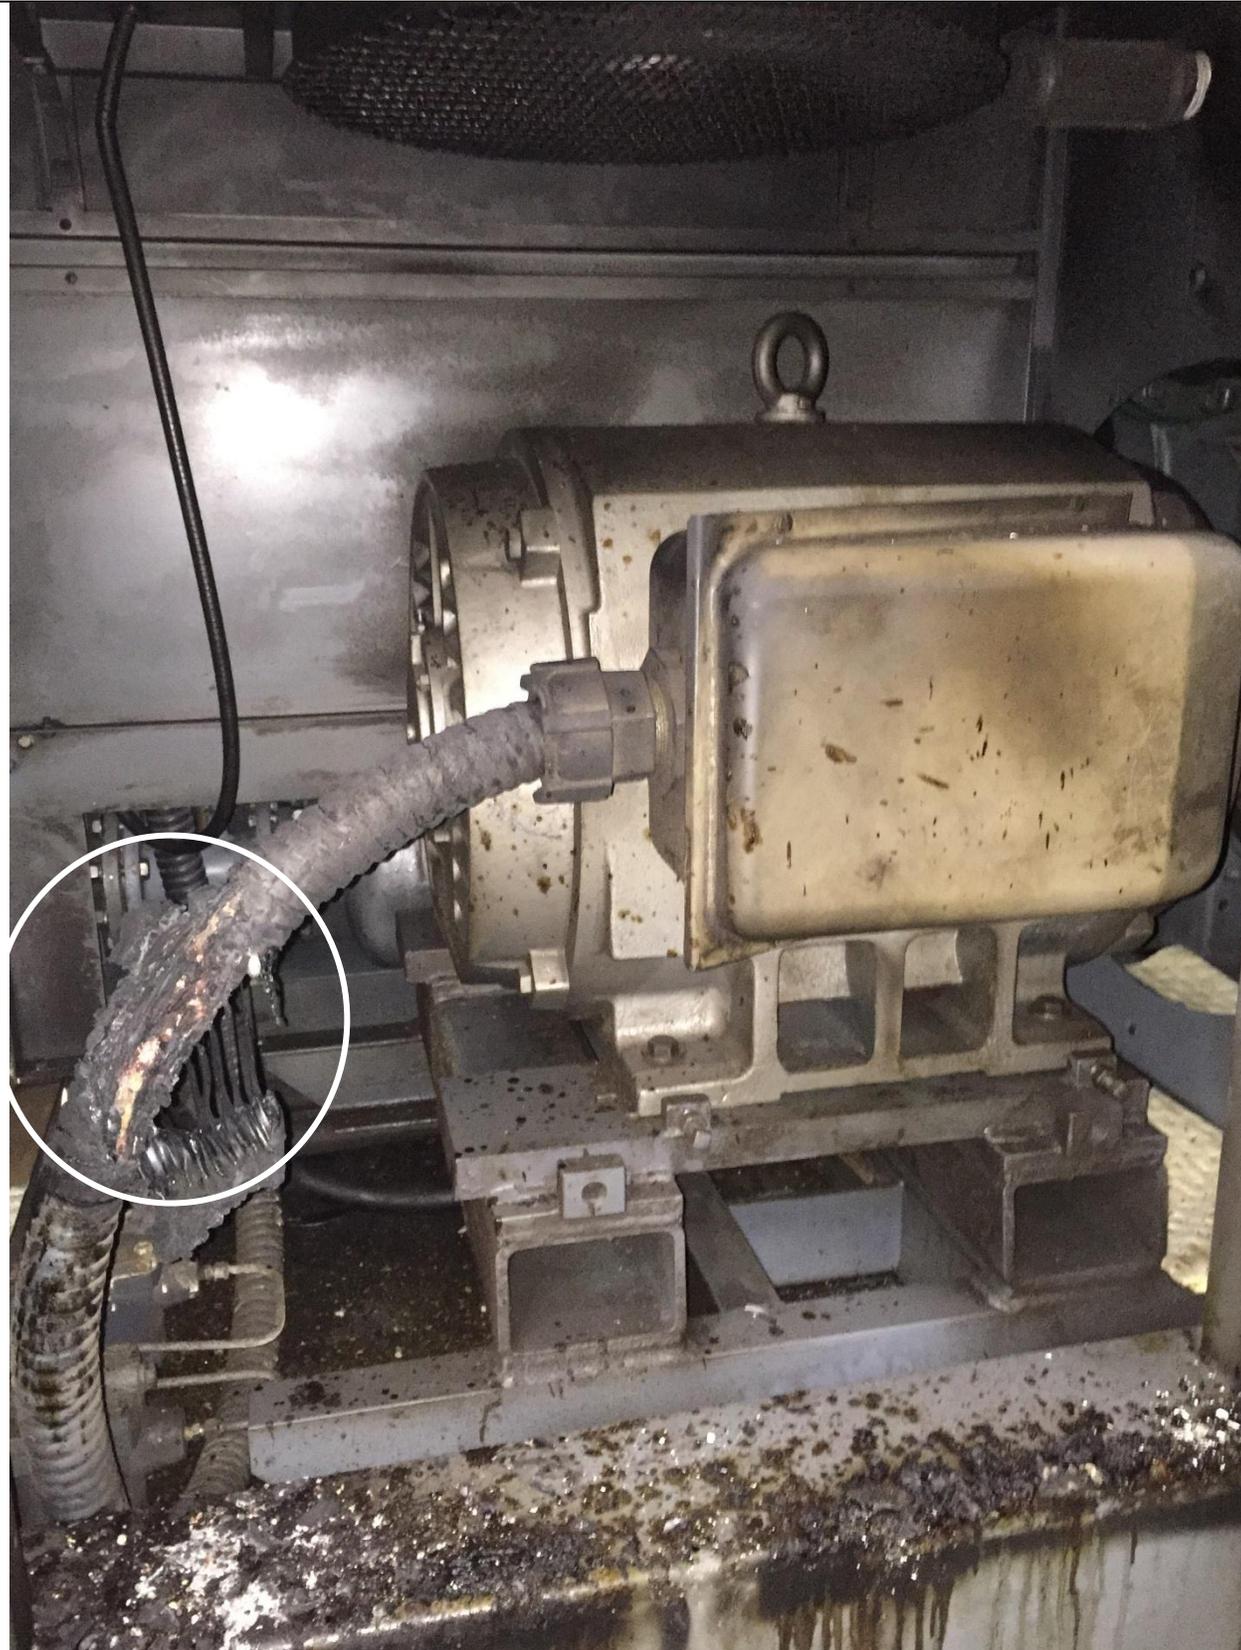
Causes and contributing factors		No evident causes or concepts contributing to the incident.

CABLE FAILURE OCCURRED TO A SECTION OF A MOTOR FEEDER CABLE THAT IS SUPPLIED AND INSTALLED BY THE MANUFACTURER. THE FAILURE OCCURRED BETWEEN PHASE CONDUCTORS; THE EQUIPMENT HAS GROUND FAULT MONITORING AND INDICATION AND DID NOT DISPLAY ANY EVIDENCE OF A GROUND FAULT PRIOR TO THE FAILURE.
