Incident Summary #II-827682-2019 (#11457) (FINAL)

SUPPORTING INFORMATION	Incident Date	March 18, 2019	
	Location	Vancouver	
	Regulated industry sector	Elevating devices - Elevator	
	Impact	Qty injuries	0
		Injury description	No injury reported
		Injury rating	None
	Damage	Damage description	Fire damage to the auxiliary elevator controller (Photo 1) which houses some of the high voltage components
		Damage rating	Major
Incident rating	Major		
Incident overview	The auxiliary elevator controller had an internal fire within the controller cabinet and caused a substantial amount of damage to the elevator components within the cabinet.		
INVESTIGATION CONCLUSIONS	Site, system and components	The auxiliary elevator controller houses components that enable the elevator system to operate. These components consist of a motor contactor, load reactor and dynamic braking resistors. The motor contactor is similar to a switch for the elevator motor which enables/disables current to flow to the motor. The load reactor minimizes the effects of voltage spikes to the elevator motor. The braking resistors are used to decelerate an electric motor by converting the motor's kinetic energy to electrical e

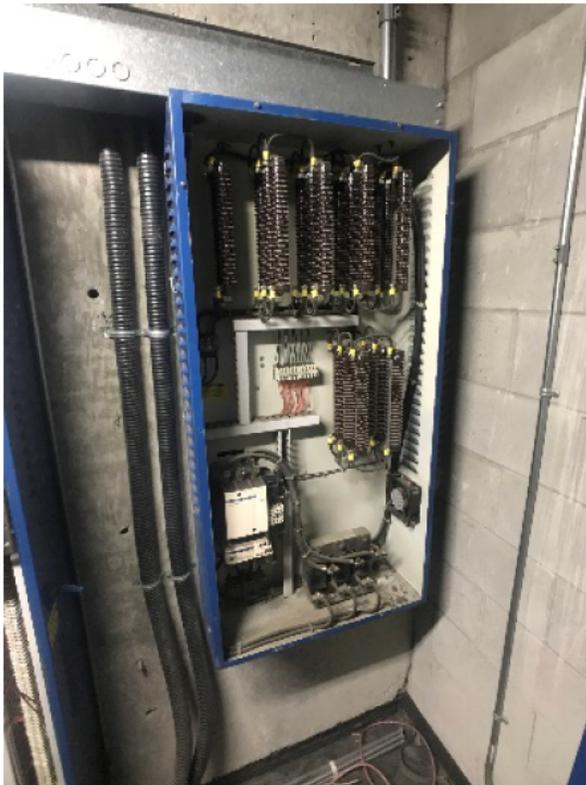
Photo 1 - Picture of Auxiliary controller from other elevator which was not affected by the fire

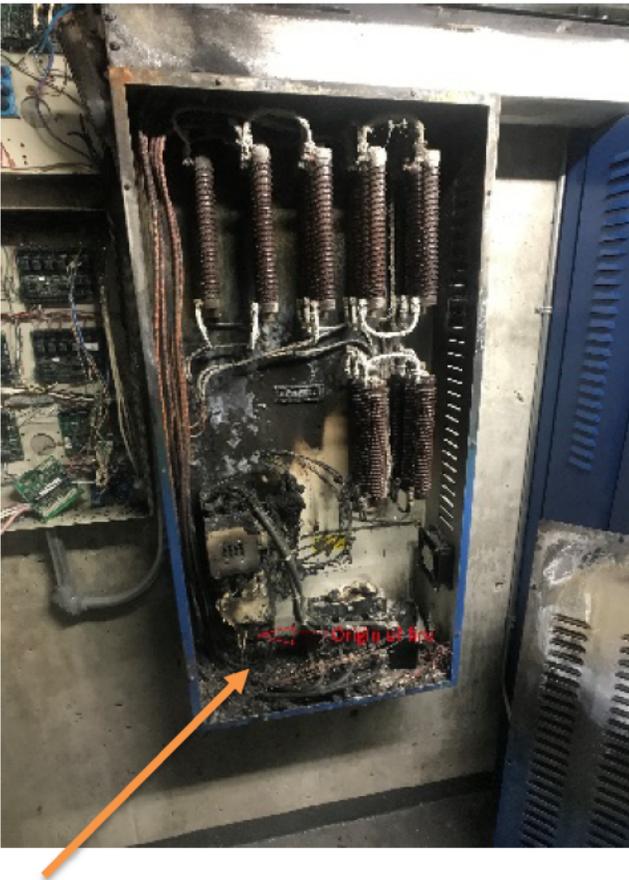
Failure scenario(s)	One or more components within the auxiliary elevator controller produced a large amount of heat and ignited components within the controller. The ignition source was just below the motor contactor.(Photo 2)	
	Facts and evidence	<p>During Onsite Investigation:</p> <ul style="list-style-type: none"> • 2 elevating units on site, only one was affected by the fire • Auxiliary elevator controller for the first unit was still in its original condition (Photo 1) • Auxiliary elevator controller for the second unit was damaged extensively from the fire(Photo 2) • During investigation it was confirmed that auxiliary elevator controller damaged during by the fire was the original, with all original parts. • Damage from fire was seen in the area just below the motor contactor (Photo 3) • Fire was investigated by a reputable fire investigation company () and a final investigation report was provided. • According to report, the left cable below motor contactor was the ignition source. The yellow colour of the cable strands indicates that the cable reached a temperature of approximately 1050 degree C, which was hot enough to ignite the enclosure of the contactor. also indicated a loose connection from the cable to the terminal block below contactor was the probable cause of the high resistance heating

Photo 2 - Origin of the fire just below the motor contactor

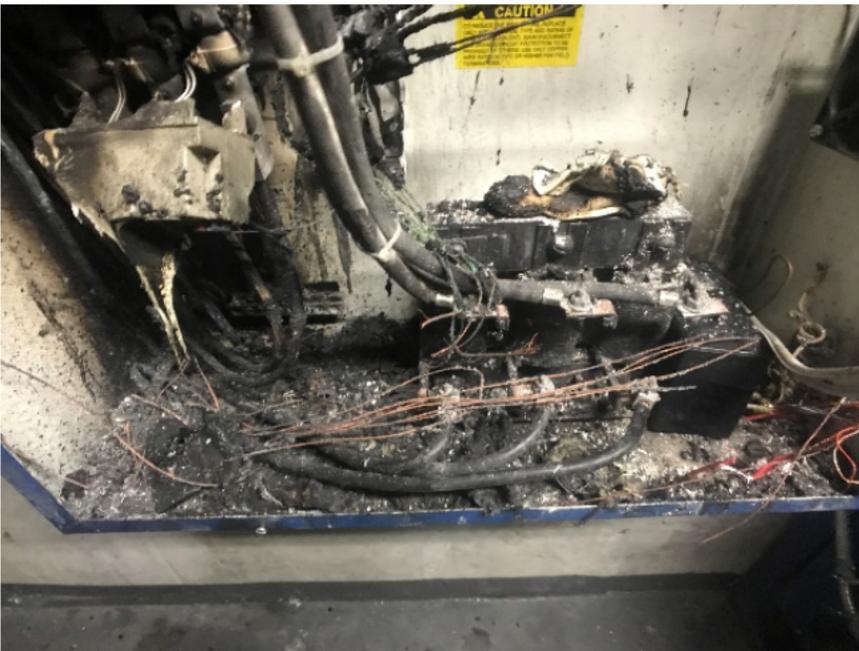
<ul style="list-style-type: none">• Entire auxiliary controller cabinet was replaced after the investigation (Photo 4)• A follow up assessment was performed on this unit prior to releasing the unit for public use
Causes and contributing factors	<p>It is very likely that a loose cable connection at the left terminal block from the high current cable was the cause of the fire within the cabinet housing the auxiliary elevator controller. Contributing factors could be improper initial installation or maintenance</p> <p>report also confirms that the yellow colour of the cable strands after the fire indicates a high resistance heating took place</p>

Photo 3 – Shows the fire damage just below motor contactor

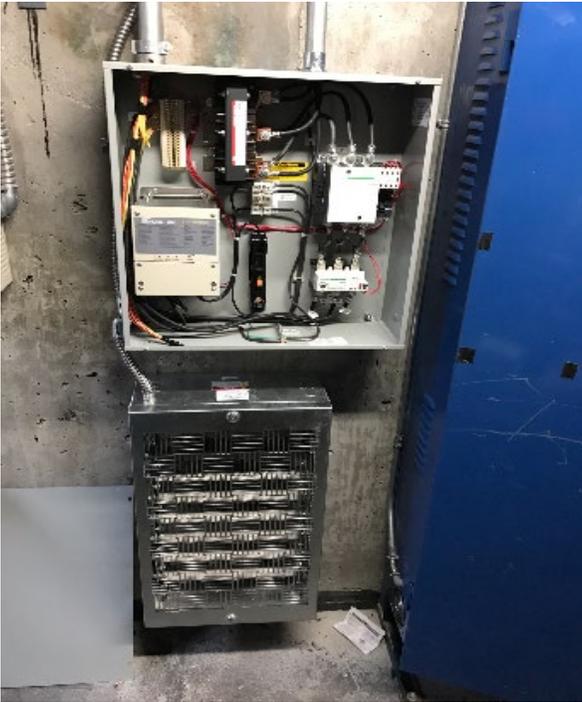
Photo 4 Picture of new replaced auxiliary controller
