Incident Summary Reference # 5616487

SUPPORTING INFORMATION	Incident Date			May 28, 2017
	Location			Penticton, BC
	Regulated industry sector			Electrical – Low voltage electrical system (30-750V)
	Impact	Injury	Qty injuries	1
			Injury description	A minor shock causing mild pain was received to the forearm. No other physical damage was incurred
			Injury rating	None
		Damage	Damage description	N\A
			Damage rating	N\A
		Incident rating		
	Incident overview			A telecom worker was installing a new aerial fibre optic cable to a residence. While attempting to remove the older communication cable run too close to the exposed power conductors his bare arm brushed against one of the power conductors and he received a minor electrical shock. The shock startled him and he jumped down off the ladder without further incident or injury.
INVESTIGATION CONCLUSIONS	Site, system and components			The electrical installation code requires a minimum separation of 300mm between insulated power and communication conductors. Modern insulation types are resistant to degradation and breakdown due to the new materials used in their construction This separation is considered enough of a safety boundary be

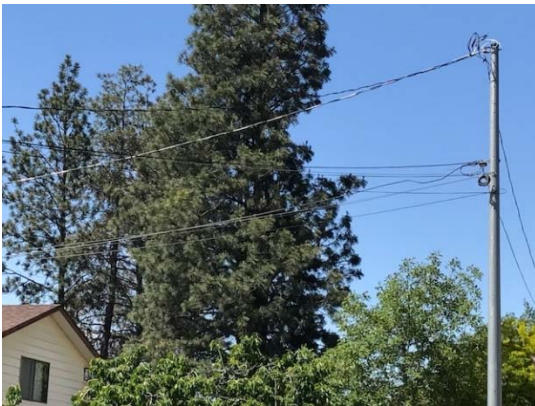
Photo of Hydro pole across street with aerial conductors to home

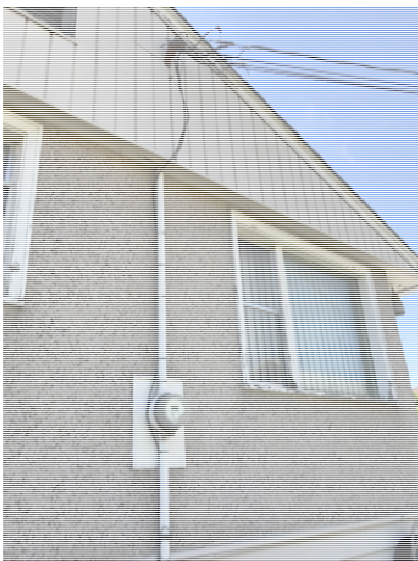
These conductors were found non-compliant in providing sufficient clearance as required by the BC Electrical Code.
	Causes and contributing factors	<p>Workers should be more thoroughly trained in recognizing the older style power conductors and in their inherent tendencies to physical break down becoming a shock risk.</p> <p>Close inspection of the service conductors could have been made to identify any insulation or lack of insulation which might pose a shock hazard when first .</p> <p>Working on a Sunday may make a worker anxious to complete the days tasks.</p> <p>The weather was very warm and a worker not wearing gloves or protective clothing on his bare arms is at an increased chance of risk. Protective clothing reduces the chance of accidental contact with energized power conductors.</p>

Photo of aerial conductors gathered at same connection point on home. The communication cables are intertwined with the power conductors

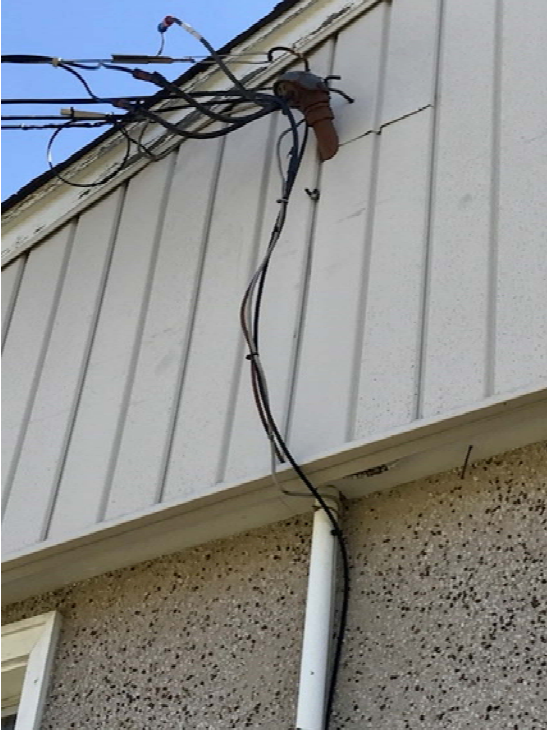
Failure scenario(s)			<p>The original power conductors supplying the home’s electrical service box were over 60 years old. The conductor insulation is weather-beaten due to environmental factors and this reduced the insulating abilities of the insulation and may have created un-noticeable bare spots.</p> <p>Over the years additional aerial cables were installed to supply cablevision service and to upgrade existing telephone service. These installations resulted in reduced clearances between the power and communication cables and the communication cable was routed between the power conductors in very close proximity to each other.</p> <p>The worker was likely required to reach in close to the power conductors to remove the existing telephone cable before connecting the new one and while doing so his bare arm contacted the energized powerline. Working with bare arms and without gloves will increase the exposure to a shock risk while performing this task.</p>

Close up of power conductors, cablevision and Telus communication cable intertwined around service head

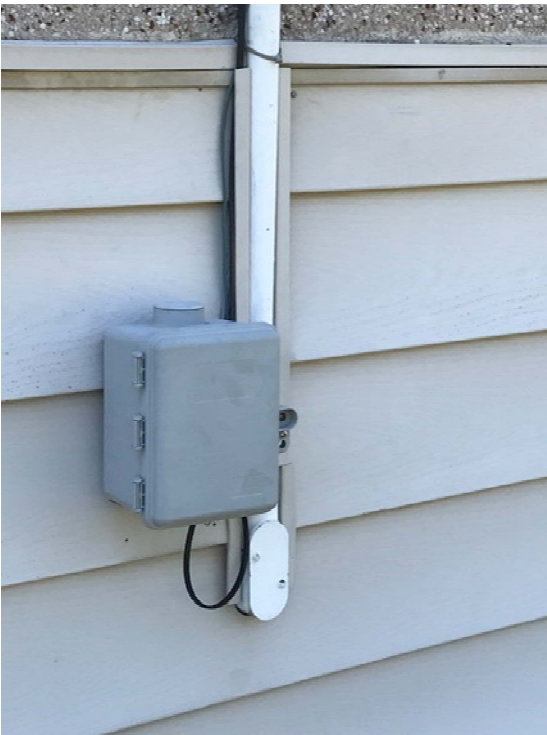
New (black) fibre optic cable connection into existing CATV connection box
