Incident Summary #II-1110571-2020 (#20084) (FINAL)

SUPPORTING INFORMATION	Incident Date	November 28, 2020	
	Location	Nanoose Bay B.C.	
	Regulated industry sector	Gas - Propane system	
	Impact	Qty injuries	2
		Injury description	-6 year old child found unconscious and received a significant concussion
			-9 year old child received a severe laceration on right cheek
	Injury rating	Major	
	Damage	Damage description	An uncontrolled release of propane resulted in damage to the structure of an outdoor living area as a result of an explosion.
		Damage rating	Major
	Incident rating	Major	
Incident overview	A propane gas log lighter was installed in an outdoor living area of a single family home. The gas line supplying the log lighter cracked inside an unventilated enclosure and created an uncontrolled release of propane resulting in an explosion.		
INVESTIGATION CONCLUSIONS	Site, system and components	<p>An uncertified log lighter was installed in a wood burning fireplace in an outdoor living area of a single family dwelling home.</p> <ul style="list-style-type: none"> -The log lighter consists of a single burner device connected to a propane fuel source operating at a pressure of 11-13"

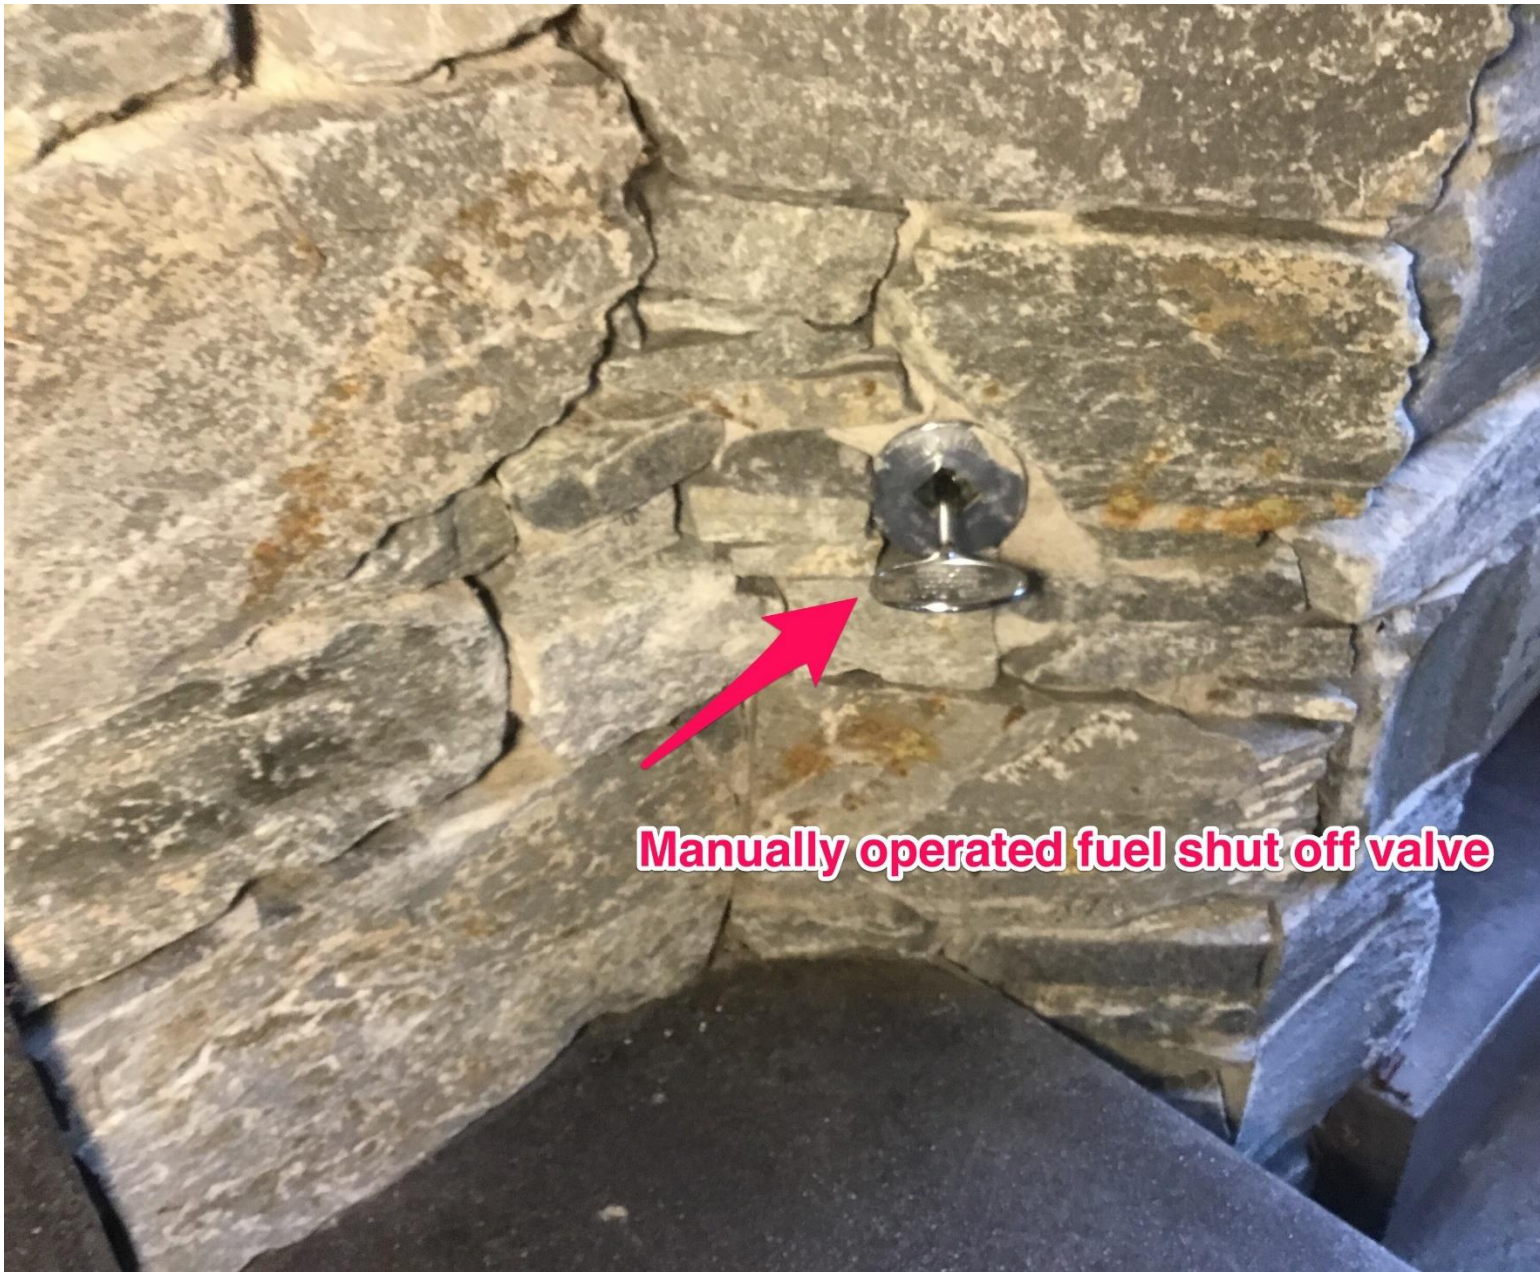
- Upon starting a wood burning fire, the log lighter was energized and as a result propane was released from the failed copper tubing supply line.
- The propane leak was downstream of the shut off valve and would only leak upon turning on the manually operated shut off valve.

Picture #1 manually operated fuel shut off valve

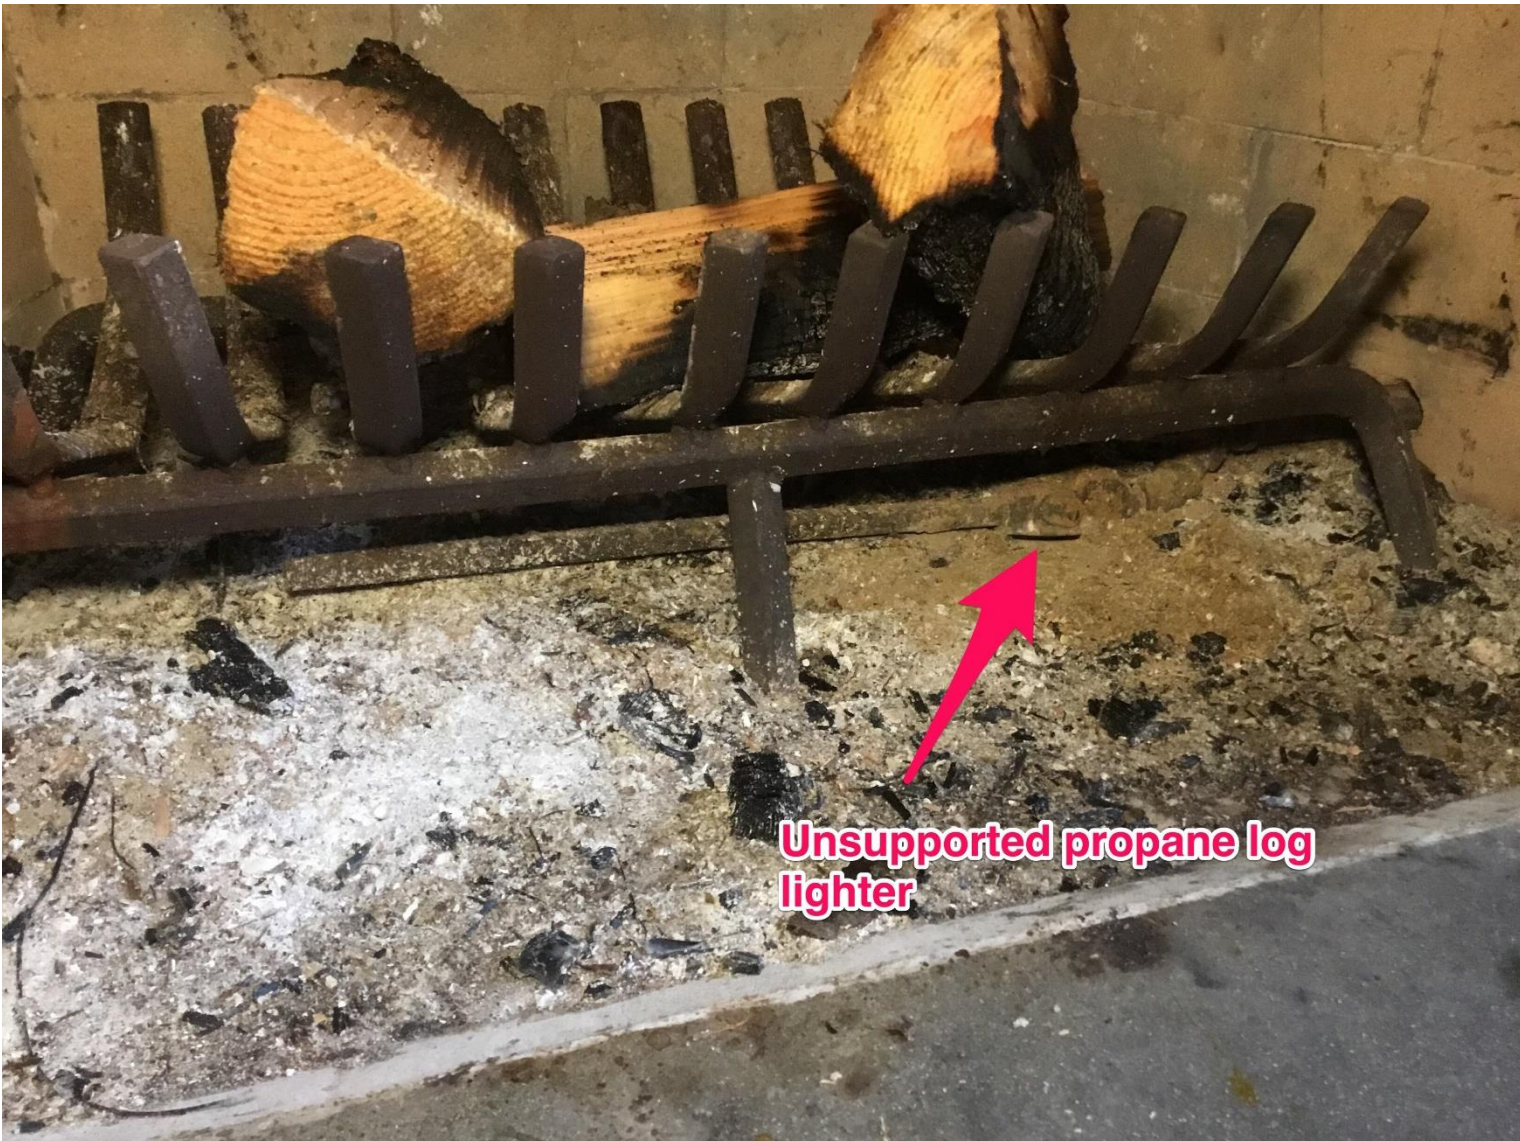
- Log Lighter Manufacturers installation instructions:
- The log lighter was not secured in a rigid manner as manufacturer installation instructions required, as a result the burner would move horizontally over one inch, which then applied force to the soft copper propane supply line.

Picture #2 Unsupported propane log lighter

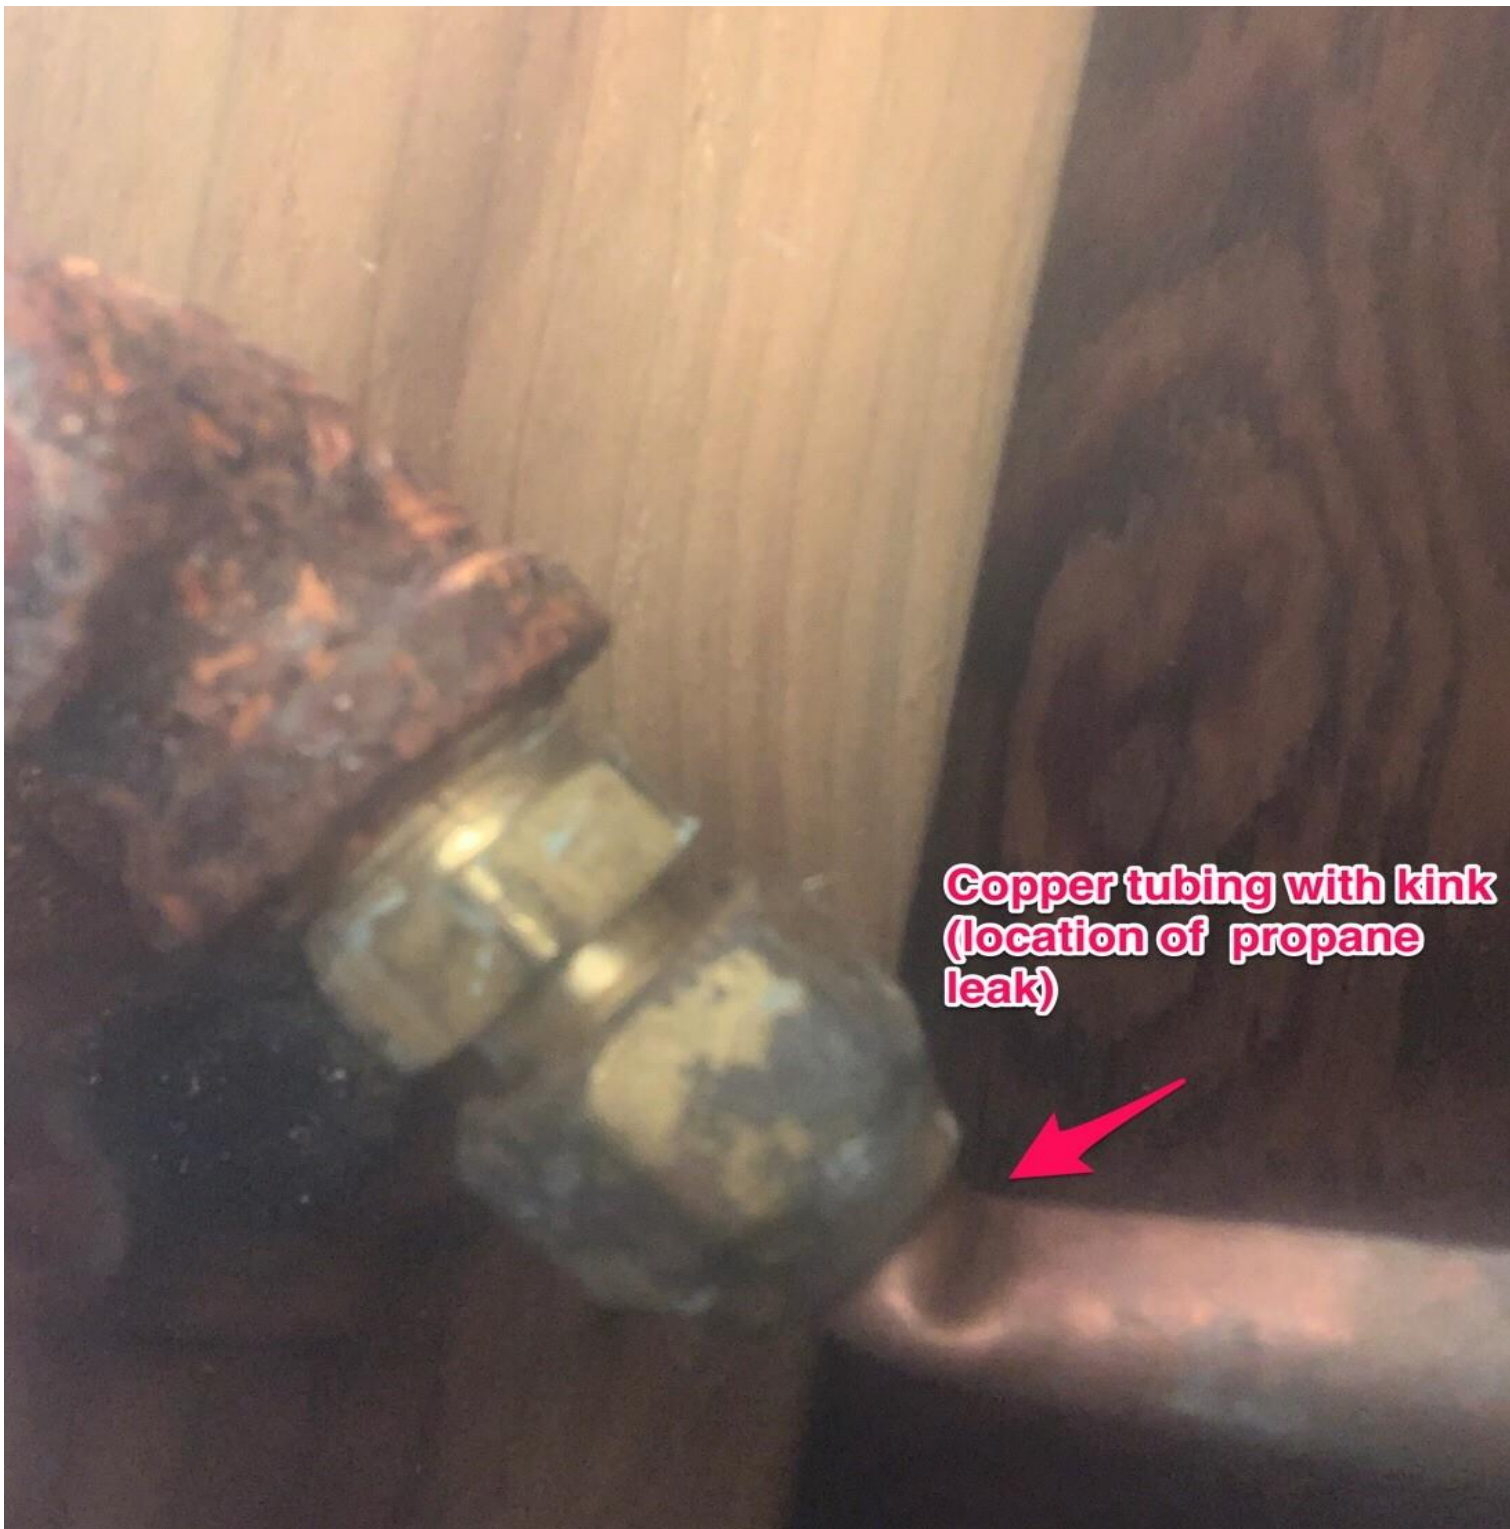
- Upon original installation of the log lighter, it appeared the ½” soft copper tubing propane supply line to the log lighter was bent in a manner which created a kink on the tubing.

- Movement from the propane log lighter over time, caused the soft copper supply line to work harden, eventually creating fatigue to the soft copper.
- This fatigue in the soft copper supply line eventually caused the fuel to leak through a crack in the soft copper.

- The soft copper tubing appeared to have a very sharp bend and the copper tubing was visibly kinked and appeared to have a visible crack.
- At the time of the investigation the piping was tested by a gas contractor and the following was witnessed during the investigation:

Picture #3- Copper tubing with kink (location of propane leak)

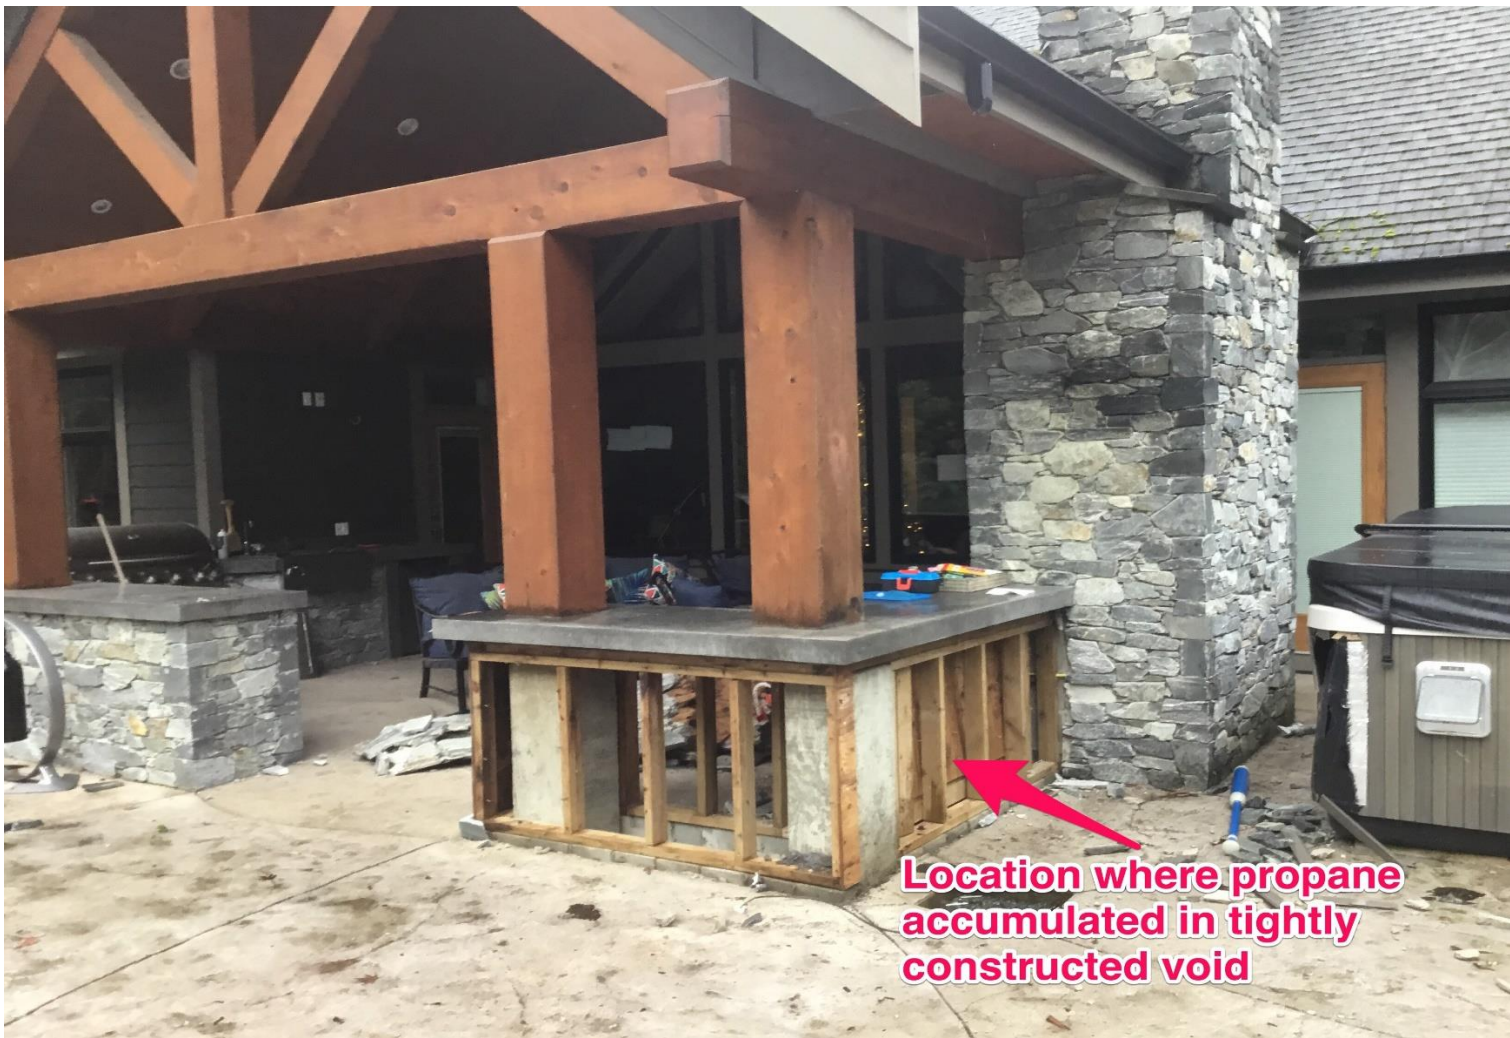
- As a result of this leak propane filled the tightly constructed under counter void where it began to accumulate.
- Propane then migrated through the gas supply piping chase, to where the main wood burning fire was established.

Picture #4 Where propane accumulated in tightly constructed void

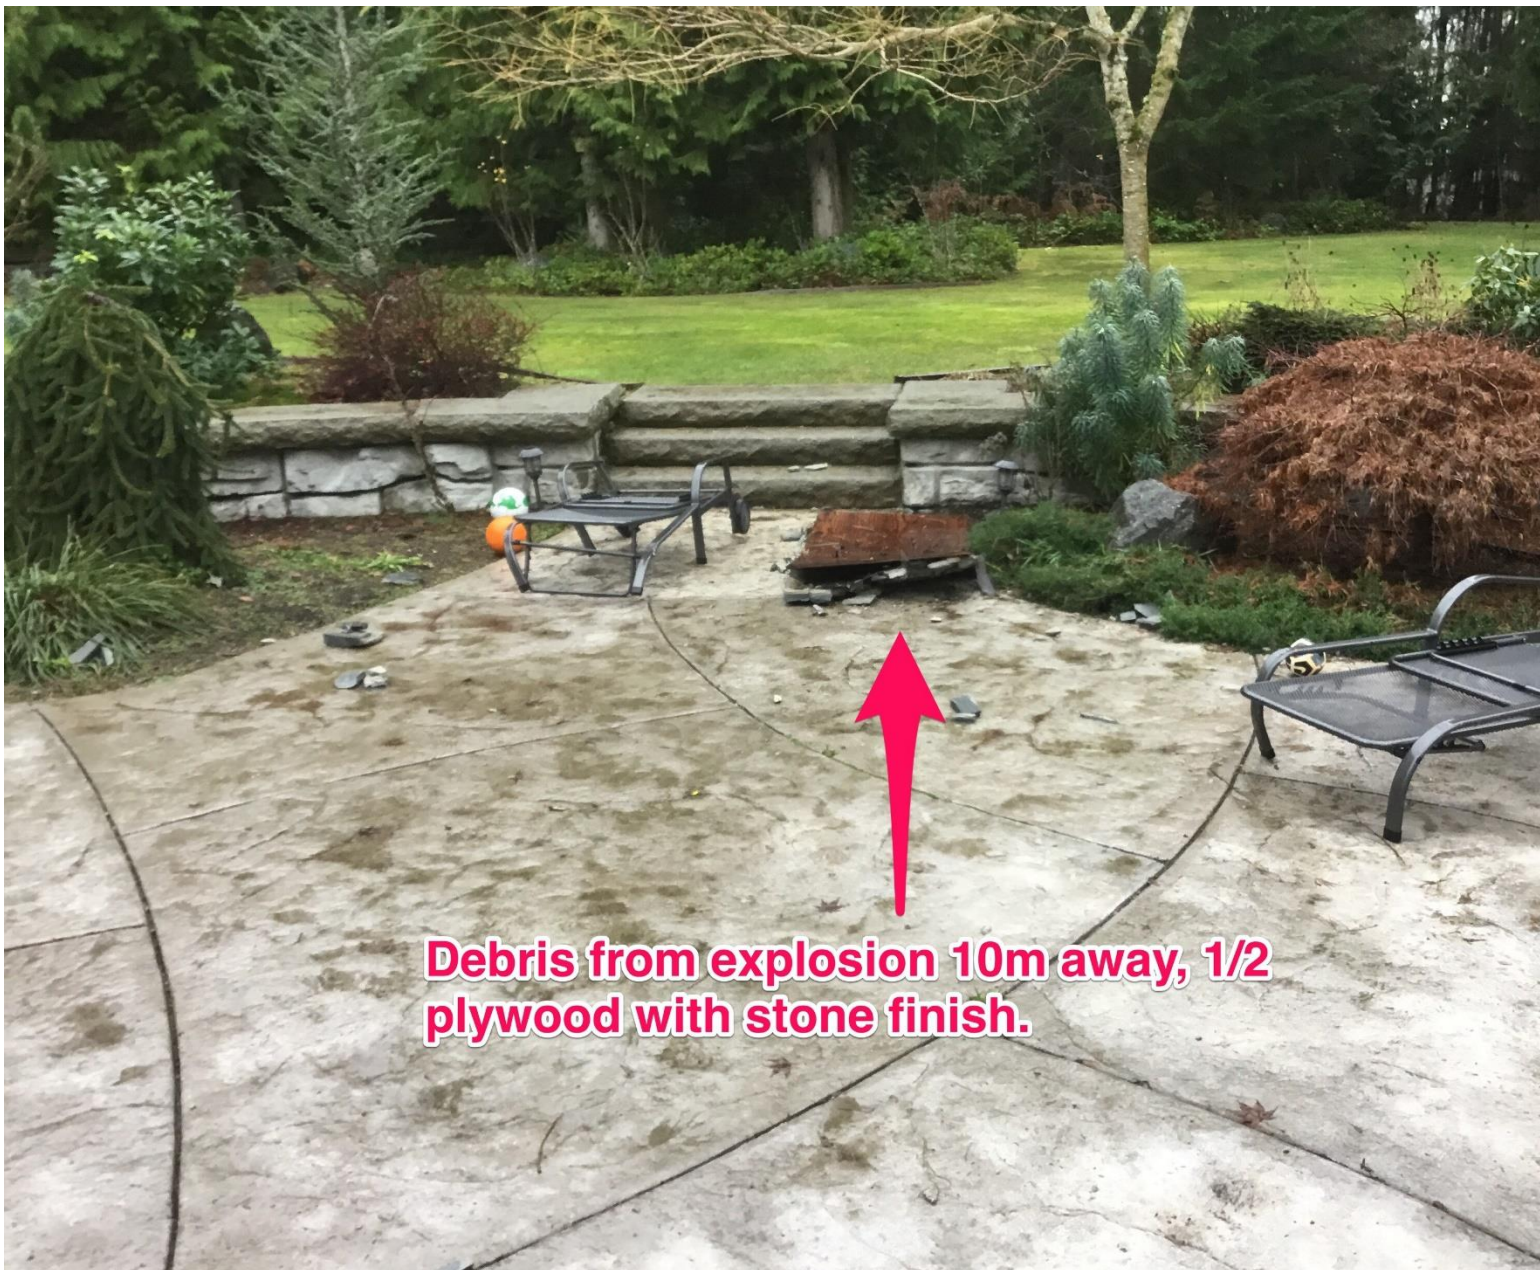
**Debris from explosion 10m away, 1/2
plywood with stone finish.**

Picture #5 Debris from explosion 10 meters away, 1/2 plywood with stone finish
