Incident Summary #II-751517-2018 (#8849) (FINAL)

SUPPORTING INFORMATION	Incident Date	September 30, 2018	
	Location	Saanich, BC	
	Regulated industry sector	Electrical - High voltage electrical system (greater than 750V)	
	Impact	Qty injuries	0
		Injury description	N/A
		Injury rating	None
	Damage	Damage description	The main power transformer suffered some charring and burning where the fault occurred on one primary winding specifically the bottom connection on the B phase winding, as well some on the secondary windings. no other equipment was damaged.
		Damage rating	Moderate
Incident rating	Moderate		
Incident overview	During a site re-energization of an upstream circuit breaker, the main 25KV to 600V 3 phase 1000KVA transformer failed to ground.		
INVESTIGATION CONCLUSIONS	Site, system and components	Utility supplied power enters the commercial building through a privately owned unit substation. Power is then transformed into usable levels to supply all electrical systems associated with the building.

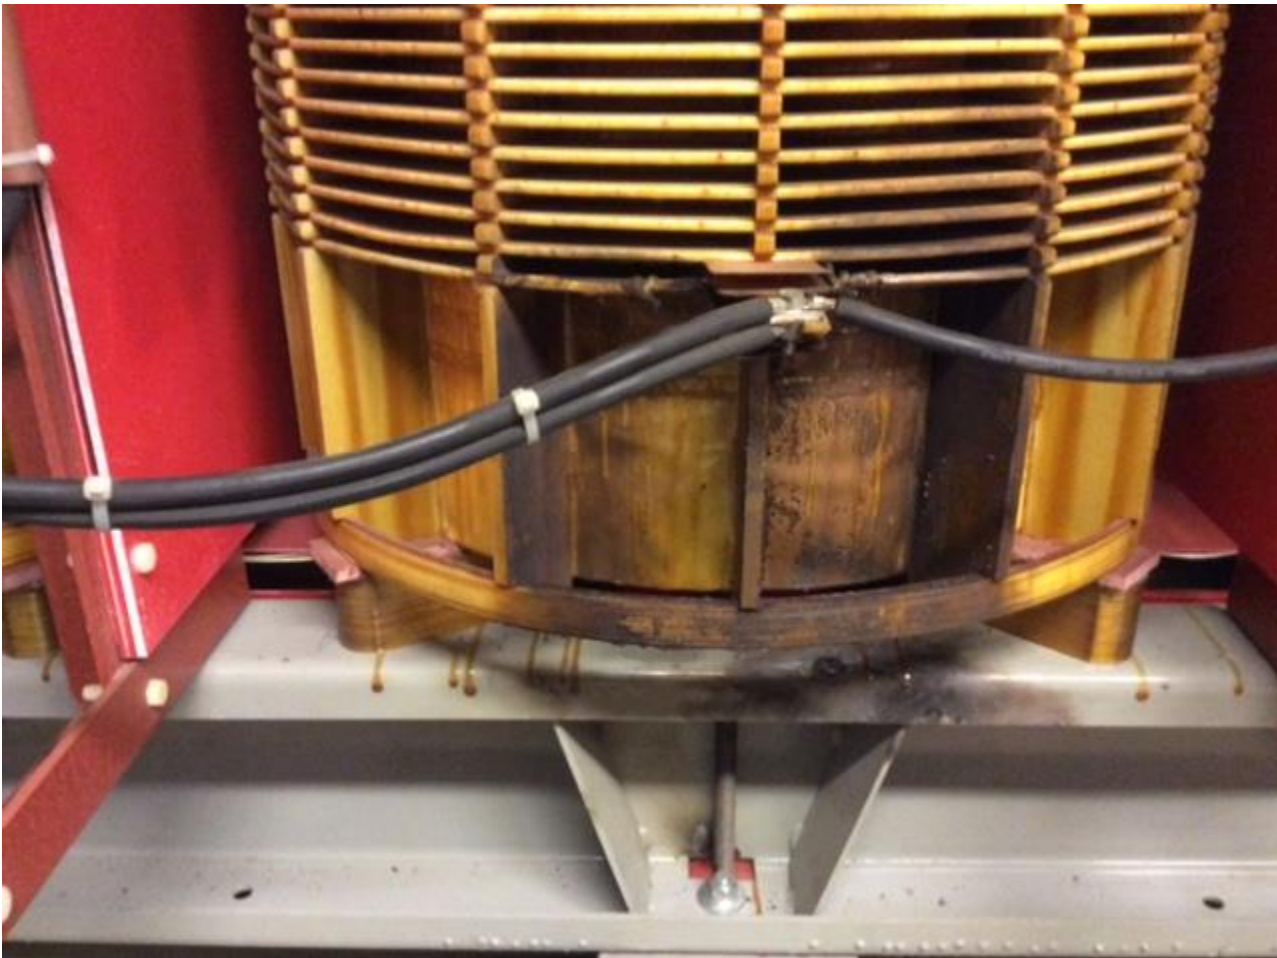
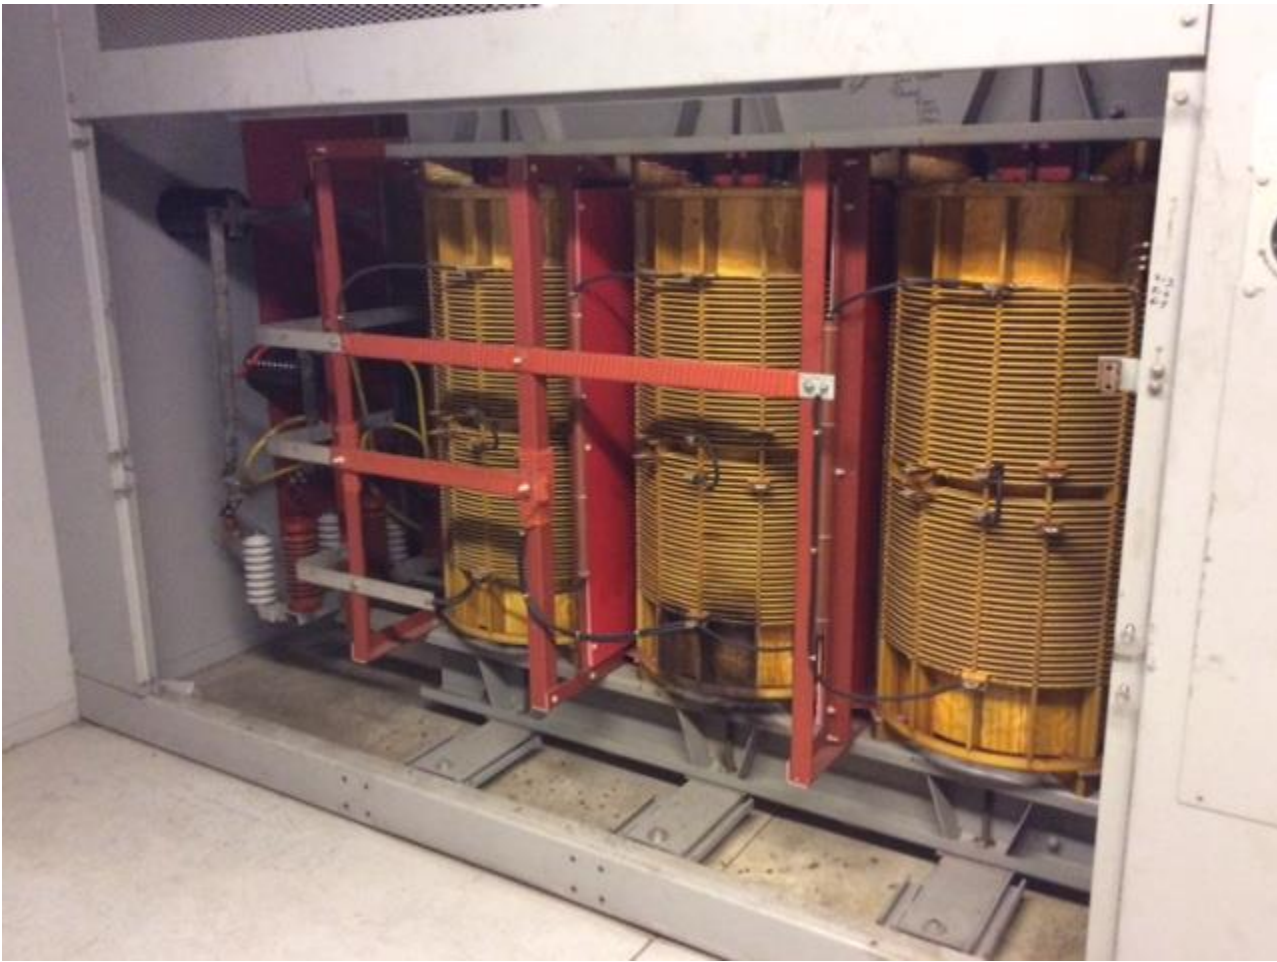
Failed transformer core.
