Incident Summary #II-757086-2018 (#9144)

SUPPORTING INFORMATION	Incident Date		Oct. 12, 2018
	Location		Powell River
	Regulated industry sector		Boiler and Pressure Vessel System
	Incident	Qty injuries	None
		Injury description	None
		Injury rating	N/A
	Damage	Damage description	Tube one ruptured at the sweeping elbow transition between the front wall and the floor tubes leaving an approximate 12” by 3” hole. The insulation and cladding covering the tube was blown off.
		Damage rating	Major
	Incident rating		Major
	Incident overview		A severe tube rupture occurred on a high pressure steam boiler which was operating at 750 pounds per square inch shortly following a warm-up period on start-up. A catastrophic tube failure caused a release of a significant portion of the 40,000 liters of water in the boiler in approximately one minute. The inside of the entire four storey boiler building was engulfed in high temperature steam. No one was inside at the time of the release. The boiler house is typically occupied by shift operators.

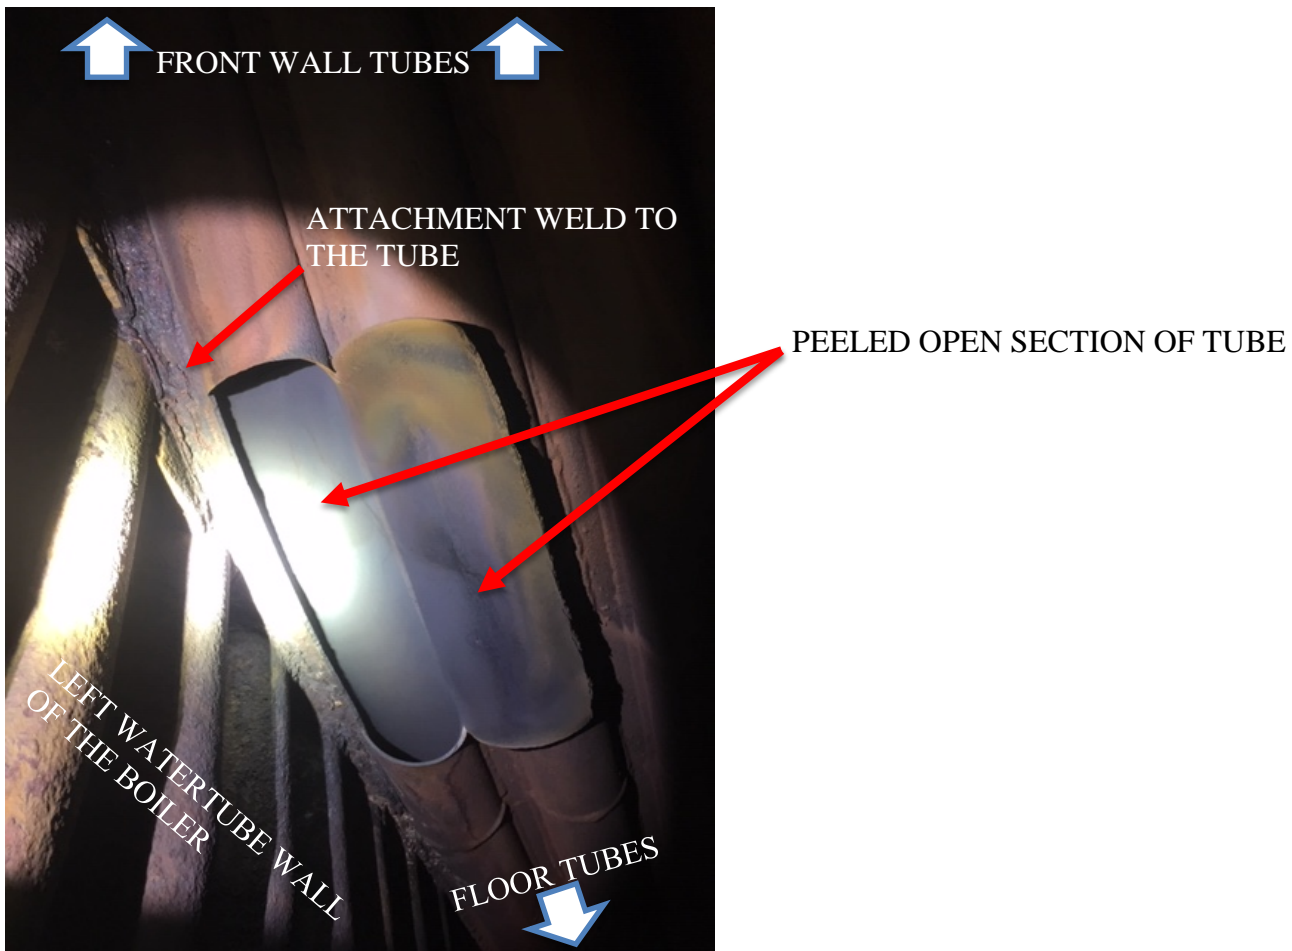
Figure 1: Tube rupture.

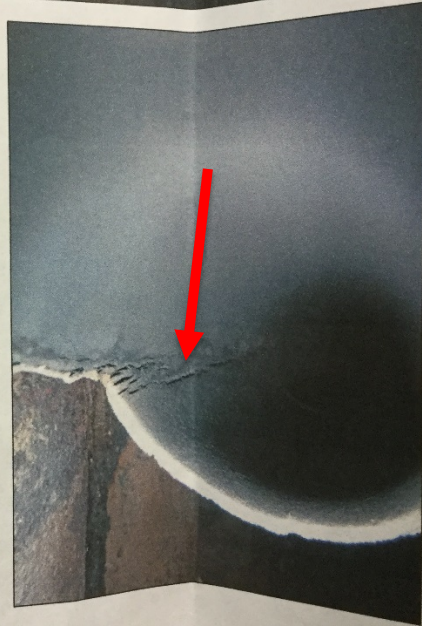
Photo 2:

View looking down floor tube showing damage typical of SAC extending along toe of fillet weld. Similar damage extends up the bend between the floor and front wall.

Figure 2: Evidence of stress accelerated corrosion inside of the tube.

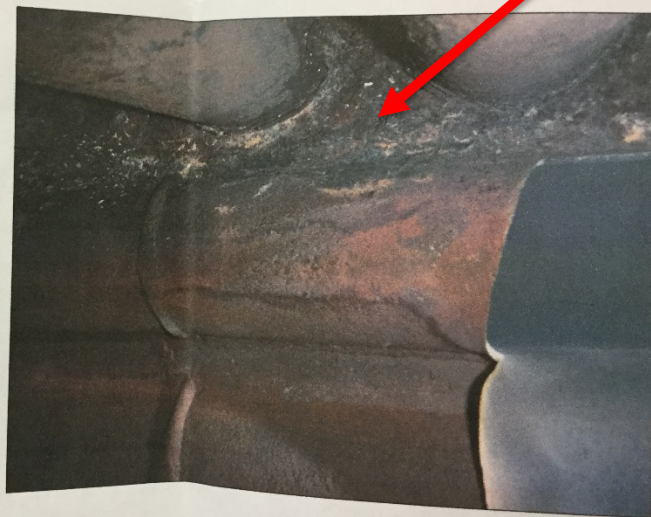
Photo 3:

View of tube OD near failure showing corrosion of the membrane on the wall side of the tube indicating that the tube was beginning to leak prior to the final failure. The side of the tube away from the wall was free of significant corrosion damage.

Figure 3: Evidence of leaking tube prior to the failure.

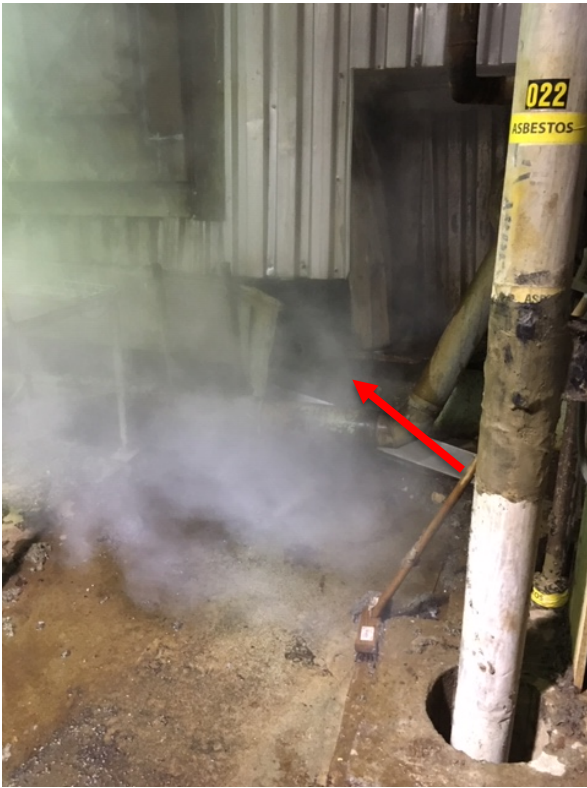
Figure 4: Damaged insulation and cladding following the failure.

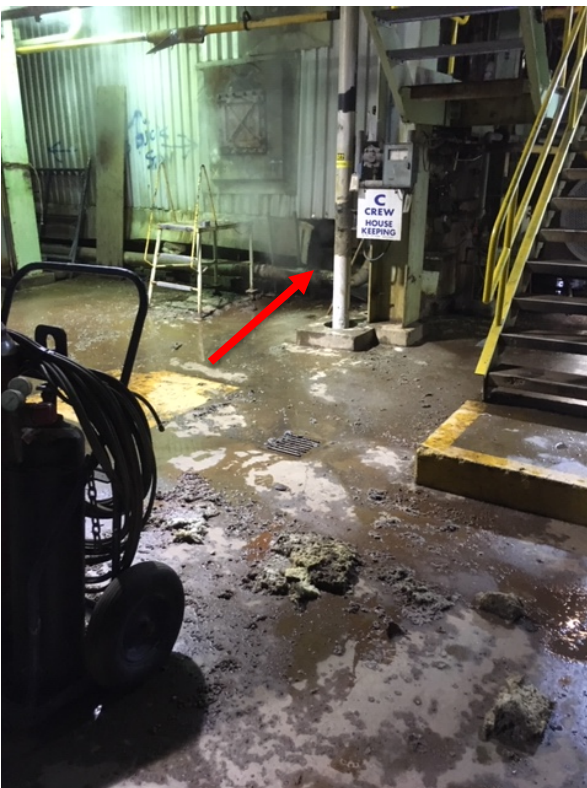
Figure 5: Adjacent area following failure.

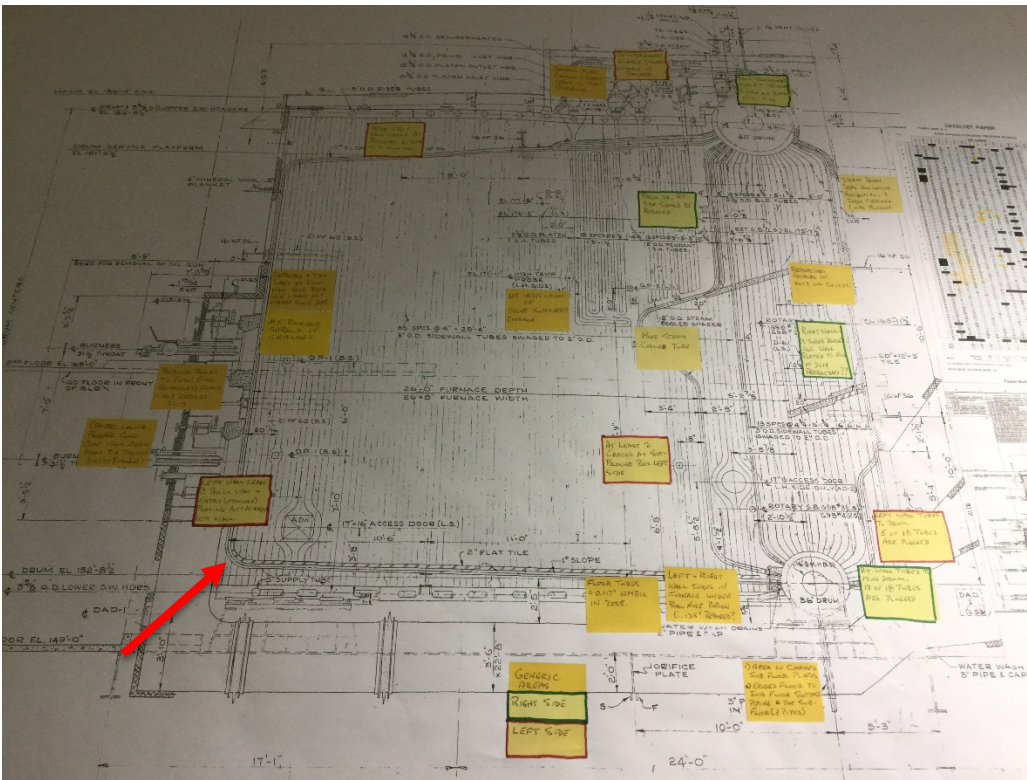
Figure 6: Location of failure on boiler drawing.

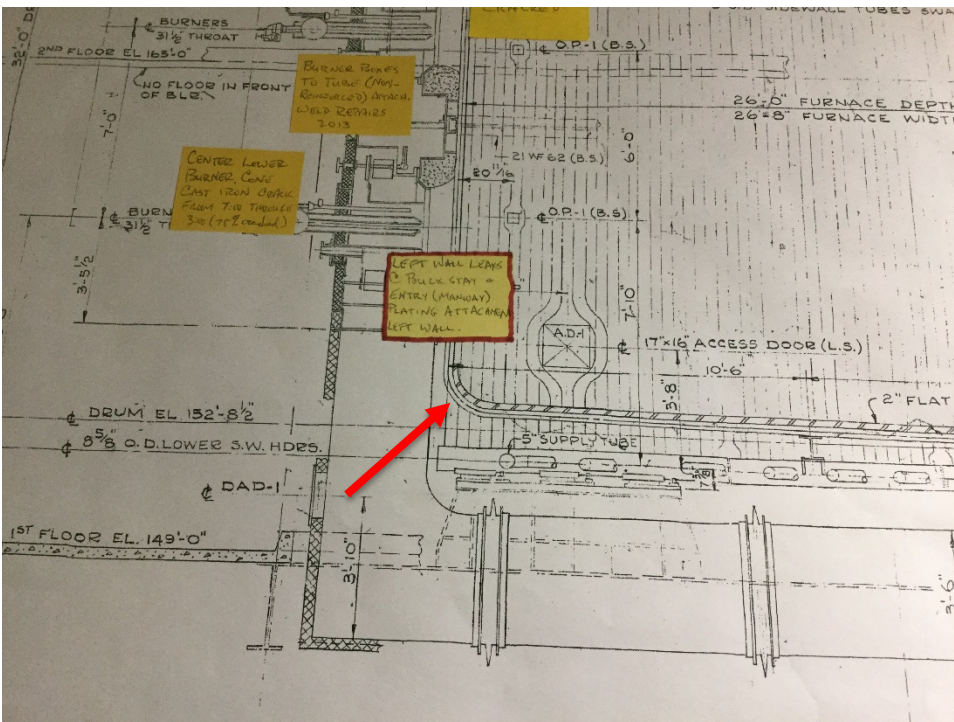
Figure 7: Location of failure on boiler drawing (close-up).

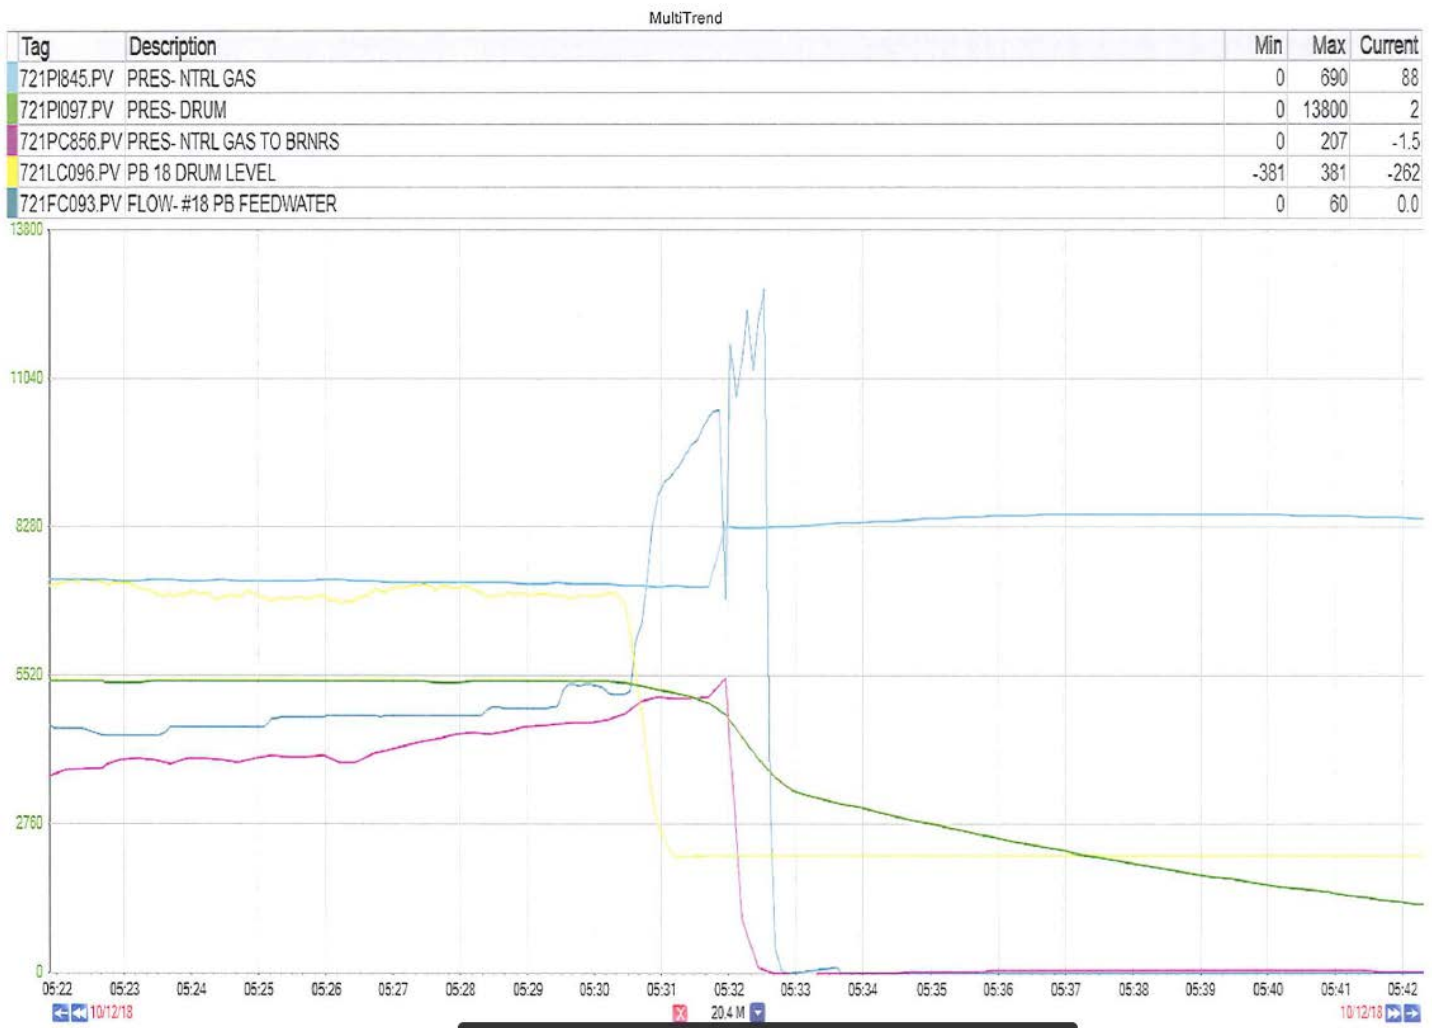
Figure 8: Boiler variables at the time of the incident.
