Incident Summary #II-1515128-2023 (#32692) (FINAL)

SUPPORTING INFORMATION	Incident Date	February 27, 2023	
	Location	Penticton, BC	
	Regulated industry sector	Electrical - Low voltage electrical system (30V to 750V)	
	Impact	Qty injuries	1
		Injury description	Young student required medical attention for minor burns sustained
		Injury rating	Minor
	Damage	Damage description	Outlet and outlet cover were left with burn marks requiring replacement
		Damage rating	Minor
	Incident rating	Minor	
Incident overview	A young student placed a metal paper clip in a non-tamper-proof 120-volt 15 amp rated duplex outlet causing an immediate short. The outlet and outlet cover were burned requiring replacement and the young student sought medical attention.		
and INVESTIGATION CONCLUSIONS	Site, system and components	<p>The common place 120-volt 15 amp rated duplex outlet is installed along useable wall space for use as convenience. These outlets are used widely within systems as the most common type of electrical system people interact with daily. These duplex outlets when installed are also accompanied by a cover plate providing limited access to energized parts.</p> <p>The 120-volt 15 amp rated

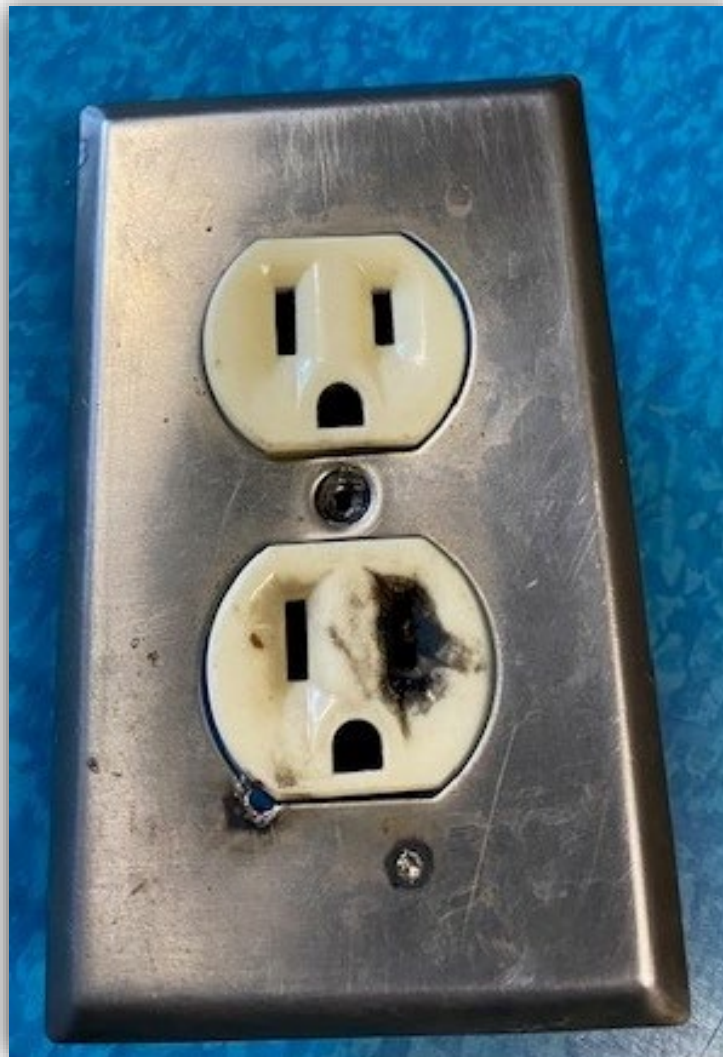
Failure scenario(s)	<p>This elementary school is dated in its construction as the electrical codes in which it was originally built to have long since been changed.</p> <p>Although many upgrades have been completed over time the tamper proof receptacles have not been installed to replace the original duplex receptacles.</p> <p>Along with a non tamper proof receptacle a metal cover plate was originally installed for a more robust finished product.</p> <p>A curious student was able to put a metal paper clip into the energized port in the plug and when it touched the metallic face plate it caused an immediate short to ground.</p>

Image 1 - Original Outlet. Burned area on the receptacle and the point where the paper clip short against the metal cover plate.

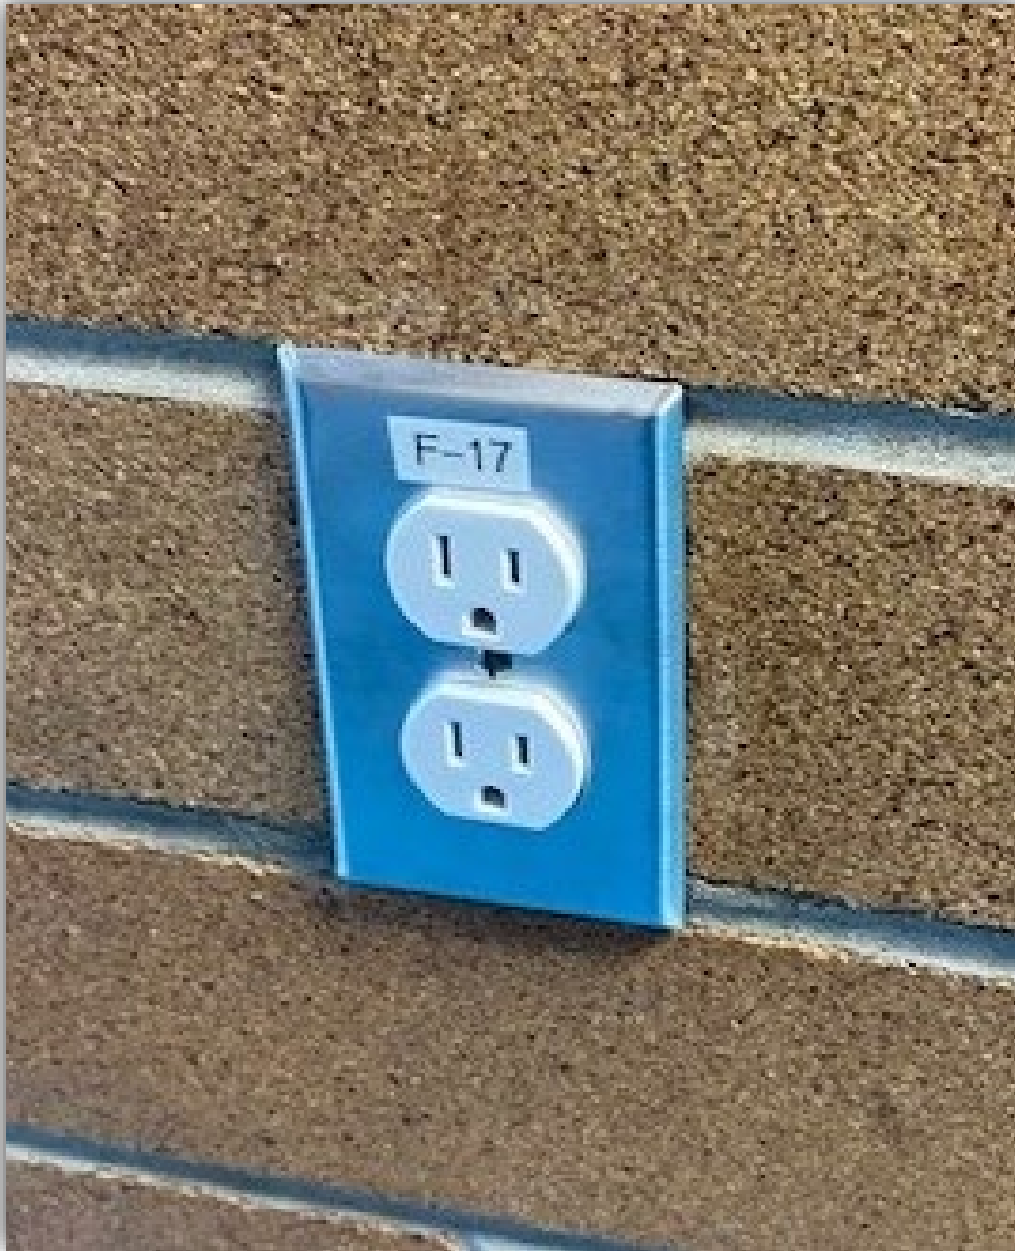
Image 2 - Location of install of original outlet. Replaced with Tamper Proof receptacle as observed in photo.

Facts and evidence	<ul style="list-style-type: none">• Student admitted to faculty that a metal paper clip was inserted into the plug causing the short.• No overcurrent device was tripped as per conversation with the district's electrical maintenance staff.• This outlet was replaced with a tamper proof receptacle and the original was able to be reviewed along with the metal cover plate (see photos below).
Causes and contributing factors	Due to the dated infrastructure the originally installed equipment does not have the modern-day safety equivalent of tamper proof receptacles. The outlet was possible then to have a metal paper clip inserted into the line side of the outlet causing the electrical short and subsequent minor injuries.
