Incident Summary #II-1368066-2022 (#27674) (FINAL)

SUPPORTING INFORMATION	Incident Date	May 1, 2022		
	Location	Mission		
	Regulated industry sector	Electrical - Low voltage electrical system (30V to 750V)		
	Impact	Injury	Qty injuries	0
			Injury description	N/A
		Injury rating	None	
	Damage	Damage description	Arcing causing heat damage to an electric vehicle receptacle located in the homeowners attached garage.	
		Damage rating	Minor	
Incident rating	Minor			
Incident overview	A receptacle in the attached garage of a single-family dwelling, installed for electric vehicle charging, overheated due to arcing causing heat and smoke damage to the receptacle and outlet box.			
INVESTIGATION CONCLUSIONS	Site, system and components	<ul style="list-style-type: none"> • 200-amp 120/240-volt main consumer service • 2 pole 40-amp Siemens circuit breaker protecting a 240-volt 40-amp electric vehicle branch circuit • 3 conductor # 6 AWG aluminum non-metallic-sheathed cable • Nema 14-50R 50-amp 125/250-volt Aluminum/Copper rated receptacle (The manufacturer requires the installer to tighten the screw termination point to a torque setting of 30 IN-LB identified on the receptacle face) • 4 11/16

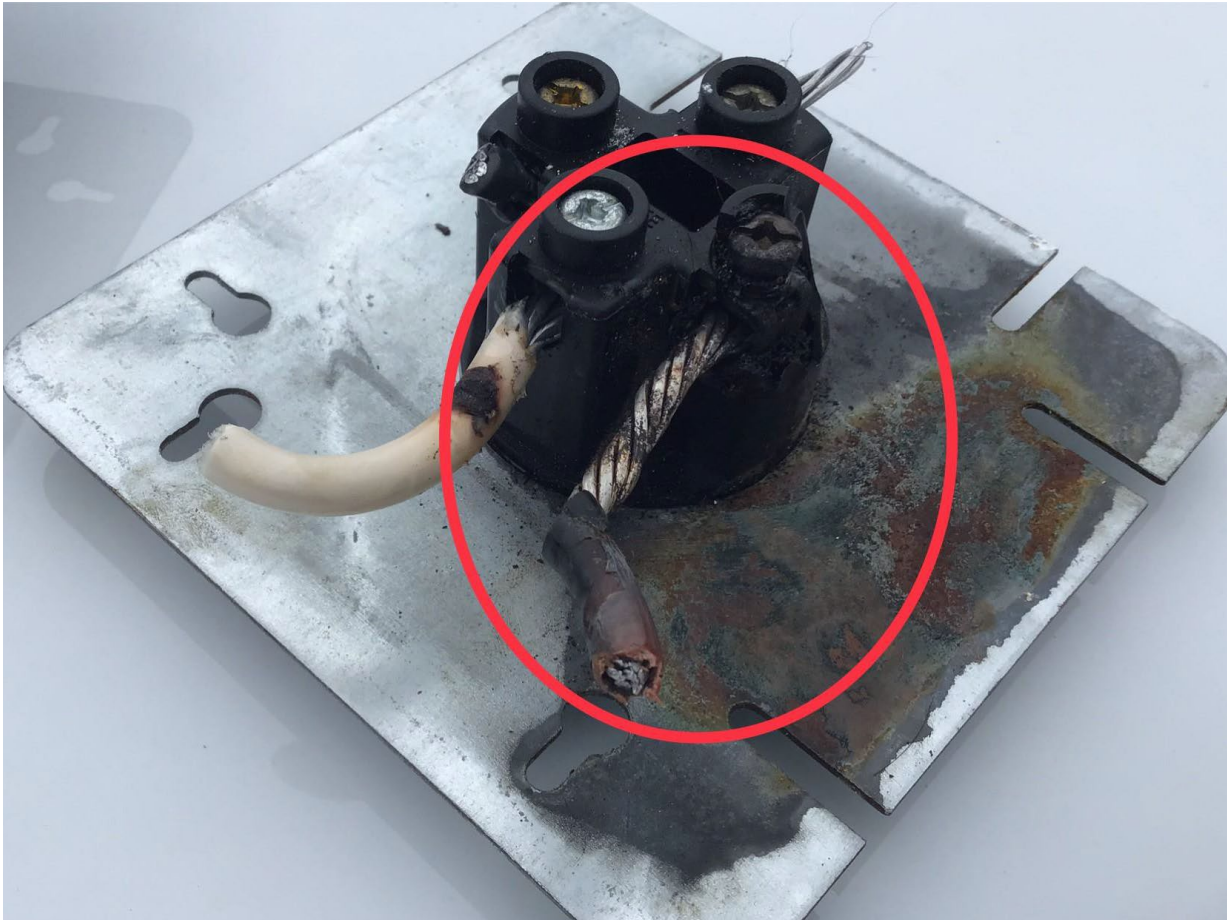
Facts and evidence	<p>Evidence was obtained by the Field Safety Representative (FSR) who completed the initial installation and the subsequent replacement of the damaged receptacle and outlet box.</p> <p>The Electrical Safety Officer (ESO) met with the FSR for an interview and to examine the damaged electrical equipment for investigation purposes. During examination of the electrical equipment, a loose termination point was identified. The Installer was unsure if the torque settings of the termination points on the receptacle were checked at the time of installation.</p>
Causes and contributing factors	<p>The probable cause of the damage to the receptacle was due to the termination of the aluminum conductor to the receptacle not being torqued to the right setting.</p>

Image 1 - Line termination point where loose connection was found.

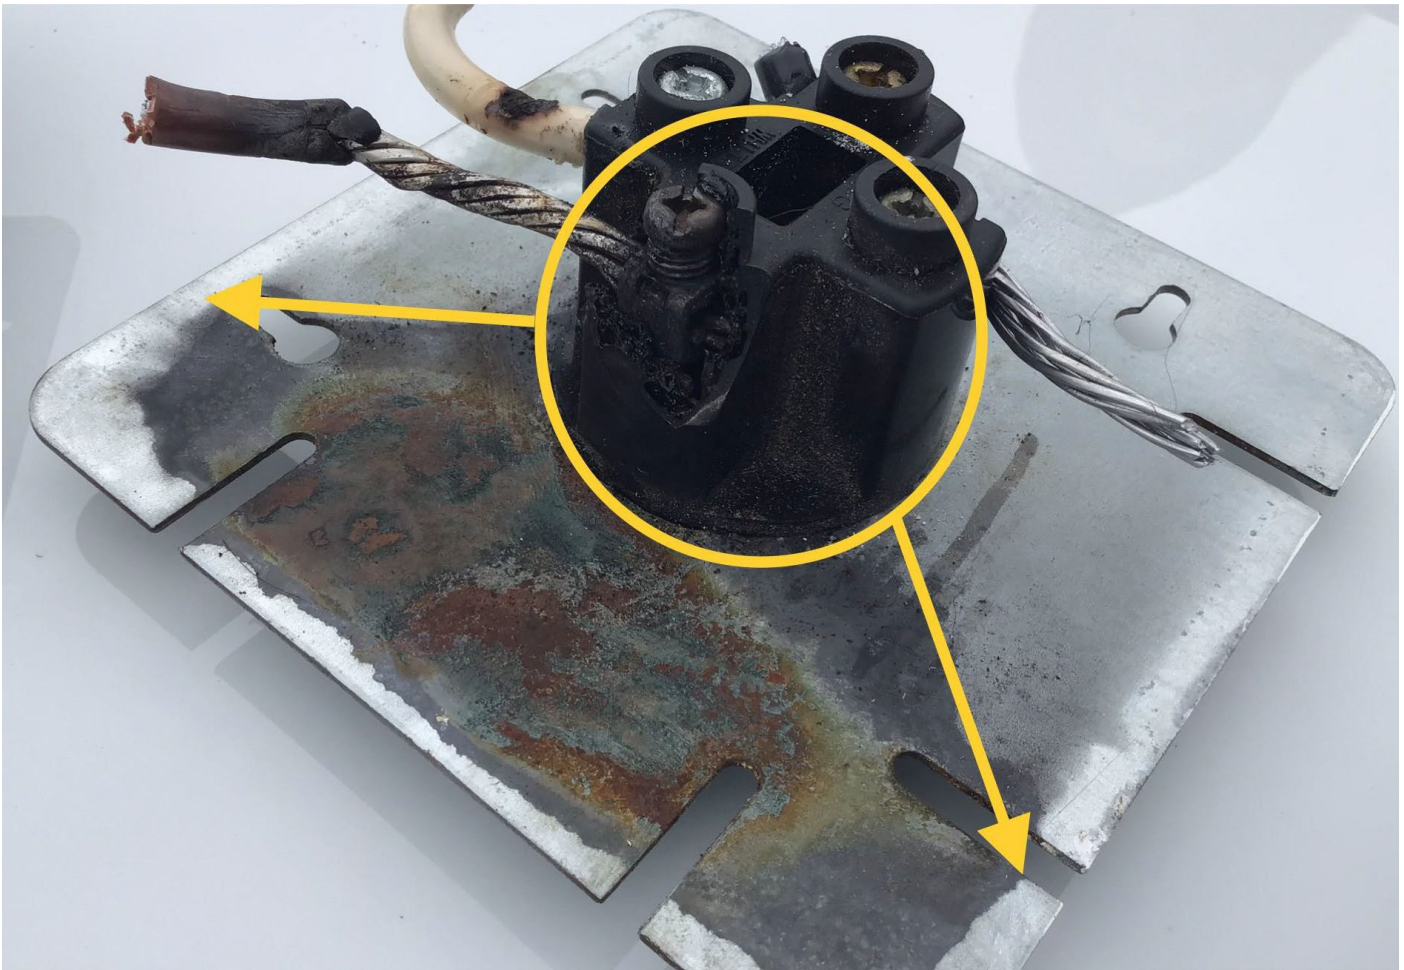
Failure scenario(s)	<p>At the time of the initial installation of the receptacle, the installer used 3 conductor #6 AWG aluminum cable for the branch circuit. Due to the aluminum conductor being soft and malleable it is good industry practice for the installer to re-check the torque settings of termination points on the receptacle, to ensure the termination point is torqued to the correct amount. The wire may have altered due to the soft and malleable characteristics.</p> <p>A connection point was loose on one of the line terminals and over time this loose connection point created a high impedance arcing condition while in use. The high temperatures due to the arcing caused the plastic components of the receptacle to melt and expose the metal plate the receptacle was mounted on to damage from the heat.</p>

Image 2 - Damage to receptacle showing origin of the arcing and subsequent heat pattern moving outward.

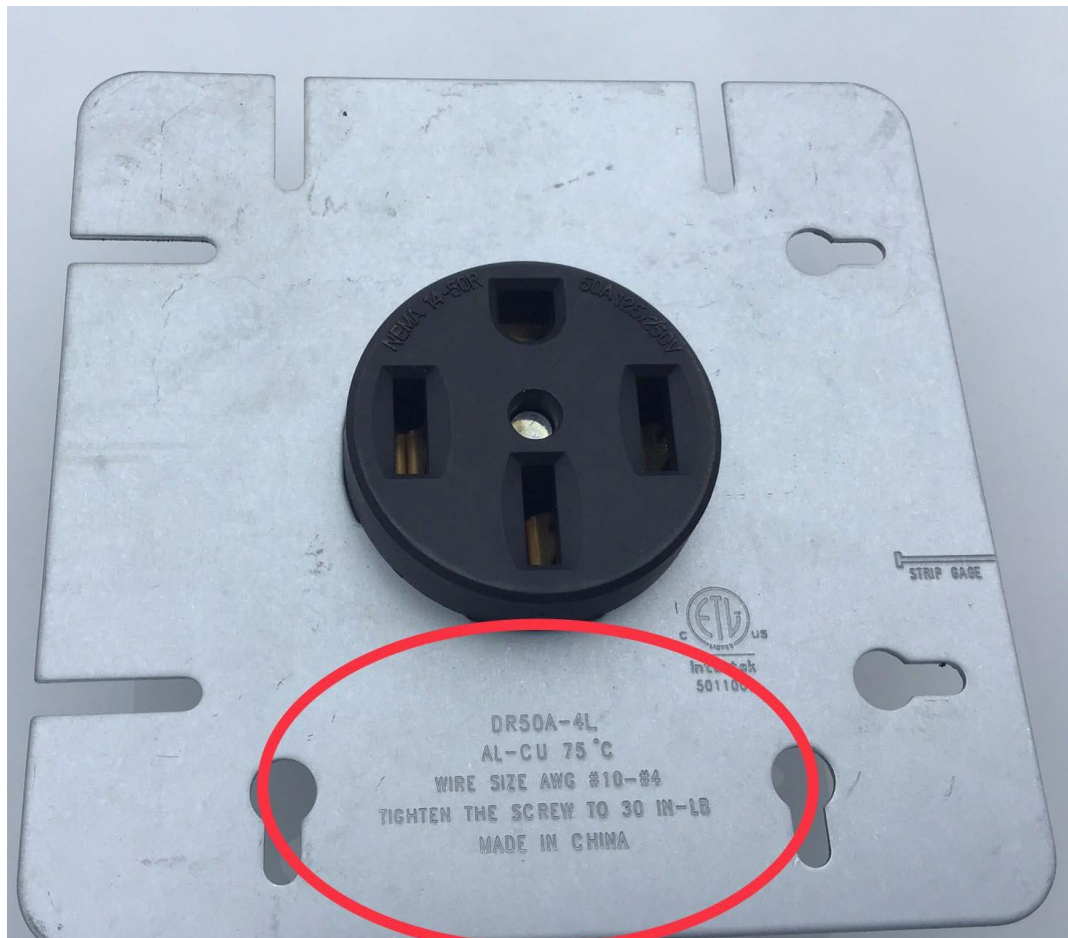
Image 3 - Manufacturer's specifications regarding; wire type, wire size and torque settings for installation.
