Incident Summary (Reference #5615856) (Final)

SUPPORTING INFORMATION	Incident Date		April 21, 2017	
	Location		Surrey	
	Regulated industry sector		Elevating Device- Construction Hoist	
	Impact	Injury	Qty injuries	0
			Injury description	0
			Injury rating	N/A
	Damage	Damage description	Construction Hoist governor brake device sustained significant internal damage.	
		Damage rating	Minor	
Incident rating		Minor		
Incident overview		Construction hoist (construction elevator) governor safety brake malfunctioned causing internal governor brake damage. The governor brake stopped the elevator. Passengers self evacuated at the floor that the elevator stopped at.		
INVESTIGATION CONCLUSIONS	Site, system and components		Construction hoists are temporarily installed elevators used to move construction workers and materials to floors of buildings under construction. The construction hoist governor is designed to apply an internal brake and stop a construction hoist in the event of a construction hoist malfunction causing the device to move at higher than normal operating speed (over speed down).

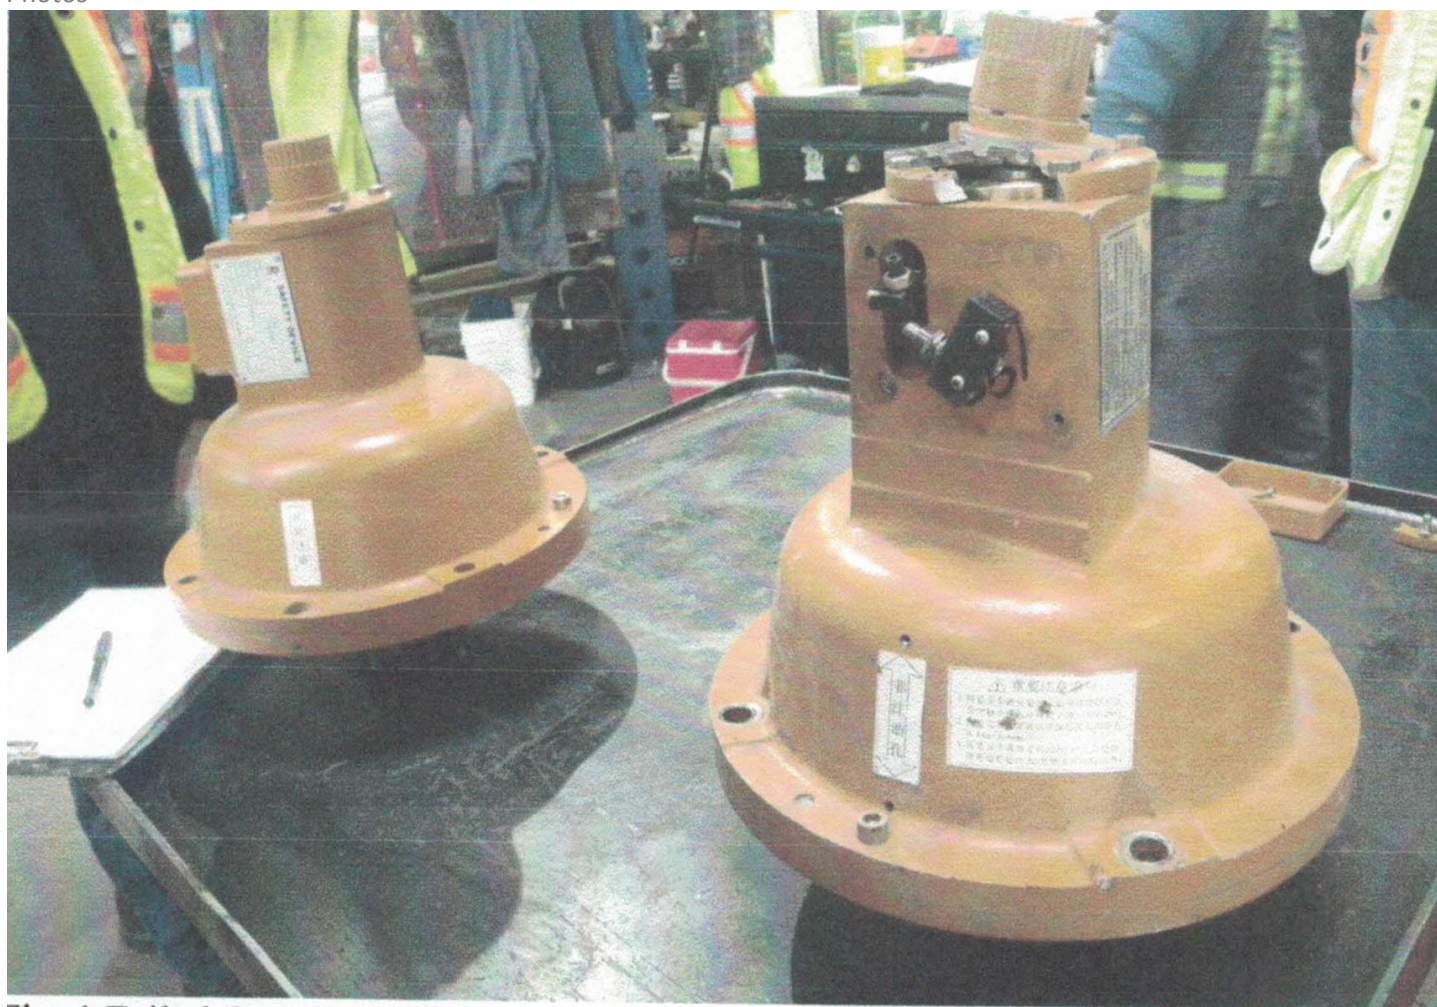
Fig. 1 Failed Over Speed Device SAJ60 on right, identical new unit on left.

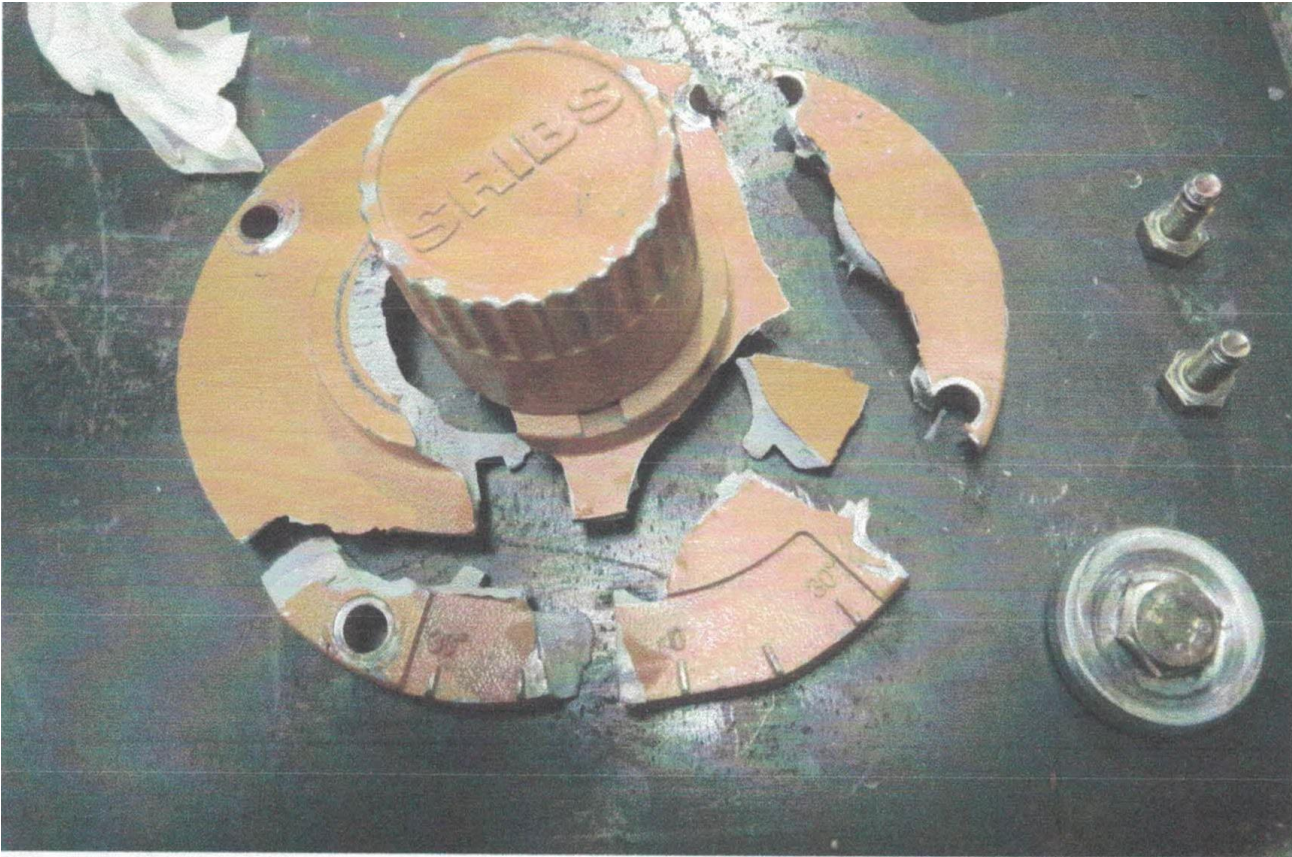
Fig 4 Top failed aluminum casting pieces, heavy steel washer deformed with failed bolt sitting in washer.

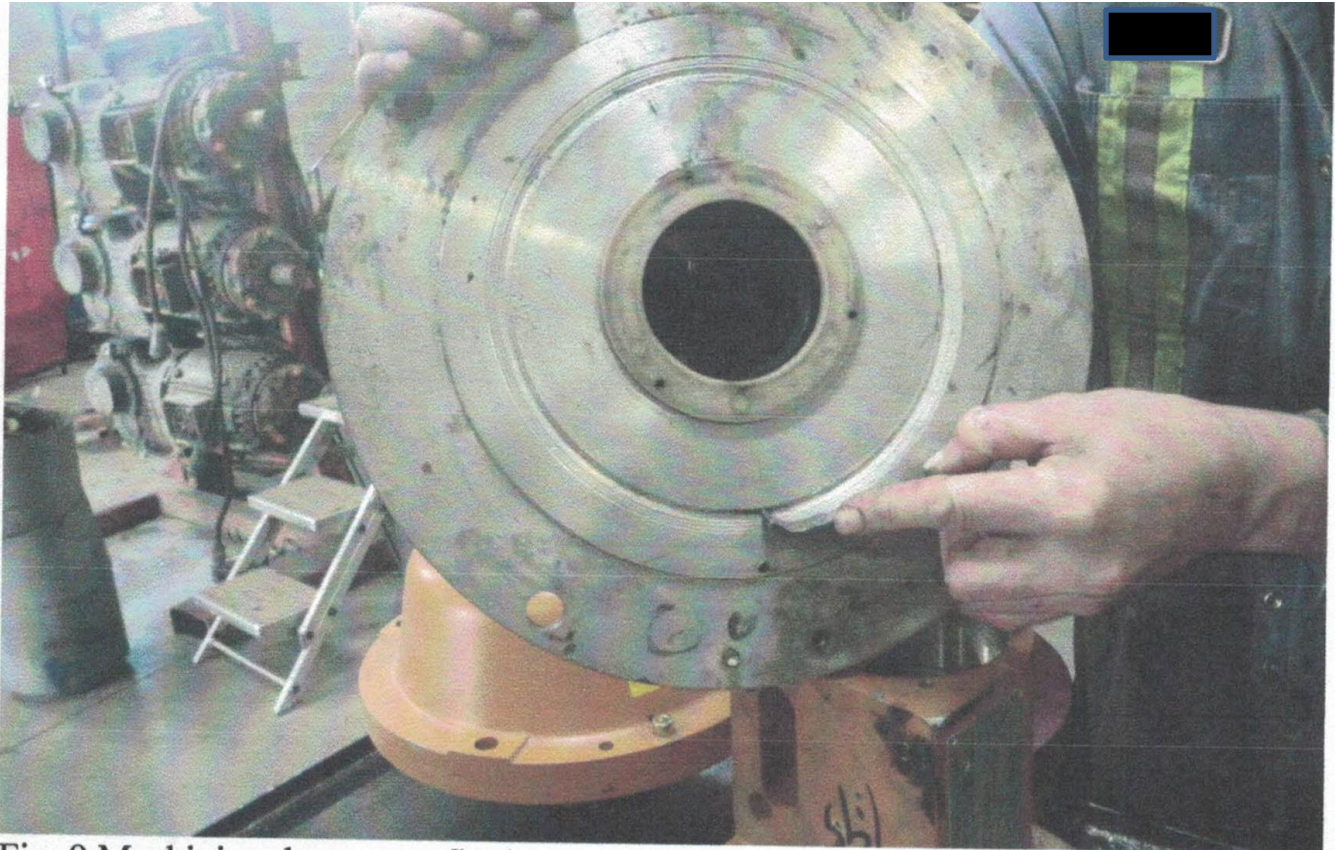
Fig. 9 Machining damage to flat bottom plate by jamming of steel backing plate inside the rotating components. See Fig 7 for aluminum shavings.

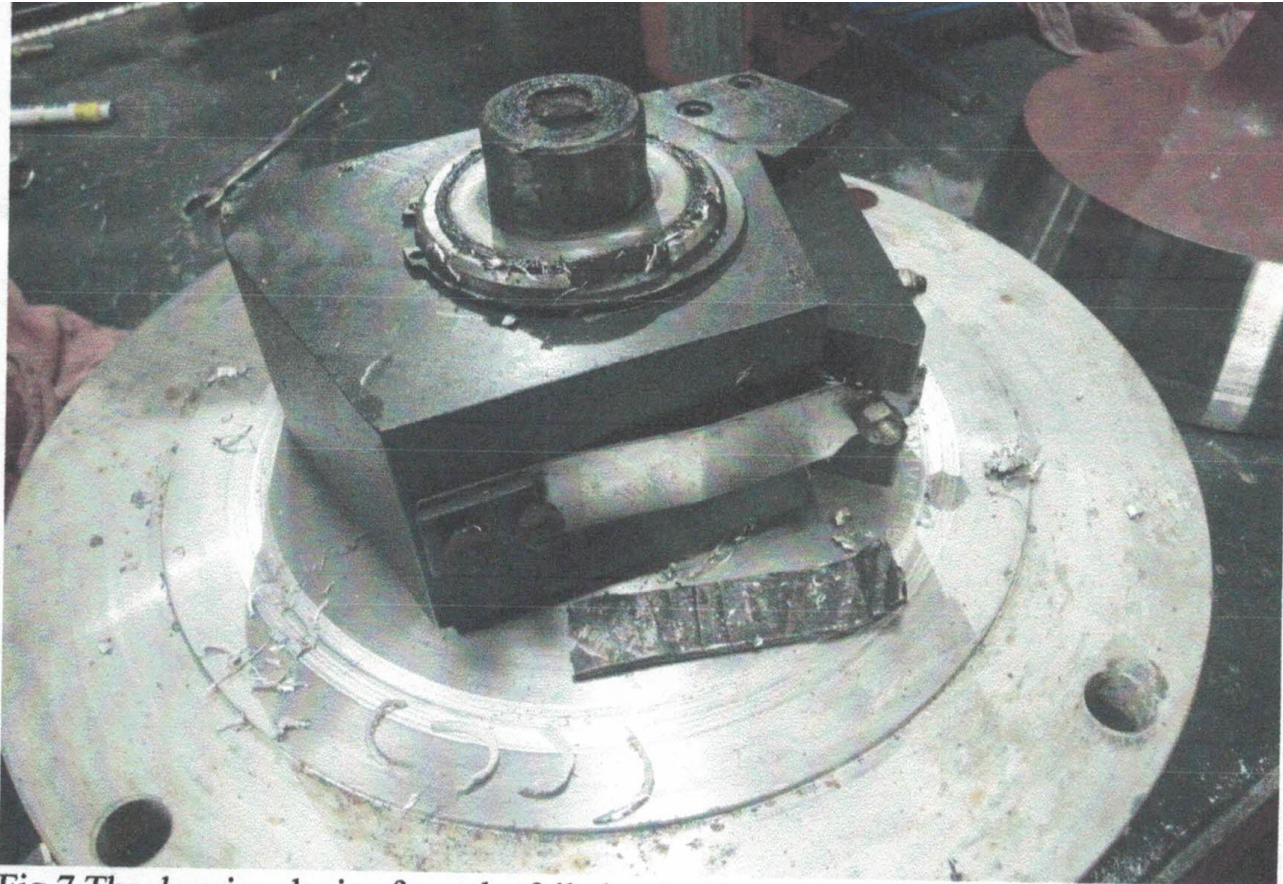
Fig 7 The dogging device from the failed unit. Note thin stainless steel adjustable trigger plate and badly damaged backing bar that failed.

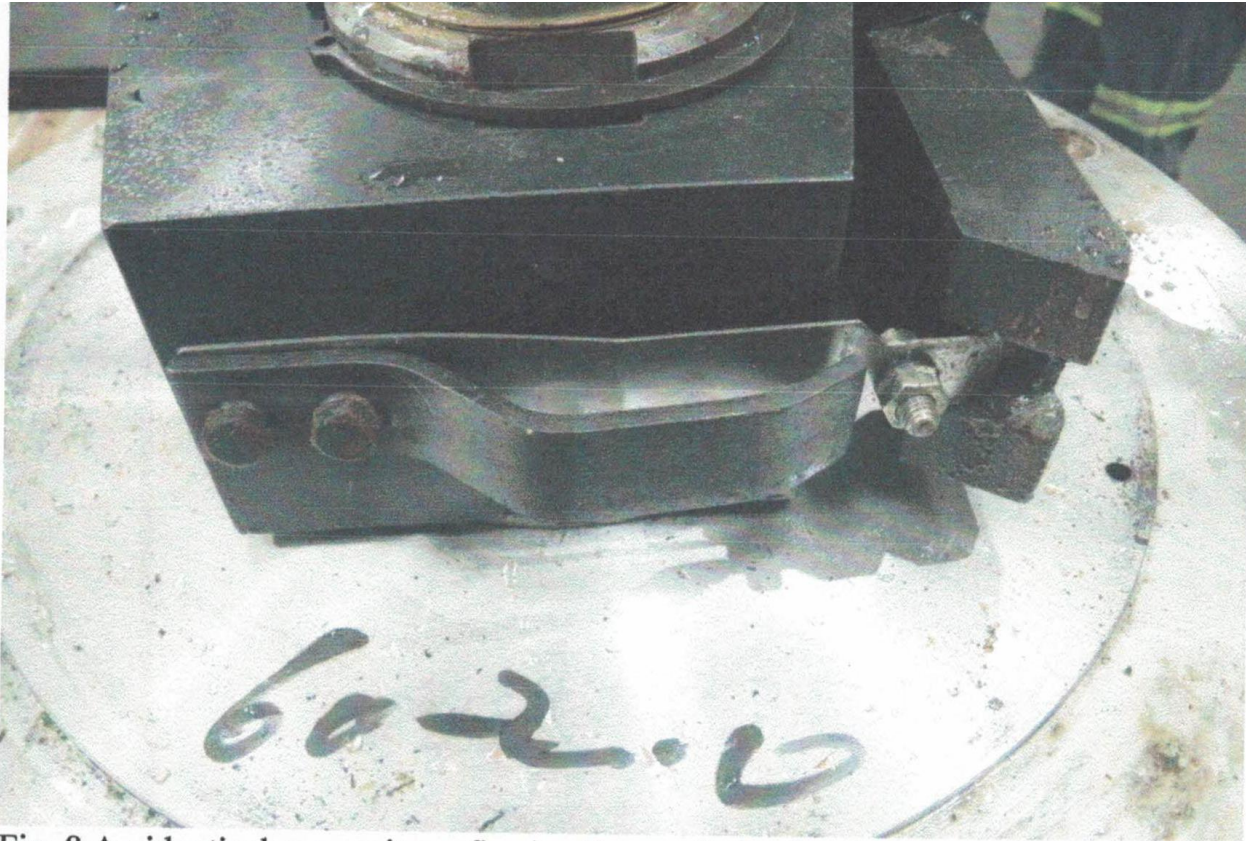
Fig. 8 An identical new unit confirming the configuration for the stainless steel adjustable trigger plate and carbon steel backing bar.

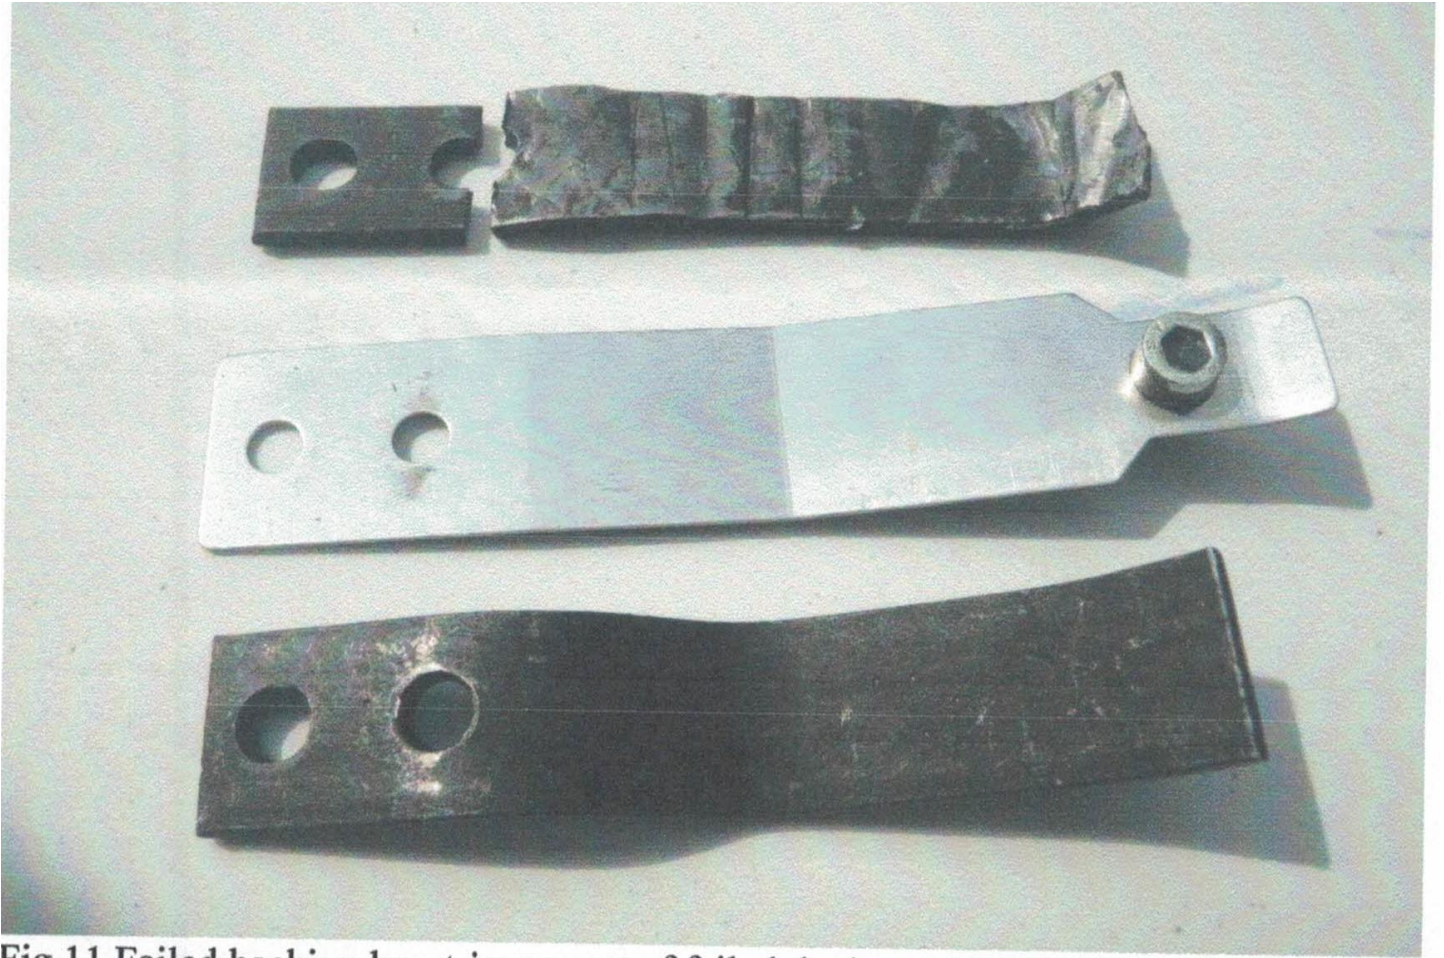
Fig 11 Failed backing bar, trigger part of failed device. New backing bar at bottom.
