## Incident Summary #II-1213932-2021 (#22571) (FINAL)

SUPPORTING INFORMATION	Incident Date	June 15, 2021	
	Location	Chase	
	Regulated industry sector	Electrical - Low voltage electrical system (30V to 750V)	
	Impact	Qty injuries	0
		Injury description	Not applicable
		Injury rating	None
	Damage	Damage description	The rigid metal service mast was damaged as well as the energized identified conductor insulation and internal stranded copper conductor.
		Damage rating	Moderate
Incident rating	Moderate		
Incident overview	<p>A worker was drilling holes through the exterior wall into the interior of a residential single-family dwelling for the installation of security cameras and drilled through the electrical service mast installed within the building envelope containing unfused service conductors.</p> <p>This caused damage to the rigid service mast and the identified conductor contained within the raceway and caused the homeowner to endure a power loss when the damage was repaired.</p>

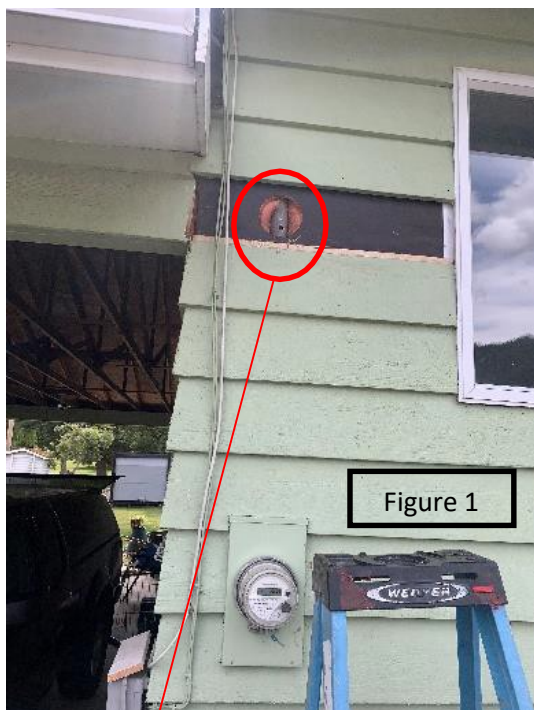
Figure 1 – Shows the damaged service mast behind the building envelope.

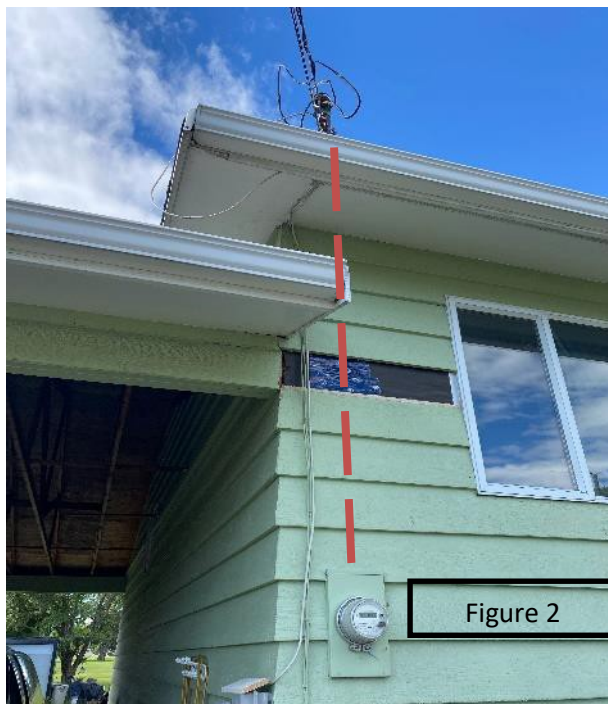
Figure 2 – Shows the vertical path of the service mast behind the building envelope in relation to the meter-base and the utility overhead conductors

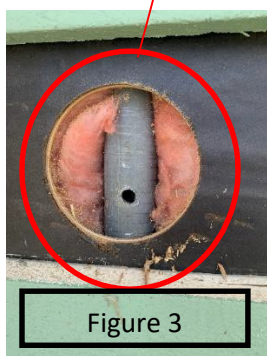
Figure 3

Figure 3- Shows a close up of the damaged service mast.

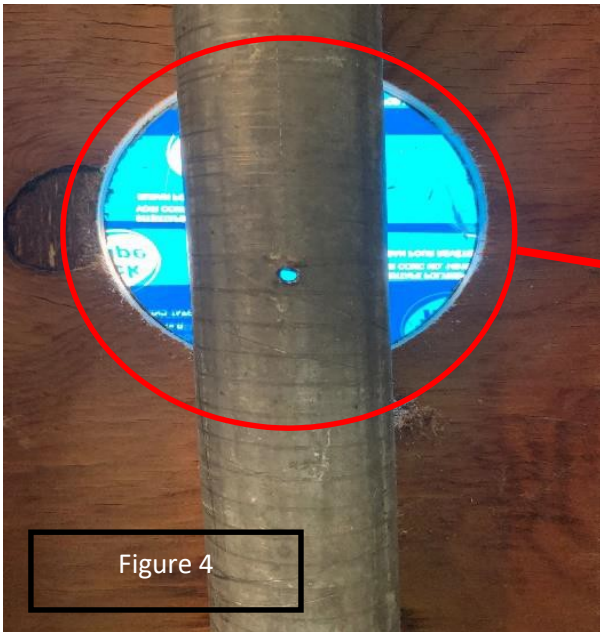
Figure 4 – Close up of the hole penetrating the mast within the building.

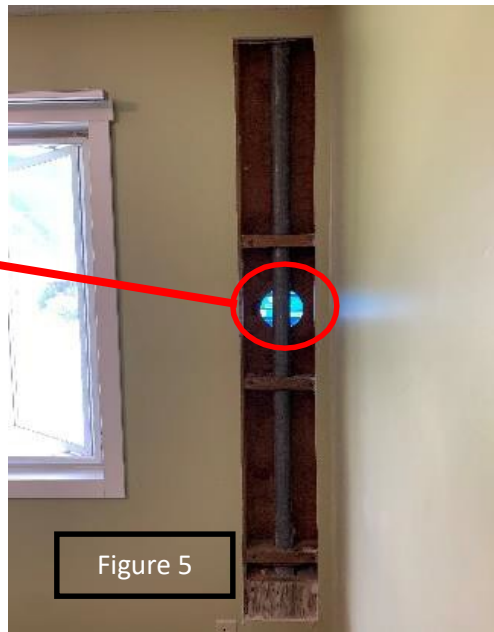
Figure 5 – position of the service mast within the building.

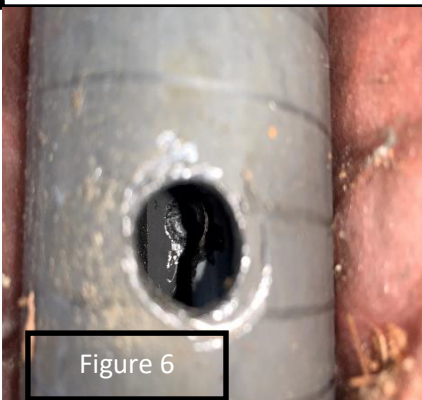
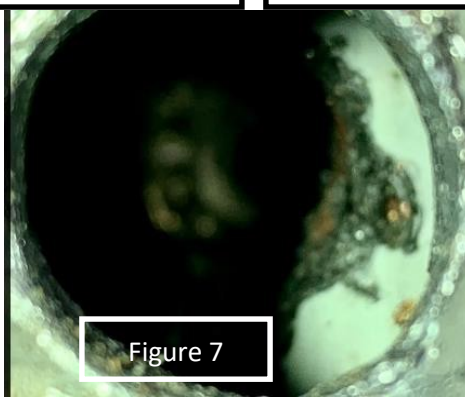
Figure 6 +7 – Close up of the drilled mast and the damaged internal conductor.

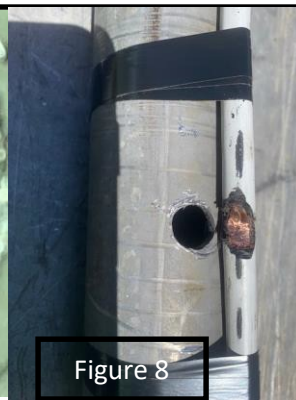
Figure 8 – Damaged mast and conductor once removed.
