Incident Summary #II-1464040-2022 (#30333) (FINAL)

SUPPORTING INFORMATION	Incident Date	November 5, 2022	
	Location	Chilliwack	
	Regulated industry sector	Electrical - Low voltage electrical system (30V to 750V)	
	Impact	Qty injuries	0
		Injury description	N/A
		Injury rating	None
	Damage	Damage description	Damage to the electrical service equipment, and damage to an exterior wall of a detached shop.
		Damage rating	Moderate
	Incident rating	Moderate	
Incident overview	A manual transfer switch for a generator failed resulting in a small fire in a detached shop that destroyed the transfer switch, and a 200-amp 120/240-volt panel. The fire also damaged the exterior wall that the transfer switch and panel were mounted to.		
INVESTIGATION CONCLUSIONS	Site, system and components	<p>The site consists of an overhead 200-amp 120/240-volt single phase utility service to a detached shop on a rural farm property. From the utility meter on the exterior of the shop, the service conductors enter into a 200-amp 120/240 fused service switch on the building interior, then into a 200-amp 120/240-volt rated generator manual transfer switch, and then into a 200-amp 120/240-volt electrical panel (Imag

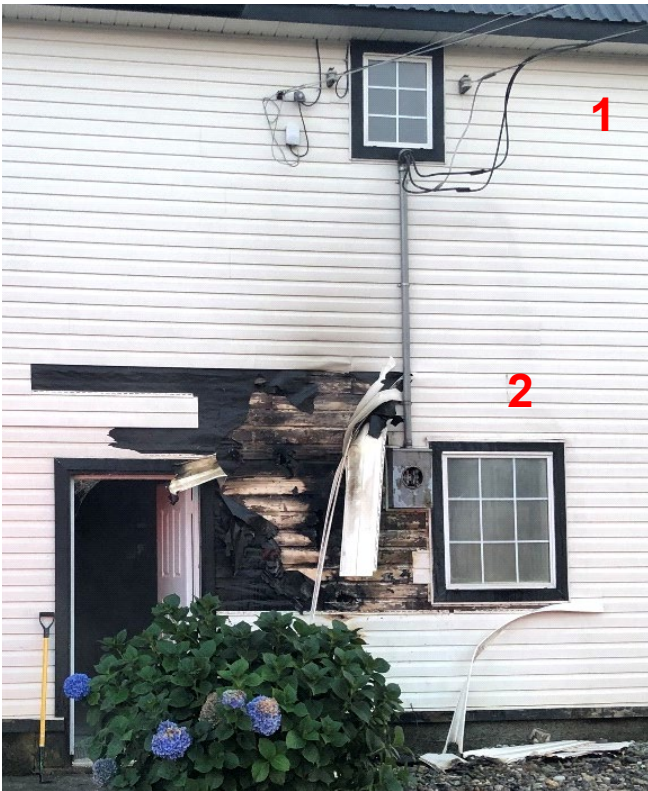
Image 1

200-amp overhead service to detached shop:

1. Utility overhead conductors.
2. 200-amp meter enclosure.

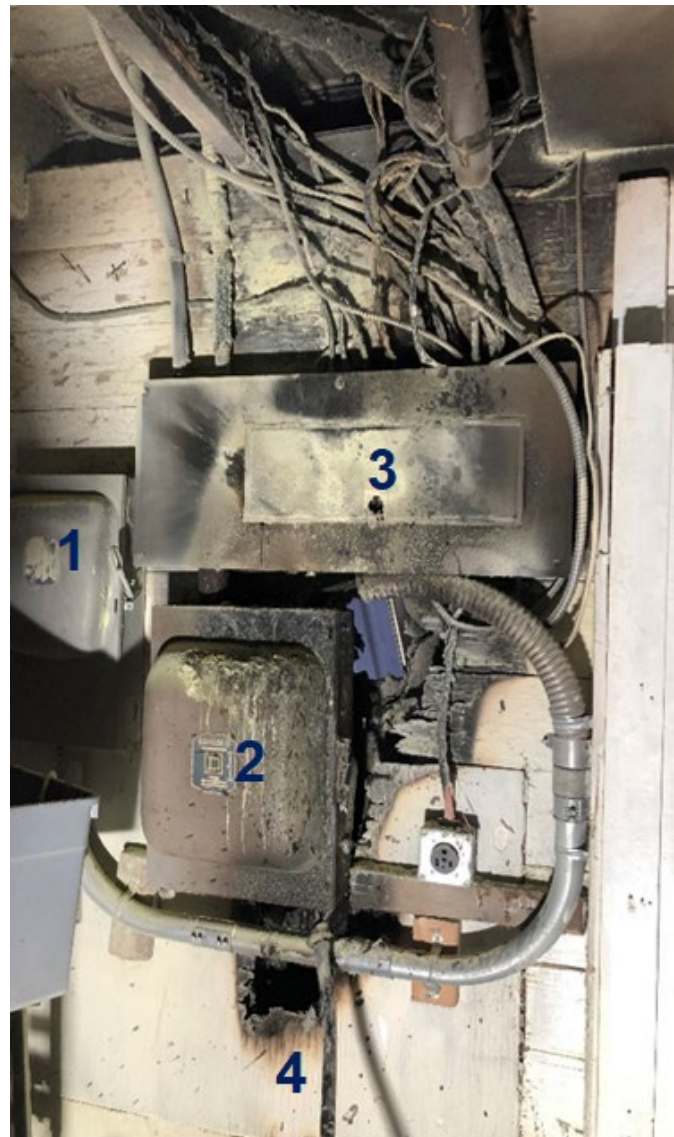
Damaged service equipment inside the detached shop:

1. 200-amp fused service switch.
2. 200-amp manual transfer switch.
3. 200-amp combination panel.
4. Cable for generator is out of the bottom of transfer switch.

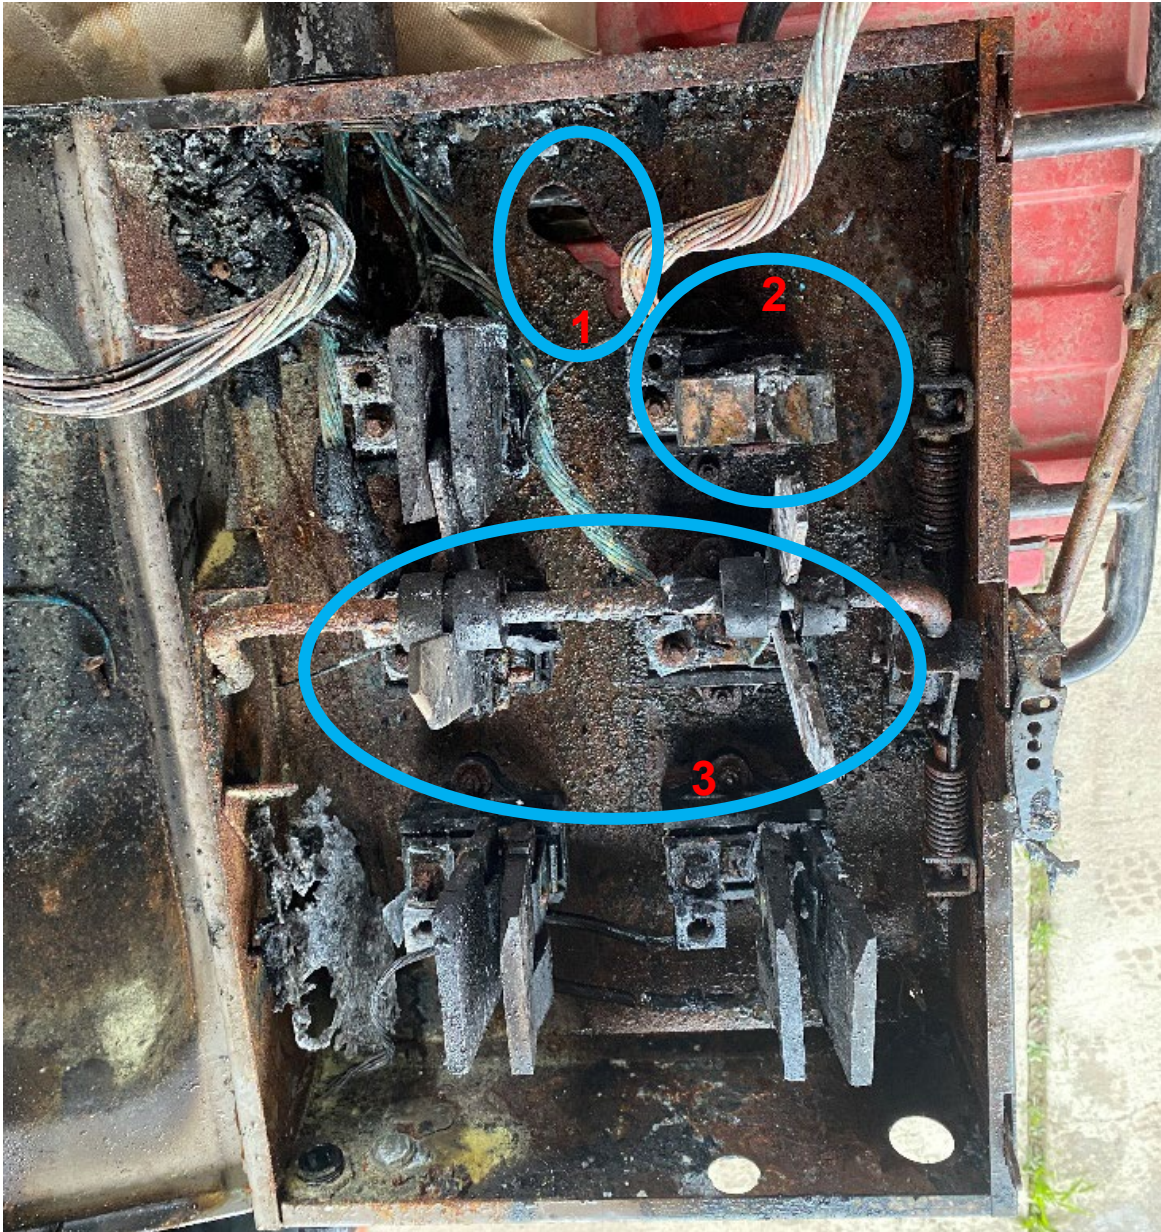
<ul style="list-style-type: none">The heat pattern on the inside of the switch shows evidence of high heat on the top right side due to a cable connector missing, most likely from being melted.
Causes and contributing factors	<p>Based on the available evidence it is very likely that the fire was caused by a poor connection at the contact surfaces between the right knife blade and the top right jaw of the manual transfer switch due to a misalignment. The heat generated from the high resistance of the poor connection was hot enough to melt the insulation from the conductors inside of the switch, and then the conductors shorted out on the metal enclosure of the switch. It is very likely that the bare conductors contacting the metal enclosure created an arc that started the fire.</p> <p>A contributing factor for the incident may be:</p> <ul style="list-style-type: none">A lack of maintenance on the switch to make sure that all internal parts were intact and that the knife blades were functioning as required.

Image 2 - The damaged manual transfer switch.

1. Hole in the back of the metal enclosure where the conductors shorted after the insulation melted.
2. Bent and damaged jaw.
3. Knife blades not in unison due to bent pivot point.

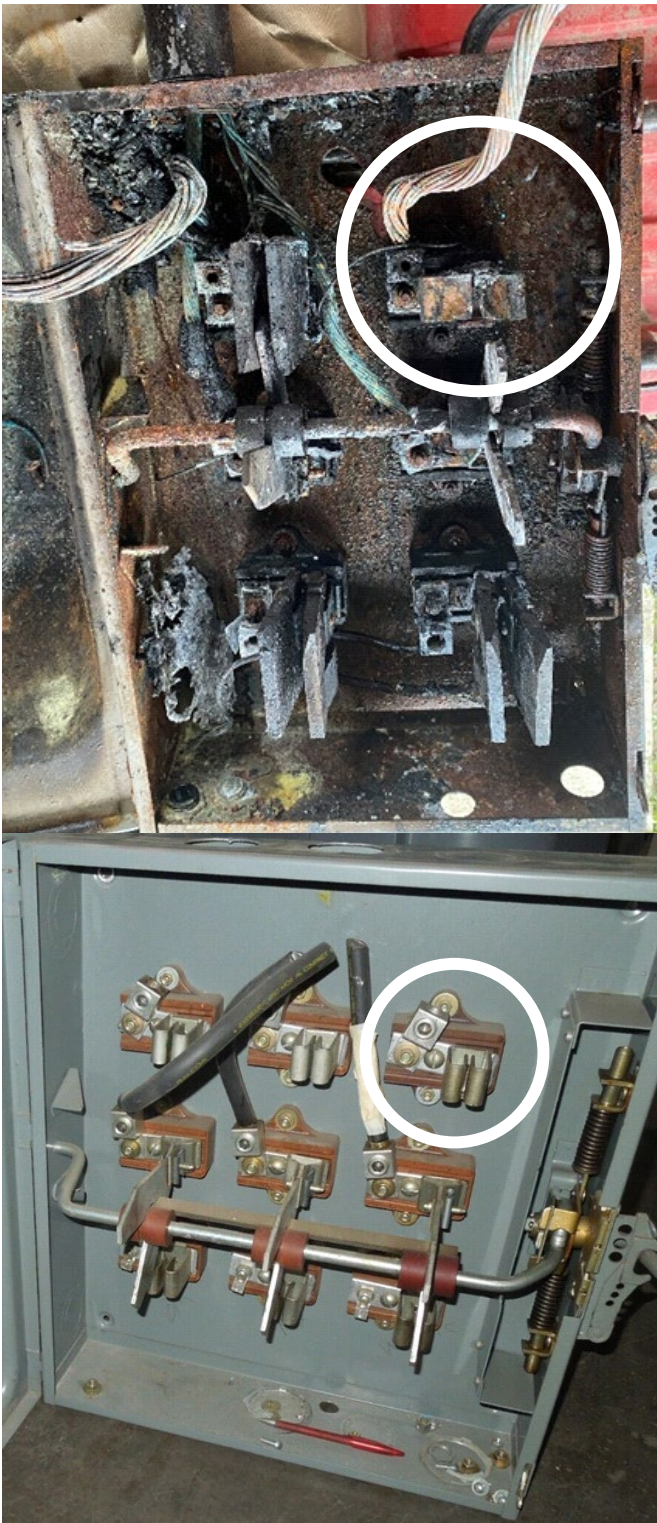
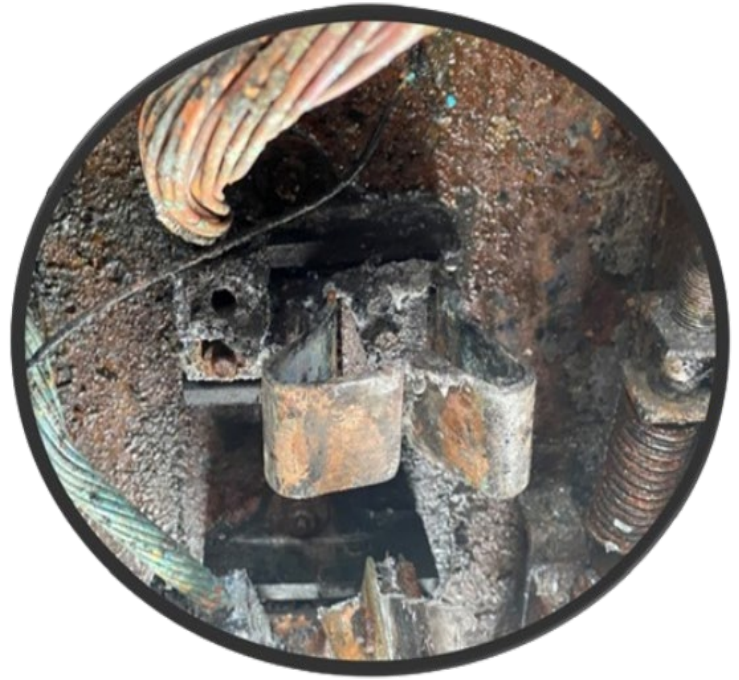
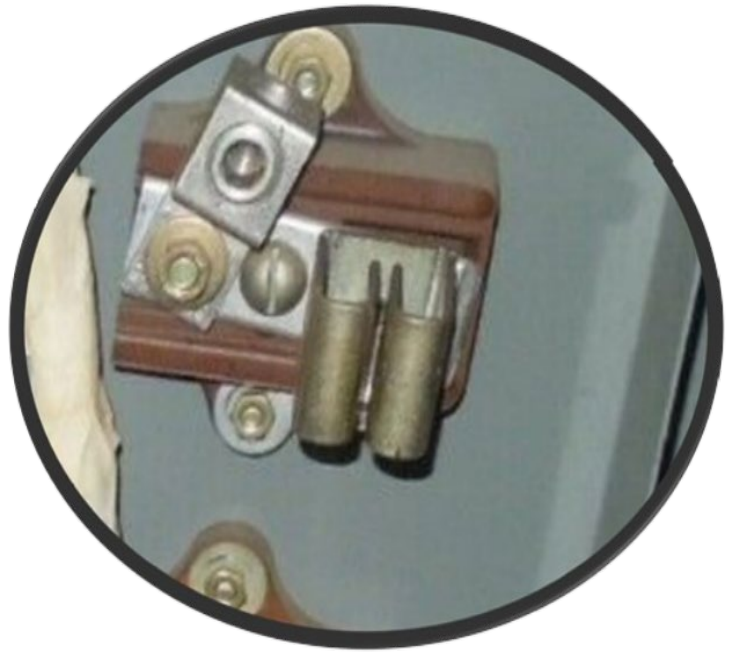
<p>Failure scenario(s)</p>	<p>During a power outage the PTO generator was used to power up the 200-amp electrical panel. The manual transfer switch cable was connected to the 50-amp receptacle on the PTO generator, and then the transfer switch was manually switched to the bottom (back up power) position. During the power outage there were no problems powering up the connected electrical loads. A few hours later the utility power was restored, and the generator was no longer required. The transfer switch was manually put back into the top (utility power) position, and the 200-amp panel was then powered by the utility again. Approximately an hour after the transfer switch was returned to the top (utility power) position, a fire started with the source of ignition being the transfer switch.</p>
<p>Facts and evidence</p>	<p>Interview with the farm manager:</p> <ul style="list-style-type: none"> • The electrical service to the detached shop also feeds a house and another smaller shop building. • When the fire happened power was disconnected by a neighbour electrician who came and pulled the utility meter out of the enclosure socket. • The fire department attended site to make sure the fire was fully extinguished. <p>Interview with property caretaker:</p> <ul style="list-style-type: none"> • Has lived on the property for 12 years. The last time the transfer switch was used was at least five to six years ago because the power rarely goes out for long periods of time. There were no problems the last time the generator was used. • The manual transfer switch is approximately 40 years old. • About an hour after the utility power was restored, he was in the shop and noticed that the switch was sparking and smoking and a fire had started, • He tried to put the fire out with an extinguisher, but it kept reigniting because the power was still on. • A neighbour who happens to be an electrician was driving by and saw the fire. He stopped and pulled the utility meter out of the socket to disconnect power to the building. • Fire department attended site a few minutes later and made sure the fire was completely out. • It was noted that the switch was in the down position. The caretaker stated that the fire department must have moved the switch because it was in the top position when the fire started. <p>Examination of the manual transfer switch after the incident (Image 2, Image 4 and Image 5):</p> <ul style="list-style-type: none"> • The handle on the outside of the switch is connected to a bar on the inside of the switch that pivots knife blades between the top (utility power) position, and the bottom (back up) power position. • The top right jaw for the knife blade was significantly bent, and the knife blade was likely not making good contact with the jaw when returned to the top position. • The top right jaw insulator was missing, and the likelihood of the jaw bending is greater with the insulator missing. • The right and left knife blades are designed to function simultaneously and both be in the same position. • The right knife blade pivot point that is attached to the back middle of the enclosure is bent, and the right knife blade is lower than the left blade when the switch is moved up. This suggests that the right blade was not fully engaged into the top right jaw at the time of the incident.

Image 4 – [Top] Damaged transfer switch bent jaw. [Bottom] Similar transfer switch normal jaw.

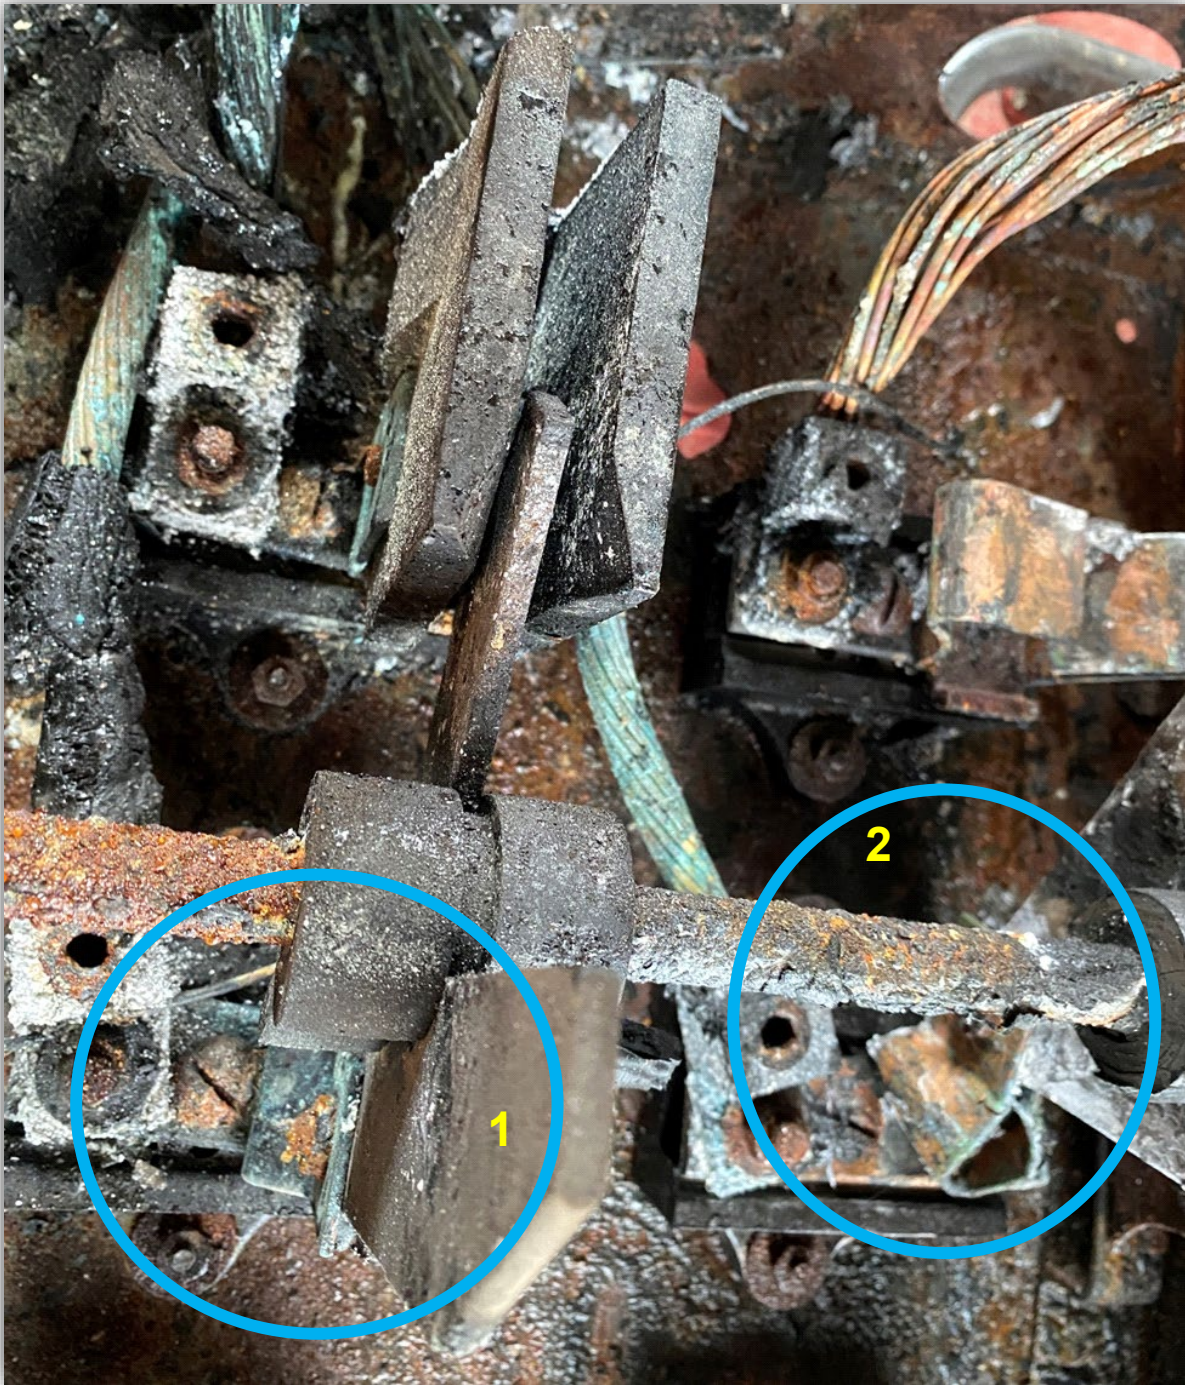
Image 5 - Close up of knife blade pivot points in damaged transfer switch. [1] Normal knife blade pivot point. [2] Bent knife blade pivot point.
