Incident Summary #II-754551-2018 (#9026) (FINAL)

SUPPORTING INFORMATION	Incident Date	October 9, 2018					
	Location	Abbotsford, BC					
	Regulated industry sector	Boilers, PV & refrigeration - Refrigeration system					
	Impact	<table border="1"> <tr> <td>Qty injuries</td><td>0</td></tr> <tr> <td>Injury description</td><td>None</td></tr> <tr> <td>Injury rating</td><td>None</td></tr> </table>	Qty injuries	0	Injury description	None	Injury rating
Qty injuries	0						
Injury description	None						
Injury rating	None						
Damage	<table border="1"> <tr> <td>Damage description</td><td>A high pressure ammonia line valve failed, releasing approximately 350 pounds of ammonia vapours into the machinery room.</td></tr> <tr> <td>Damage rating</td><td>Moderate</td></tr> </table>	Damage description	A high pressure ammonia line valve failed, releasing approximately 350 pounds of ammonia vapours into the machinery room.	Damage rating	Moderate		
Damage description	A high pressure ammonia line valve failed, releasing approximately 350 pounds of ammonia vapours into the machinery room.

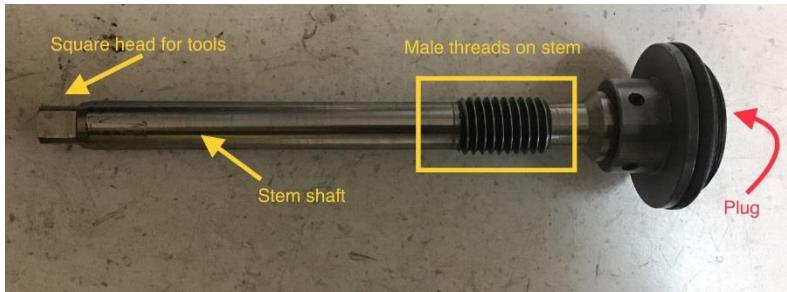
Causes and contributing factors	<p>It is probable that the installation of an incompatible bonnet/stem and valve body eventually failed during maintenance and operation allowing ammonia to escape from the system.</p>

Picture 1: Stem and Plug assembly – 1 1/2 inch shut off Ammonia Refrigeration Valve (actual part involved in the incident)

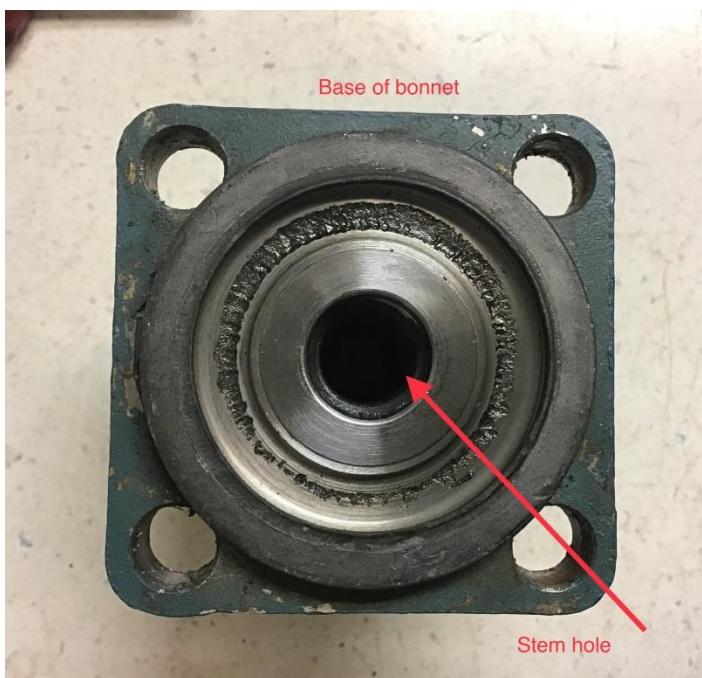
Picture 2: Bonnet base view – 1 1/2 inch shut off Ammonia Refrigeration Valve (actual part involved in the incident)

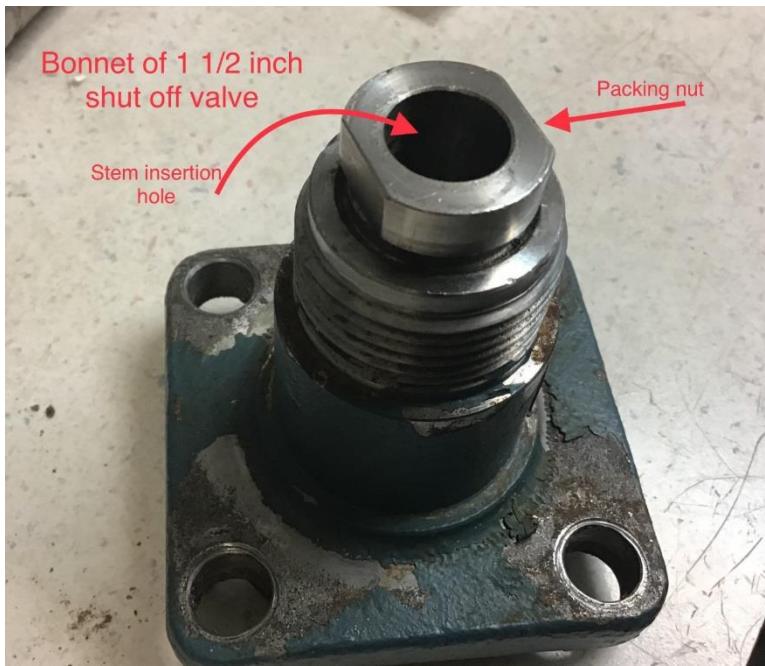
Picture 3: Overall view – 1/1/2 inch shut off Ammonia Refrigeration Valve (actual part involved in the incident)

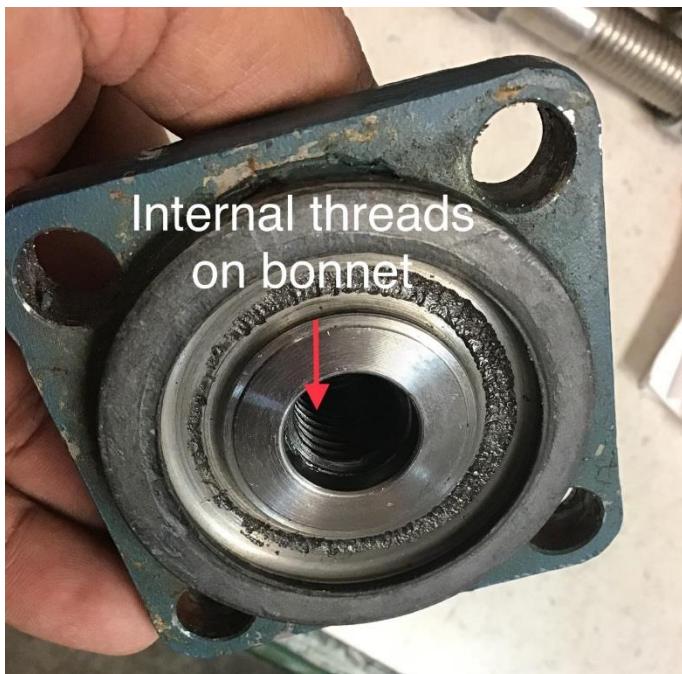
Picture 4: Bonnet base – internal threads shown on stem home (actual part involved in the incident)

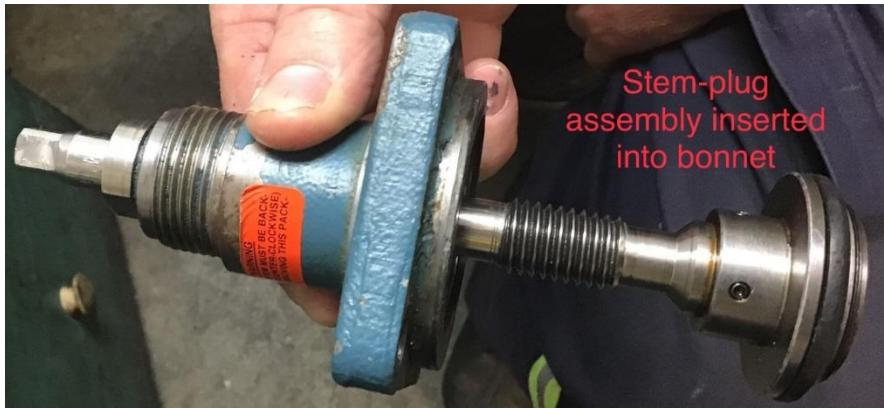
Picture 5: Assembly of stem-plug with valve bonnet – 1/1/2 inch shut off Ammonia Refrigeration Valve (**note: exemplar only**)

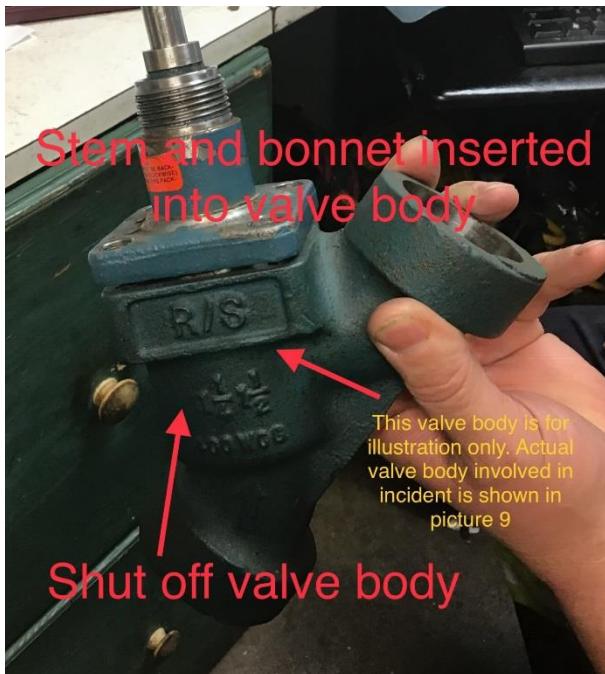
Picture 6: Bonnet and Valve body assembly – 1½ inch shut off Ammonia Refrigeration Valve (**note: exemplar only**)

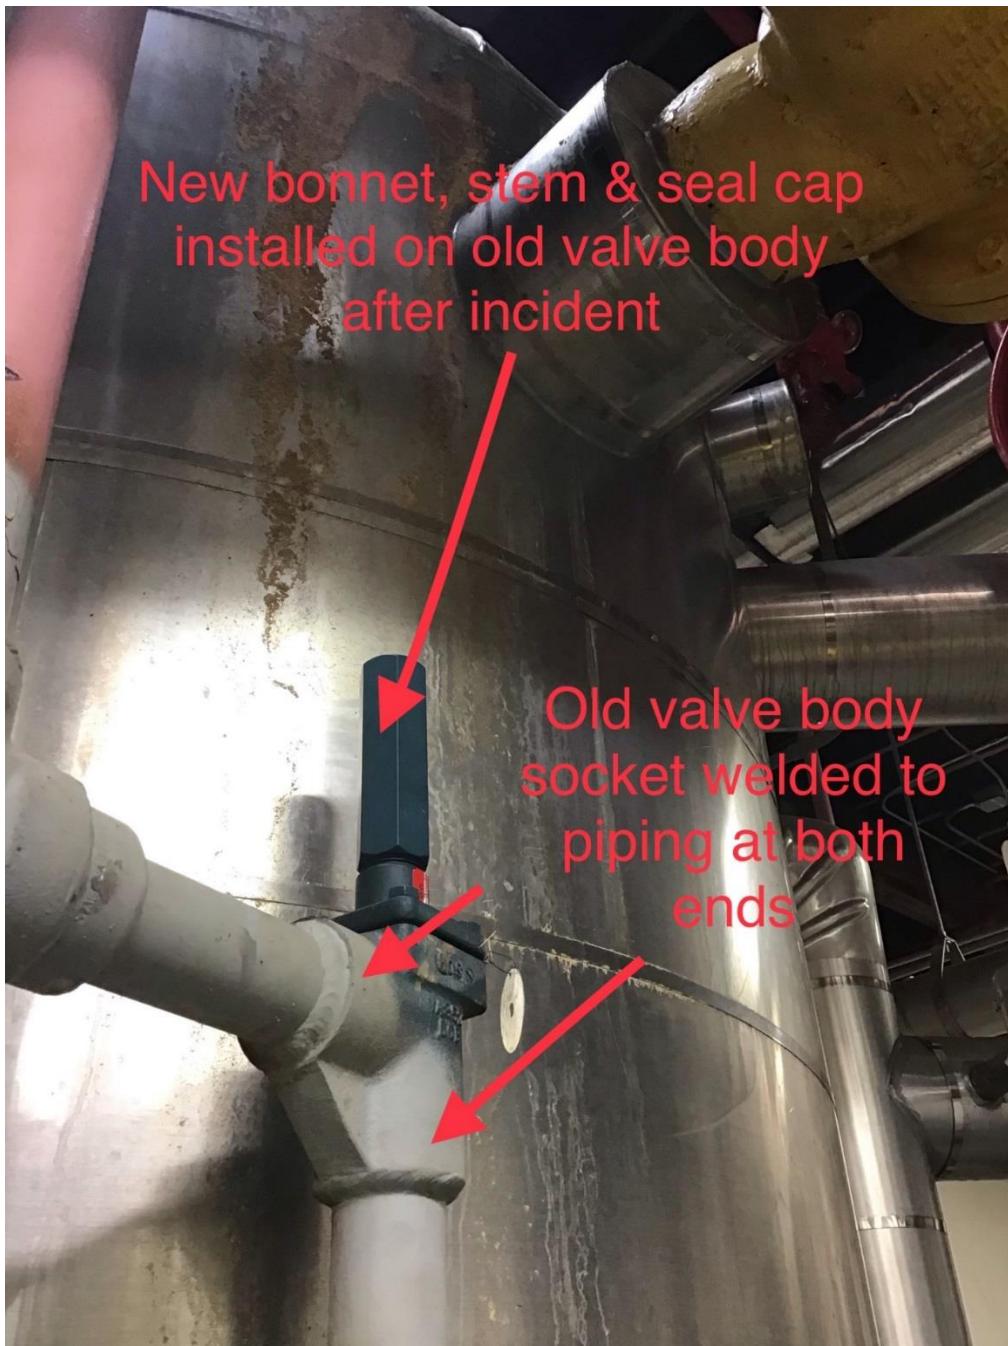
Picture 7: 1 1/2 inch shut off Ammonia Refrigeration Valve socket welded to piping. (Note: the vessel shown here in background is the inter-cooler V3).

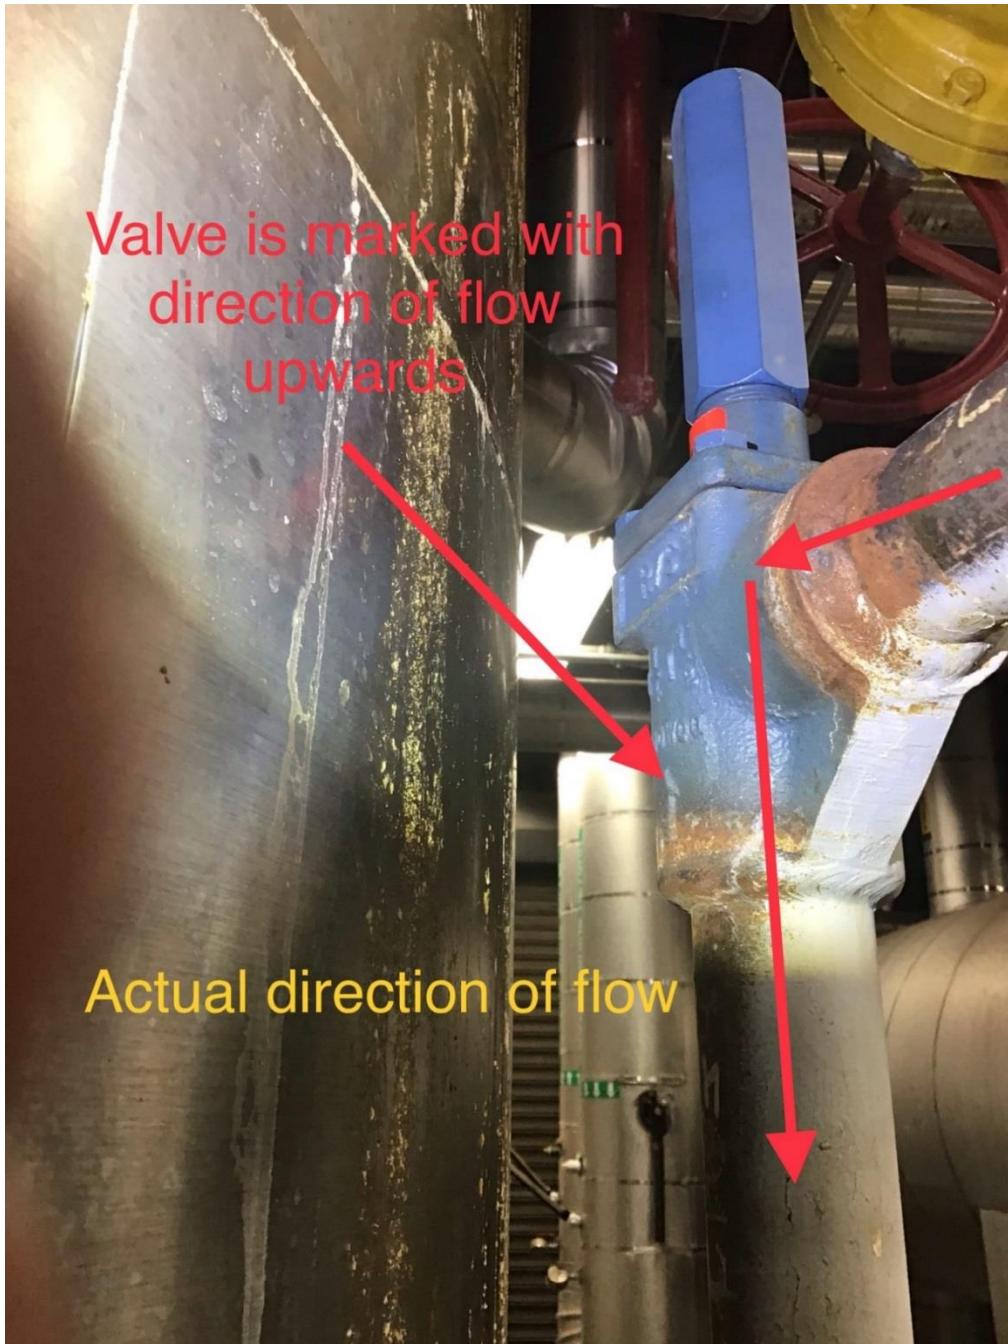
Picture 8: Direction of flow on Valve Vs actual flow direction – 180 degree apart. (Note: body shown was involved in incident. Stem/bonnet shown is newly installed after incident).

<p>The system ammonia charge pump down started at 3 pm and completed at 8 pm. The stem-plug and bonnet assembly was replaced with a new one. The shut off valve body could not be replaced as it is welded to the piping on both ends.</p>
Facts and evidence	<p>There were two witness accounts. The first was from a refrigeration mechanic working on the system at the time of the leak and the second was the maintenance supervisor of the facility, as follows;</p> <p>The body and bonnet/stem assembly on failed valves were found to be incompatible and not of the correct type. External threaded portion on the replacing stem was longer than the replaced stem. Both mentioned that it is possible that at the time when this shut off valve was originally installed by another licensed refrigeration contactor in 2015 – the body and bonnets were inadvertently mixed up so an incompatible type of bonnet/stem may have been installed on the valve body. They mentioned that mechanics usually use a center punch to mark on the valve body and bonnet so that they will not get mixed up and correct set gets installed.</p> <p>The installation of the incorrect bonnet/stem into the valve prevented the isolation of the ammonia liquid which is what the valve is intended to do. Also when the valve is installed with its stem in vertical position, back seating it becomes difficult as pressurized liquid acts against plug base and forces it upwards.</p> <p>The failed valve was placed into the piping in the opposite direction to that displayed by the direction of flow arrow on the valve. The stem was supposed to be in horizontal position but it was found to be in vertical position. They are not sure why the valve was installed with its stem in vertical position.</p>
