Incident Summary #II-1326616-2022 (FINAL)

SUPPORTING INFORMATION	Incident Date	February 9, 2022
	Location	Fernie
	Regulated industry sector	Gas - Natural gas system
	Impact	Qty injuries
		2
		Injury description
	Damage	Injury rating
		Minor
		Damage description
INVESTIGATION CONCLUSIONS	Site, system and components	Explosion and fire damage to a residential home, including blown out walls and collapsed roof. Damage to neighbouring homes from explosion concussion and flying debris.
		Damage rating
		Severe
		Incident rating
SUPPORTING INFORMATION	Incident overview	Severe
	Escaping gas from a damaged gas line migrated into a home through building openings and contacted a source of ignition which resulted in a large explosion and subsequent fire. The exposed underground gas line was struck by an excavator while digging for a new water line for a new planned detached building on the property. The excavator strike caused the gas line to sever underground next to the home 50 feet away from where the excavation was taking place.

Incident Summary #II-1288074-2021 (#26151) (FINAL)

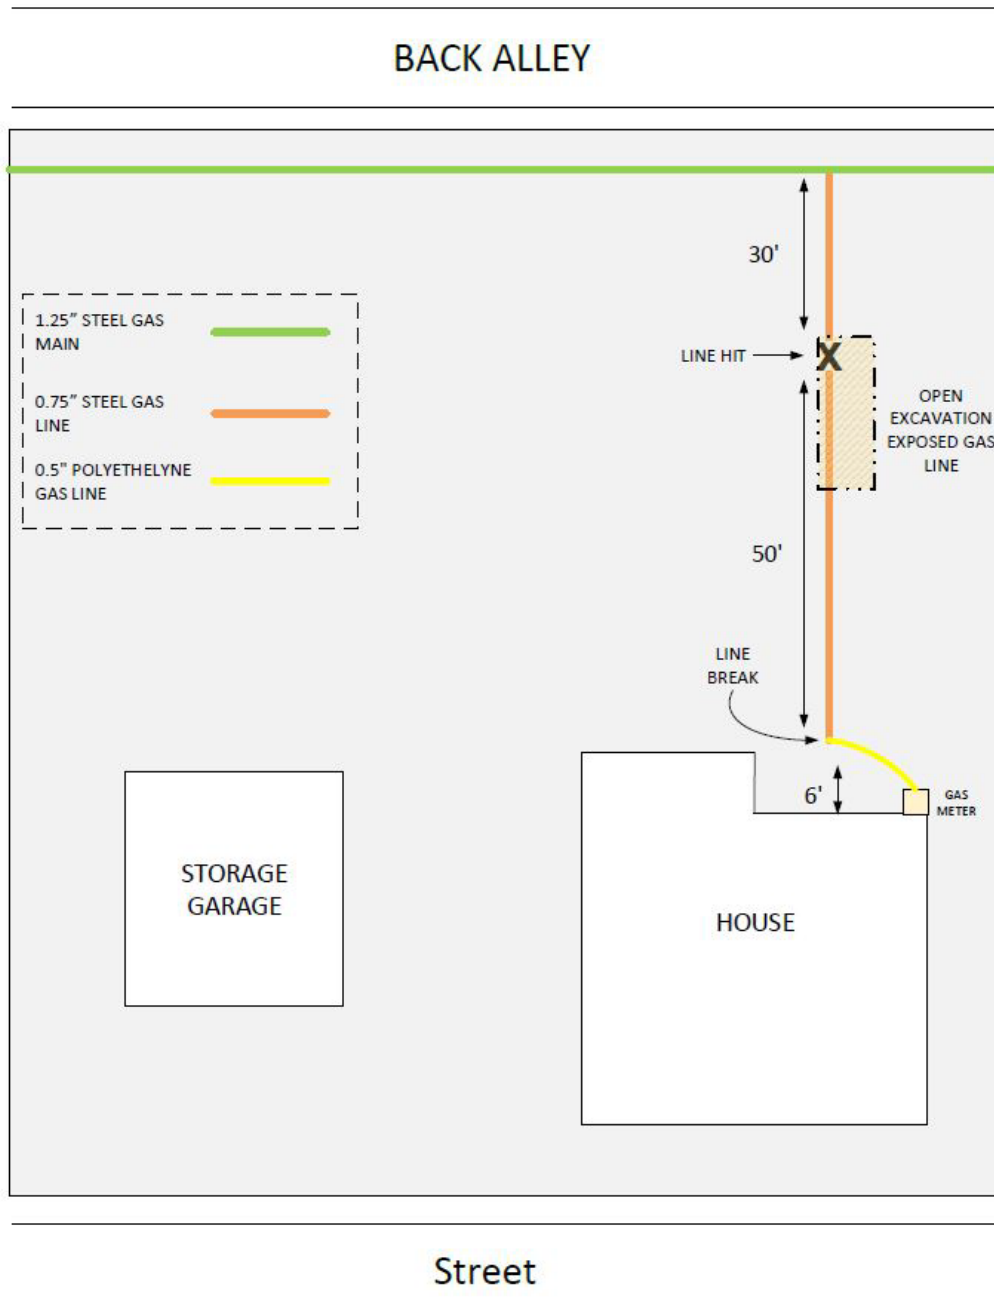
Image 1 – Diagram of site showing locations of buried gas lines, line hit and line break.

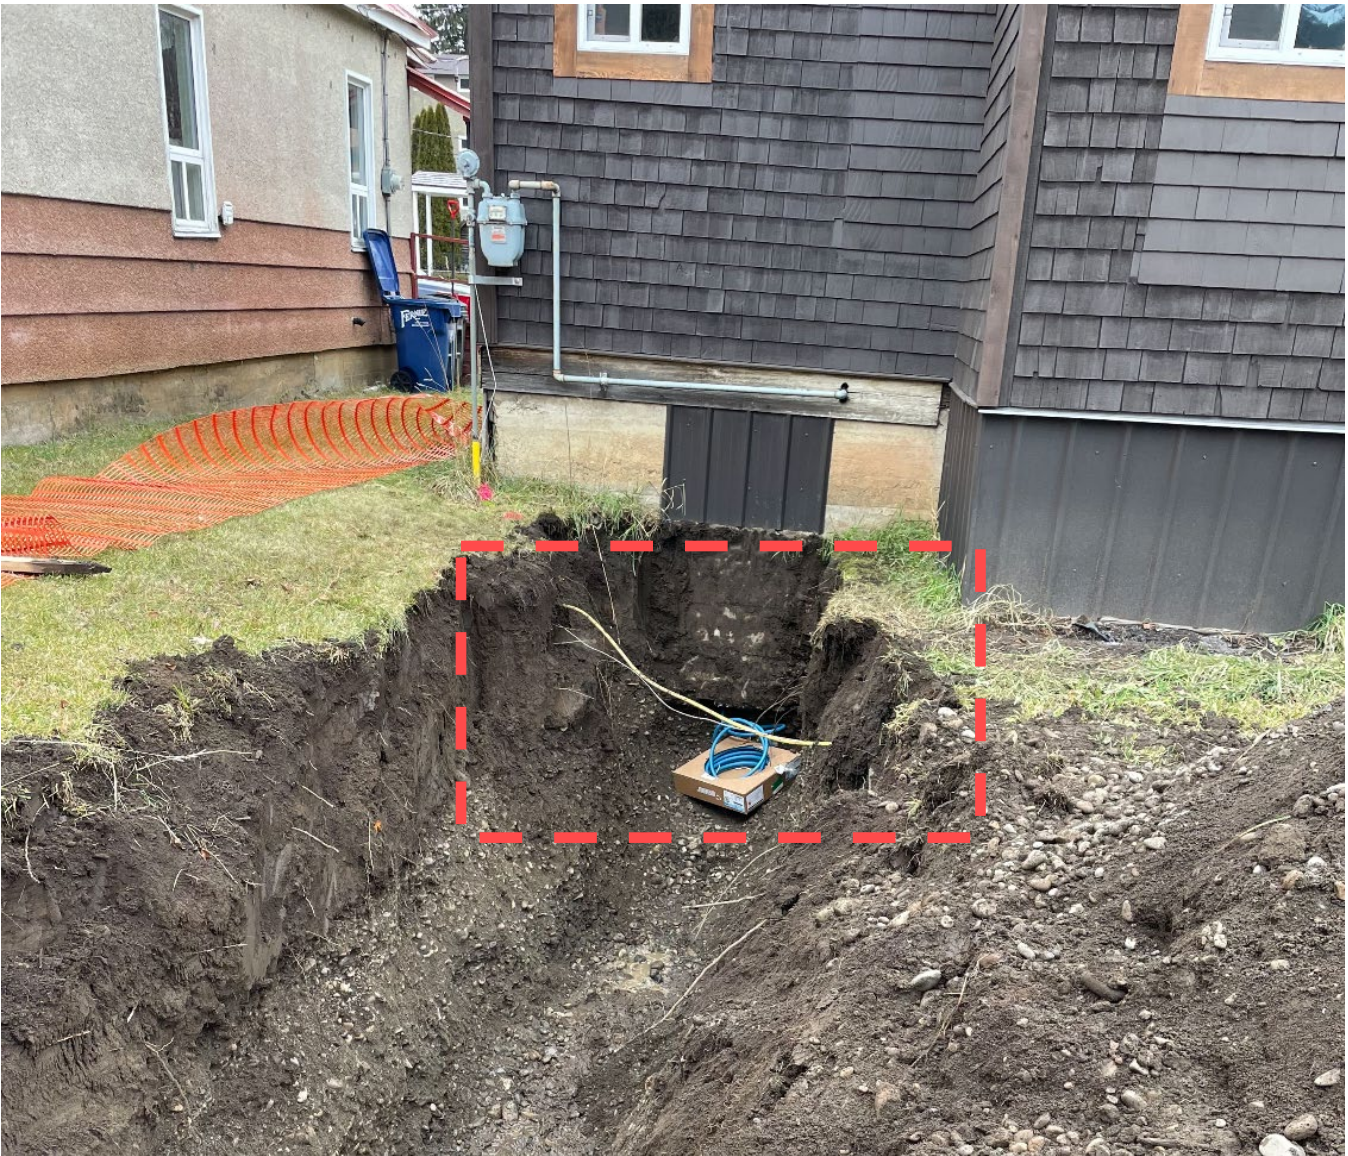
Approximately two months prior to the incident, the homeowner, who is a homebuilder by trade, began work to add a detached building at the rear of the property next to a laneway. A BC One Call ticket was obtained prior to this work being started which identified the location of the gas line service for the property. Work had begun to dig a trench for a new water line from the existing home to the new building location. A section of the polyethylene gas line was located and exposed where it crossed the new trench by the contracting company that was hired to trench for the water line. The gas line was exposed up to the transition fitting at the older steel gas service. A trench was dug part way from the foundation of the home to the location for the new building ([Image 3](#)). A waterline was installed in the trench from the crawlspace of the home through a drilled hole in the foundation. The trench was only partially dug to the new building location and the remainder of the waterline was left coiled in the trench, covered with plywood, and backfilled and marked with a wooden 2x4 to identify its location. When the trench was backfilled, the area around the gas line from the transition fitting up to the home foundation was backfilled with 3/4" clear crushed rock.

Image 3 – Red box showing exposed gas line (yellow) during previous excavation for new water line (blue). Area was later backfilled with $\frac{3}{4}$ " crush rock.

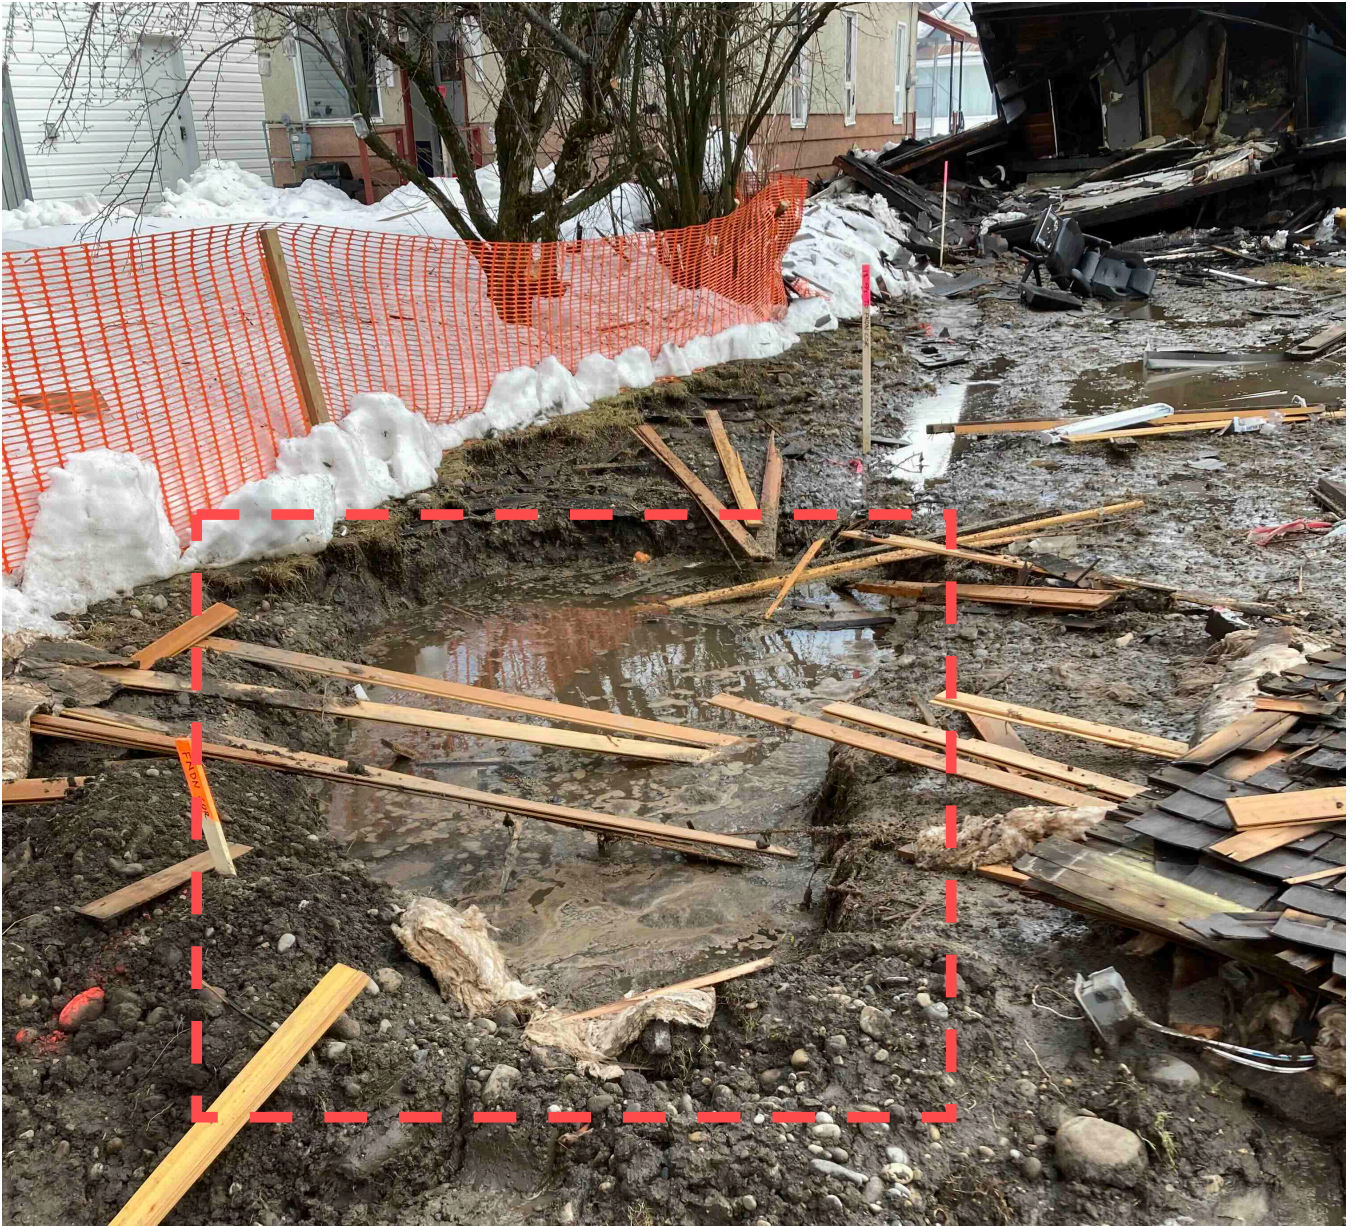
The location of the existing underground steel gas line needed to be relocated to accommodate the foundation of the new building. On the day of the incident, the gas utility was scheduled to disconnect the existing gas service and install a new one, relocated away from the new building location. The homeowner hired an excavator and planned on trenching for the new gas line, for the gas company, to reduce the cost of installation. The morning of the incident, the gas company crew did not arrive at the site as scheduled. While waiting for the gas company crew to arrive later in the afternoon, the homeowner and excavator operator began trenching to expose the buried coiled water line to extend it out to the new building location. The steel gas line was exposed and ran parallel to the new water line trench and was visible to the excavator operator from the machine.

Image 4 – Red box showing area of excavation work and exposed gas line on day of incident. Excavation filled with water after the incident.

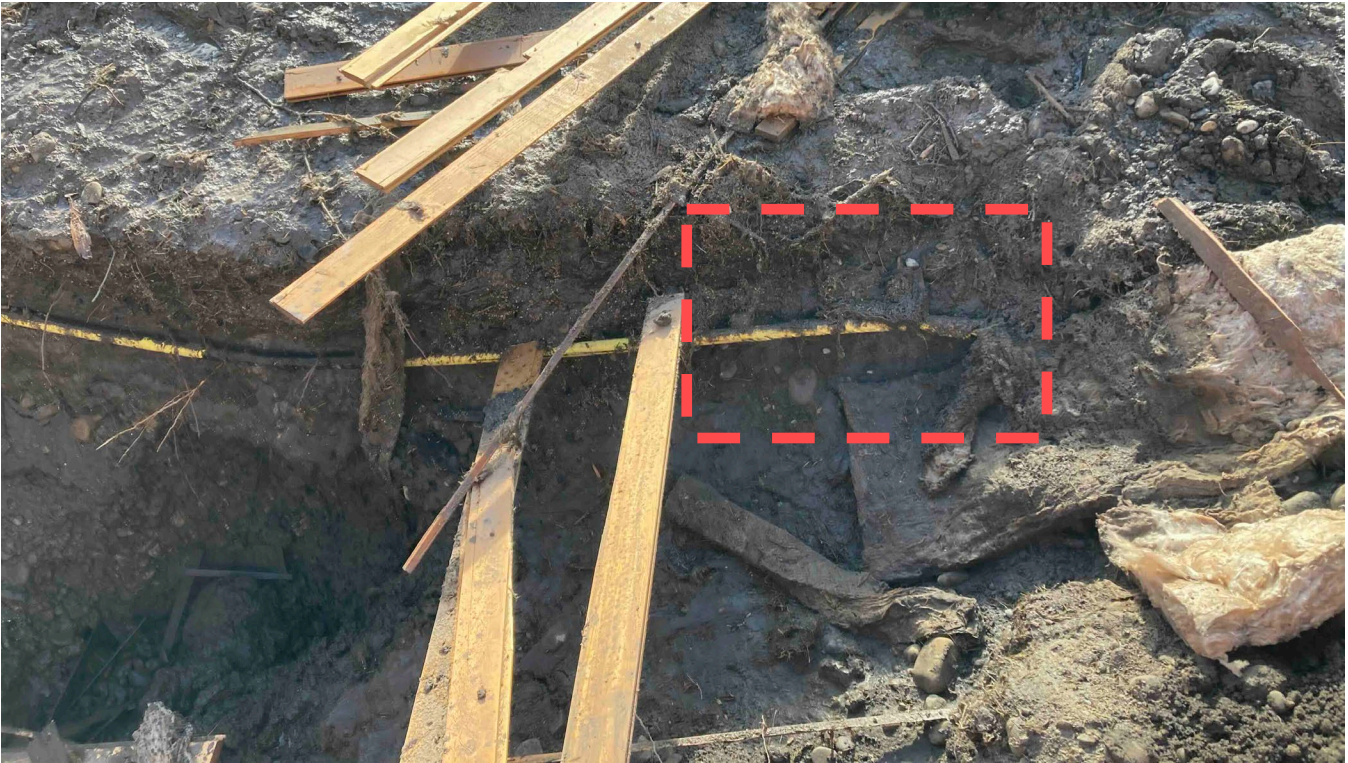
While digging the trench, the excavator contacted the steel gas line approximately fifty feet away from the home, pulling it upwards, causing it to bend, and damaging its protective outer coating ([Image 5](#)). The operator shut down the machine and the operator and homeowner thoroughly inspected the gas line. No sign of a gas leak was found at the location where the excavator struck the line. The gas utility was notified immediately that the line had been struck and a gas company technician was dispatched to investigate but did not arrive prior to the explosion.

Image 5 – Excavation showing exposed yellow 3/4" steel gas line. Red box showing area gas line was struck and pulled upward by excavating machine.

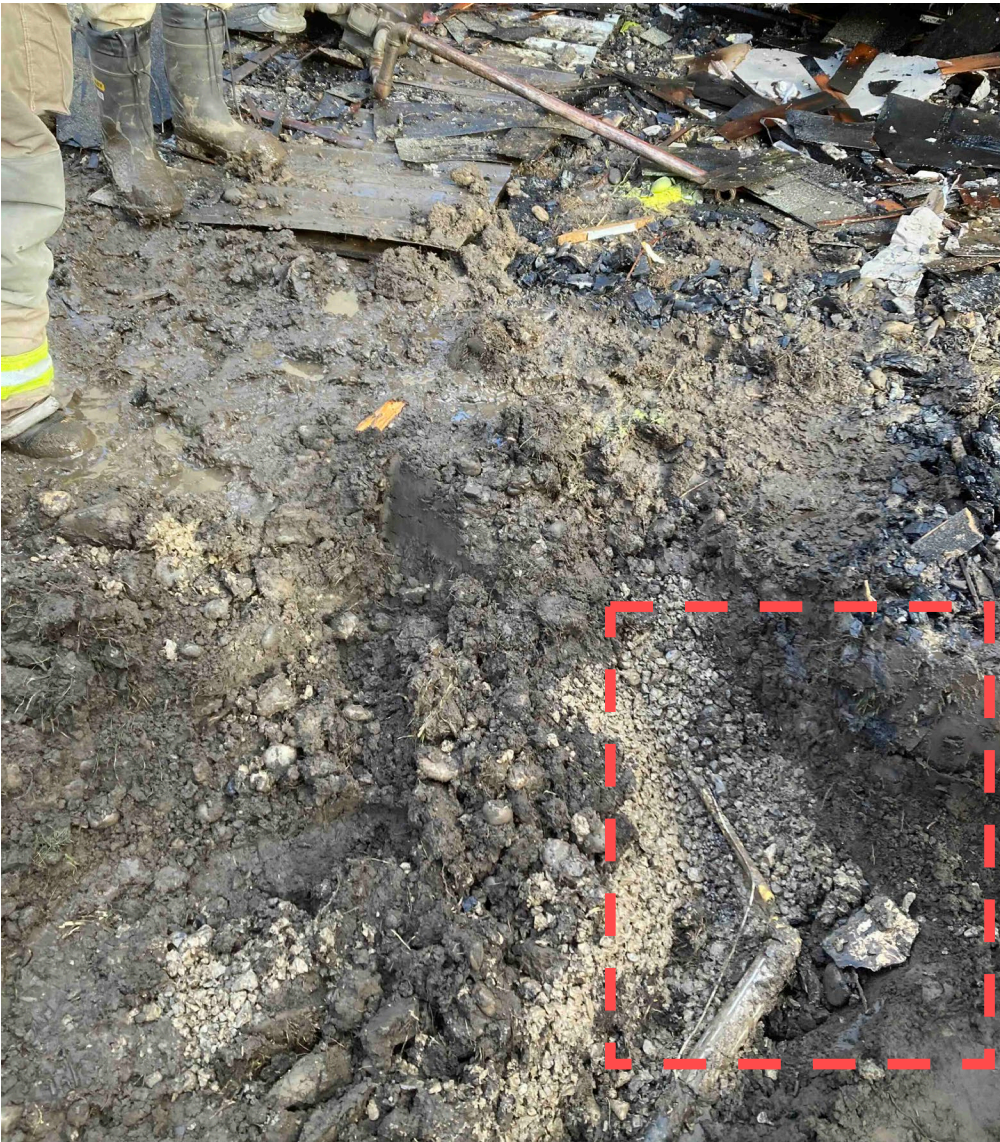
The excavator pulling up on the steel line caused the buried polyethylene gas line to sever at a 90-degree elbow at the steel to plastic transition fitting, 6 feet away from the home ([Image 7](#)). The escaping gas traveled underground through the void spaces in the clear crush backfill up to the home and migrated inside.

Image 6 – Red box showing area exposed by hand after the incident detecting the separated gas line. 3/4" clear crush backfill was observed surrounding 1/2" plastic gas line.

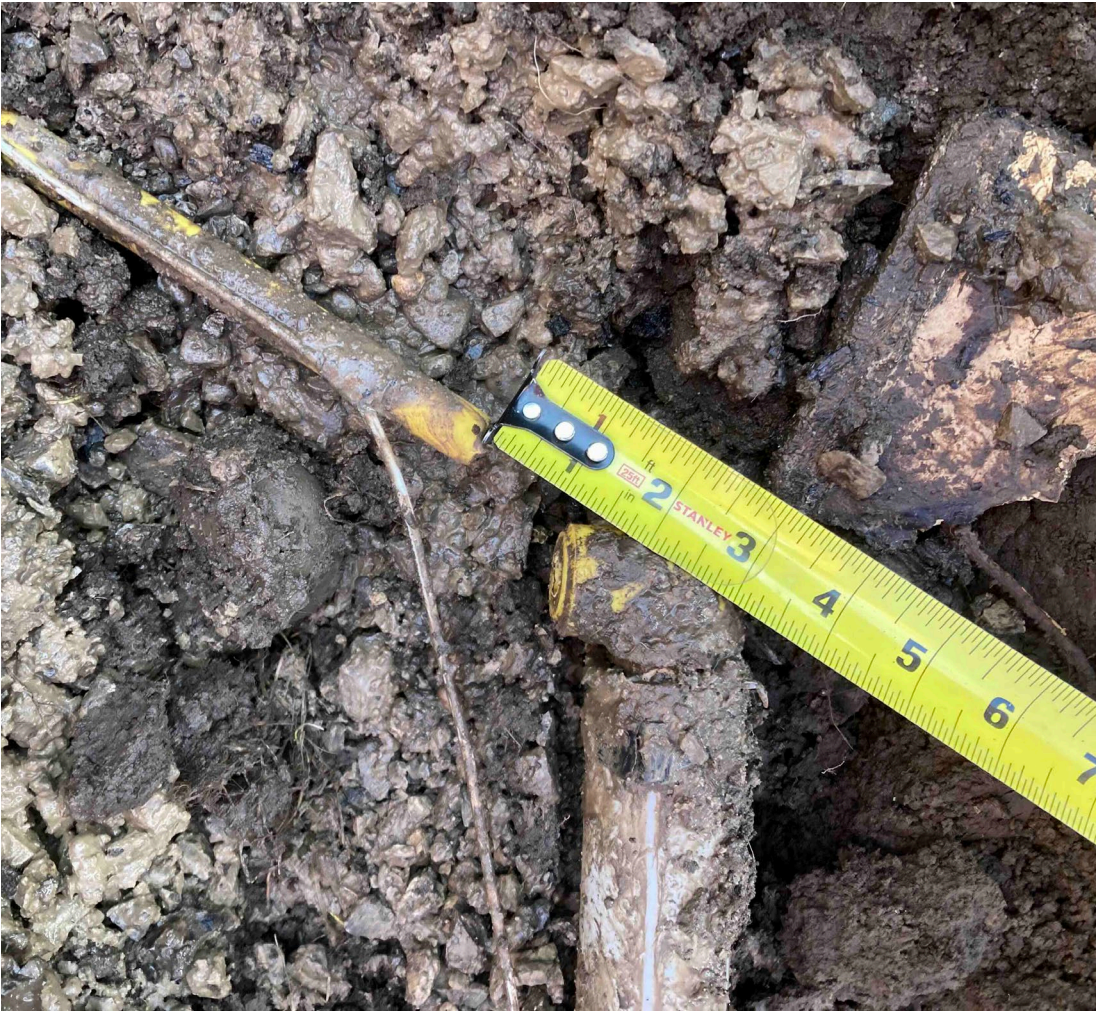
Analysis of the damaged sections of piping was conducted by an independent laboratory (Appendix A). The analysis concluded that the material of the pipe fittings examined was consistent with the requirements for underground gas lines and there were no signs of manufacturing defects. Analysis found that the pipe suffered a catastrophic ductile fracture due to overload conditions introduced to the pipe. The damage to the pipe indicates the piping and elbow were fully restrained or loaded at a high strain rate at the elbow location. The gas line at the location of the damage was buried in the earth which fully restrained it. The excavator applying force to the gas line provided a high strain rate causing the gas line to sever from the elbow.

<p>The independent engineering report also stated that, in general, when subject to the same force, elbows can increase the stress on a pipe when compared to a long radius bend, increasing the chances of the failure occurring near the elbow.</p>
Causes and contributing factors	<p>The gas line in the vicinity of the excavation work had been located, identified, and exposed. The cause of the explosion was the ignition of an uncontrolled release of gas from the disconnected/broken gas line after it was struck and dislodged by the nearby excavating work.</p> <p>The emphasis of the regulation and guidelines are focused on prevention of damage through identification and exposure of underground gas lines and has not been found to directly consider explosion risks prior to an accidental gas release.</p> <p>Contributing factors that could be considered dangerous manners of excavation work include:</p> <ul style="list-style-type: none">• Working in close proximity to an exposed and unprotected gas line with a mechanical excavator.• Working in close proximity to an unprotected gas line without a spotter.• Misunderstanding of explosion risks when working near live gas lines.• Not moderating excavation practices when increased risk of explosion hazards are present such as occupied buildings, and ignition sources.

Image 7 – Close up of separated gas line that was uncovered after the incident.

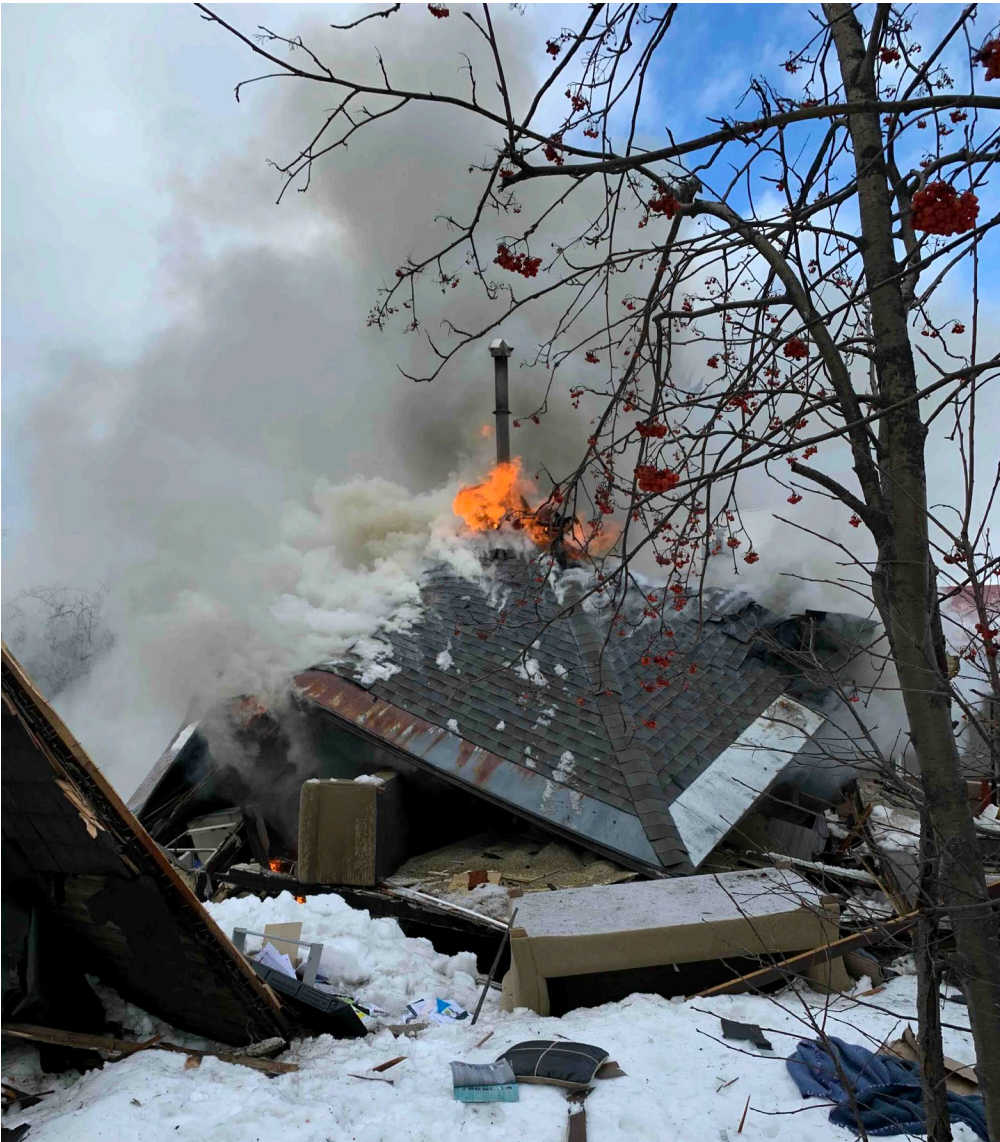
Image 8 – Home collapsed from explosion with fire fueled by leaking gas.

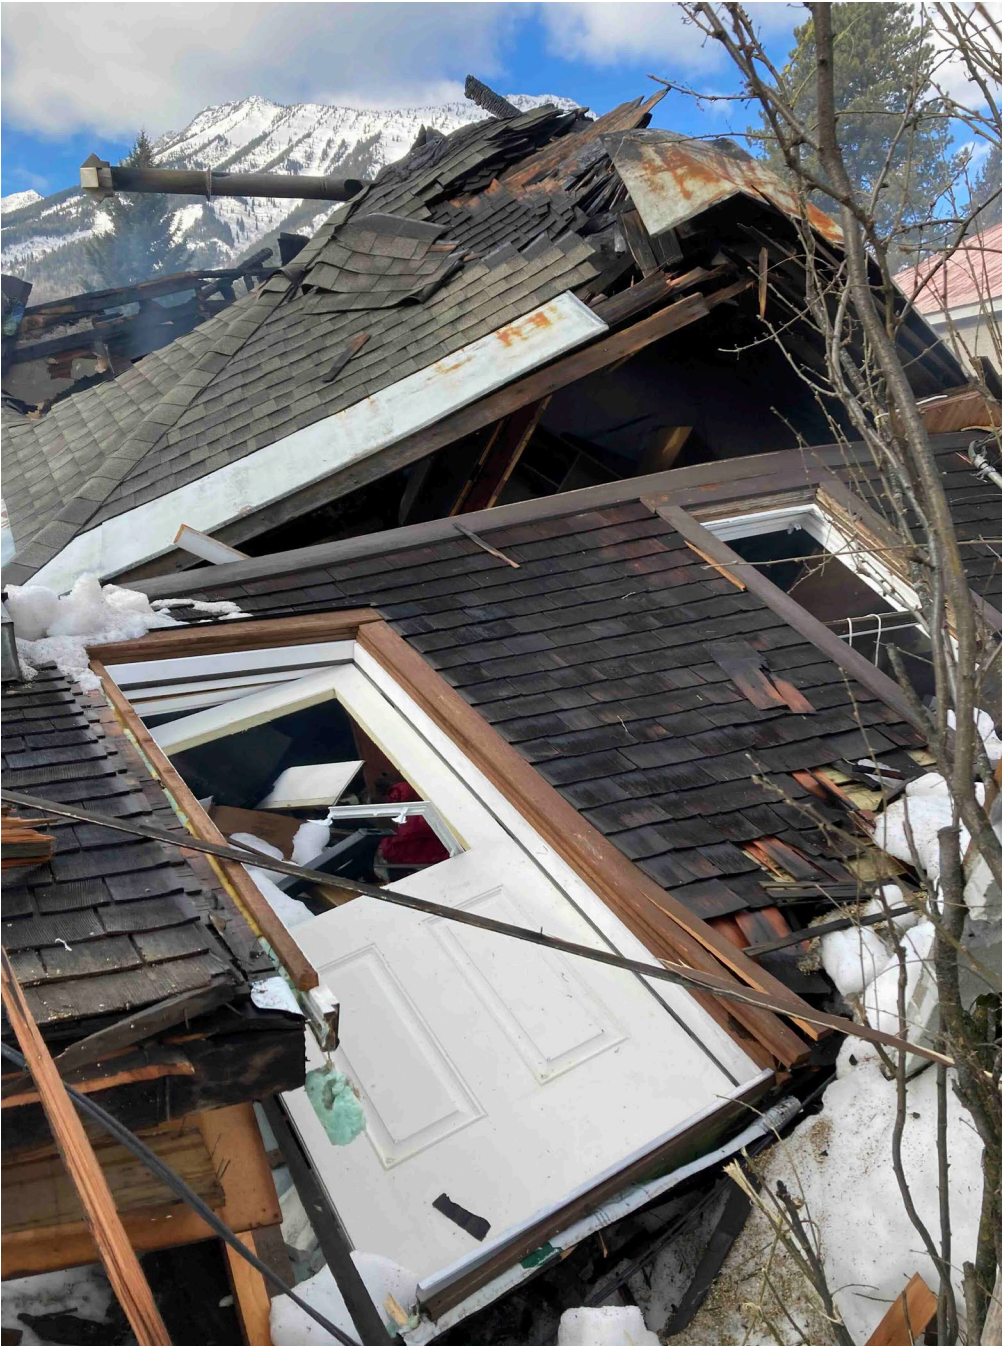
Image 9 - Front of home collapsed from explosion.

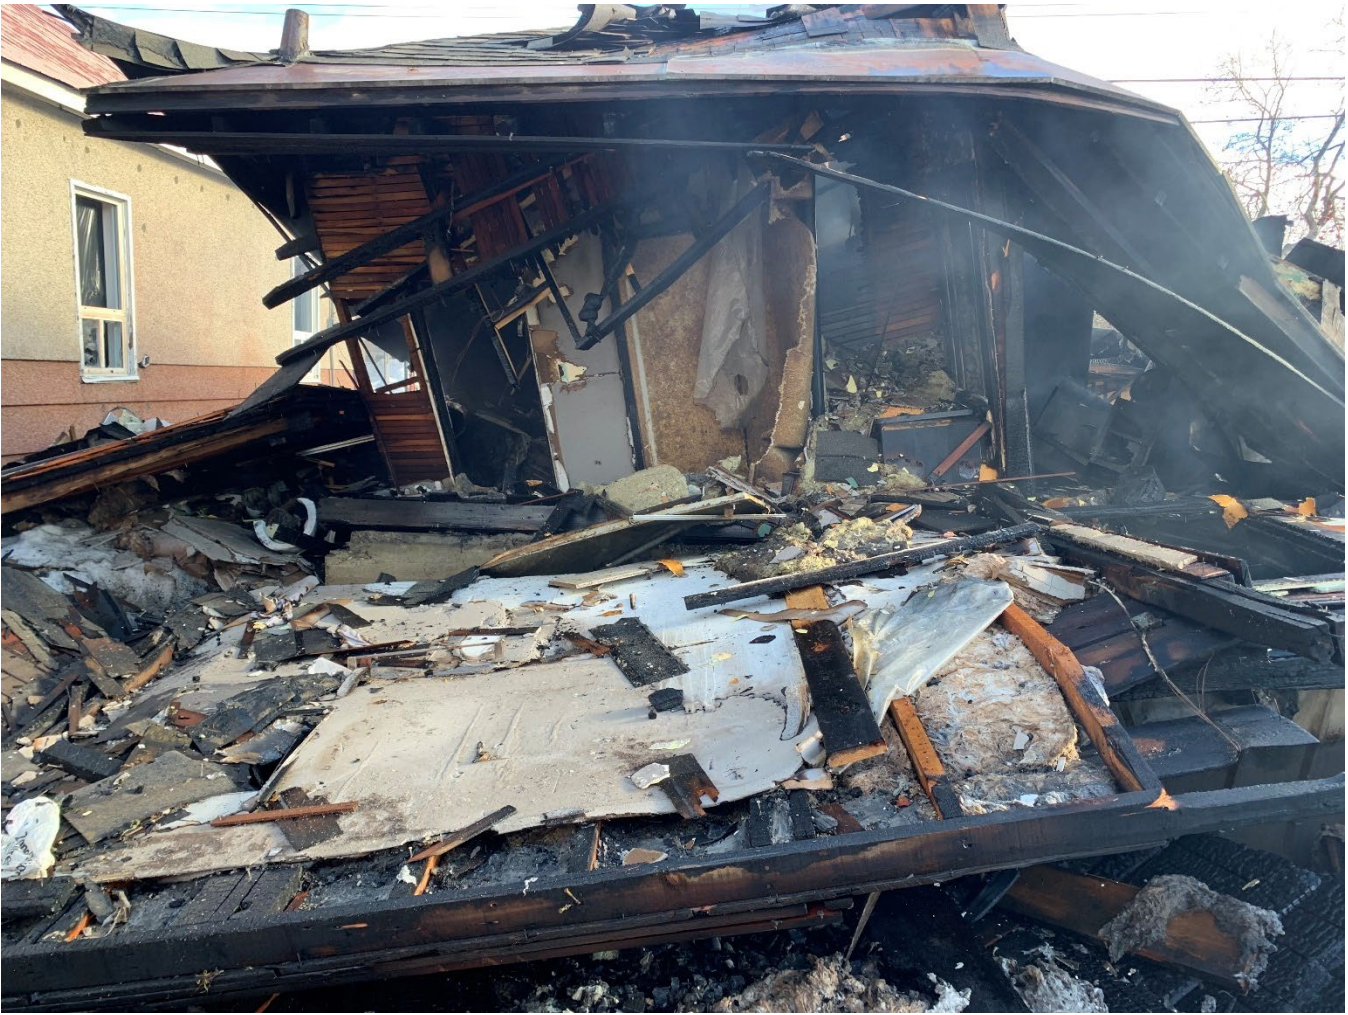
Image 10 – Home with rear exterior wall removed.
