Incident Summary #II-1691775-2024 (#45324) (FINAL)

SUPPORTING INFORMATION	Incident Date	March 29, 2024	
	Location	Vancouver	
	Regulated industry sector	Amusement Devices - Amusement ride	
	Impact	Qty injuries	0
		Injury description	N/A
	Damage	Injury rating	None
		Damage description	The bogey wheels and carriage frame on a miniature train car derailed, turned sideways, and dragged across tracks for approximately 30 feet damaging several track ties and the brake linkage on the bogey as a result of the impact.
		Damage rating	Minor
	Incident rating	Minor	
Incident overview	A train car designed for wheelchair accessibility, derailed on a rideable miniature railway amusement attraction while the train was being put away at the end of the day without any passengers riding on it.		
INVESTIGATION CONCLUSIONS	Site, system and components	<p>The miniature railway amusement attraction was designed, built, and opened to the public in 1964. The railway consists of a 20" wide narrow-gauge track that winds approximately 2 kilometers through the forest in the city park. The railway incorporates gasoline engine powered locomotives which tow up to 5 passenger carrying cars that can hold up to 70 pa

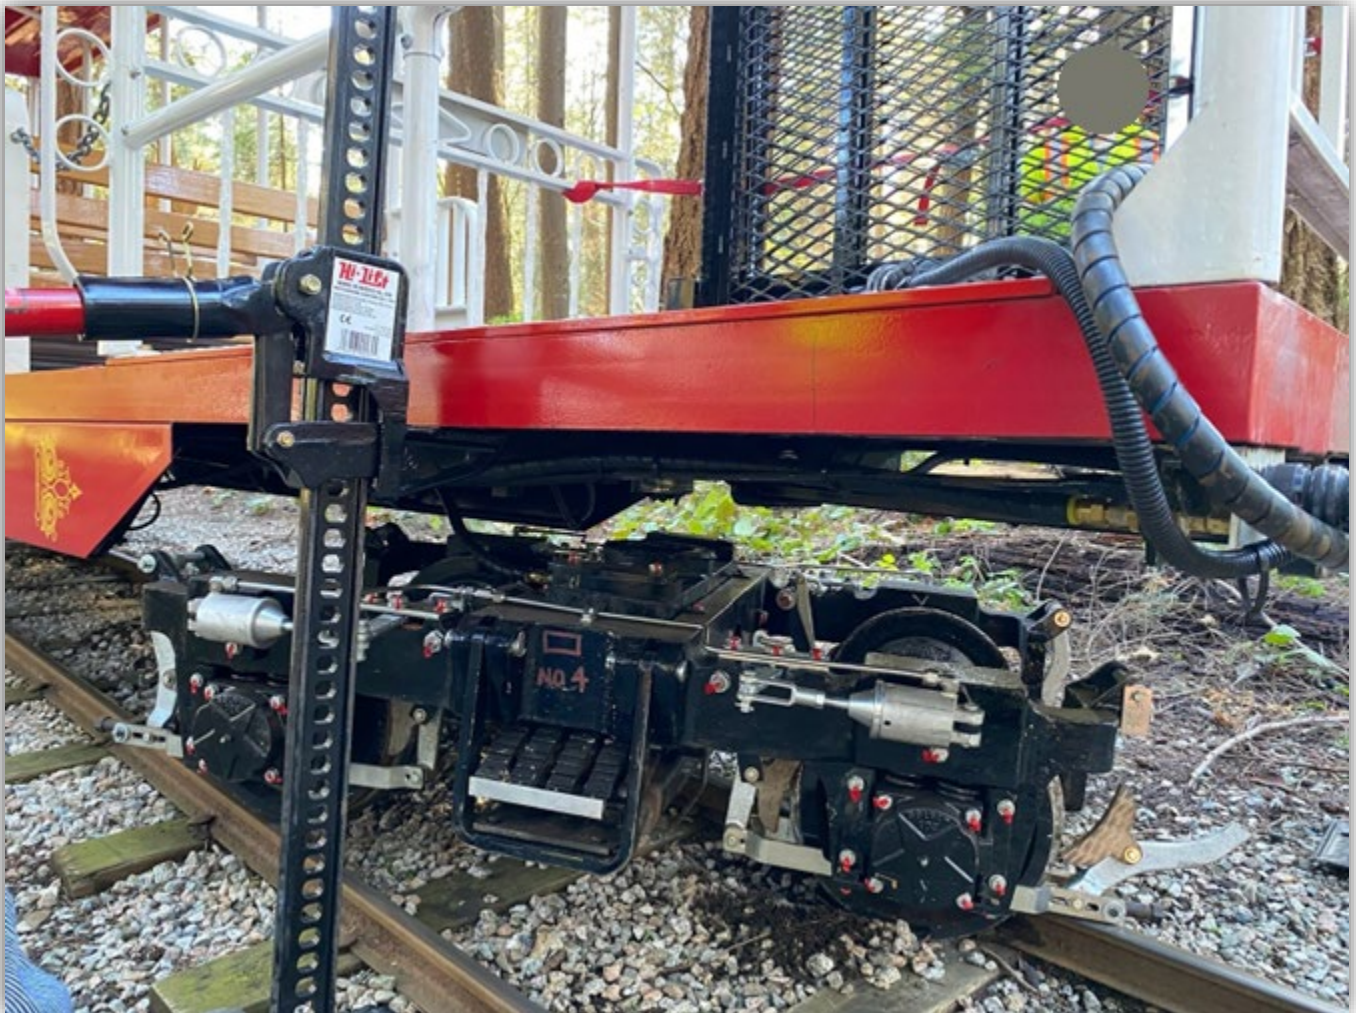
It is very likely that the train being operated with a combination of track conditions out of specifications, new unworn bogey wheels, and unloaded train car orientation and speed caused the derailment.

Image 1 – The accessibility car jacked up and the derailed bogey.

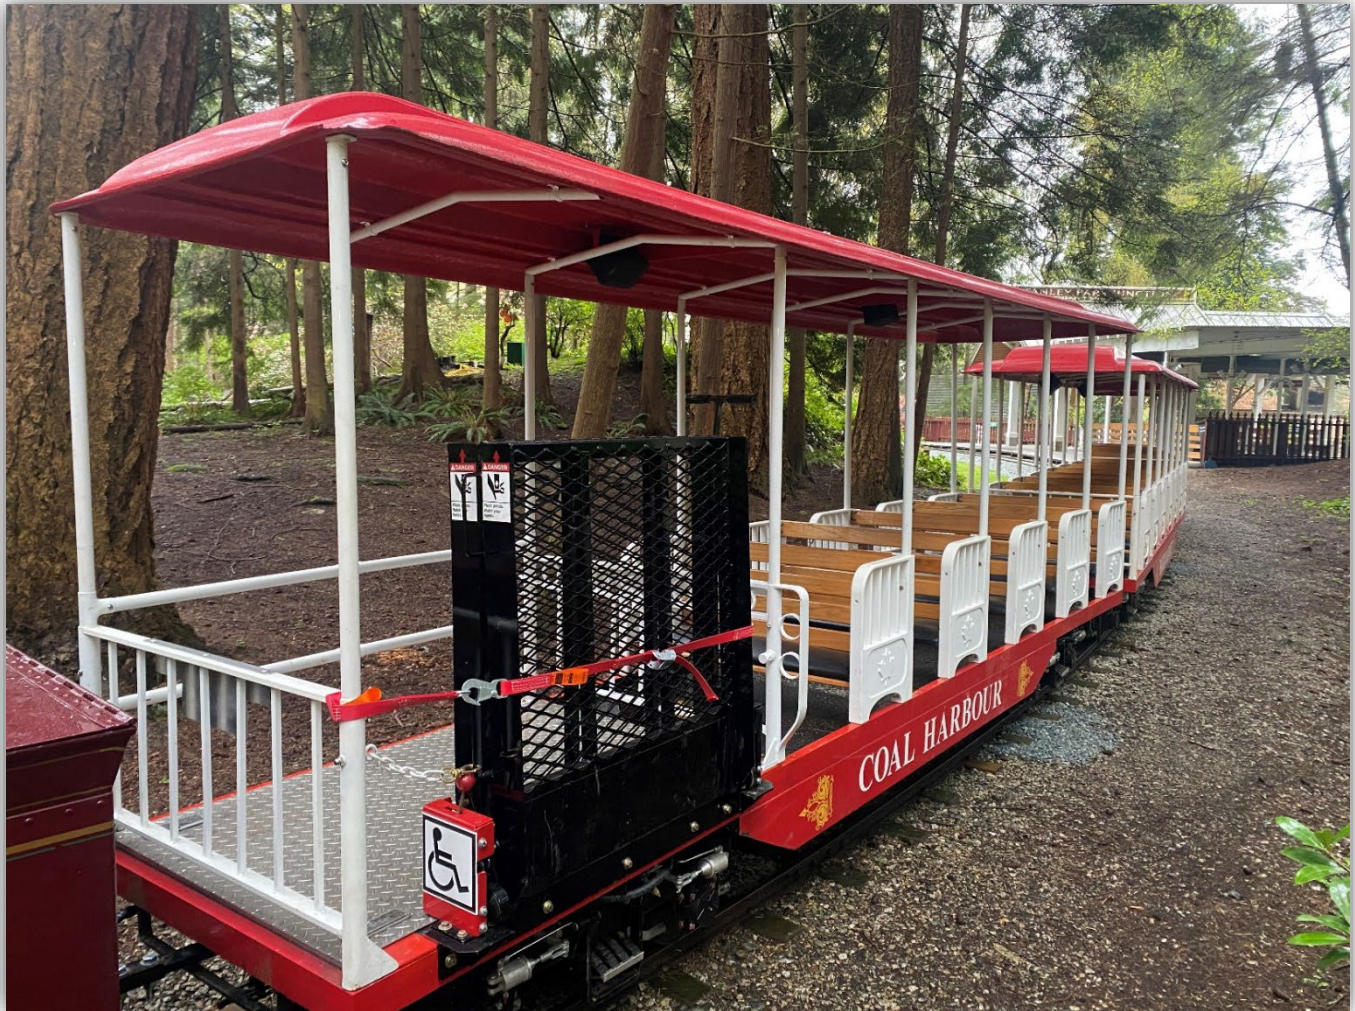
- The train being continued to operate without inspection and repair of the issue after the engineer noticing a continued feeling of “dragging” at the same location of track.
- The accessibility car being placed at the end of the train with the loading ramp weight hanging on the outside of the car.
- The train being operated at a higher rate of speed with the cars unloaded while being put away at the end of the day.
- The new bogey wheels combined with the tight tolerances at the location of track.

Image 2 – The accessibility car ramp folded up adding extra weight to the outside of the car.

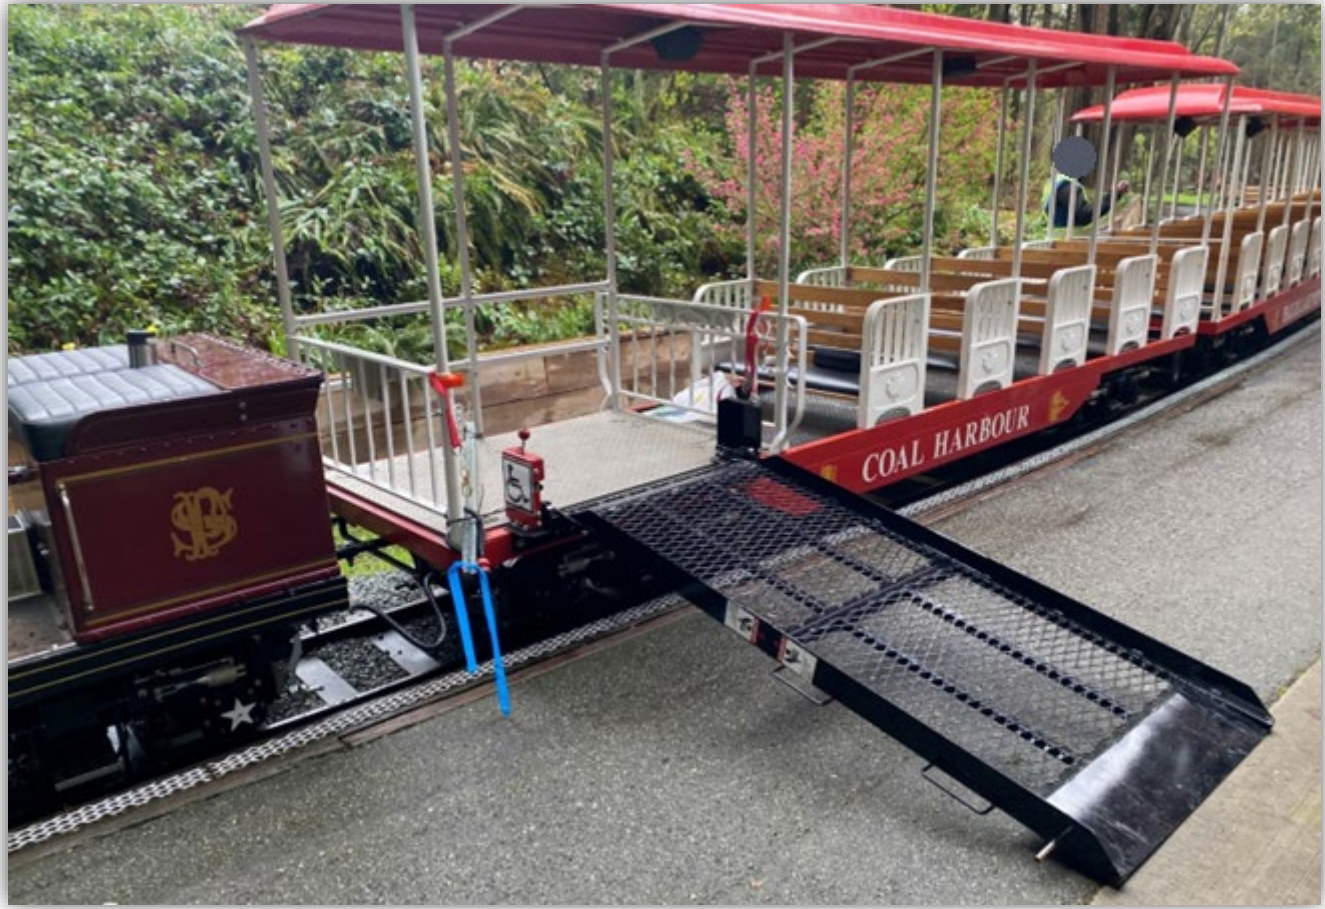
Image 3 – Accessibility ramp unfolded at the loading station.

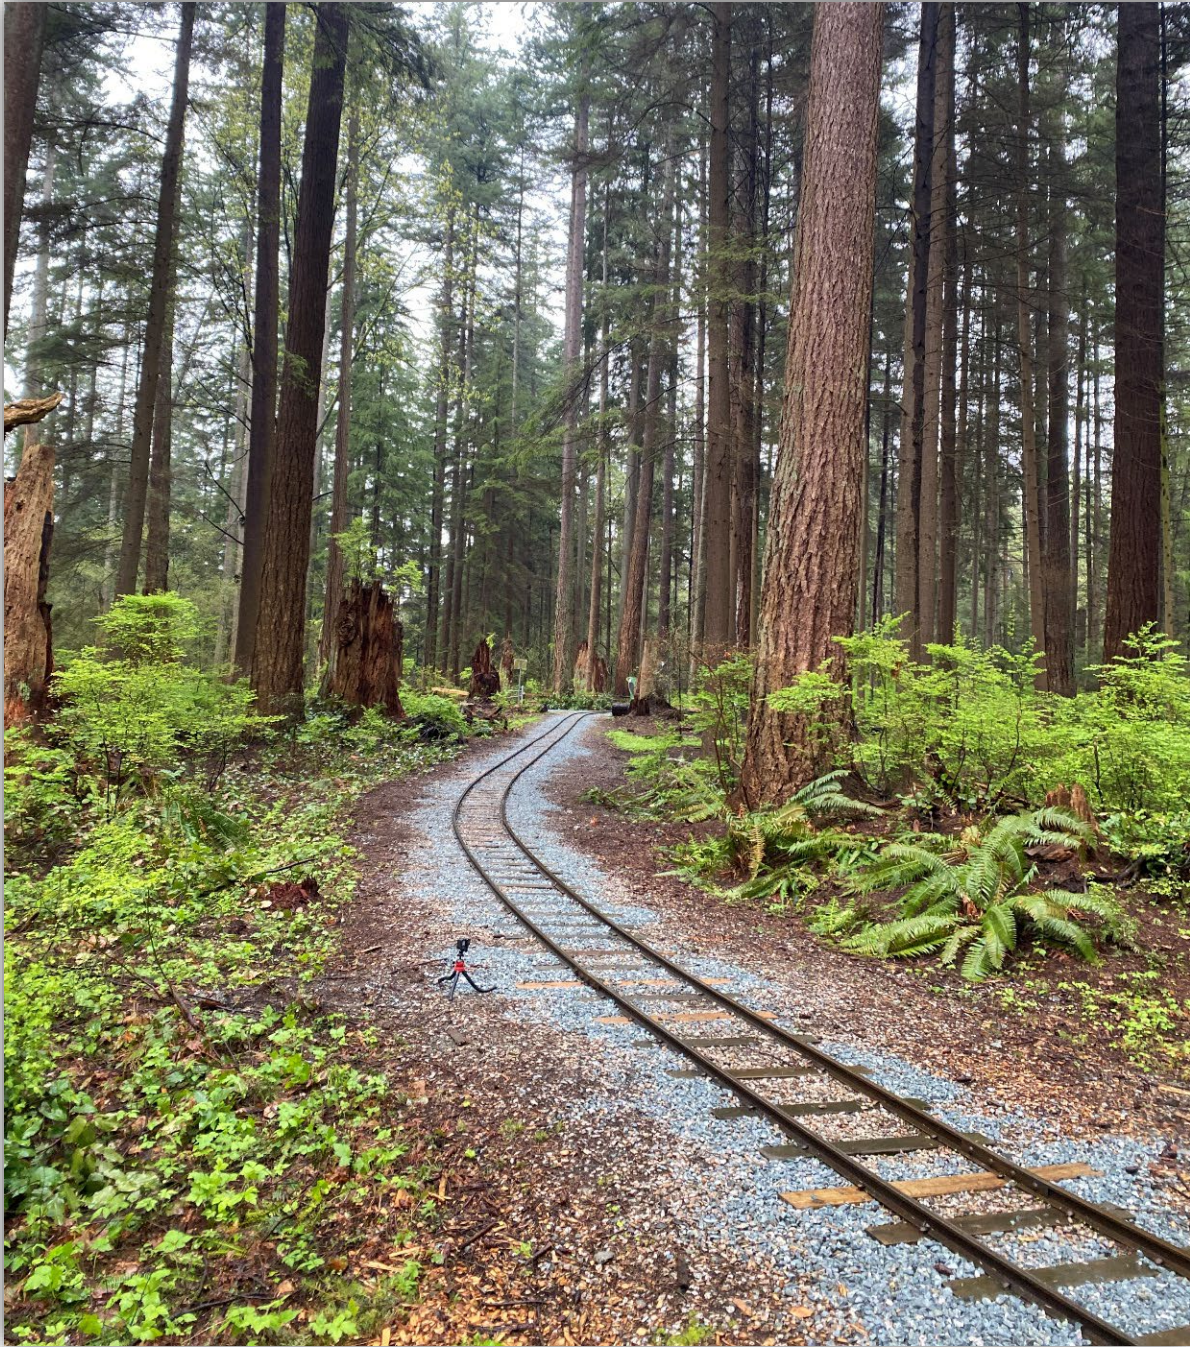
- The area is known by operators to be sensitive to environmental events.
- Inspection of the area of track after the incident found an area of the track measured 19.5” in width which is ¼” narrower than allowable.
- The bolts on one track joint were found to be loose.
- A visible depression was observed in the track at the area of the derailment.
- A rail contracting company inspected, re-leveled, and re-aligned the affected section of track after the incident.
- After the area of the track was inspected and repaired after the incident, the train travelled over the area multiple times and the previously reported “dragging” feeling was no longer present.

Image 4 – Area of track where the derailment occurred after repairs, realignment and releveling completed by rail contractor.

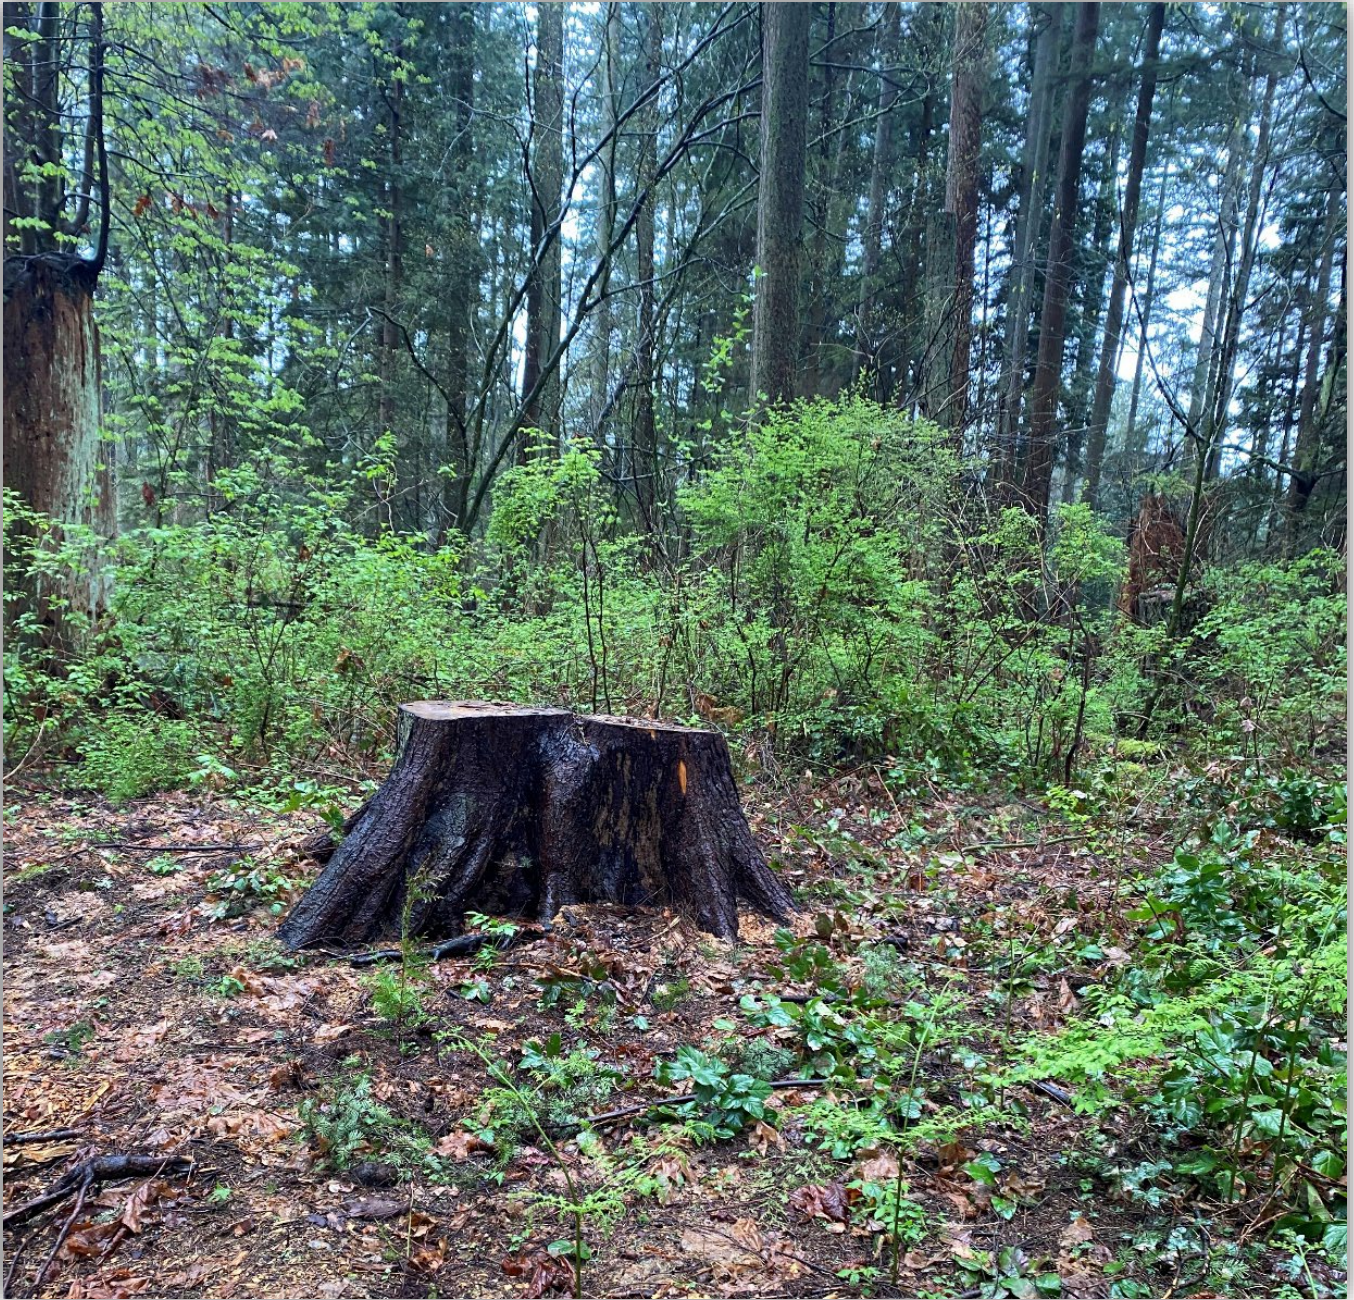
- Three trees had been removed from the area of the derailment earlier in the year which allowed more sunlight into the area of the track and the existing surrounding trees then previously experienced.

- The removal of trees in the location of the derailment allowed sunlight to warm the track causing linear expansion as well as allowing quicker growth of the existing trees and the tree roots passing under the area of track.

Image 5 – Stump from one of the three large trees removed from the area allowing much more sunlight into the area.

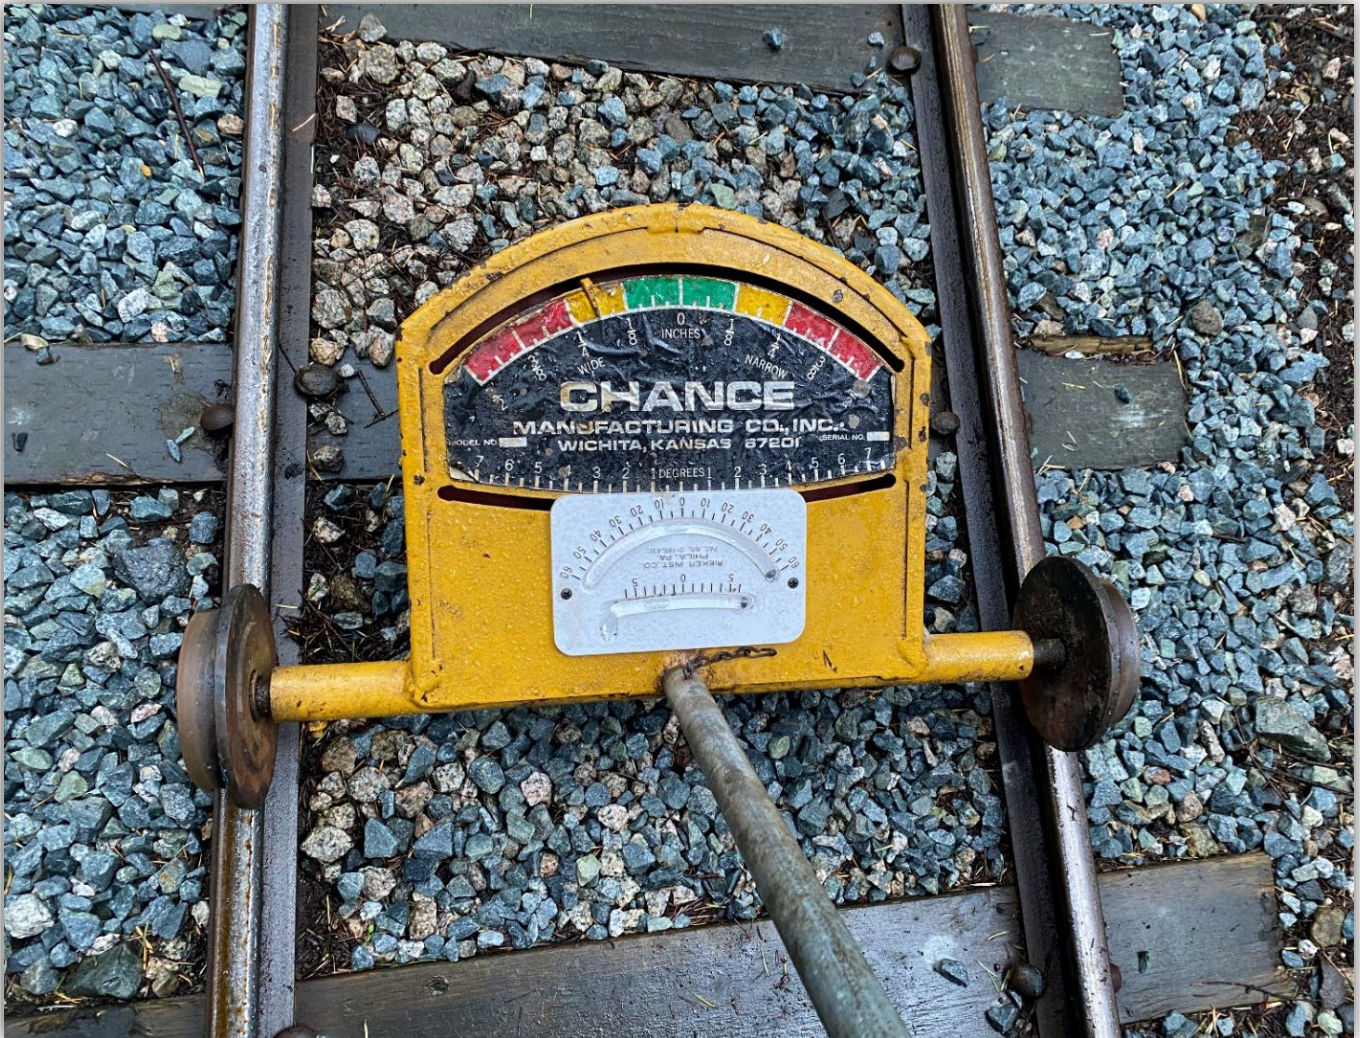
- The track gauge was heavy, difficult to use, and not functioning properly to accurately assess the track width and level and it had not been used in some time.

- The recent wet weather contributing to the softening of the ground.
- The improper functioning track gauge and difficulty of use leading to no identification of the improper track conditions or potential repairs of maintenance before train operation.

Image 6 – Chance track gauge in use after it was repaired after the incident.

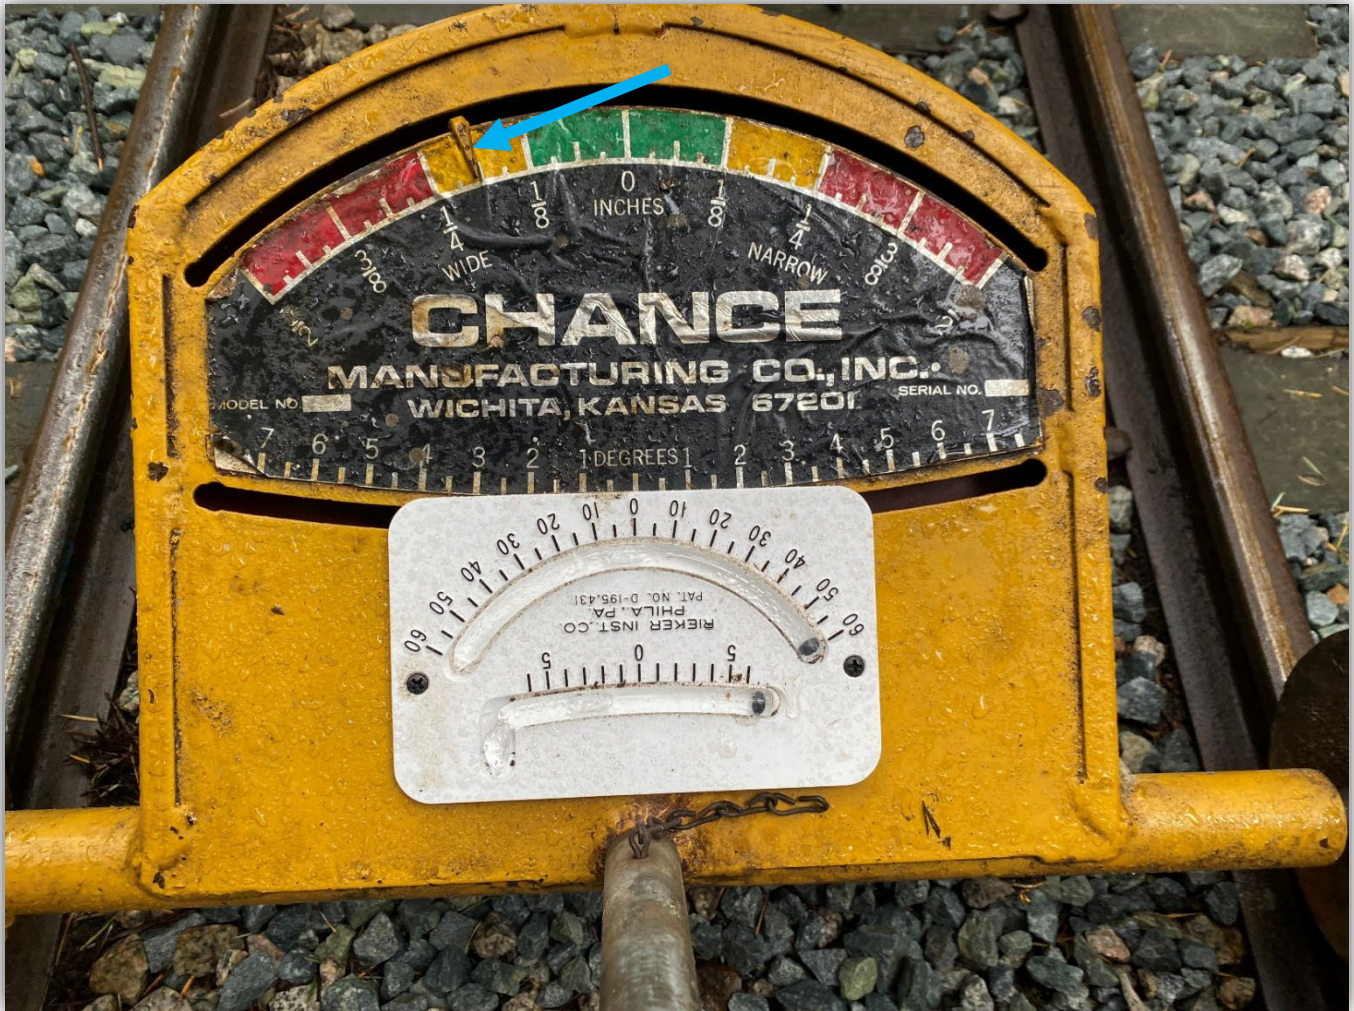
Image 7 – Track gauge with arrow showing needle indicating track width and tolerances.
