## Incident Summary #II-1228132-2021 (#22910) (FINAL)

SUPPORTING INFORMATION	Incident Date		July 22, 2021	
	Location		Vancouver Island	
	Regulated industry sector		Amusement Devices - Zip line	
	Impact	Injury	Qty injuries	1
			Injury description	Index finger on the left hand was severed at the second knuckle
			Injury rating	Moderate
	Damage	Damage	Damage description	No damage
			Damage rating	None
	Incident rating		Moderate	
Incident overview		Zipline trolley braking system was not engaged as the patron approached the landing area. Patron approached the zipline braking system, located at the landing area, faster than anticipated. Patron reached up with the left hand to slow down, and in doing so, the patron's hand was run over by the trolley wheel, at the point where the wheel meets the zipline cable.		
INVESTIGATION CONCLUSIONS	Site, system and components		A zipline is a pulley or trolley suspended under a tensioned cable with an elevation change, allowing the user to travel down a predetermined finite path using gravity. In this configuration, there are two separate braking systems: the trolley is equipped with a user-applied/released brake, and a braking spring system mounted

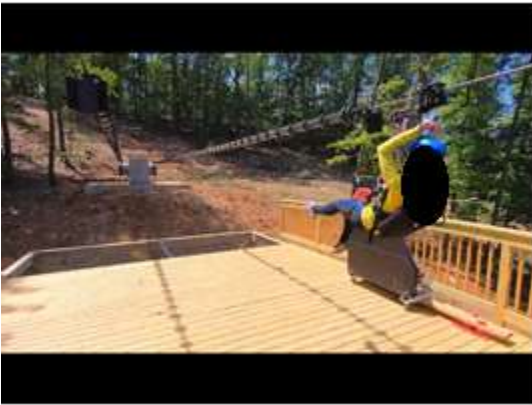
Trolley entering lower terminal brake system.

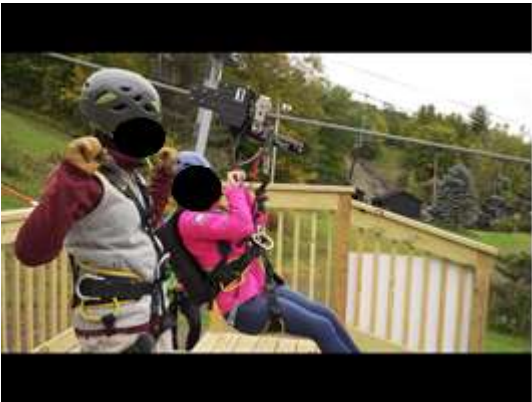
Trolley braking - Pull down to increase speed.

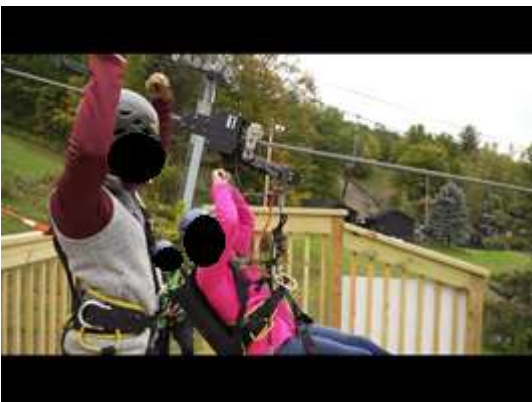
Trolley braking - Push up to slow and stop trolley.

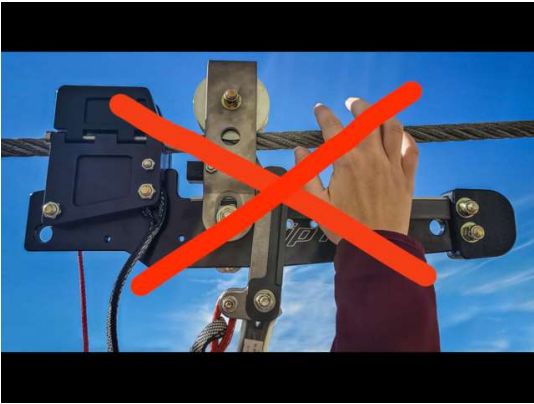
It is very likely the patron came into the bottom terminal faster than anticipated, and in reaction to that speed, attempted to slow themselves down using their hand, instead of following instructions and procedures for both braking systems.

Example of improper hand placement.

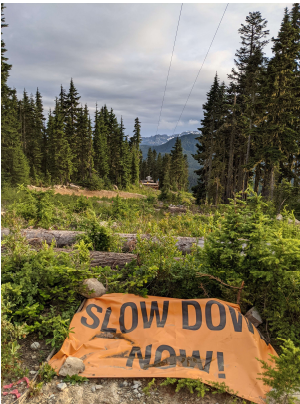
Sign located at the point patron slowed prior to entering terminal brake system.
