## Incident Summary #II-1420734-2022 (#29331) (FINAL)

SUPPORTING INFORMATION	Incident Date	August 13, 2022	
	Location	Chilliwack	
	Regulated industry sector	Electrical - Low voltage electrical system (30V to 750V)	
	Impact	Qty injuries	0
		Injury description	N/A
		Injury rating	None
	Damage	Damage description	A 600-amp main service switch suffered internal fire damage. The underground service conductors that enter the bottom of the 600-amp switch were damaged. All the fire damage was contained inside the 600-amp service switch.
		Damage rating	Moderate
Incident rating	Moderate		
Incident overview	Small fire in a 600-amp, 240-volt main service switch at a mobile home park resulting in damage to electrical service equipment that left 48 mobile homes without power.		
INVESTIGATION CONCLUSIONS	Site, system and components	<p>The incident occurred at a mobile home park that consists of 99 mobile homes. One of the electrical services to this park is a 600-amp, 240-volt single phase service fed from a utility pole mount transformer, underground to a small storage building. The 600-amp service consists of a bottom fed 600-amp 240-volt rated fused switch that feeds a 600-amp rated splitter,

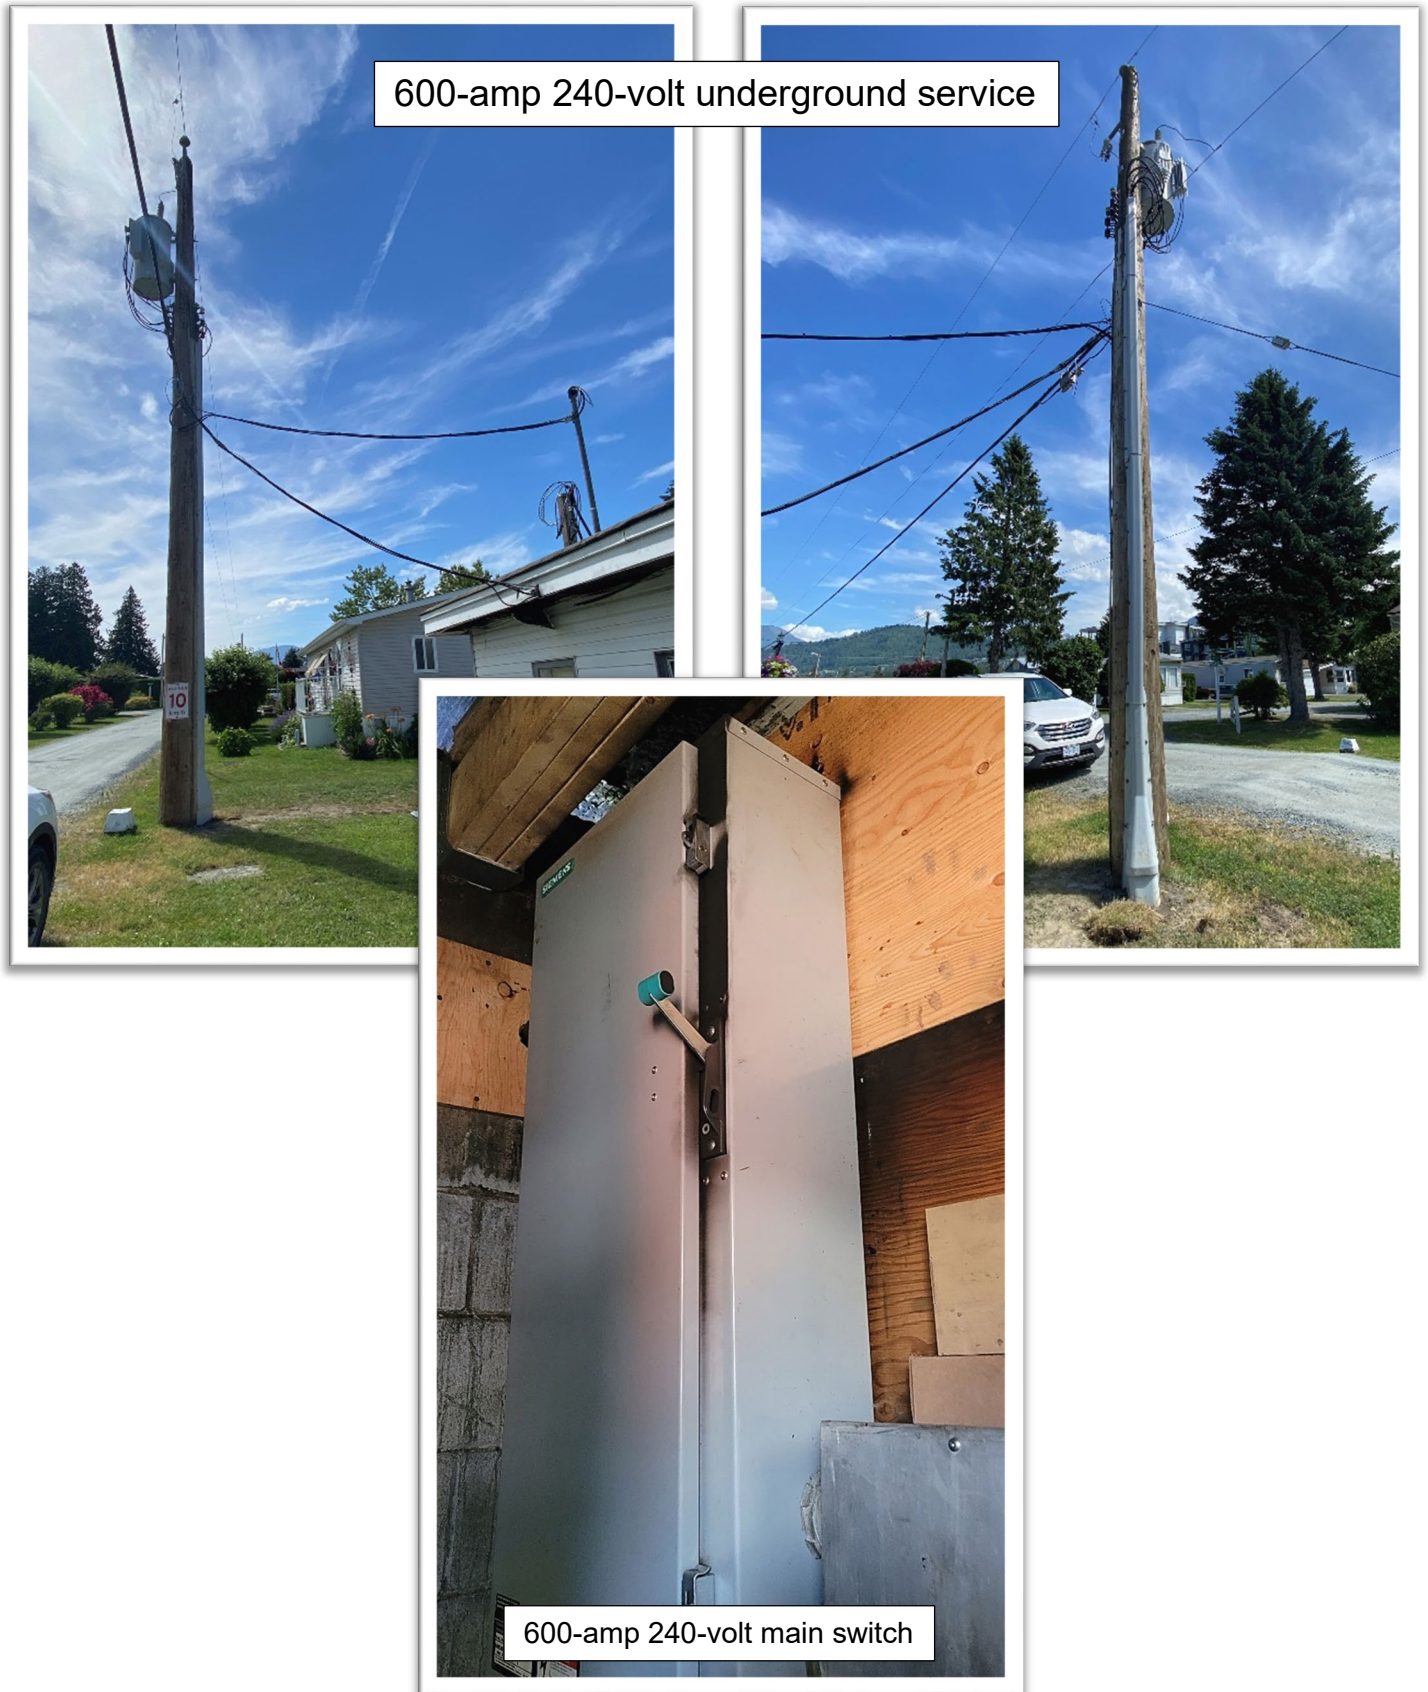
Figure 1

Failure scenario(s)	<p>On the line side of the 600-amp main switch there was a poor connection on one of the service conductors. This led to a build up of heat at the conductor termination point. The heat was caused by electrical current trying to flow through the high resistance at the poor connection point. The heat at the connection point eventually resulted in a small fire inside the switch. The fire melted the insulation on the service conductors, causing the conductors to short out on the metallic enclosure of the switch. When the conductors shorted out, the primary fuse blew at the utility transformer on the pole, and completely disconnected power to the building. When power was cut off to the building, current stopped flowing through the conductors and the fire was put out.</p>

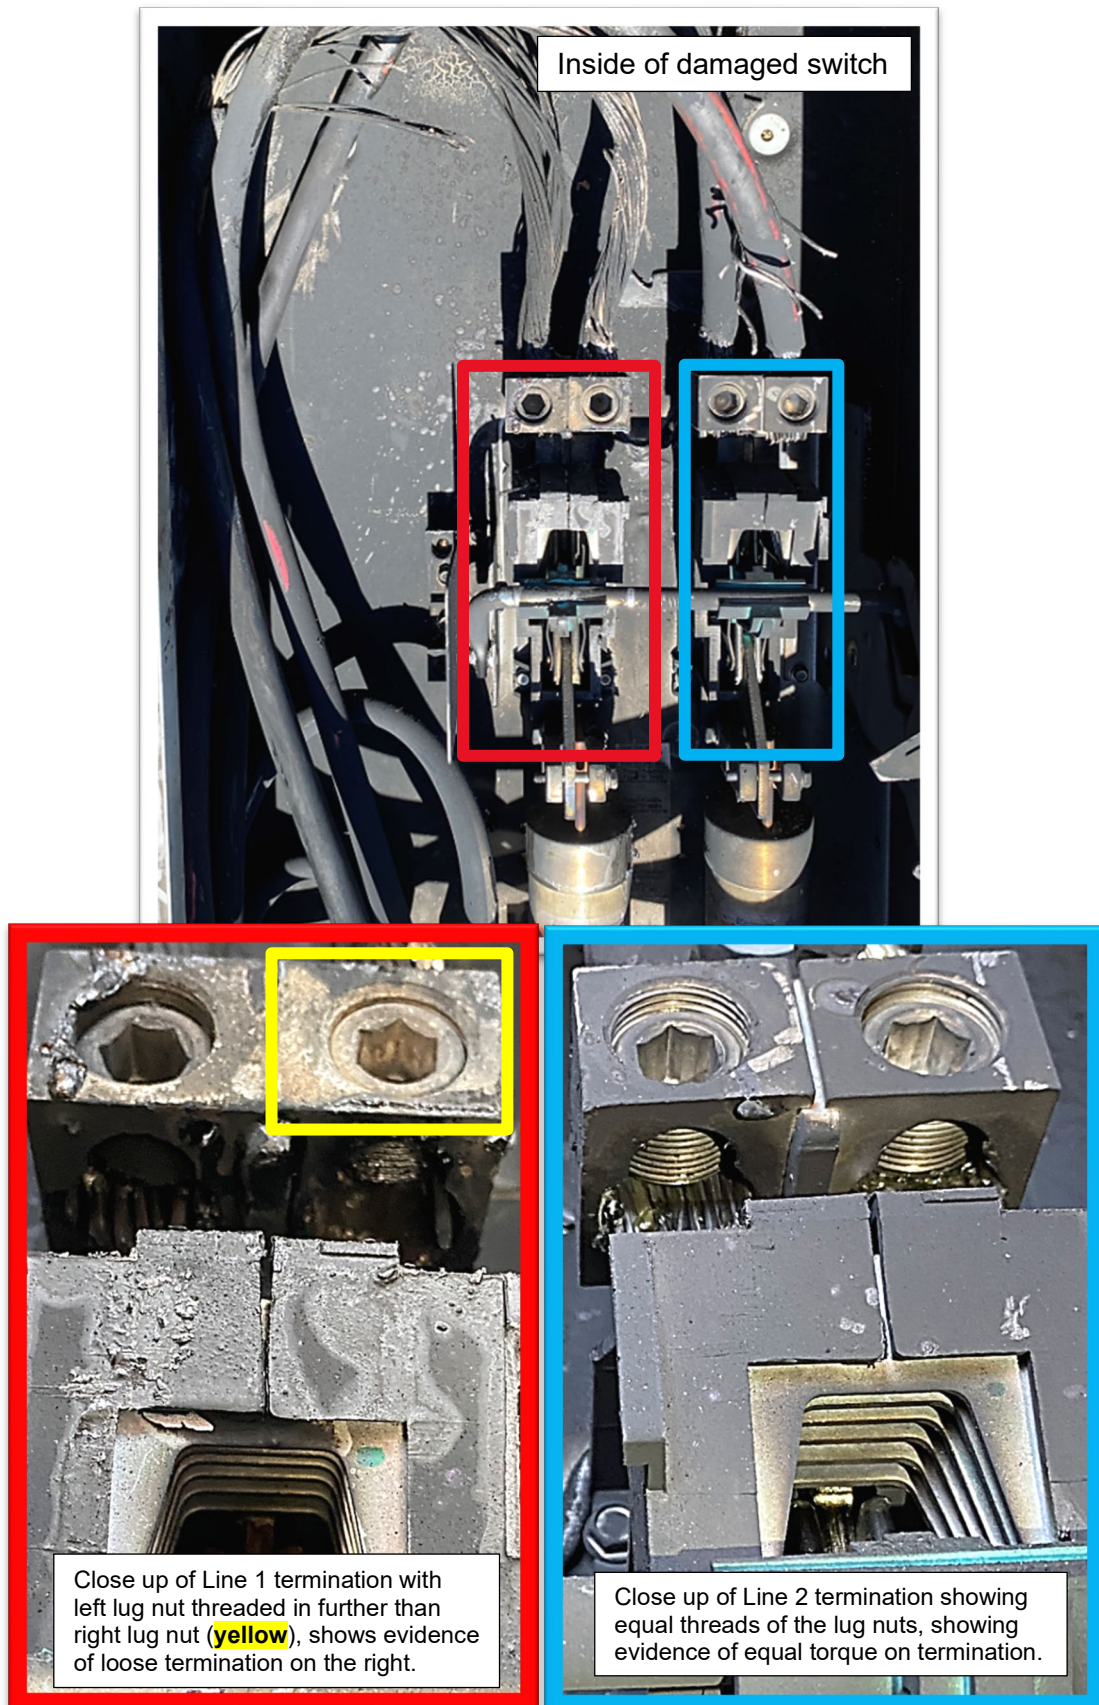
Figure 2

<p>Facts and evidence</p>	<p>Examination of the damaged fused switch showed:</p> <ul style="list-style-type: none"><li>• A lug nut on the Line 1 conductor termination point that was not threaded in as far as the lug nut beside it meaning one of the terminations was not as tight (see <a href="#">Figure 2</a>).</li><li>• Melted insulation on the service conductors above the Line 1 termination point suggesting the high heat location.</li><li>• The Line 2 service conductor insulation was not as damaged as Line 1 above the termination point, suggesting this location was not as hot (see <a href="#">Figure 2</a>).</li><li>• There was more soot present on the Line 2 conductors and termination lugs, suggesting this location was not as hot as the Line 1 side.</li><li>• Service conductors pressing up tight against the top of the metallic enclosure of the switch.</li><li>• Burn marks and high heat markings on top of the inside of the metallic switch enclosure, suggesting conductor short circuit location.</li></ul> <p>Other evidence:</p> <ul style="list-style-type: none"><li>• The primary fuse was hanging down at the pole mount transformer meaning there was a short circuit between the Line side of the 600-amp main switch and the transformer.</li><li>• A power analyzing meter was installed on the service conductors after the fire and showed that the 600-amp service is near capacity. This would suggest a large amount of current flowing through the poor connection point which would cause excessive heat.</li></ul>

<p>Causes and contributing factors</p>	<p>It is very likely that this fire occurred due to a poor connection of a line side conductor termination inside the 600-amp fused switch. Contributing factors are the heavily loaded service cables that created high heat at the loose connection point, that could eventually start a fire.</p>
