Incident Summary #II-877057-2019 (#14064) (FINAL)

SUPPORTING INFORMATION	Incident Date	July 2, 2019	
	Location	Oliver B.C	
	Regulated industry sector	Electrical - Low voltage electrical system (30V to 750V)	
	Impact	Qty injuries	0
		Injury description	No Injury
		Injury rating	None
	Damage	Damage description	Fire resulting in electrical panel and all associated components being destroyed
		Damage rating	Moderate
	Incident rating	Moderate	
	Incident overview	Dry location rated electrical panel installed outdoors caught fire and destroyed all associated equipment.	
INVESTIGATION CONCLUSIONS	Site, system and components	Under normal conditions in outdoor and other locations subject to falling water/rain, a rain tight electrical panel (type 3R rating) should be installed. The installed electrical panel limits and distributes electricity to receptacles, lights and other electrical devices used daily by the general public. A type 3R electrical panel will help prevent water infiltration and corrosion of internal components.

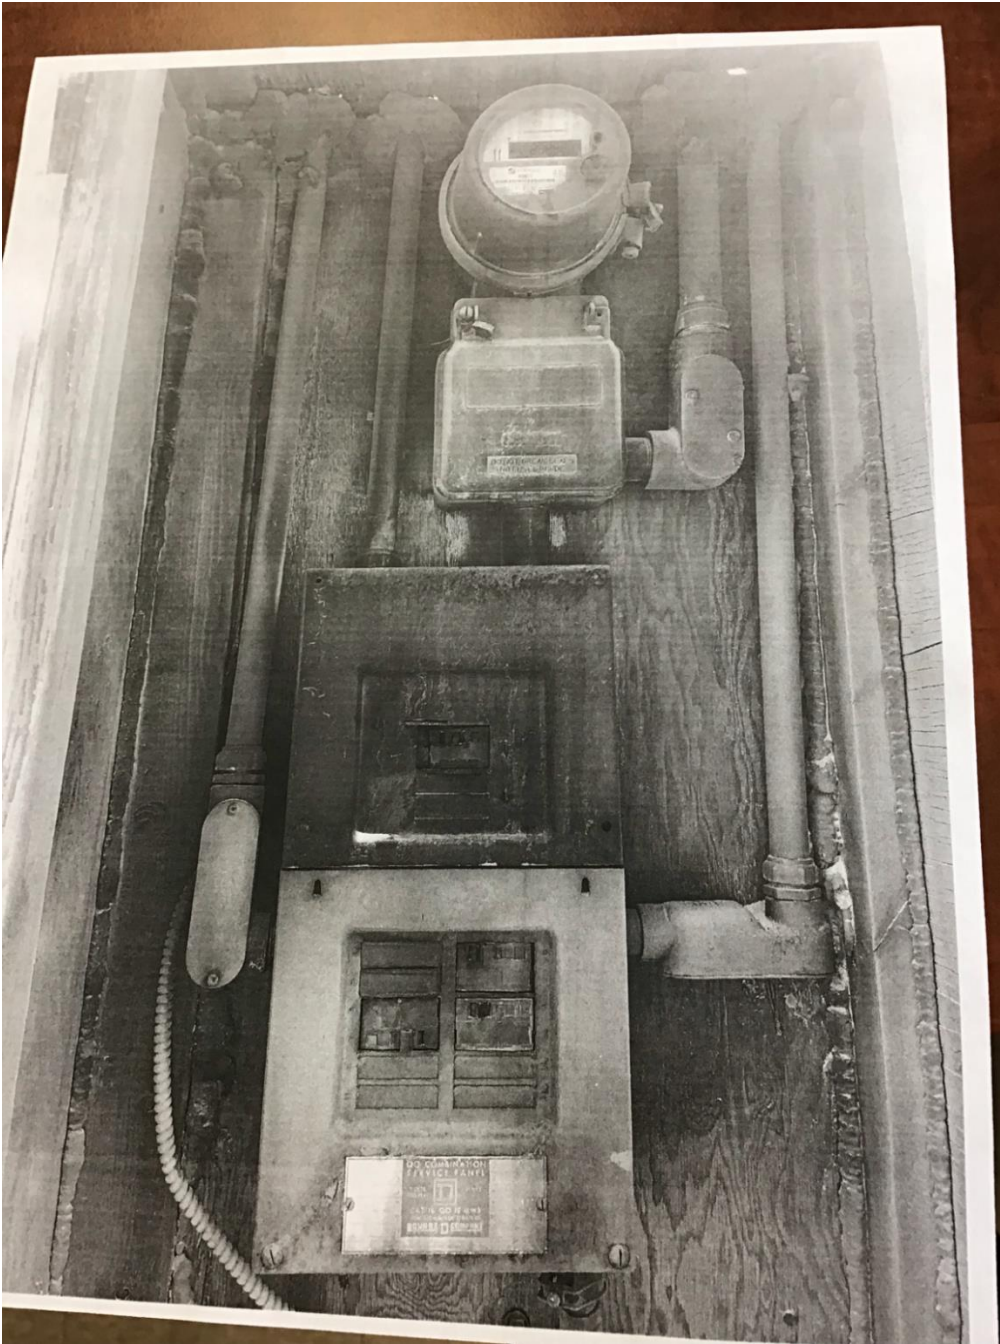
Photo #1

Failure scenario(s)	A dry location main distribution panel was installed on an electrical pole in an outdoor location. The panel board was installed in a 3/8" plywood enclosure with roofing materials on top but with holes all around the enclosure including on the top. (See Photo #1) Water was able to infiltrate the plywood enclosure and eventually the panel board resulting in corrosion building up on the electrical connections at the internal components.	
	Facts and evidence	<ul style="list-style-type: none"> -Type 1 (dry location) panel board was installed in an outdoor location in a plywood enclosure. -Plywood enclosure had holes in it as confirmed by the electrical contractor who removed the damaged equipment. -Panel board has been in place for a lengthy amount of time as indicated by the age of the components. -Recent weather conditions in this area of the valley have been extremely wet with above average rain fall. -Water on electrical components will result in an oxidation of the metal over time. -Oxidation of metal increases the electrical resistance of the connections and will result in excessive heat at the termination points.

As found by condition after fire.

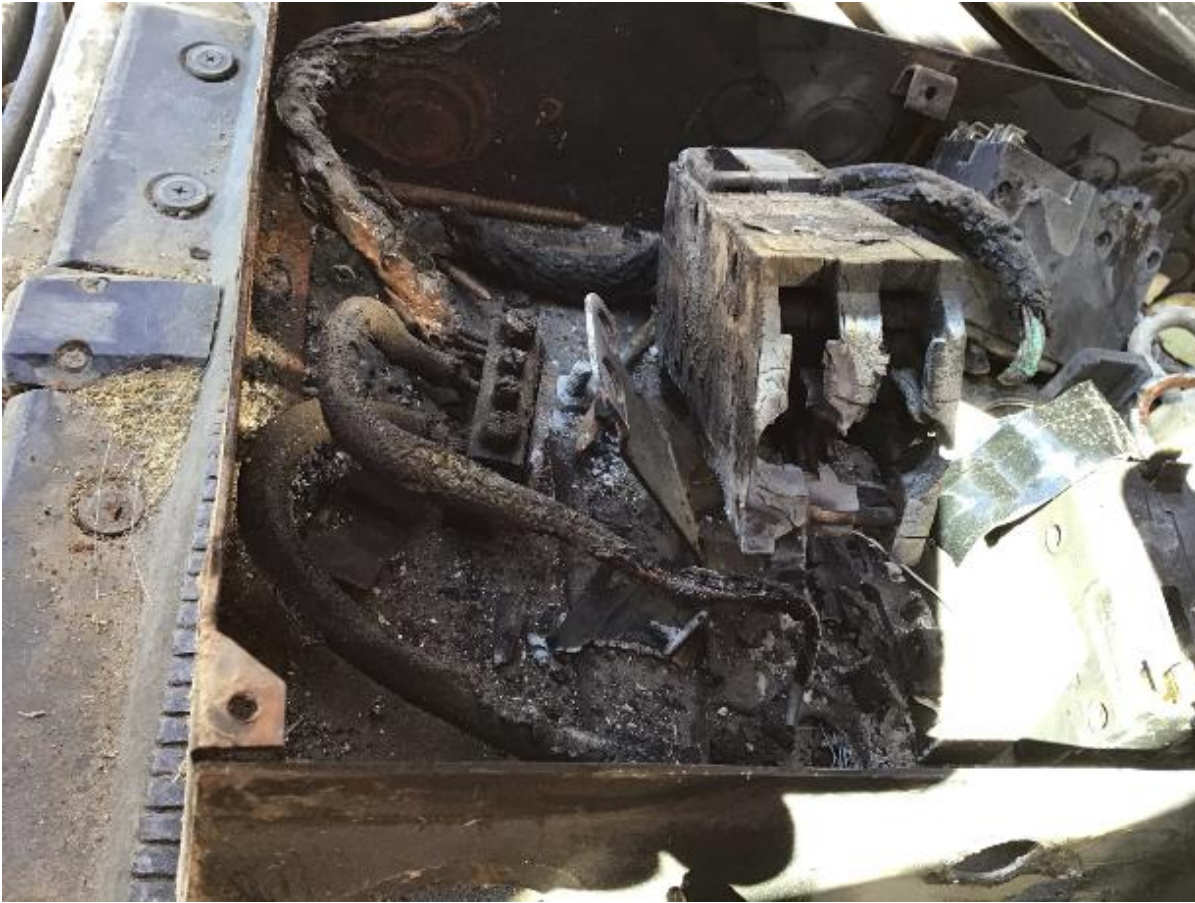
Photo #2

<p>-Plastic cases of the circuit breakers in panel and the insulation on the jackets of the wiring are flammable when exposed to a high enough temperature.</p> <p>-Fire damage was contained to panel and surrounding enclosure no other ignition sources found.</p>
Causes and contributing factors	<p>It is probable that the panel which was only rated to be installed in a dry location has been subjected to water and moisture while installed in an outdoor damp location. The introduction of water to the connection points internal to the panel built up corrosion over time and subjected the connections to higher resistance and heat than the components where designed for. The additional heat can cause an internal fire in the panel which would have been sustained with the fuel of the plastic parts used for insulation purposes.</p>

Source of heat and visible corrosion on wiring.

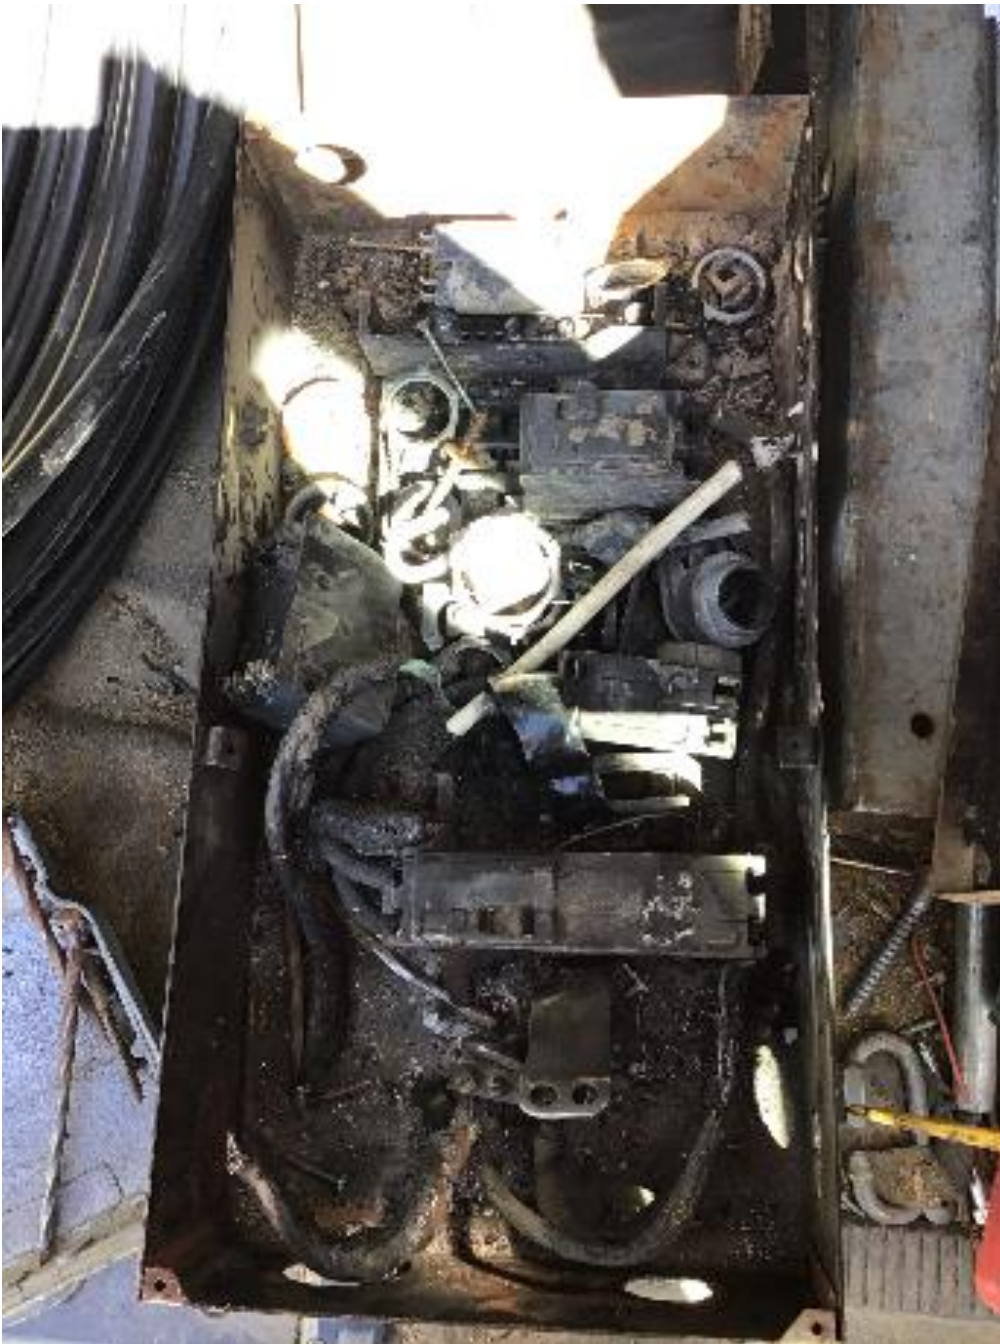
Photo #3

Panel after removal destroyed

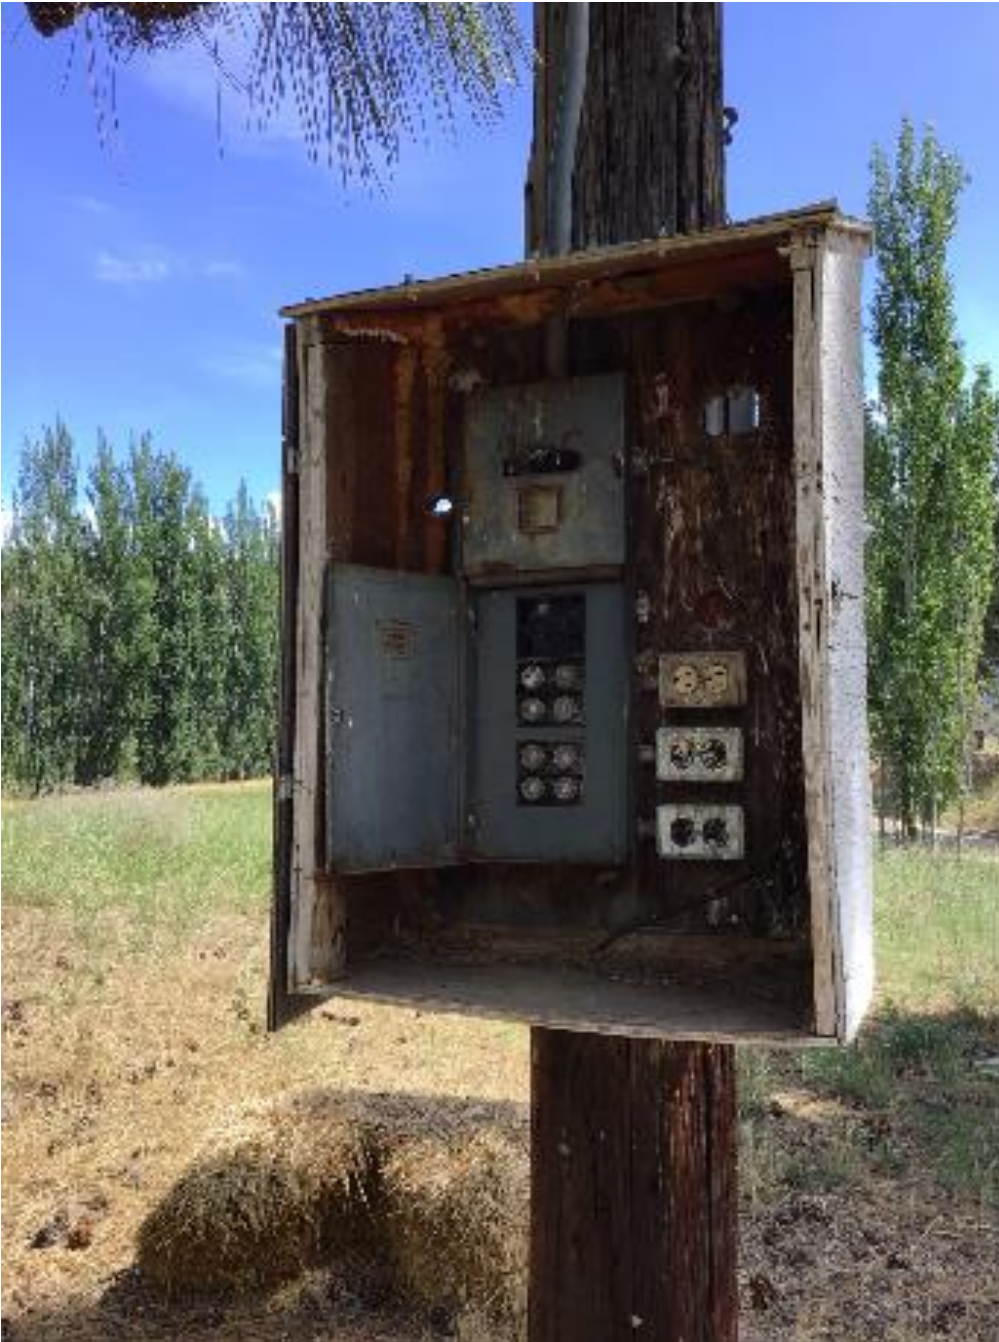
Photo #4

Enclosure of similar construction on same property. This service has been disconnected by owners since the fire on the first service.
