## Incident Summary II-682766-2018 (#7048) (Final)

SUPPORTING INFORMATION	Incident Date	April 30, 2018	
	Location	Port Coquitlam	
	Regulated industry sector	Electrical - Low voltage electrical system (30V to 750V)	
	Impact	Qty injuries	None
		Injury description	None
		Injury rating	None
	Damage	Damage description	Electrical sub-distribution panel board and its electrical equipment components of conductors, bus bars and over-current devices (breakers) damaged from fire contained inside panel board enclosure.
		Damage rating	Minor
	Incident rating	Minor	
Incident overview	A fire occurred in an electrical distribution panel board.		
INVESTIGATION CONCLUSIONS	Site, system and components	Approved distribution panel boards are approved for use, entry and connection of feeder and branch circuit conductors use and conductors must be terminated with correct tightness as per approved terminal torque tightness ratings specified for approved equipment. Other foreign materials, such as cardboard paper, are not approved to be installed or used within approved electrical equipment.

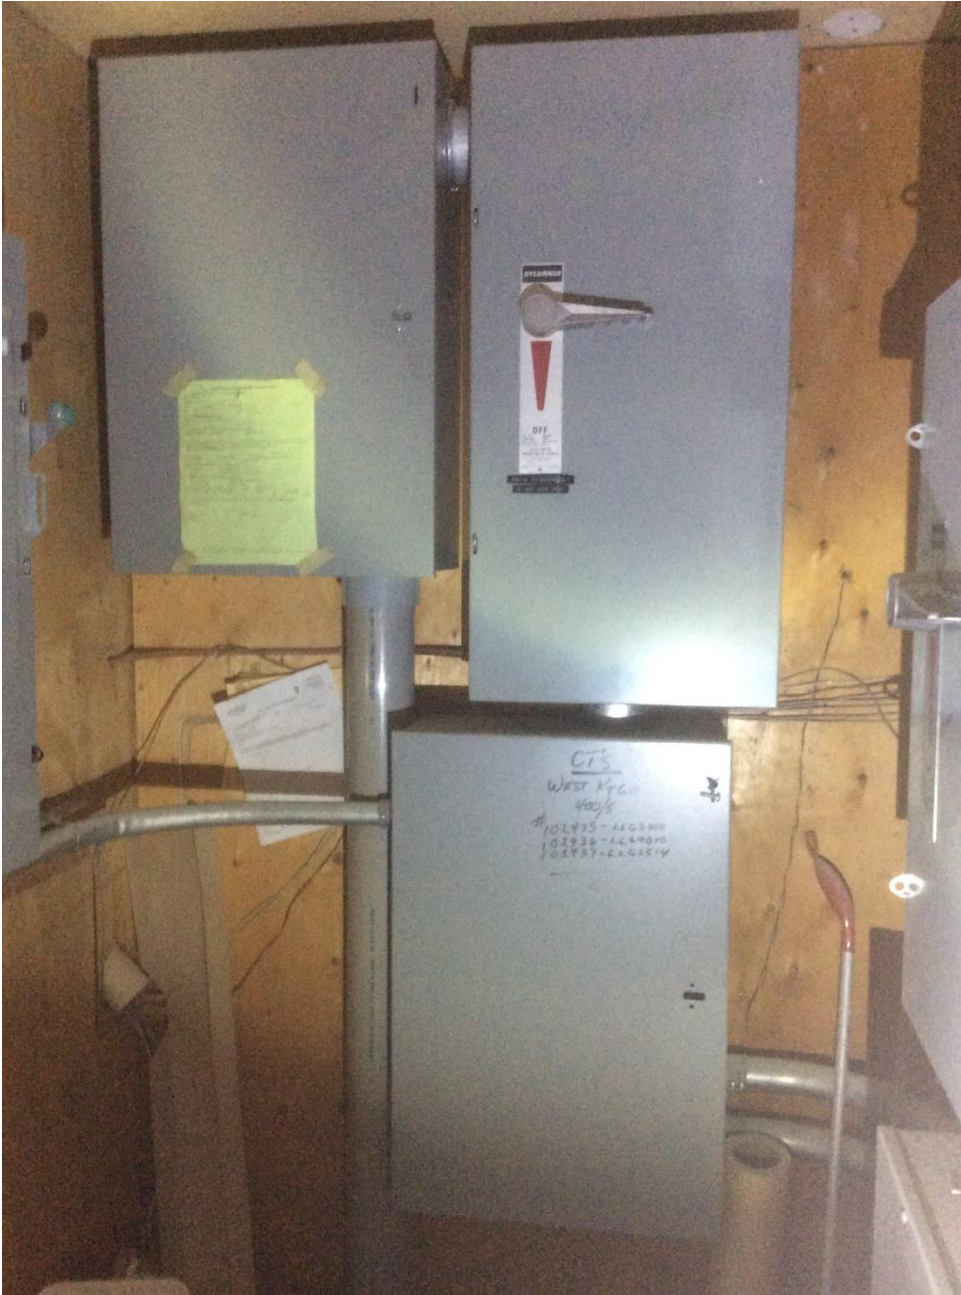
Photo #1 Main electrical room with 400amp 120/208 volt main service from utility hydro.

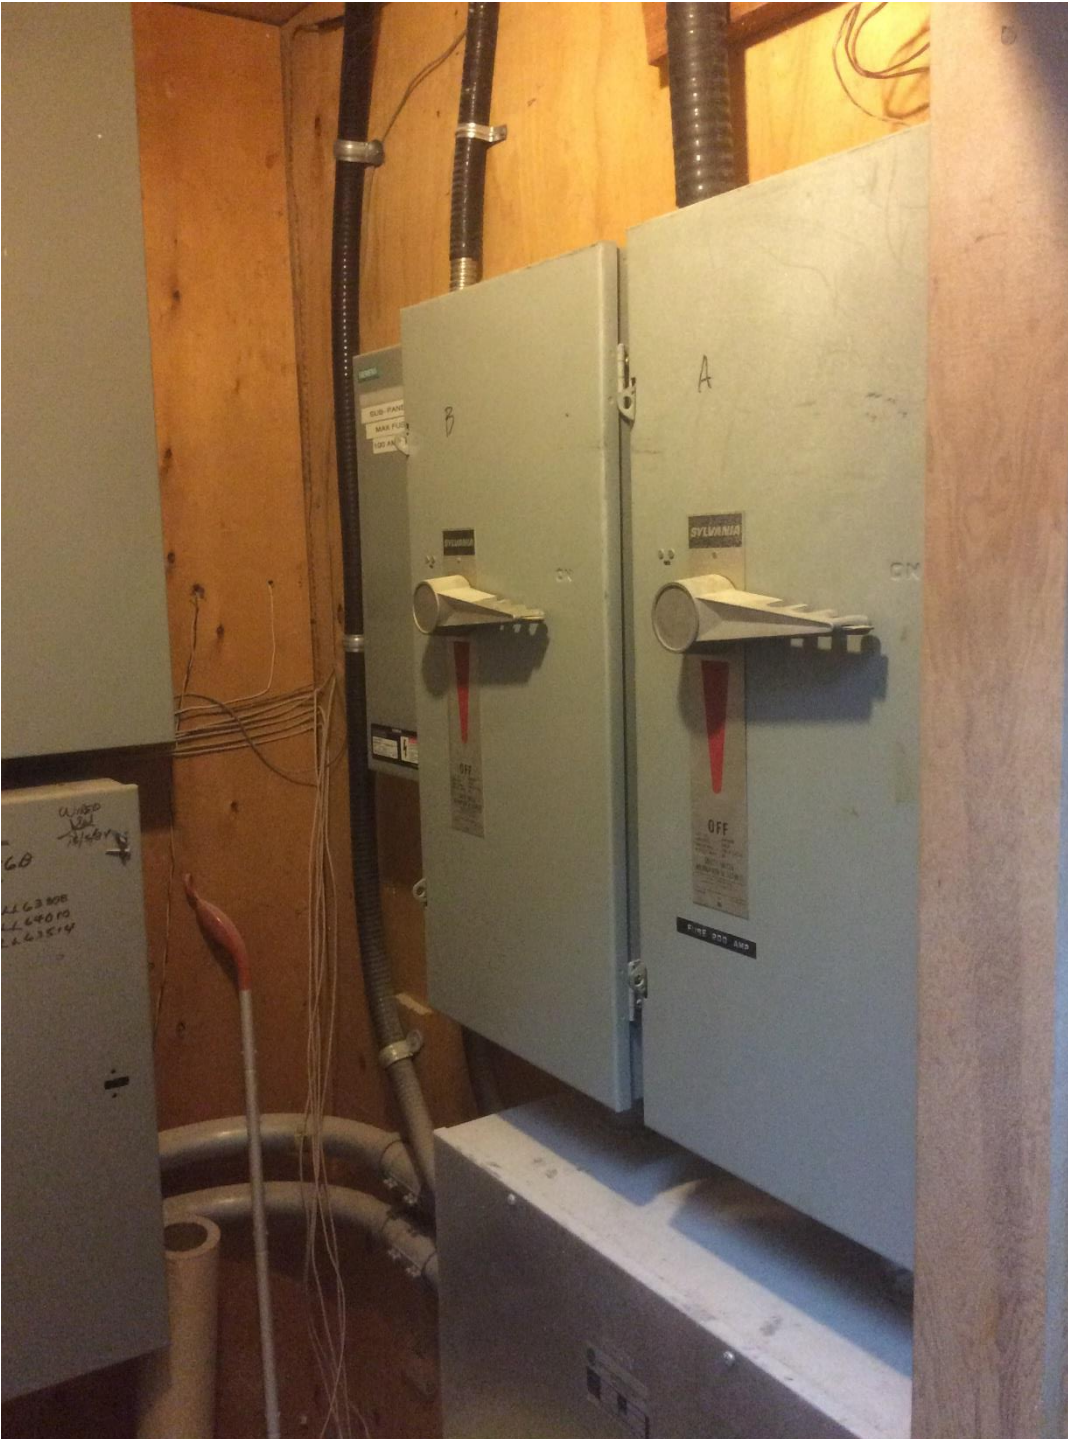
Photo #2 Main electrical room with sub-distribution feeder disconnects on right which feeds sub-panels on other side of this wall where electrical fire occurred.

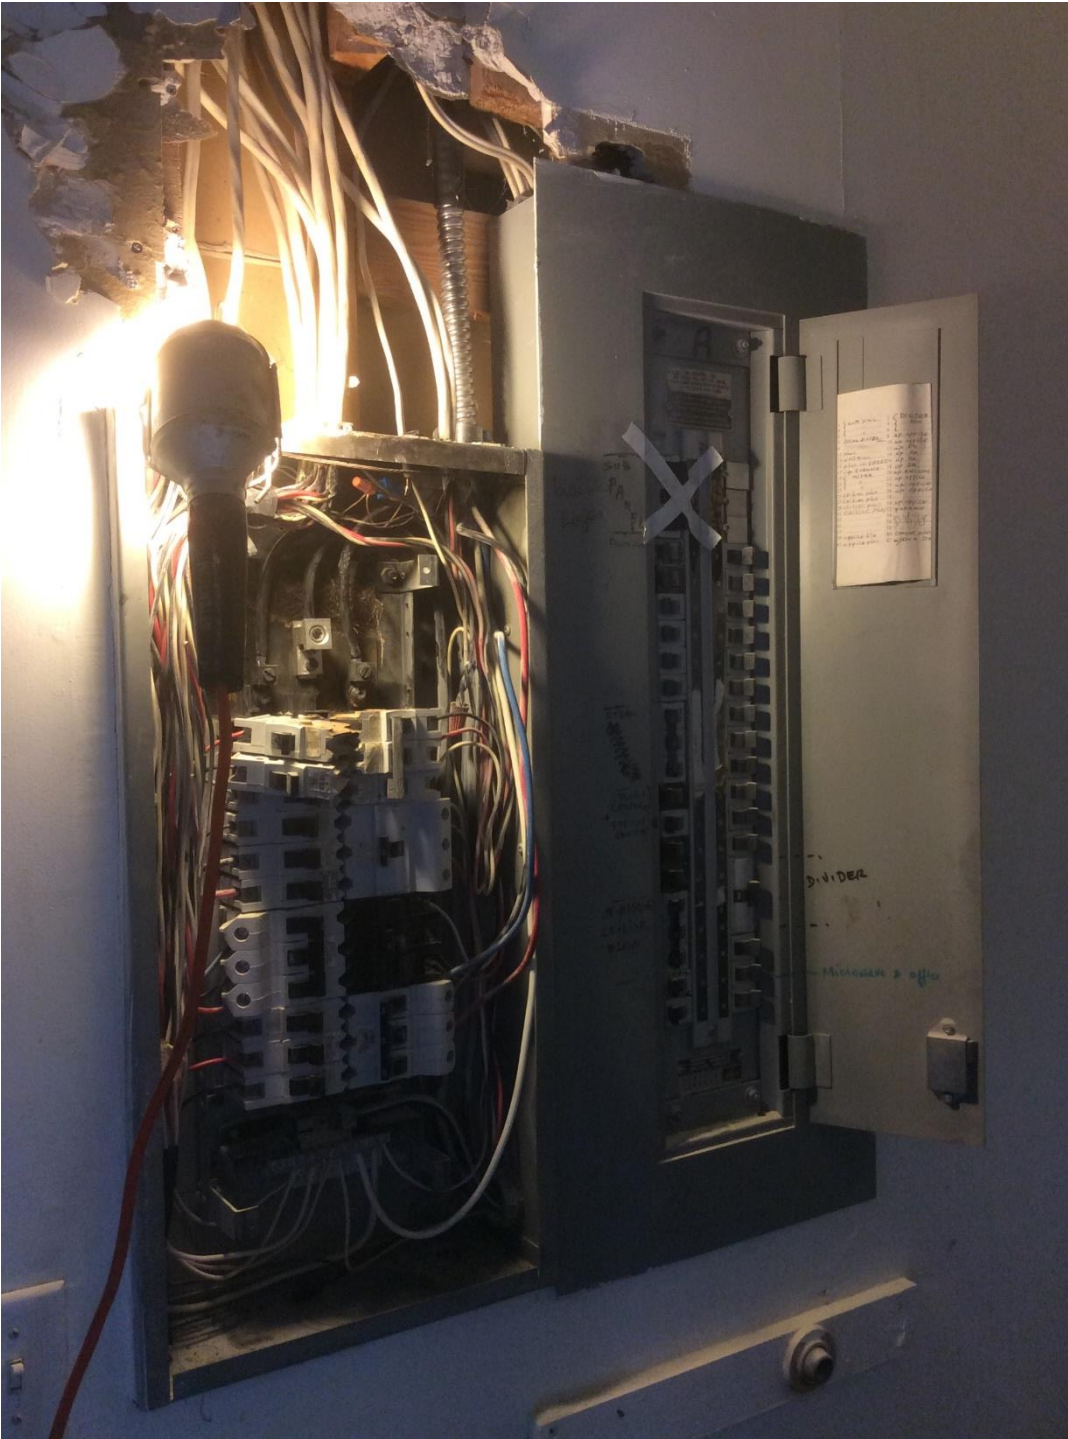
Photo #3 Sub-distribution panel on opposite side of wall where feeder disconnects are. Panel board on left is where electrical fire occurred. Panel board on right is fed from power from panel board on left via a breaker which has an "X" of white tape covering feeder breaker to leave OFF.

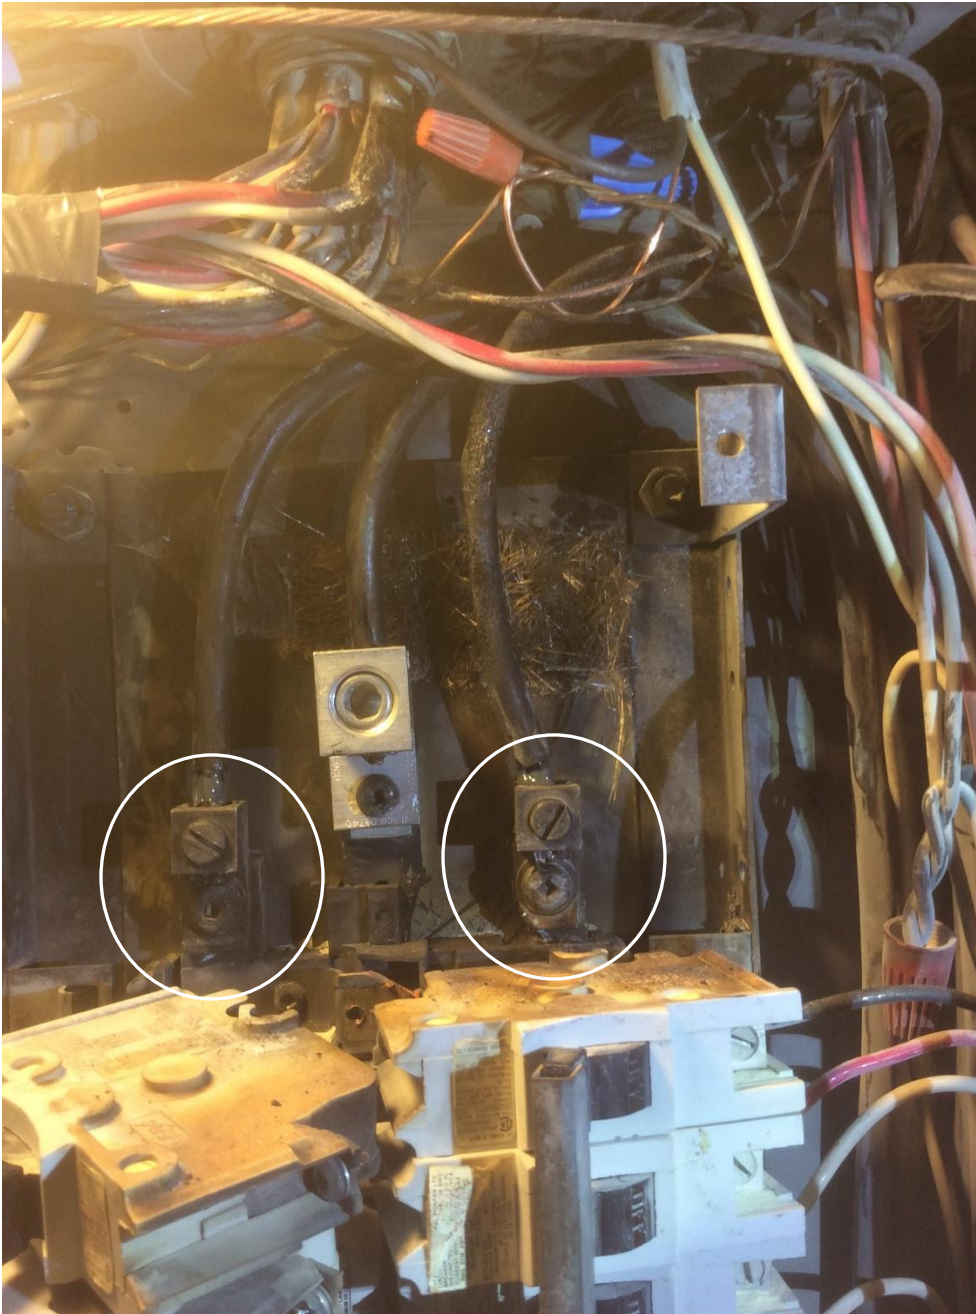
The fire was likely caused by loose terminal lug connections on conductors. It is possible that if the paper hadn't been inside the panel board near the feeder conductor terminal lugs, there would not have been a fire.

Photo #4 Panel board where electrical fire occurred in top portion of this panel at location of 3 feeder conductors terminated above the white breakers

If the owner had obtained an electrical operating permit with a proper maintenance program, a qualified individual would have checked and possibly found and corrected feeder conductor terminal lug connections, ensuring proper tightness and also removed cardboard paper from inside panel board.

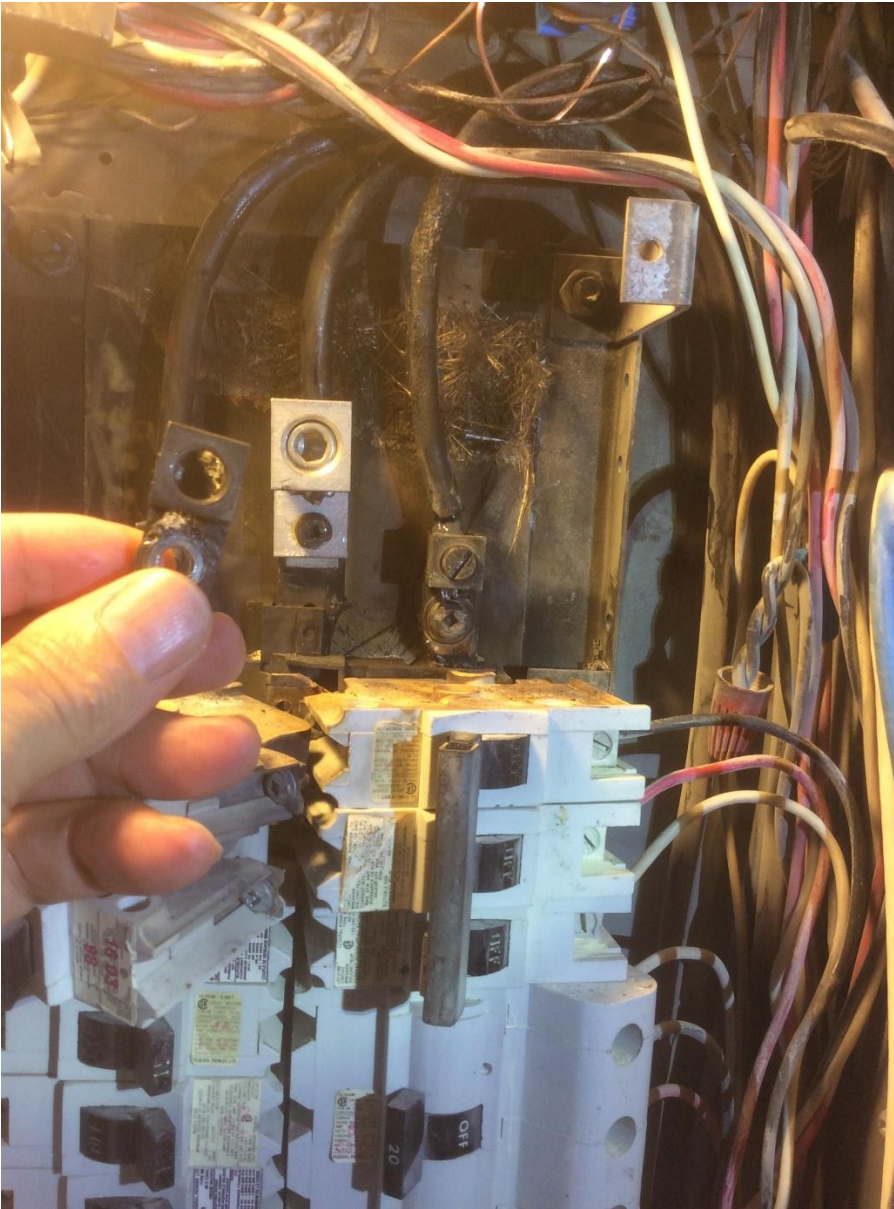
Photo #5 Person holding terminal lug in fingers is the one that was removed and replaced by shiny new terminal lug on middle phase of the 3 feeder conductor terminal lugs above

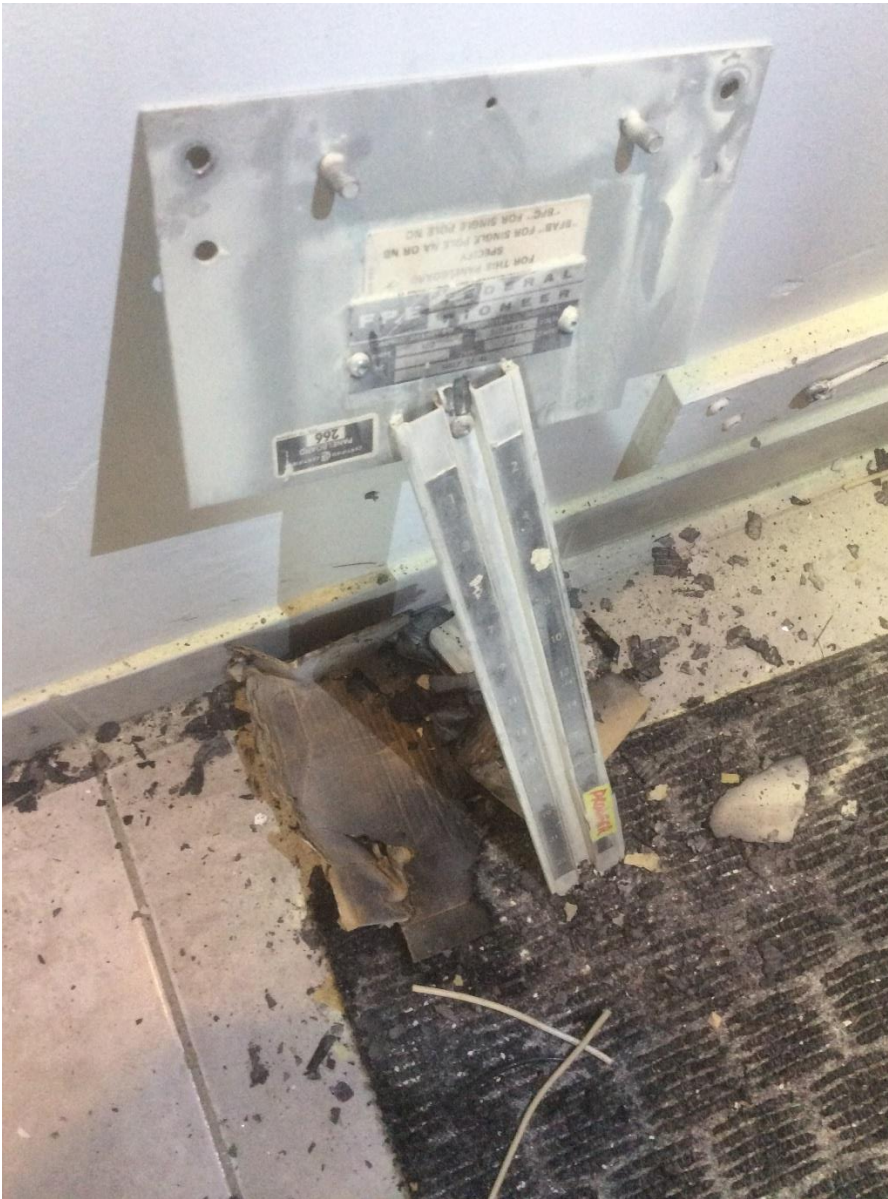
Photo #6 Remnants of the cardboard paper laying on the floor below panel board that electrician said was inserted beside terminal feeder lugs and paper caught fire near 3 phase terminal lugs

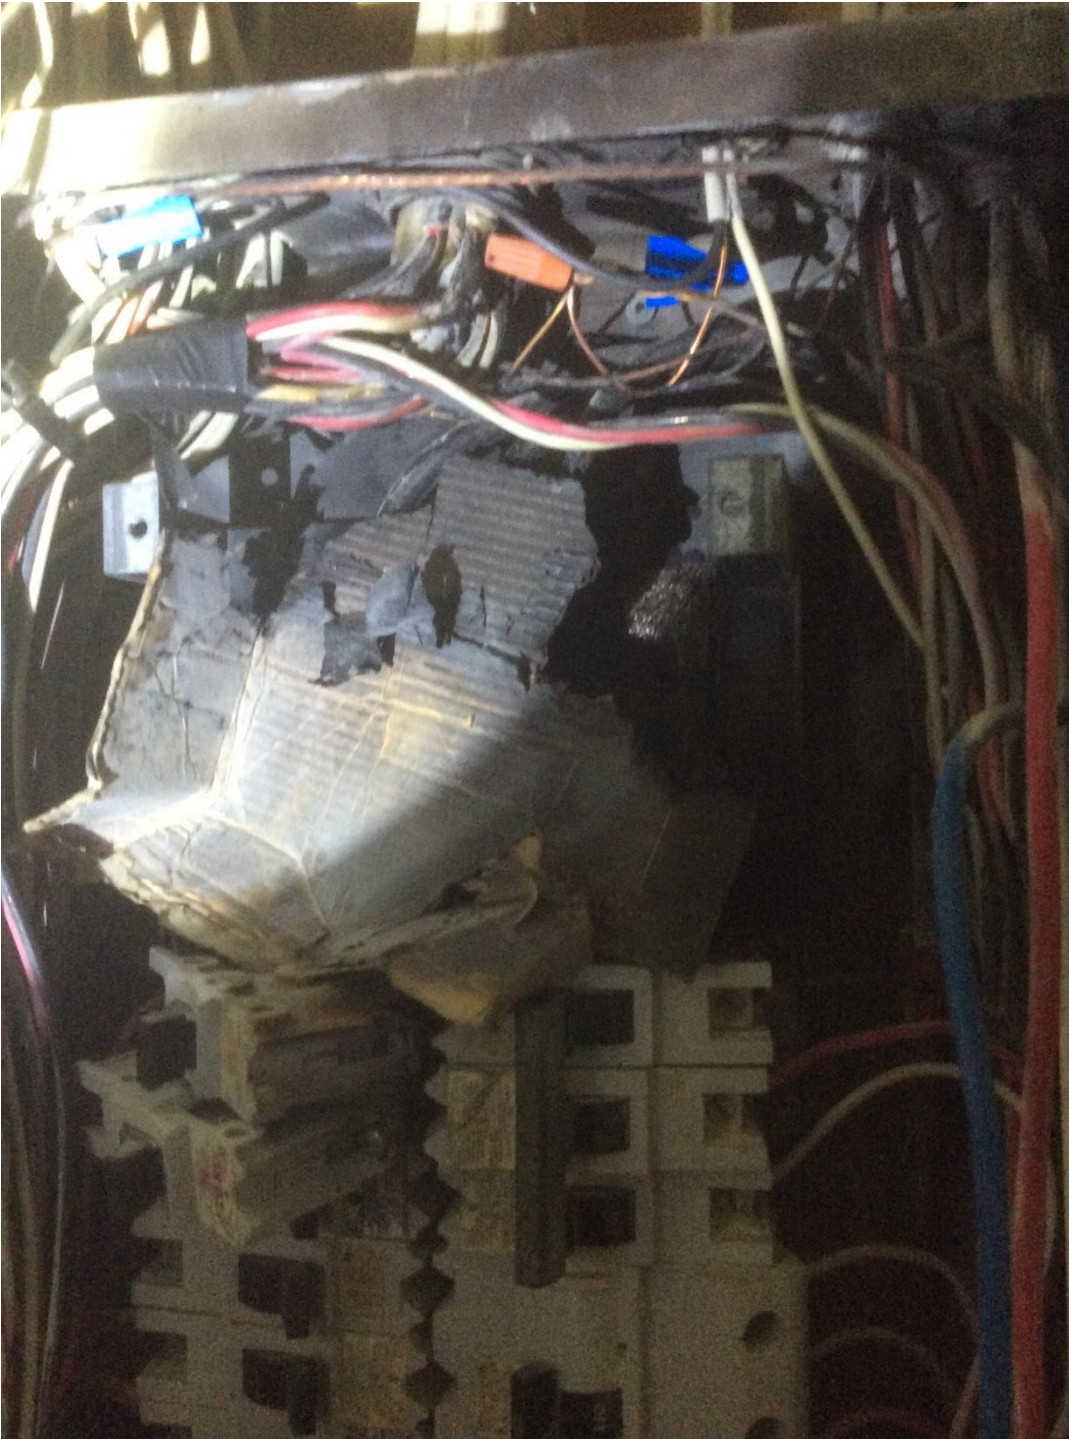
Photo #7 Picture of cardboard paper that is a mock-up and placed to show where cardboard was found installed and to exist and which caught fire near feeder terminal lugs that were loosely connected and overheated.

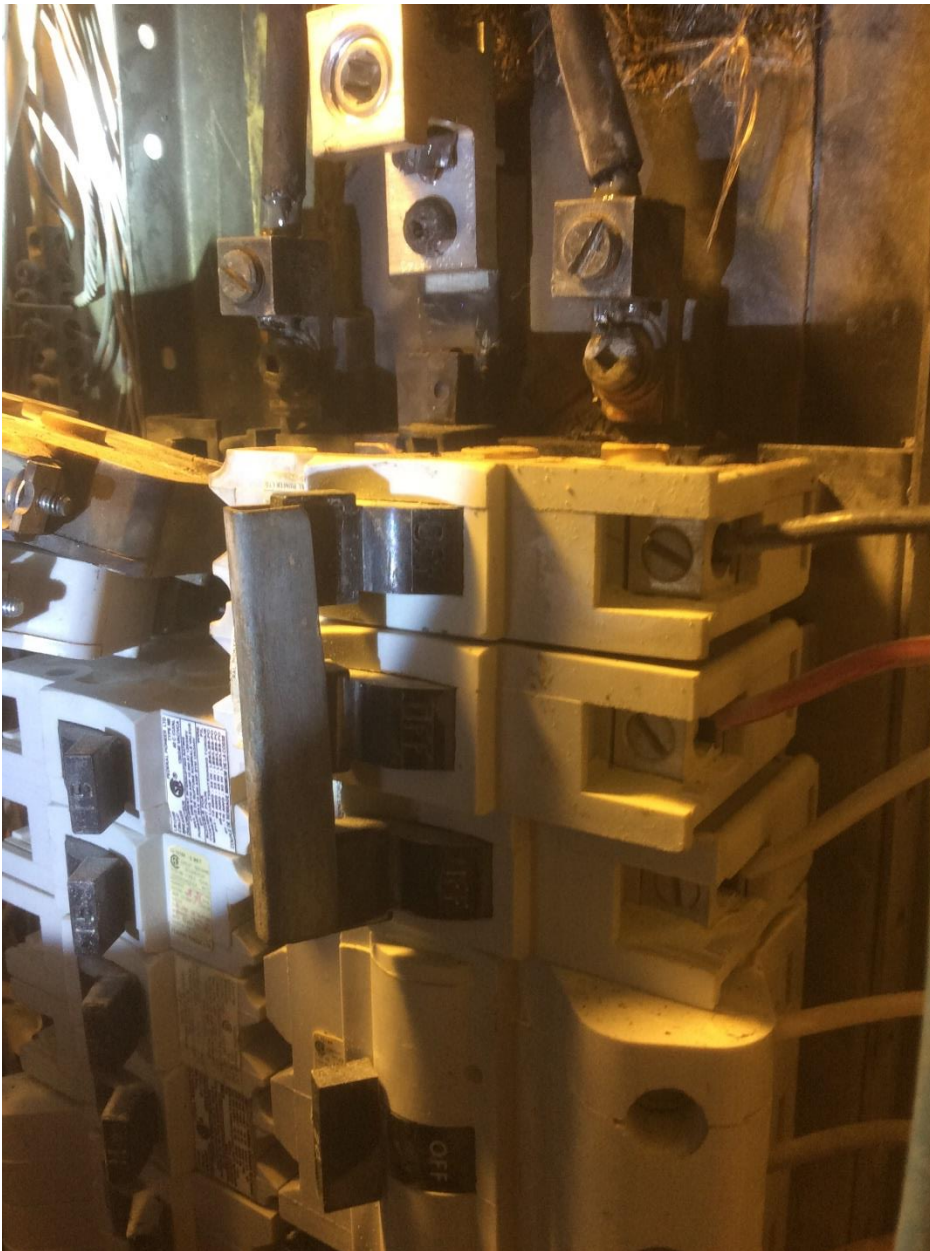
Photo #8 The previous existing terminal lug was removed and was replaced by electrician doing repairs as shown a shiny new terminal lug as compared to the other two burned and damaged terminal lugs.
