Incident Summary #II-845396-2019 (#12047) (FINAL)

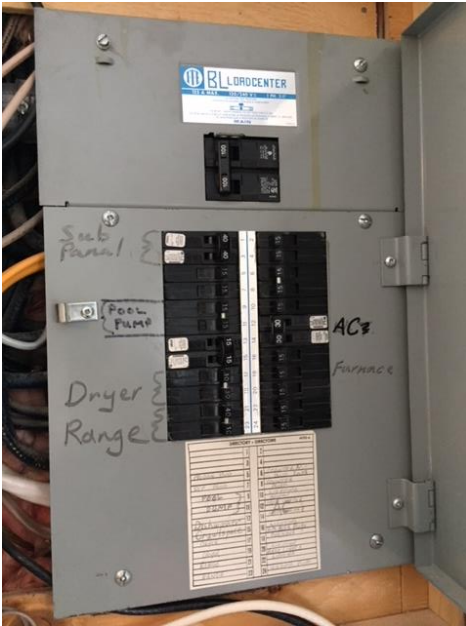
Photo 1: Subject panel board

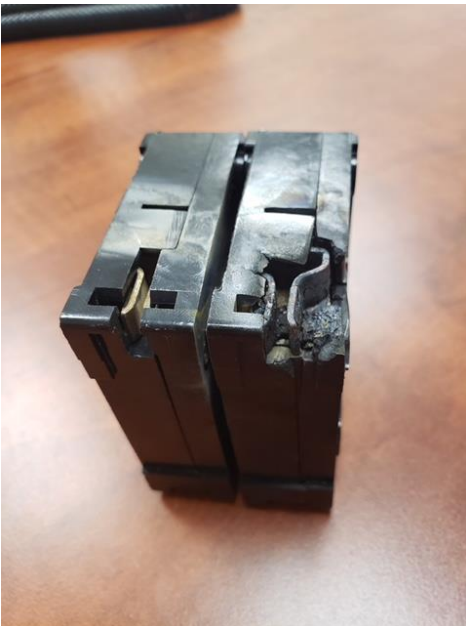
Failure scenario(s)	A high electrical load was placed on the main breaker and arcing occurred at the contact points between the main breaker and the panel buss.	
	Facts and evidence	<ul style="list-style-type: none"> - The panel was a 125 amp maximum, 120/240 volt 1 phase combination panel. The main breaker was rated for 100 amperes (amp) - The panel supplies a regular house load as well as an AC unit, pool heater and crawlspace heater. This load would be close to the maximum breaker rating of 100 amp. - The 100 amp main breaker and panel buss showed signs of overheating, pitting and arcing. - The breaker contact surface and the panel buss mating surface overheated and burned out the breaker which cut (interrupted) the power supply to the residence. - The main breaker and panel buss were misaligned and did not provide full contact between the two points. This produced gaps between the two contact points.

Causes and contributing factors	<p>The breaker and panel buss interconnection was unable to safely conduct the high current load placed on this breaker due to the condition of the breaker connection at the time of the incident.</p> <p>A contributing factor may be that the small contact surfaces of the breaker may be subject to overheating if misaligned.</p>

Photo 2: Burnt out breaker

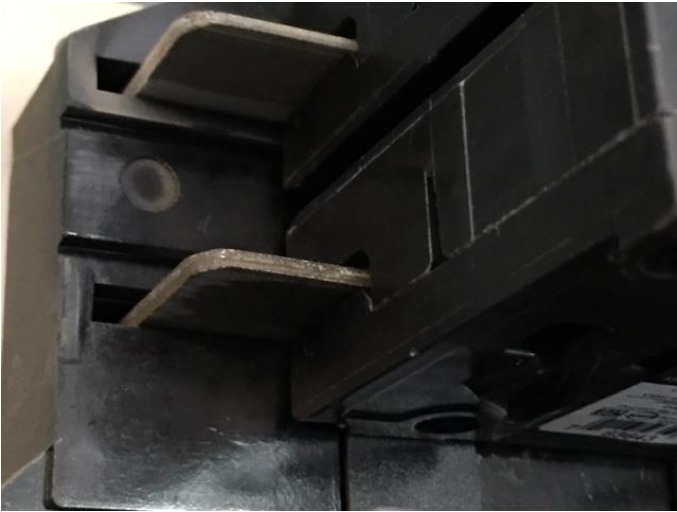
Photo 3: New breaker installed on refurbished buss work. Note slightly different colored buss material of lower component

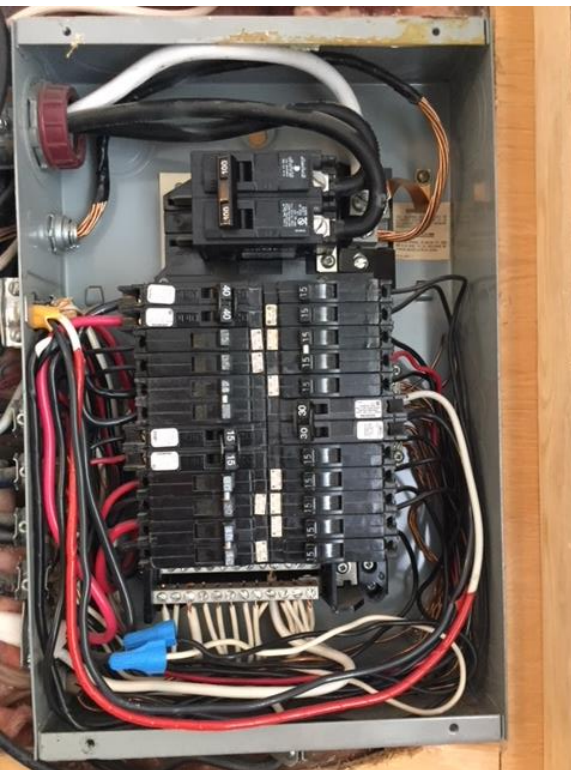
Photo 4: Repaired installation
