Incident Summary #II-911227-2019 (#15344) (FINAL)

SUPPORTING INFORMATION	Incident Date	September 23, 2019	
	Location	Black Creek	
	Regulated industry sector	Electrical - Low voltage electrical system (30V to 750V)	
	Impact	Qty injuries	0
		Injury description	NA
		Injury rating	None
	Damage	Damage description	200A main breaker destroyed.
		Damage rating	Moderate
	Incident rating	Moderate	
Incident overview	The occupant of a house noticed a burnt smell in the evening around 10:30pm. He went to the electrical panel where the smell was coming from and heard a buzzing sound. He contacted a neighbour who is an electrical contractor who turned the main breaker off. The panel was replaced the next day.		
INVESTIGATION CONCLUSIONS	Site, system and components	When properly installed this 200Amp 240Volt residential service panel is rated to carry a continuous load of 80% (160Amp). To prevent overheating, the main breaker will trip if the continuous load of 80% is continuously exceeded or under short circuit conditions.

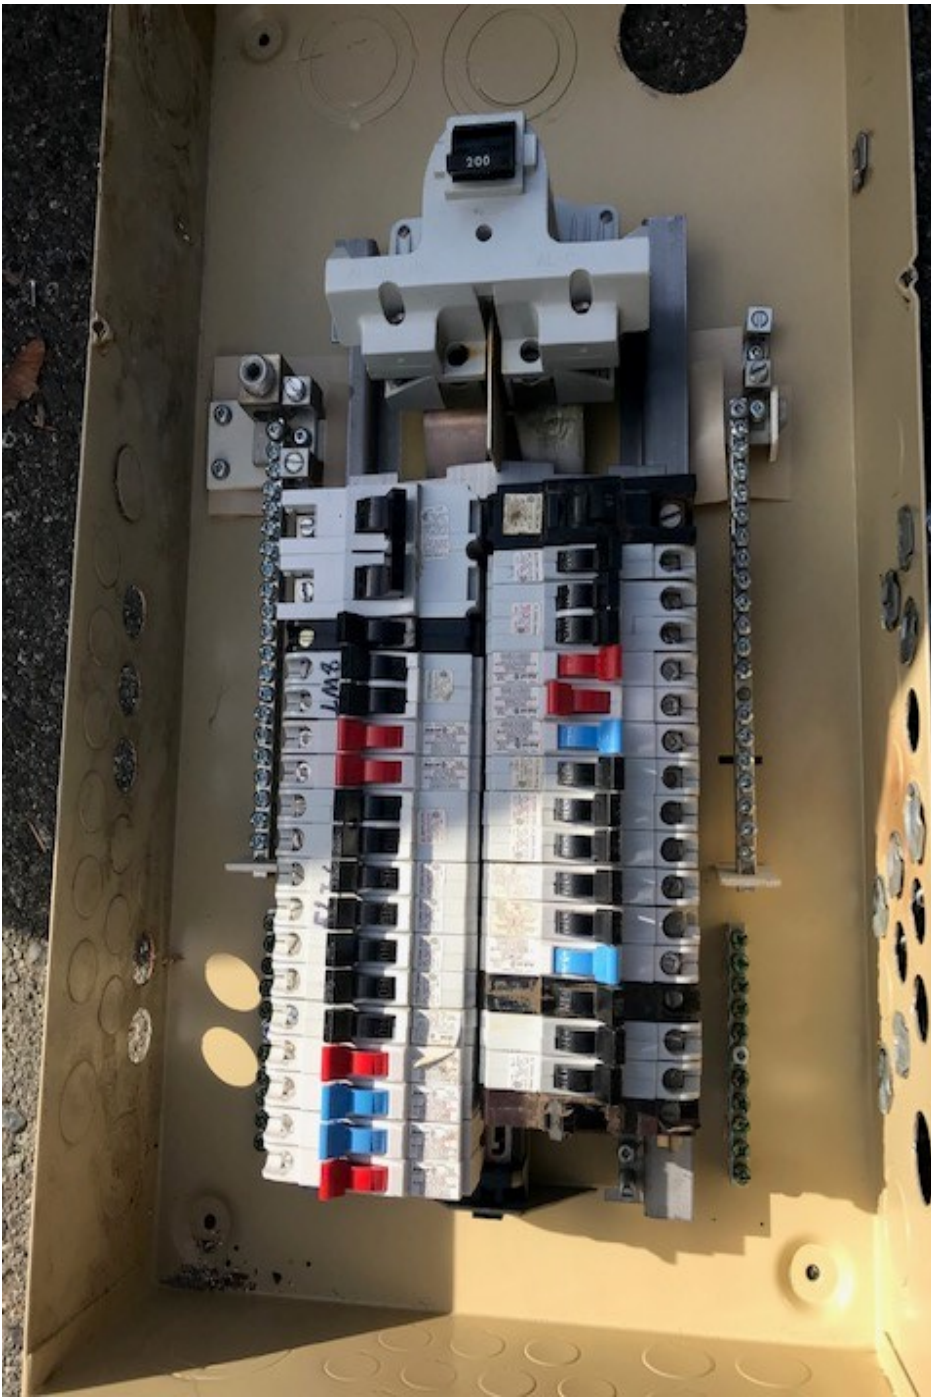
Photo 1: FPE 200A breaker panel removed

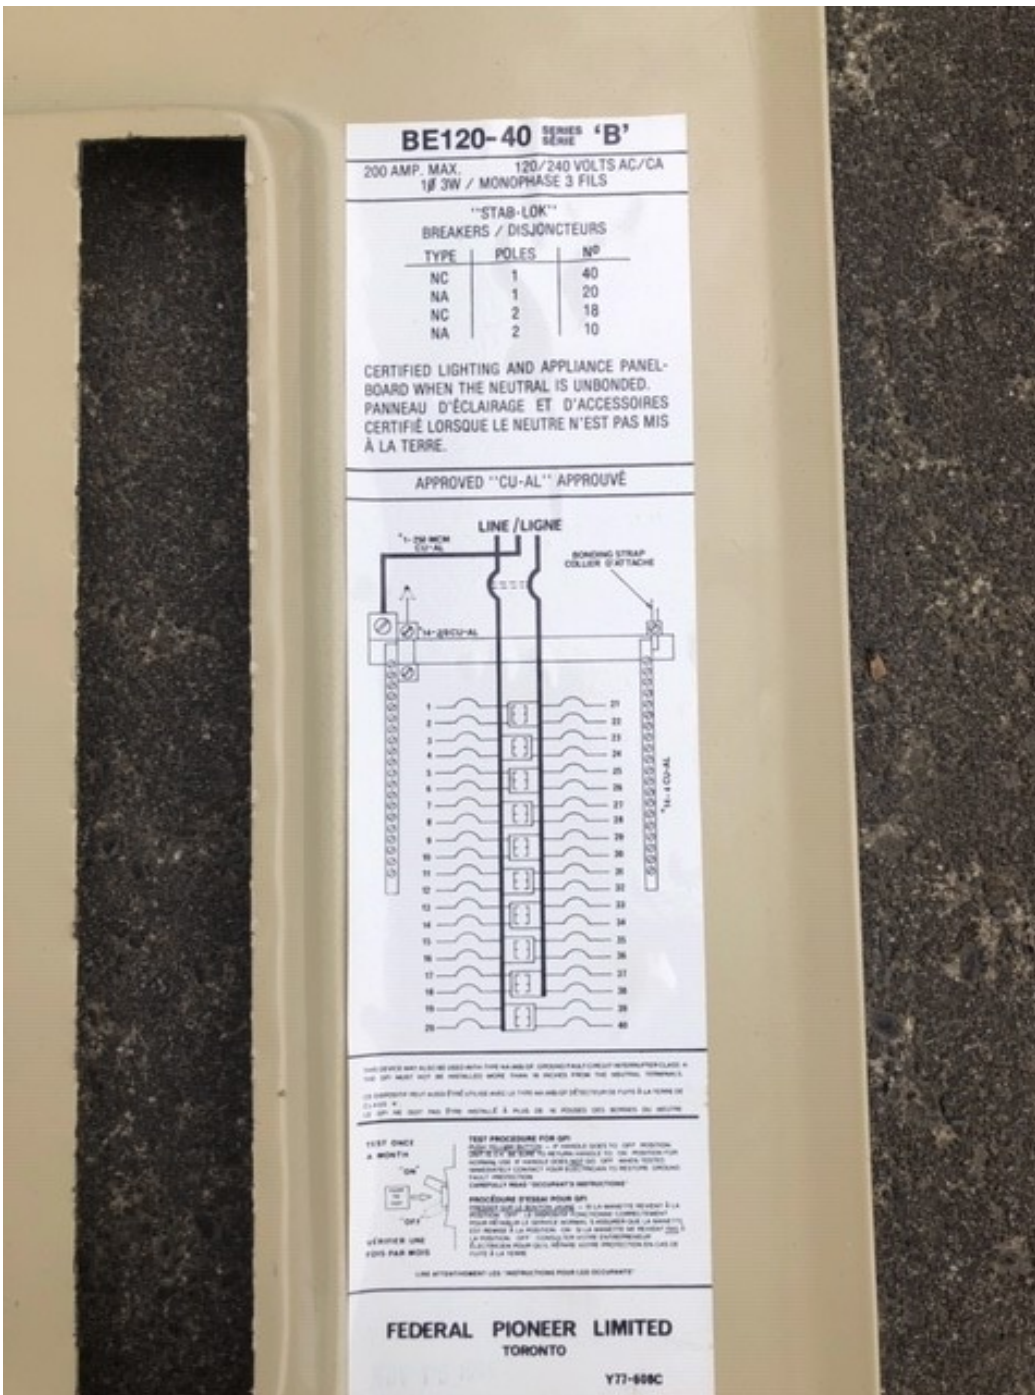
Photo 2: Panel cover

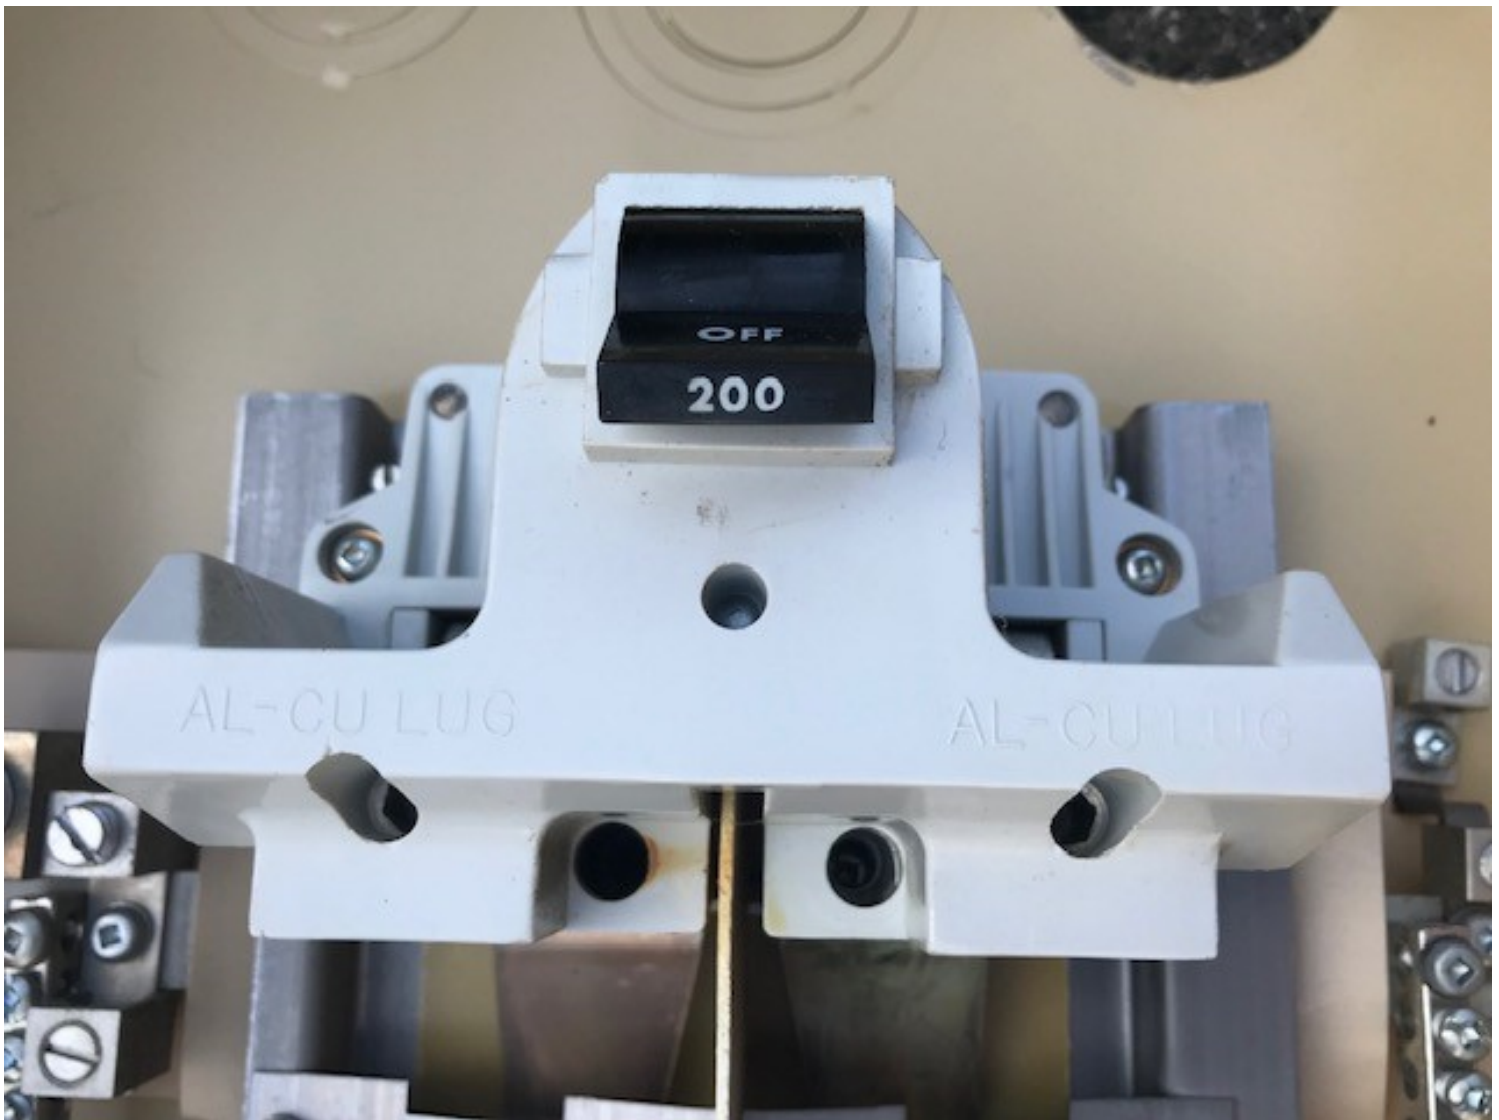
Photo 3: 200A breaker with slight discoloration on the left buss screw

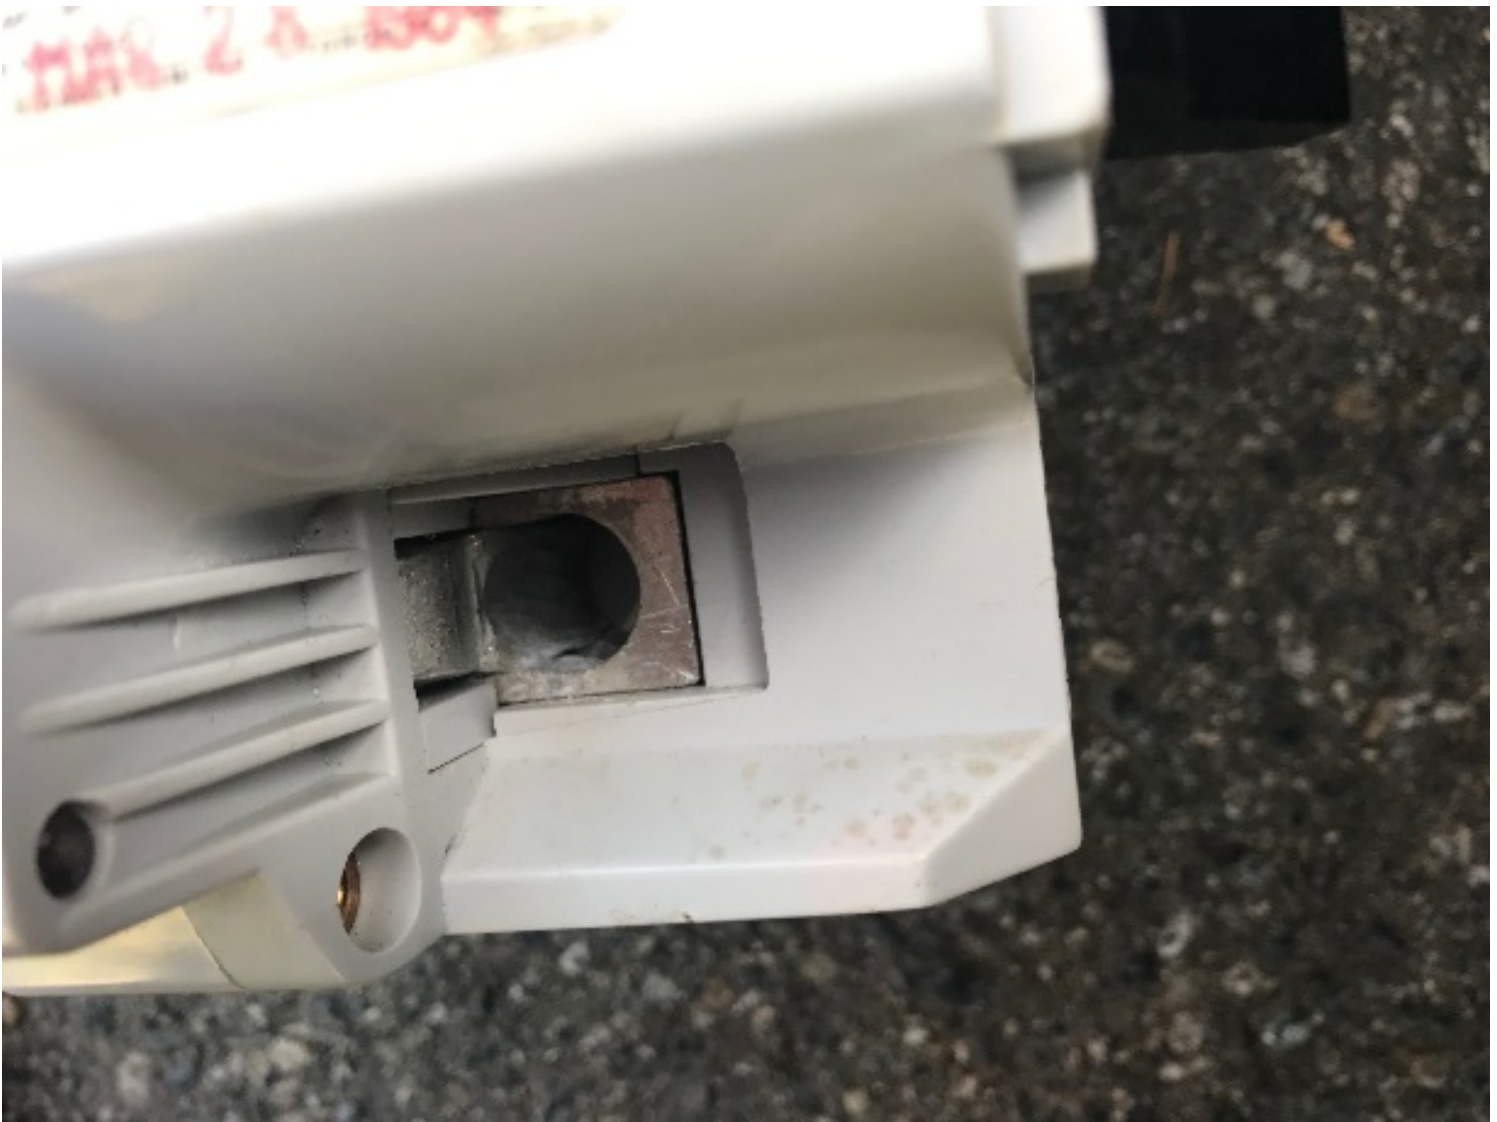
<p>SO observation of the panel after removal:</p> <ul style="list-style-type: none">• White powder was built up where the service conductor had terminated to the breaker (See Photo #4)• The plastic that holds the service conductor termination lug was burnt and broken (See Photo #5)• Electrical loads listed on the panel cover were within the normal of a residential 200A service
Causes and contributing factors	<p>The cause of this incident was likely due to a poor electrical connection where the service conductor terminates at the breaker. During the field installation it is probable that factory torque specifications for the service conductors may not have been met and over time got worse as did overheating until failure.</p>

Photo 4: Breaker cable termination shows white powder

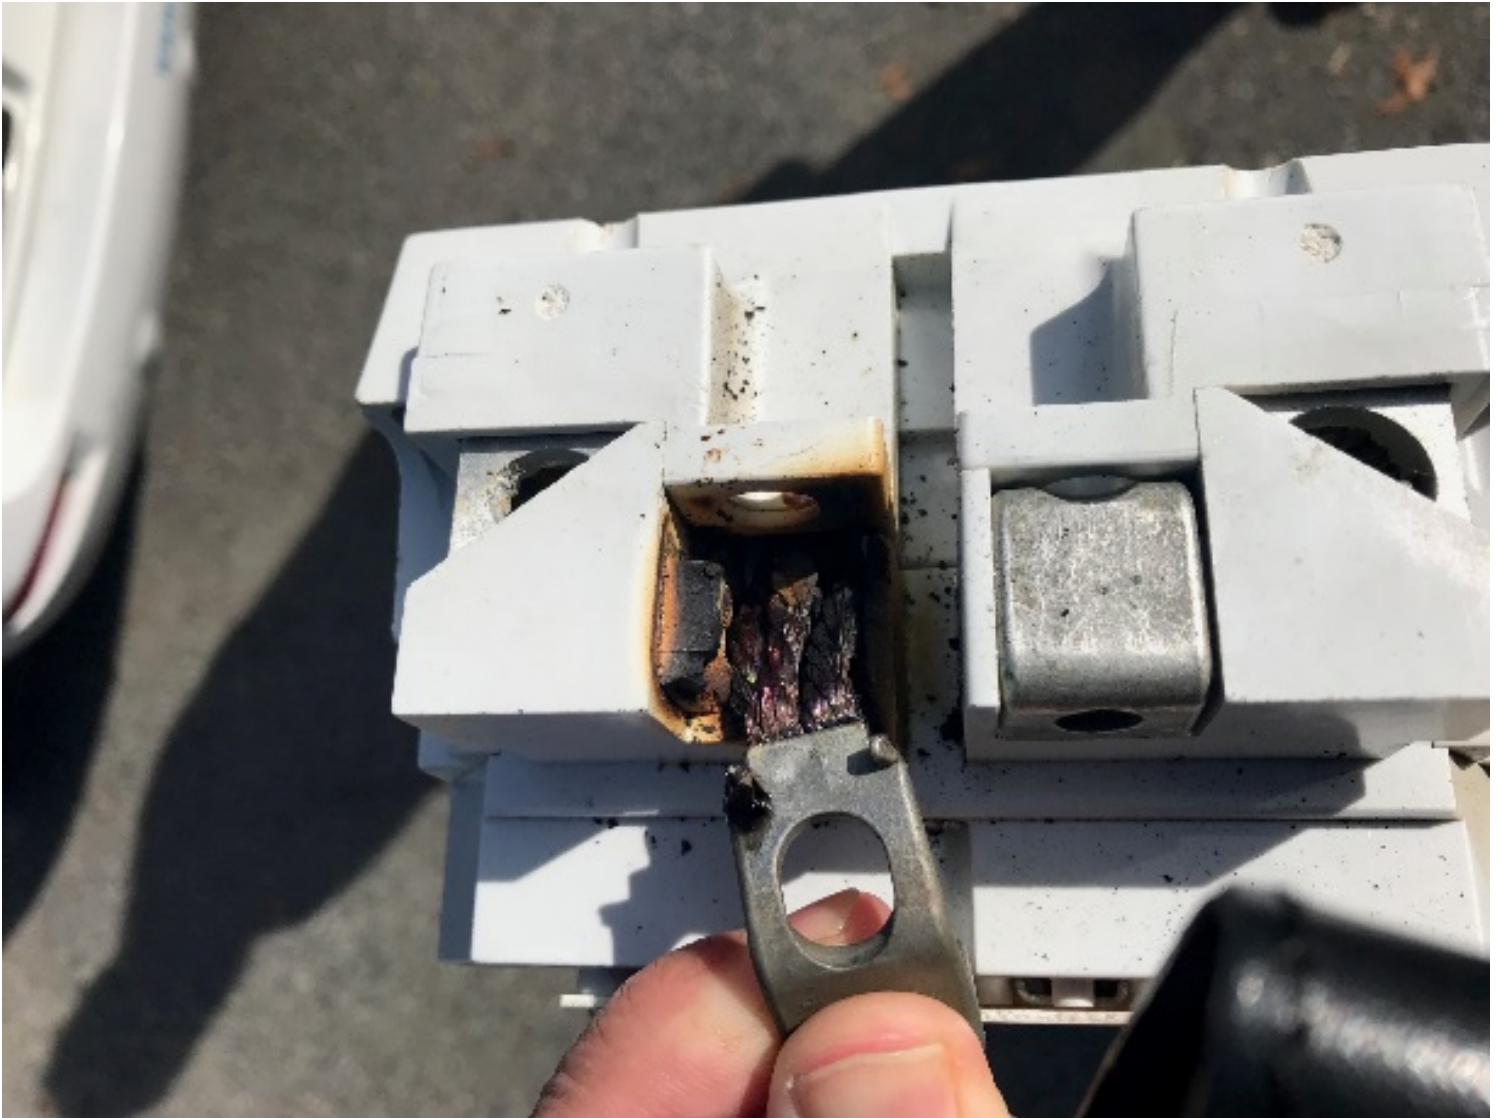
Photo 5: Breaker to buss contact melted apart
